Dakota Territory Air Museum's P-47 Update

by Chuck Cravens

AIRCORPS AVIATION

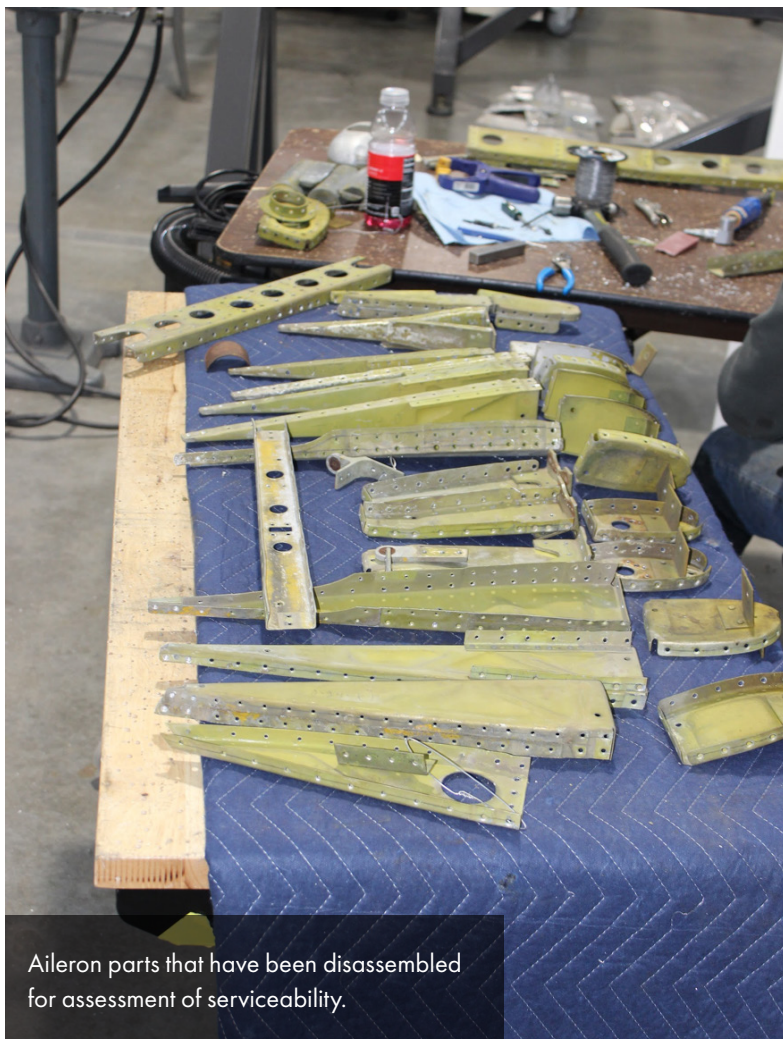
Aileron parts that have been disassembled for assessment of serviceability.

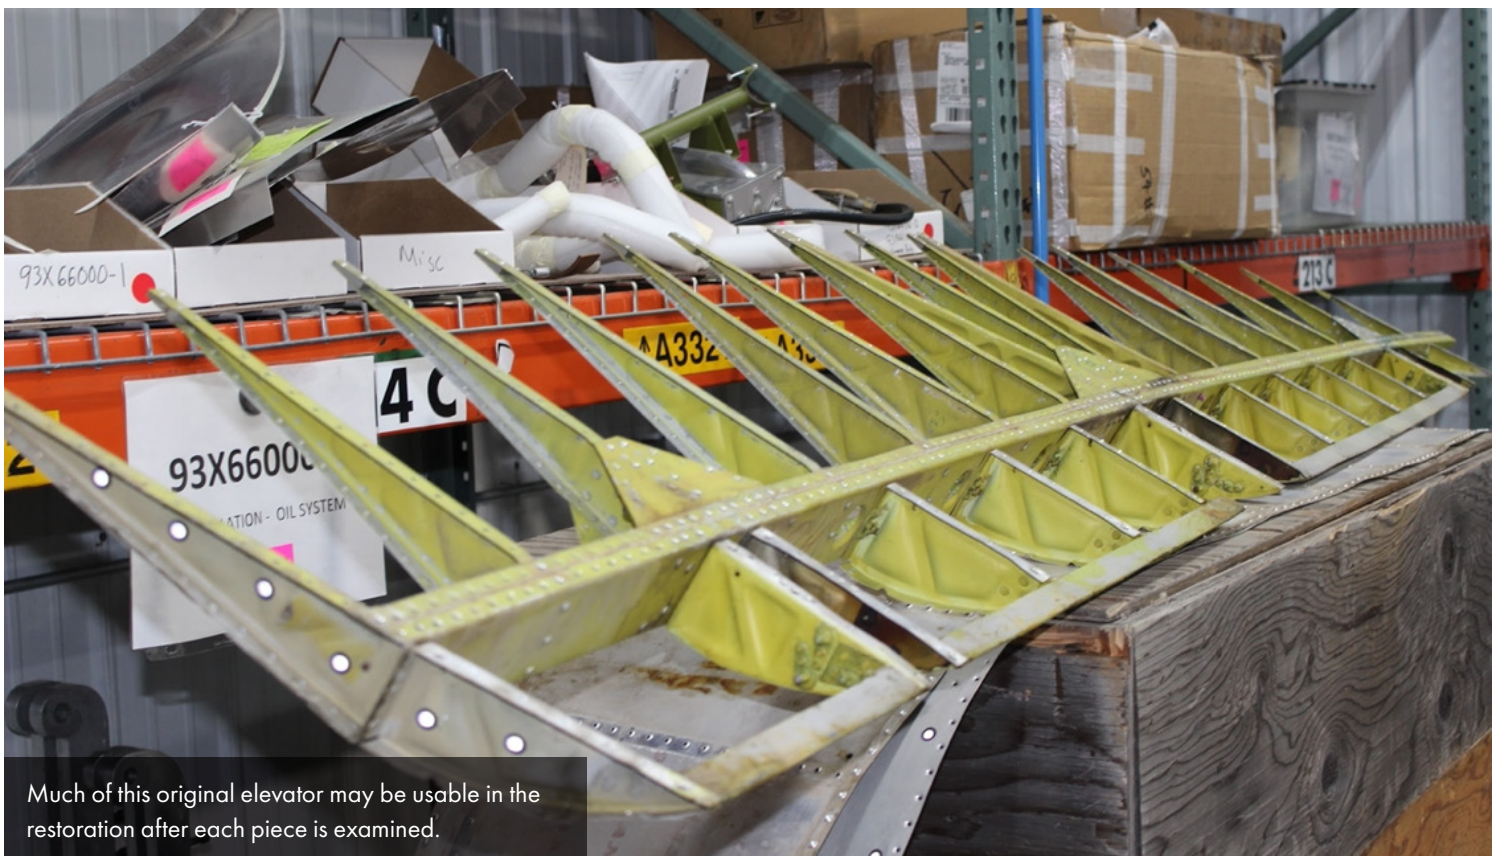
Much of this original elevator may be usable in the restoration after each piece is examined.

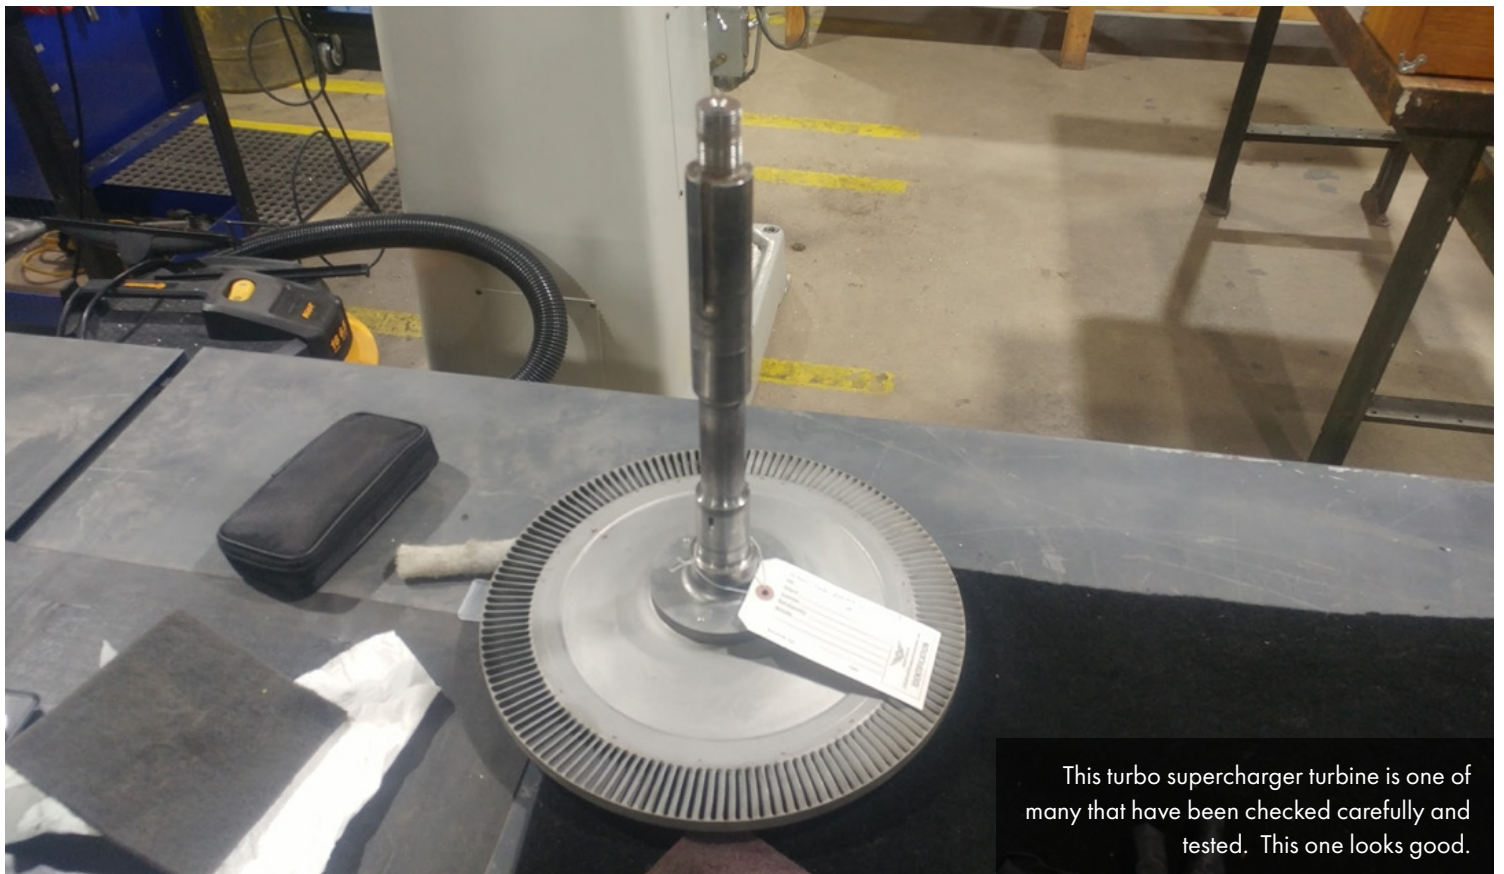
This turbo supercharger turbine is one of many that have been checked carefully and tested. This one looks good.
