Landing Gear Retraction Rod End Failures & Safety Spring Installation

All P-51 Mustang Variants

Manufacturer	North American Aviation
Aircraft	P-51 Mustang
NAA Part Number	<u>73-33578-3</u>
Rod End Manufacturer	ATE-6N (Schafer)
P/N	
Proper Description	ROD ASSEM - LANDING GEAR RETRACTING STRUT CONNECTING
Location	One assembly is located in each main landing gear wheel well
Nickname	Gear Links / Landing Gear Rod Ends

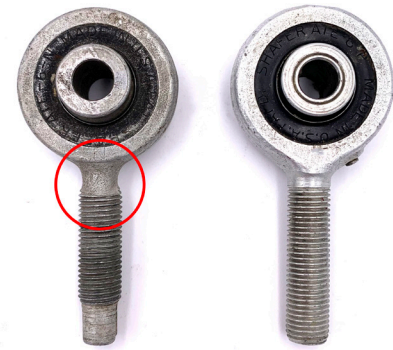
The difference between the often referred to light or heavy landing gear retract rod ends can be seen in the neck / transition from the threaded end to the rod end assembly and in the slot that was cut for the AN392-21 pin to hold the rod end in place.

The early or "light" version of the Schafer Bearing Corporation ATE-6 / #A-7462 had a narrower neck in which the diameter reduced in size. This lightweight "Schafer Special Bearing" also had a .125 inch slot cut in the threaded end of the assembly used on 73-33578. The early ATE-6 rod end was slotted and then it was given North American Aviation part number 73-33582 - END - LDG. GR. RETRACTING STRUT CONNECTING ROD. Interestingly, on the 73-33758 drawing in the title block bill of materials draftsmen noted the changes and updated the later assembly 73-33578-3 but never updated the title block on the earlier versions of the rod assembly. The earlier rod end 73-33582 was made inactive for future use on July 14th, 1943 and calling for all future procurement to use Schafer Bearing Corporation P/N ATE-6N / #A-7836.

Lightweight ATE-6N Rod End

Heavy ATE-6N Rod End

Note: Narrowing neck on early style lightweight ends

If you're replacing any parts 73-33578-3 ROD ASSEM – LANDING GEAR RETRACTING STRUT CONNECTING, ensure airworthiness prior to purchasing by inspecting for cracks, straightness, and finish. If swapping out ATE-6N rod ends, operators and maintainers should confirm them to be the heavier variant.

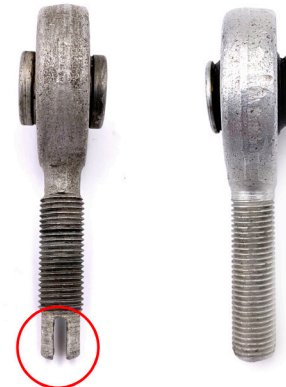
It is important to note that on the latest revision 73-33578-3 ROD ASSEM. - LANDING GEAR RETRACTING STRUT CONNECTING is to be set assembled to the 13" length and then the threaded end of ATE-6N was drilled for assembly with the AN392-21 pin. Per the assembly drawing, there is no slot cut in the ATE-6N rod end assembly on 73-33578-3. It is important to not be operating with lightweight rod ends, a number of operators have experienced broken rod ends as the result of using lightweight variants. If the rod end on the cylinder end of the rod breaks, the rod will fall and jam on the Sta. 61.5 wing rib. When an extension occurs after the rod breaks the landing gear will extend halfway and stop. With a rod jammed on the rib and a broken rod, the only option will be a gear up landing.

Lightweight ATE-6N Rod End

Heavy ATE-6N Rod End

Note: Narrow neck and .125 slot on early style lightweight ends

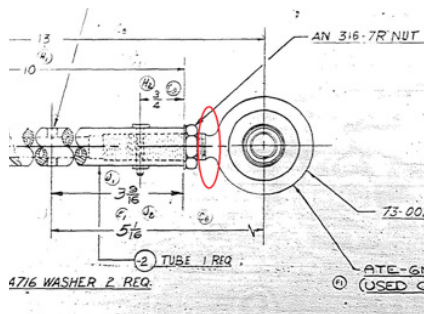
Failure Location # 1

The most common break occurs at the neck of ATE-6N or 73-33582 with the majority of failures occurring at the cylinder (inboard) side of the rod assembly.

Solutions offered: Replacement of Rod Ends

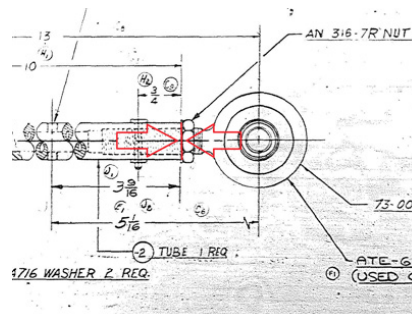
Failure Location # 2

In the threads at the check nut where the ATE-6N or 73-33582 meets the steel tube. Again a majority of breaks occur on the cylinder end.

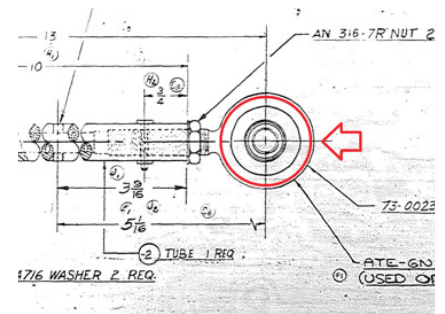
Failure Location # 3

The least common occurrence we have seen is a blowout of the shell on the ATE-6N or 73-33582. We have only seen this type of failure twice.

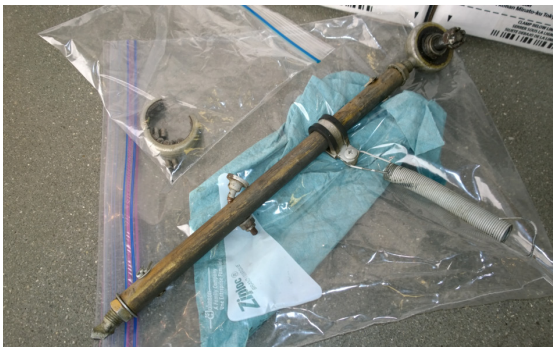
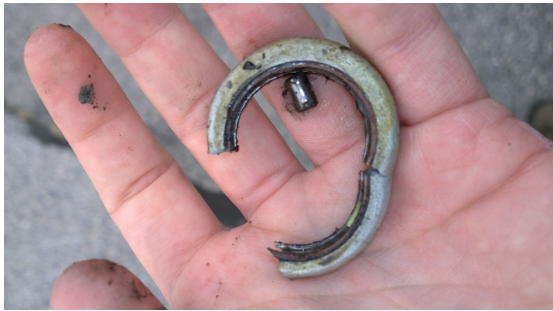
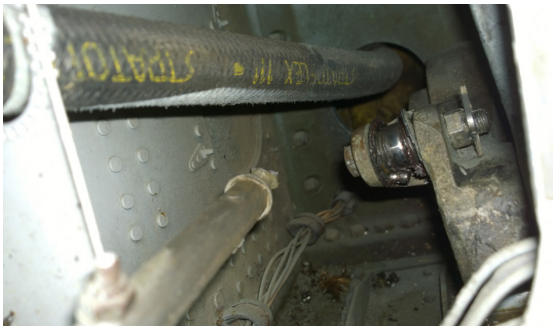
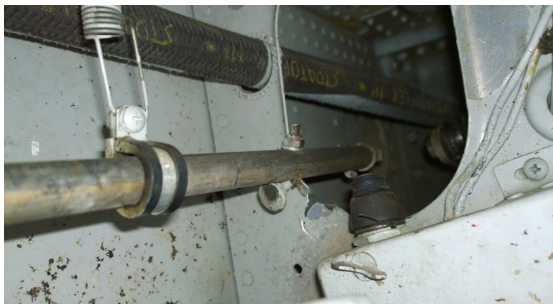
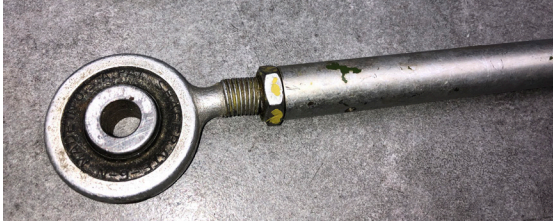
Examples of Broken Rod Ends

As the images to the left show, this end appears to have been rolled off - meaning the force applied to retract the gear has bent the rod end until failure.

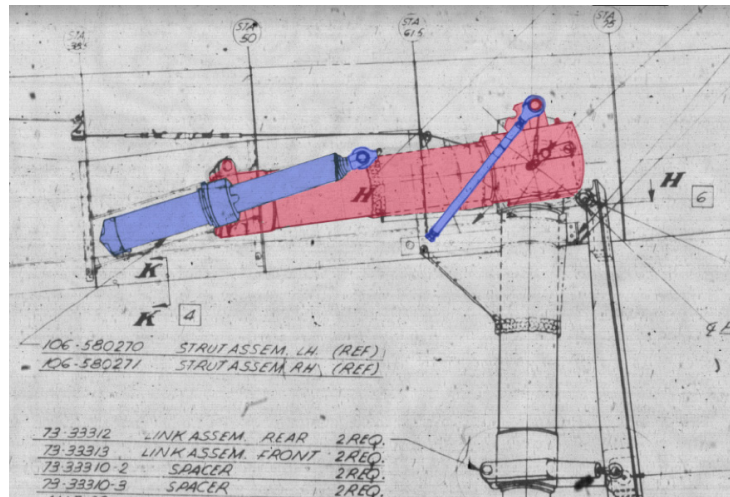
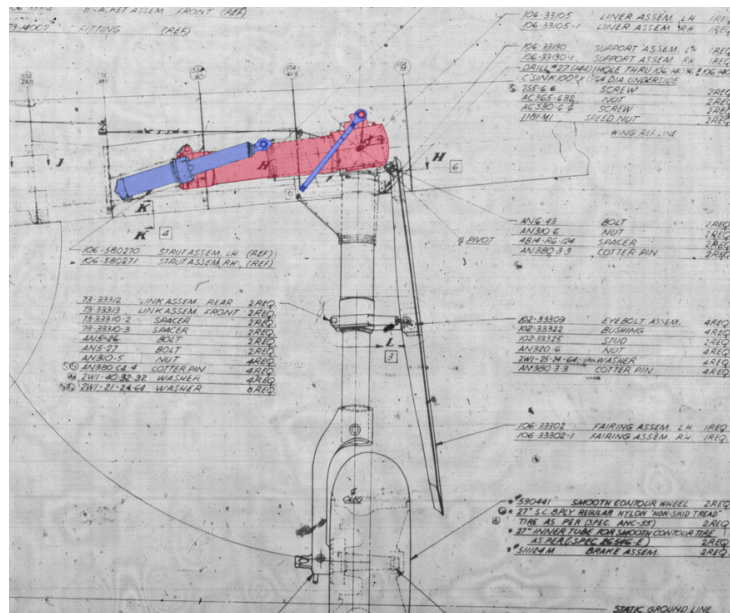
With the landing gear retracted, a failure at the cylinder end of 73-33578 Rod Assembly causes the broken rod to fall and wedge on the structural skin of the aircraft and rib at wing station 61.5. If the rod breaks and wedges on the rib, there is nothing a pilot can do to solve the problem in the air.

The rendering below simulates a broken retract rod with the landing gear upper cylinder in the up position indicated in red. The broken rod assembly, separated at the extended cylinder end is colored blue. The majority of the 73-33578 rod assembly will remain attached to the Arm Landing Gear Torque (Nicknamed the Porkchop). The rod assembly will wedge itself between the heavy skin and rib at wing station 61.5 and will prevent the landing gear from fully extending.
