Landing Gear Retraction Rod End Failures & Safety Spring Installation

All P-51 Mustang Variants

Manufacturer	North American Aviation
Aircraft	P-51 Mustang
NAA Part Number	<u>73-33578-3</u>
Rod End Manufacturer	ATE-6N (Schafer)
P/N	
Proper Description	ROD ASSEM - LANDING GEAR RETRACTING STRUT CONNECTING
Location	One assembly is located in each main landing gear wheel well
Nickname	Gear Links / Landing Gear Rod Ends

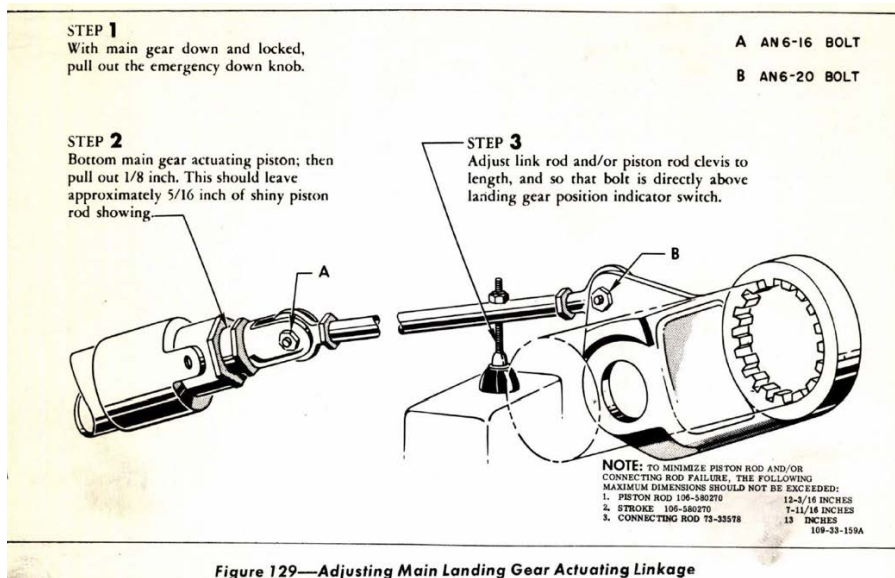
Figure 129—Adjusting Main Landing Gear Actuating Linkage

Because the hydraulic strut never fully bottoms in either direction, the rod assembly is constantly under pressure or tension at both ends of travel. Because of the hinge-like motion of the cycle, misalignment of the bearings will cause additional pressure and tension, and potentially failure of the rod ends.

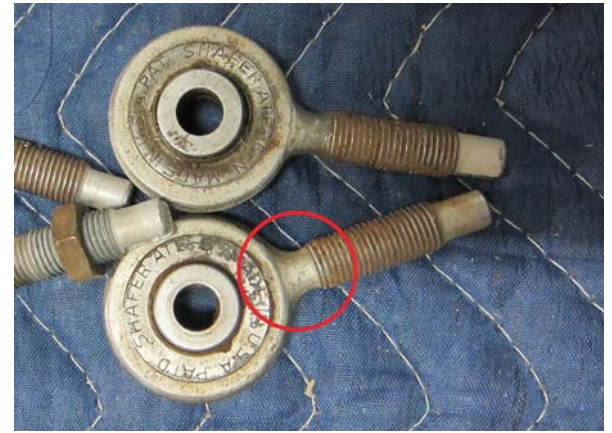
Lightweight ATE-6N Rod End Example
Note: Narrowing neck on early style lightweight ends

The difference between the often referred to light or heavy rod end can be seen in the transition from the threaded end to the rod end assembly. The early or "light" version of the ATE-6N had a narrower neck in which the diameter reduced in size.

A number of operators have experienced broken rod ends as the result of using lightweight variants. If the rod end on the cylinder end of the rod breaks, the rod will fall and jam on the Sta. 61.5 wing rib. When an extension occurs after the rod breaks the landing gear will extend halfway and stop. With a rod jammed on the rib and a broken rod, the only option will be a gear up landing.

If you're replacing any parts 73-33578-3 ROD ASSEM – LANDING GEAR RETRACTING STRUT CONNECTING, ensure airworthiness prior to purchasing by inspecting for cracks, straightness, and finish. If swapping out ATE-6N rod ends, operators and maintainers should confirm them to be the heavier variant.

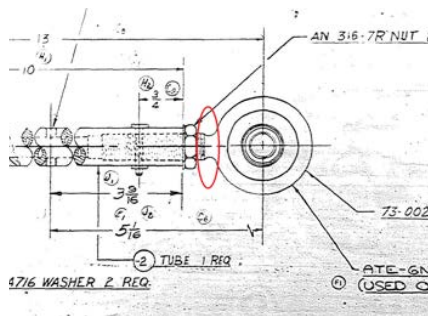
Failure Location # 1

The most common break occurs at the neck of ATE-6N or 73-33582 with the majority of failures occurring at the cylinder (inboard) side of the rod assembly.

How to inspect - visual inspection, magnaflux
Tolerance of damage or wear : Zero
Solutions offered: Replacement of Rod Ends

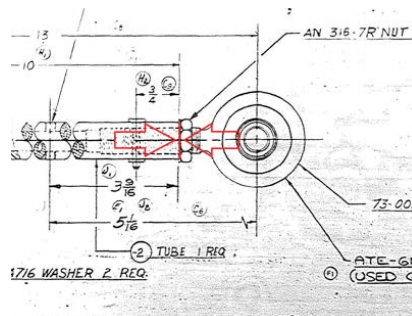
Failure Location # 2

In the threads at the check nut where the ATE-6N or 73-33582 meets the steel tube. Again a majority of breaks occur on the cylinder end.

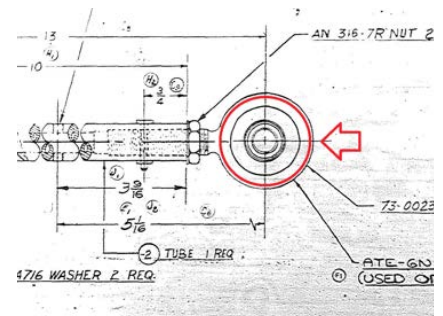
Failure Location # 3

The least common occurrence we have seen is a blowout of the shell on the ATE-6N or 73-33582. We have only seen this type of failure twice.

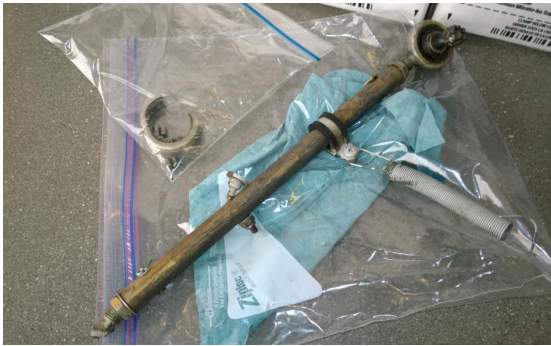
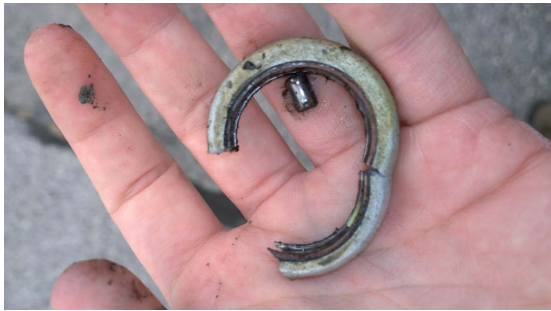
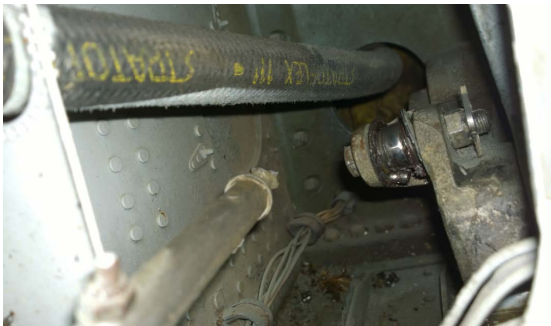
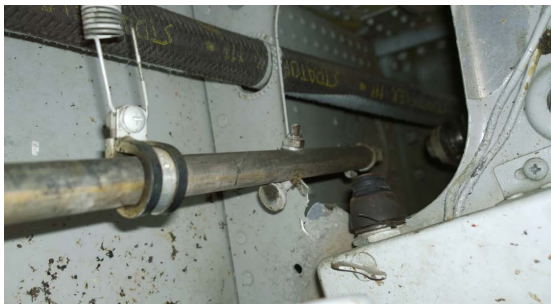
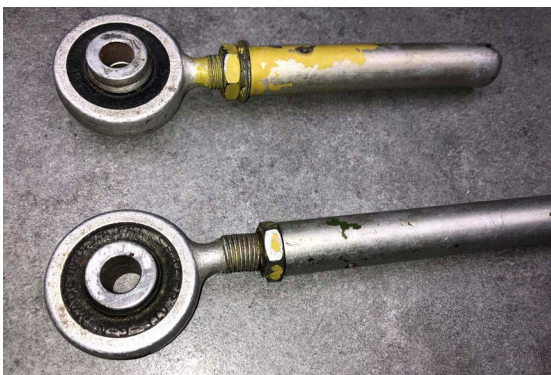
Examples of Broken Rod Ends

As the images to the left show, this end appears to have been rolled off - meaning the force applied to retract the gear has bent the rod end until failure.

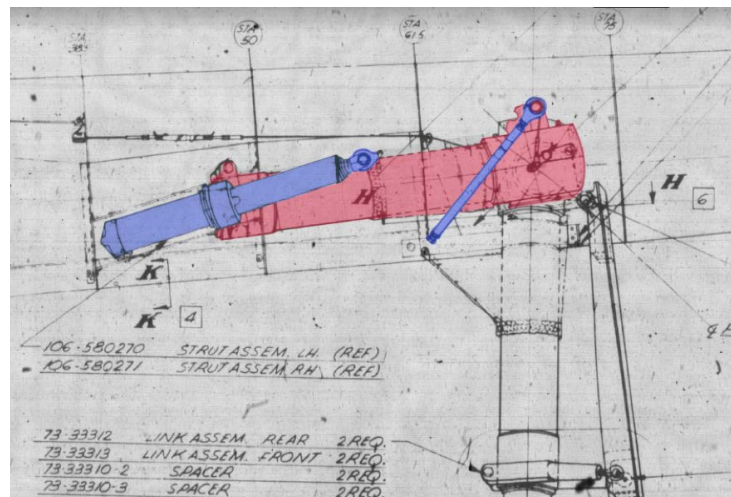
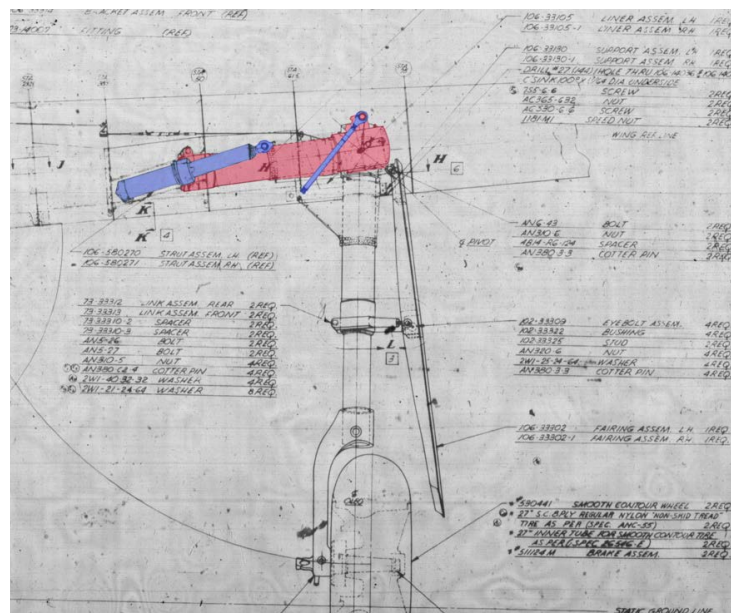
With the landing gear retracted, a failure at the cylinder end of 73-33578 Rod Assembly causes the broken rod to fall and wedge on the structural skin of the aircraft and rib at wing station 61.5. If the rod breaks and wedges on the rib, there is nothing a pilot can do to solve the problem in the air.

The rendering below simulates a broken retract rod with the landing gear upper cylinder in the up position indicated in red. The broken rod assembly, separated at the extended cylinder end is colored blue. The majority of the 73-33578 rod assembly will remain attached to the Arm Landing Gear Torque (Nicknamed the Porkchop). The rod assembly will wedge itself between the heavy skin and rib at wing station 61.5 and will prevent the landing gear from fully extending.
