Dakota Territory Air Museum's P-47 Update

by Chuck Cravens

AIRCORPS AVIATION

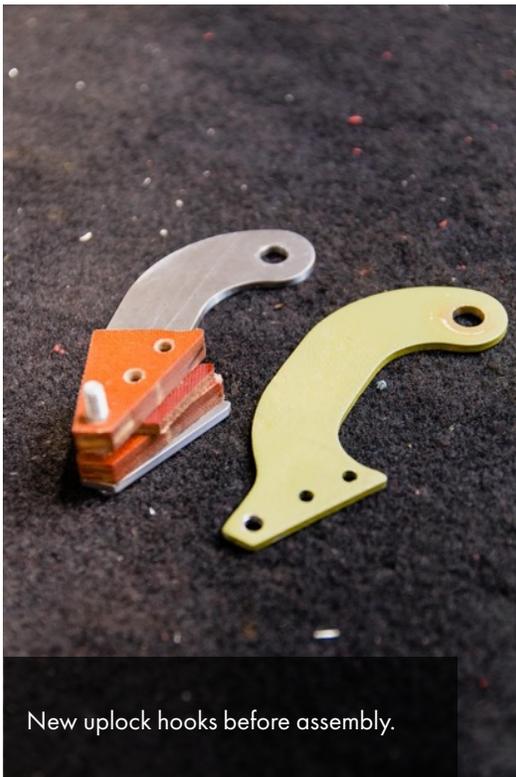
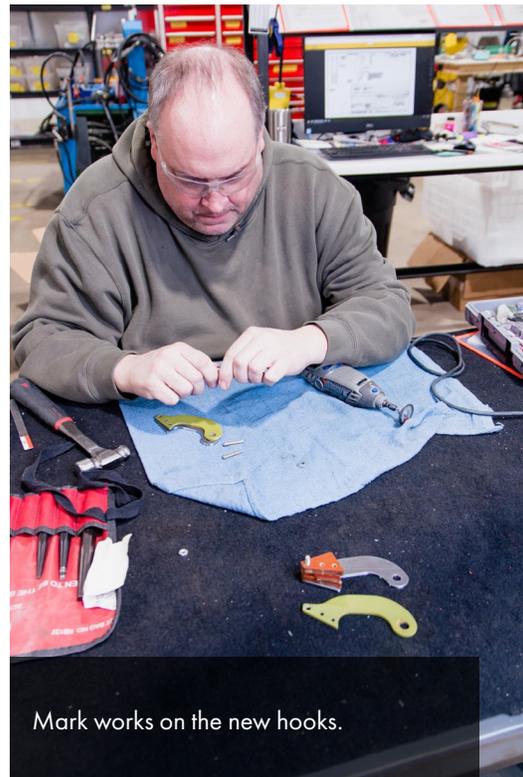
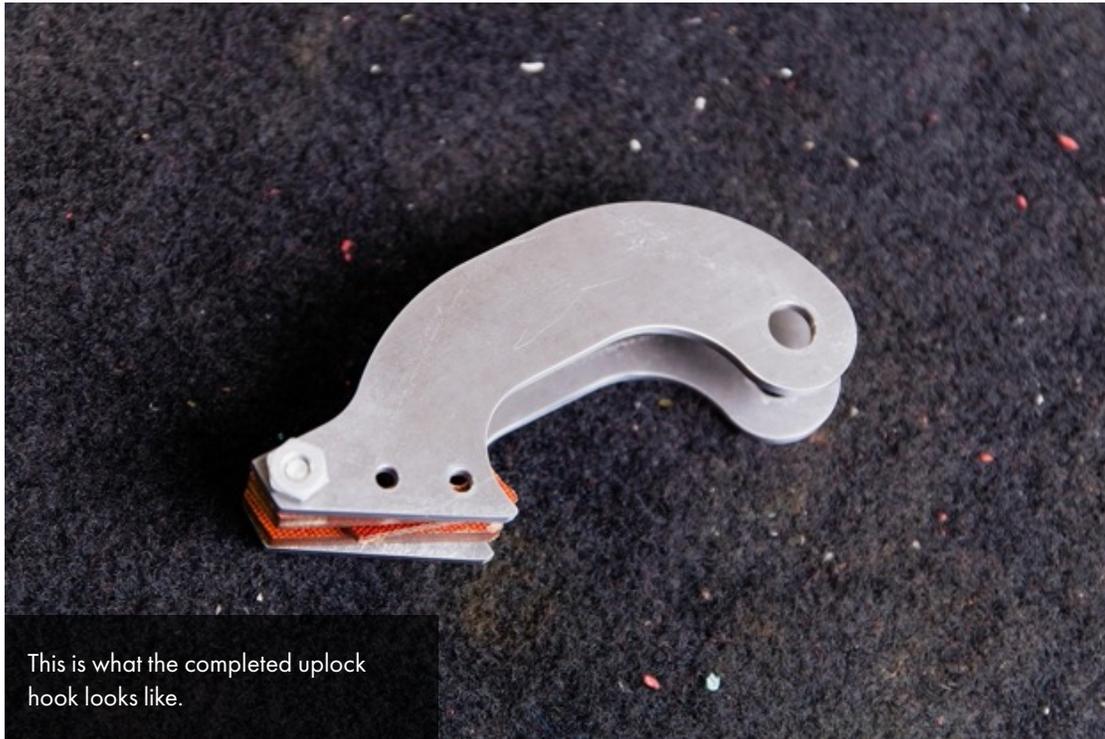
The original 1944 uplock hooks were found to be too worn to be usable. So new parts were fabricated.

This is what the completed uplock hook looks like.

Once both methods were experimented with, it became clear that adjusting in the neutral position was the effective way to do this task.

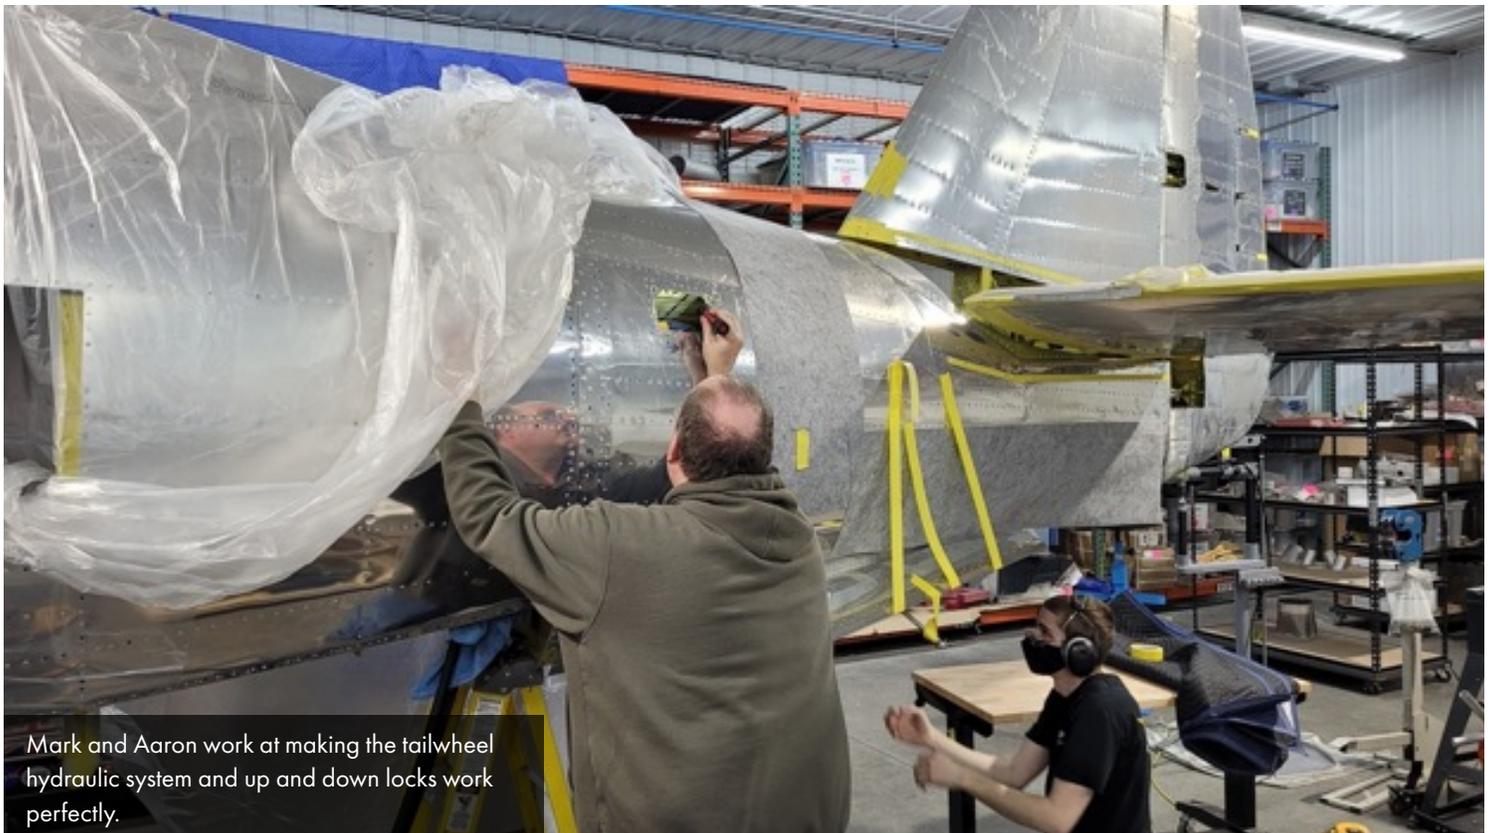
One of the issues that came up in the restoration was getting the tail wheel to firmly lock in the up position. Several things contributed to the problem. Speaking to folks who currently operate razorback P-47s, we found this to be a fairly common problem. One thing that exacerbates the issue is conflicting methods of adjusting the tail wheel locks. Some manuals say to adjust in the locked-up position and others say to do so in a neutral position instead of a locked position.

Mark and Aaron work at making the tailwheel hydraulic system and up and down locks work perfectly.
