June/July 2021

Dakota Territory Air Museum's P-47 Update

by Chuck Cravens

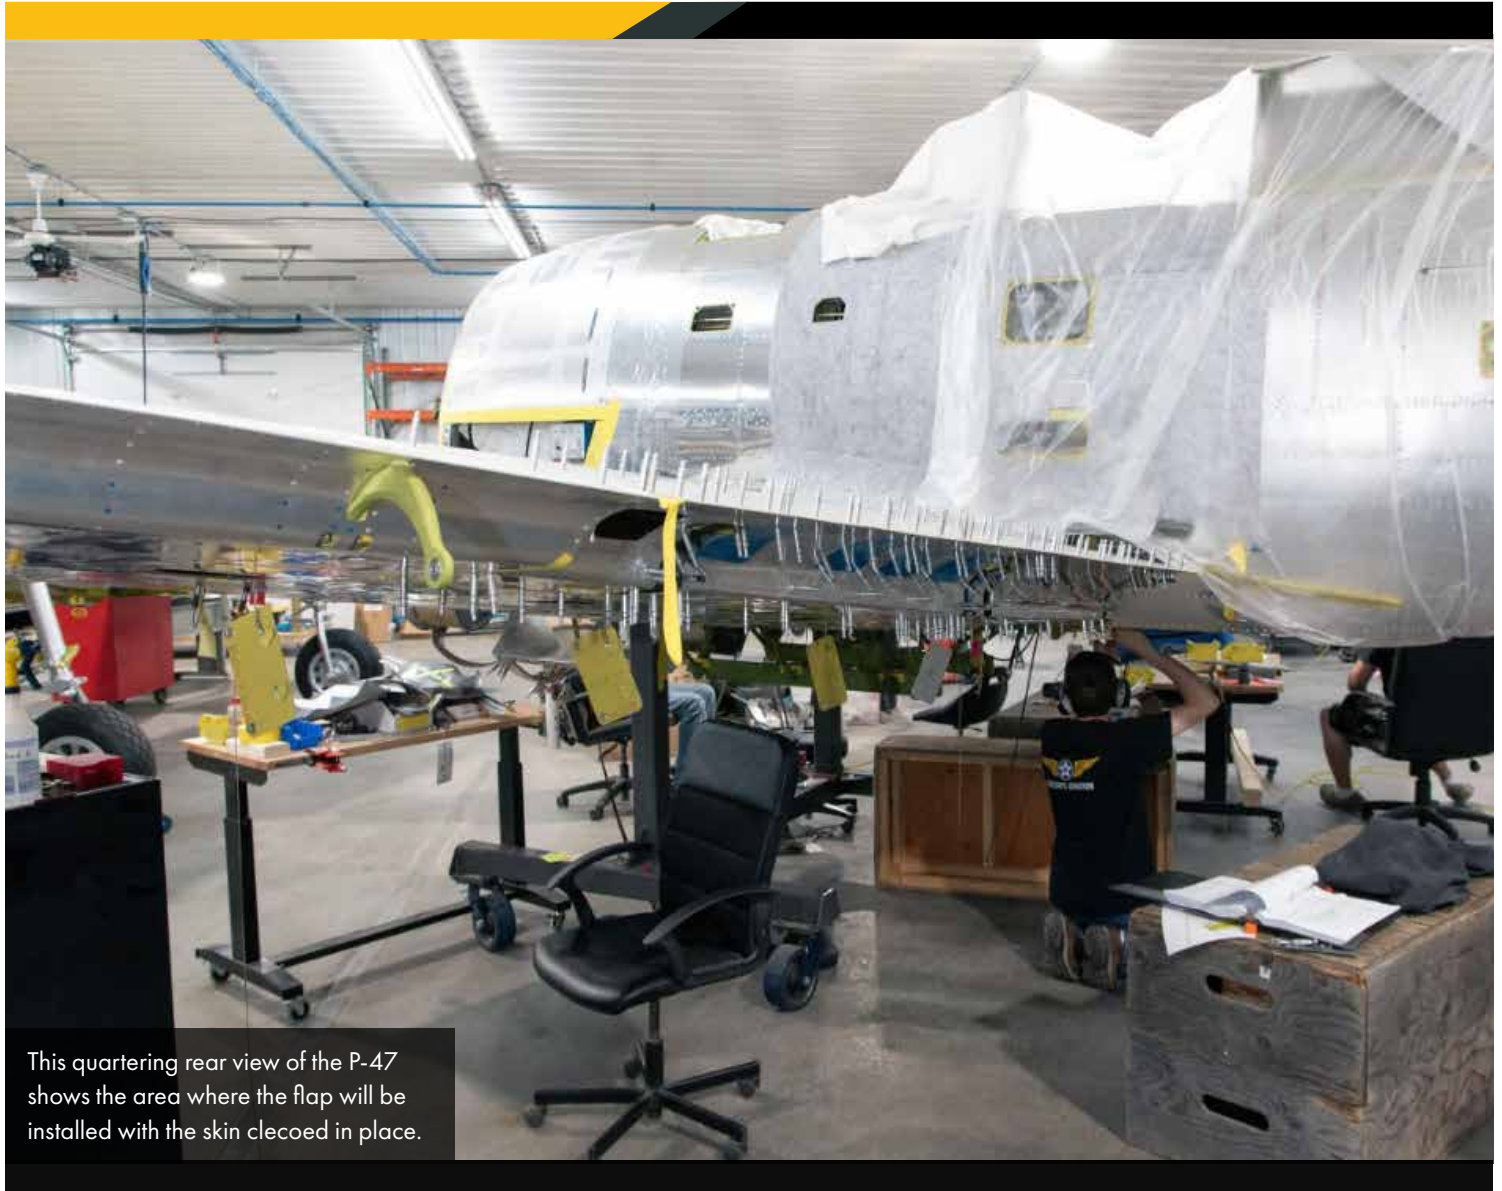
This quartering rear view of the P-47 shows the area where the flap will be installed with the skin clecoed in place.

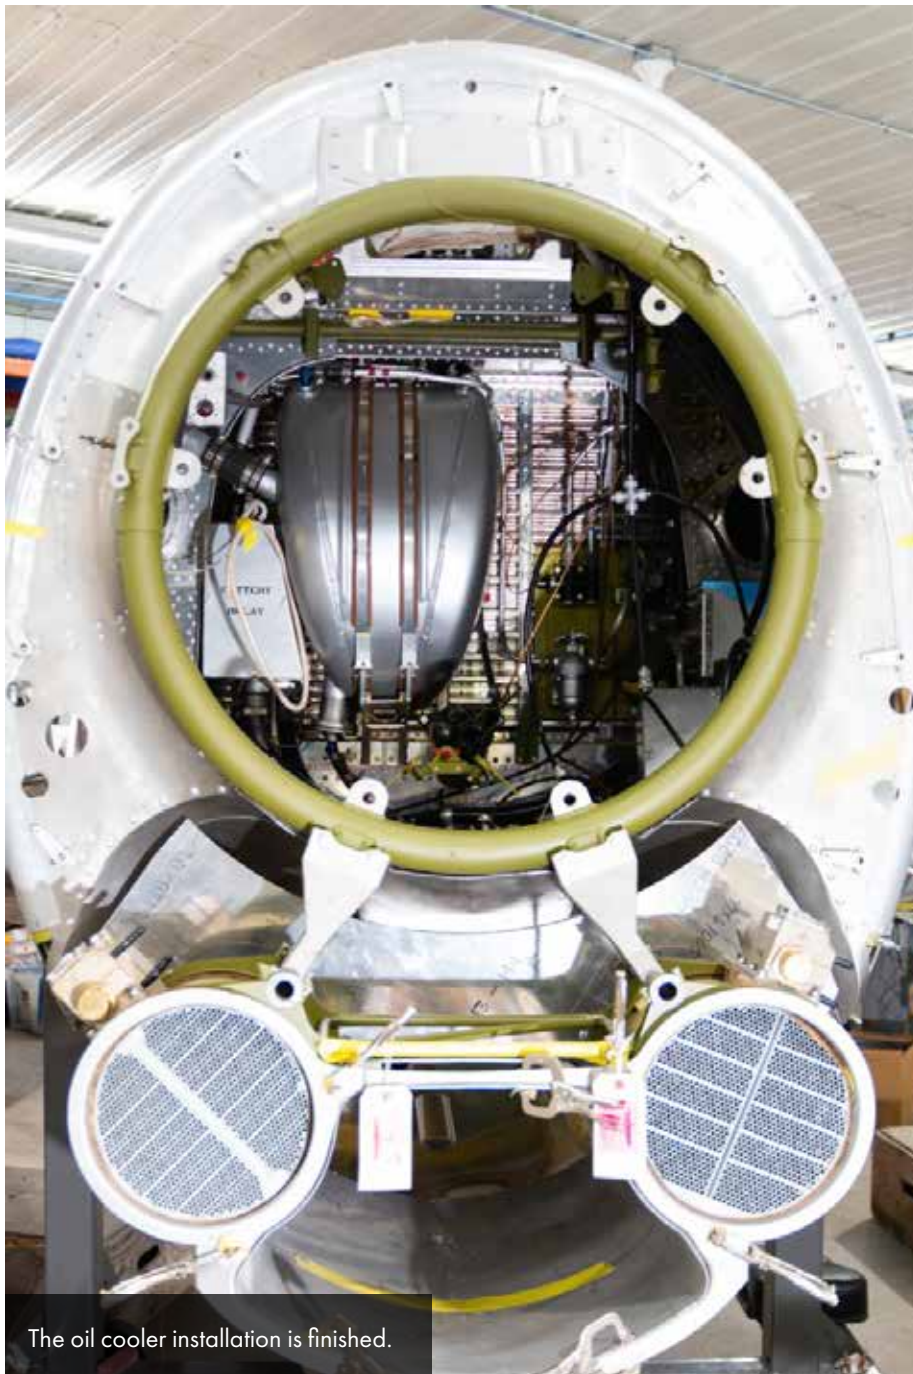
The oil cooler installation is finished.

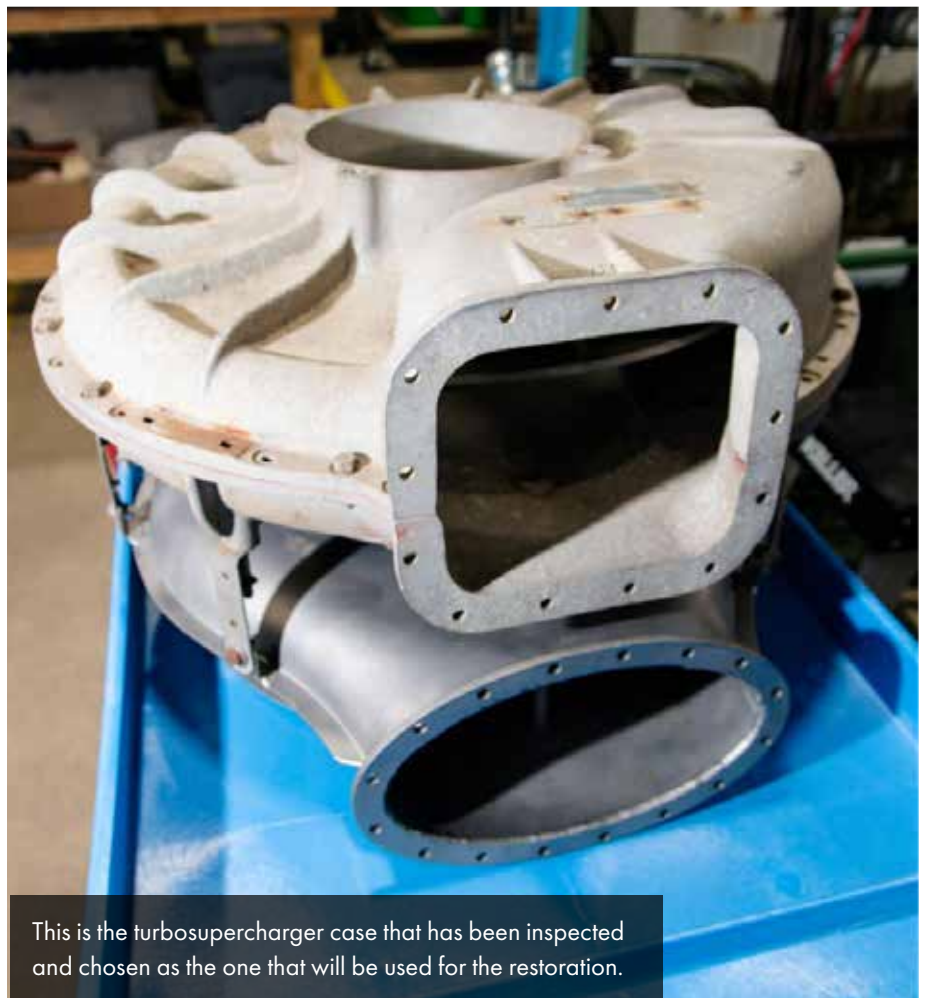
This is the turbosupercharger case that has been inspected and chosen as the one that will be used for the restoration.

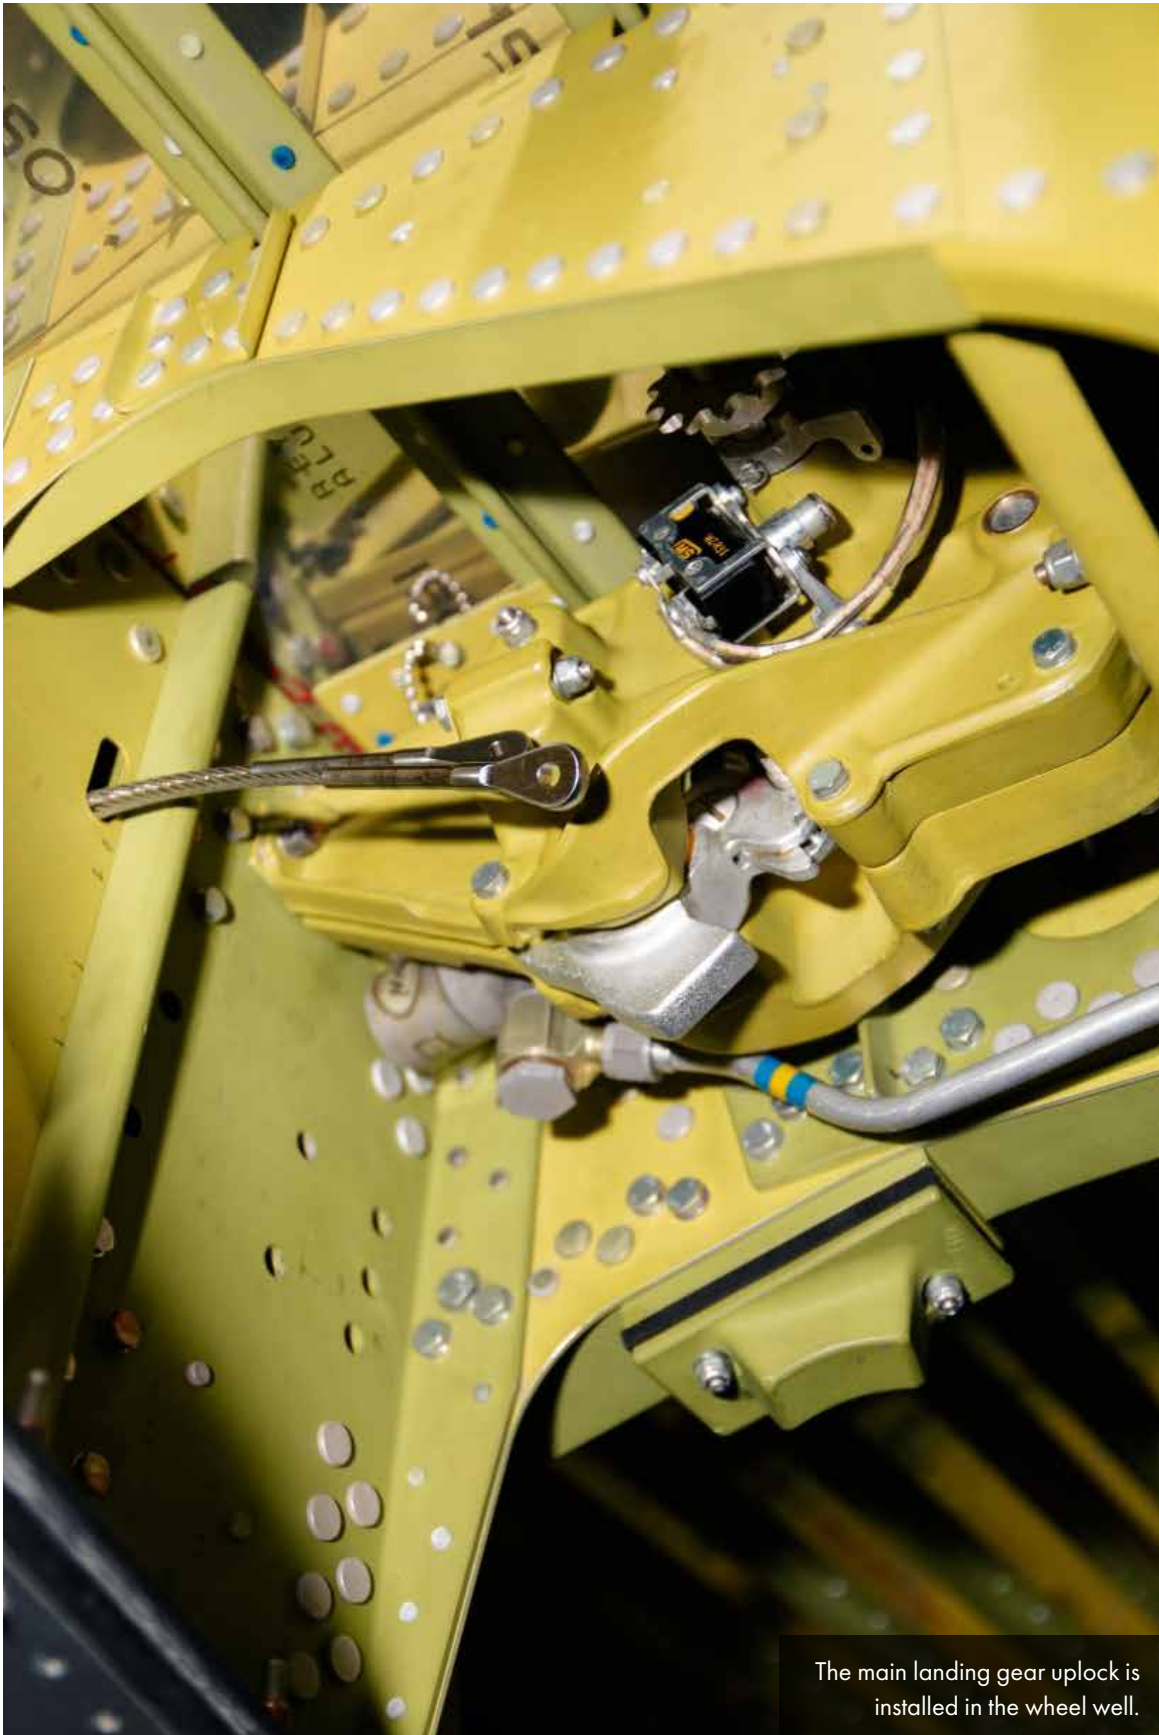
The main landing gear uplock is installed in the wheel well.

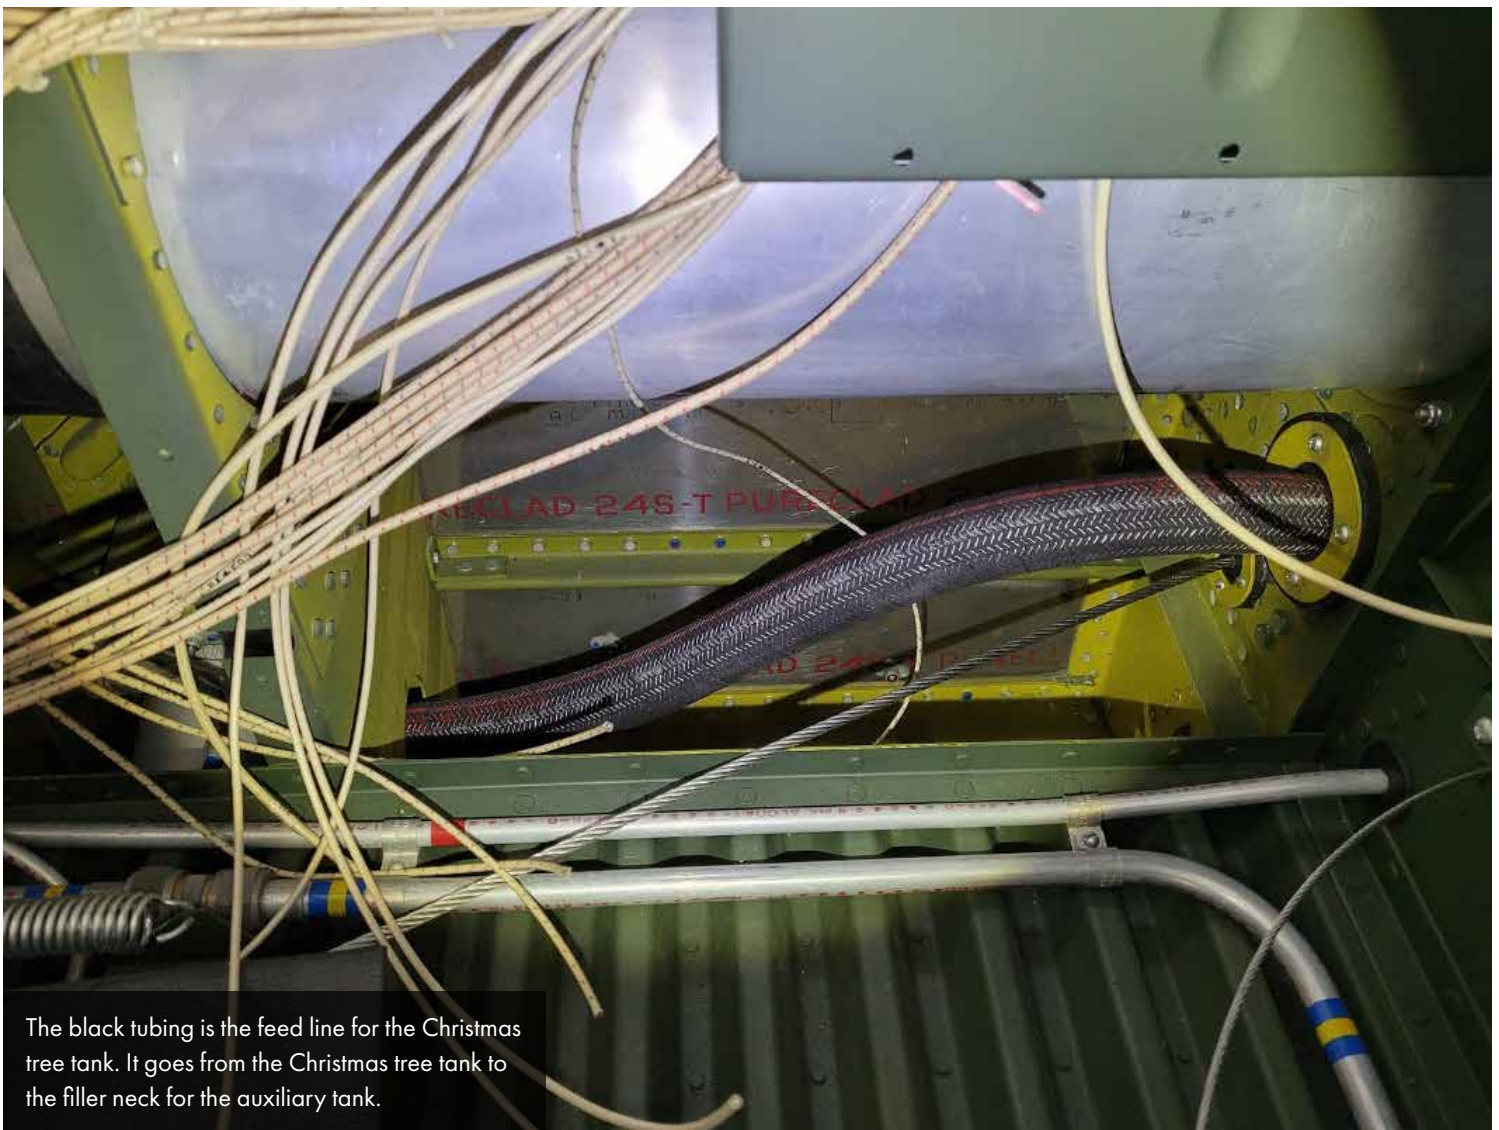
The black tubing is the feed line for the Christmas tree tank. It goes from the Christmas tree tank to the filler neck for the auxiliary tank.

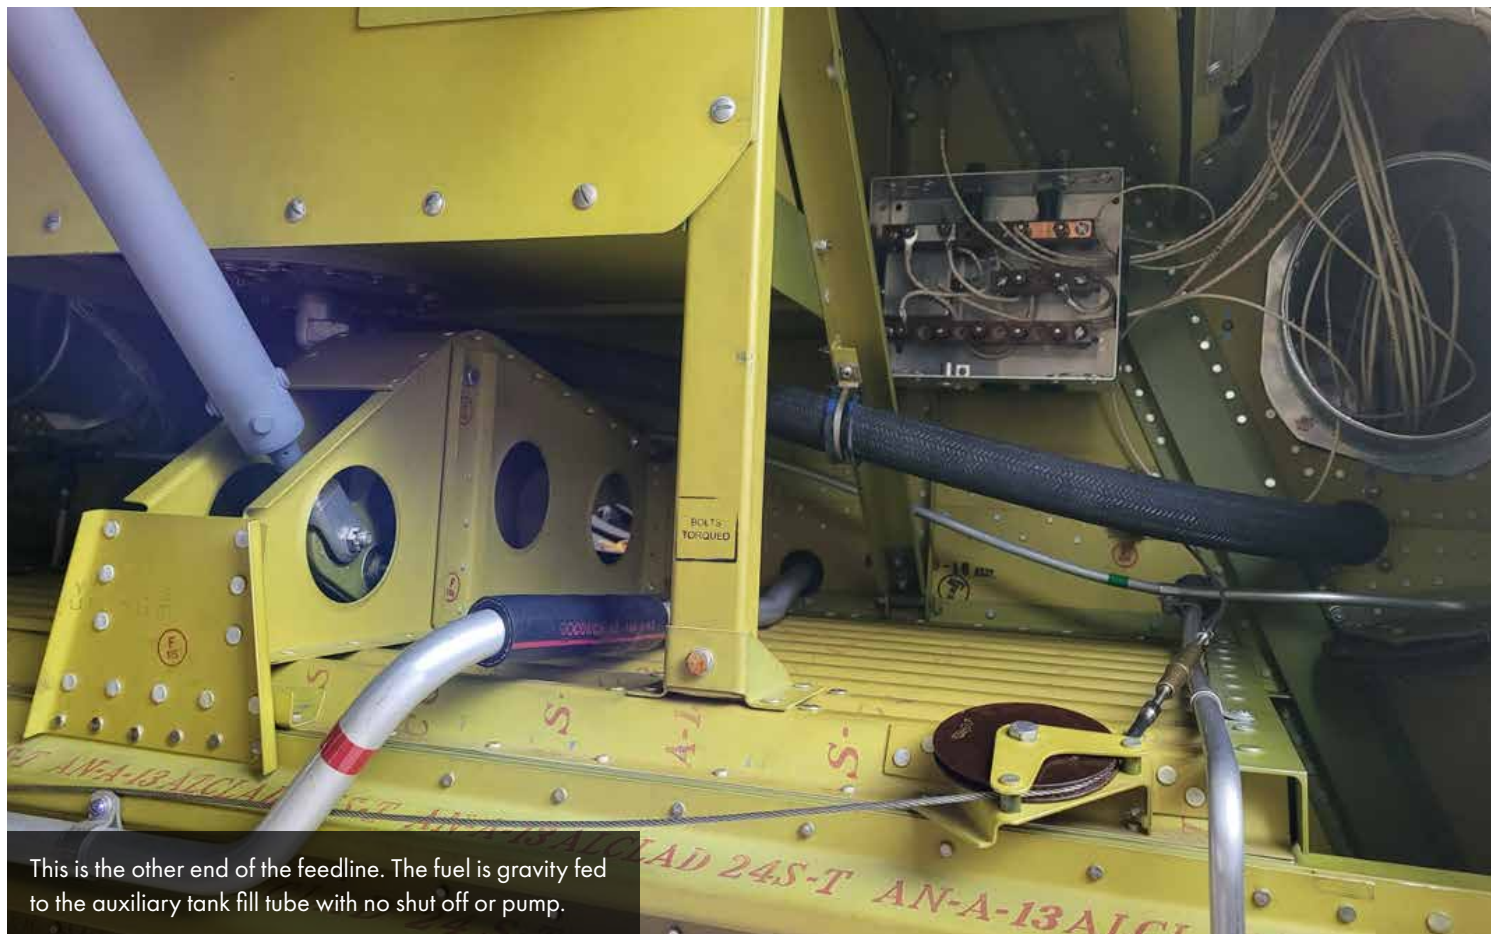
This is the other end of the feedline. The fuel is gravity fed to the auxiliary tank fill tube with no shut off or pump.

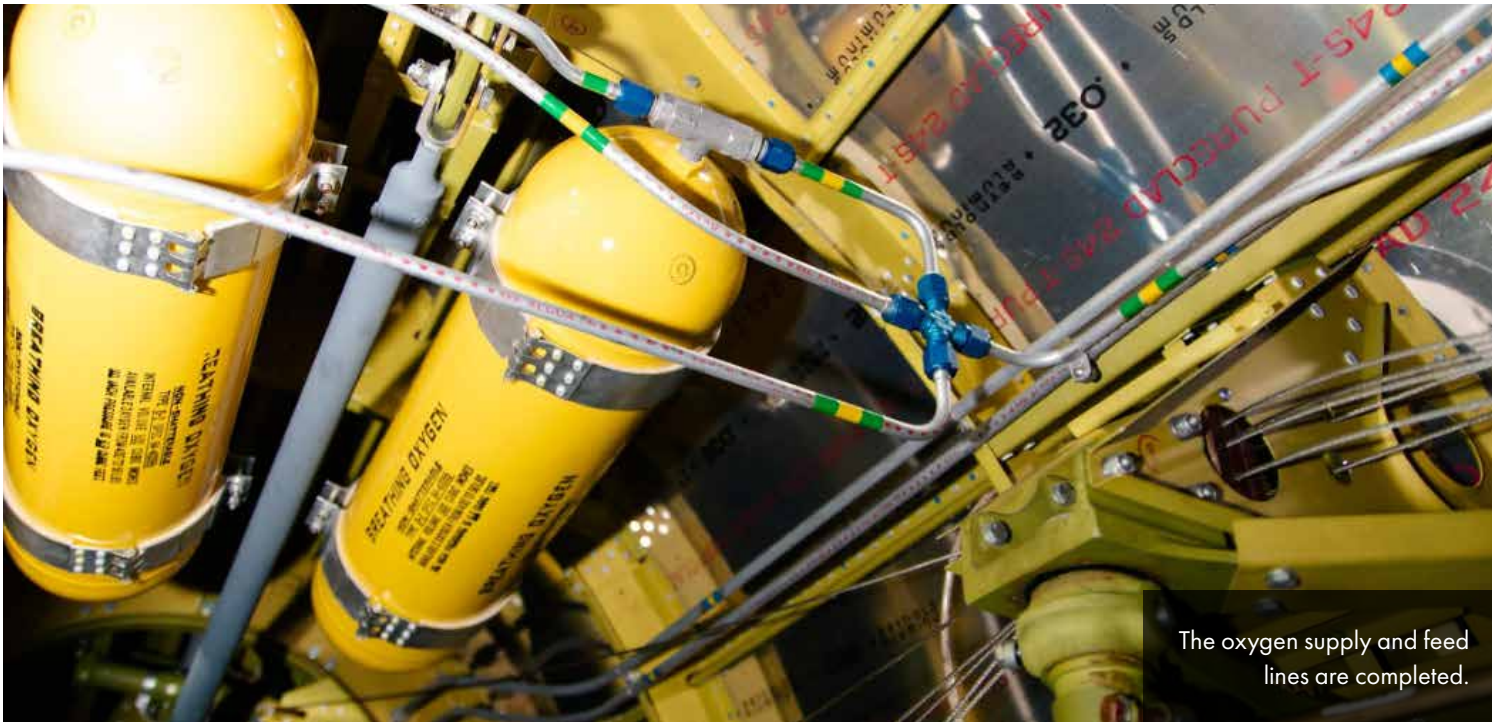
The oxygen supply and feed lines are completed.

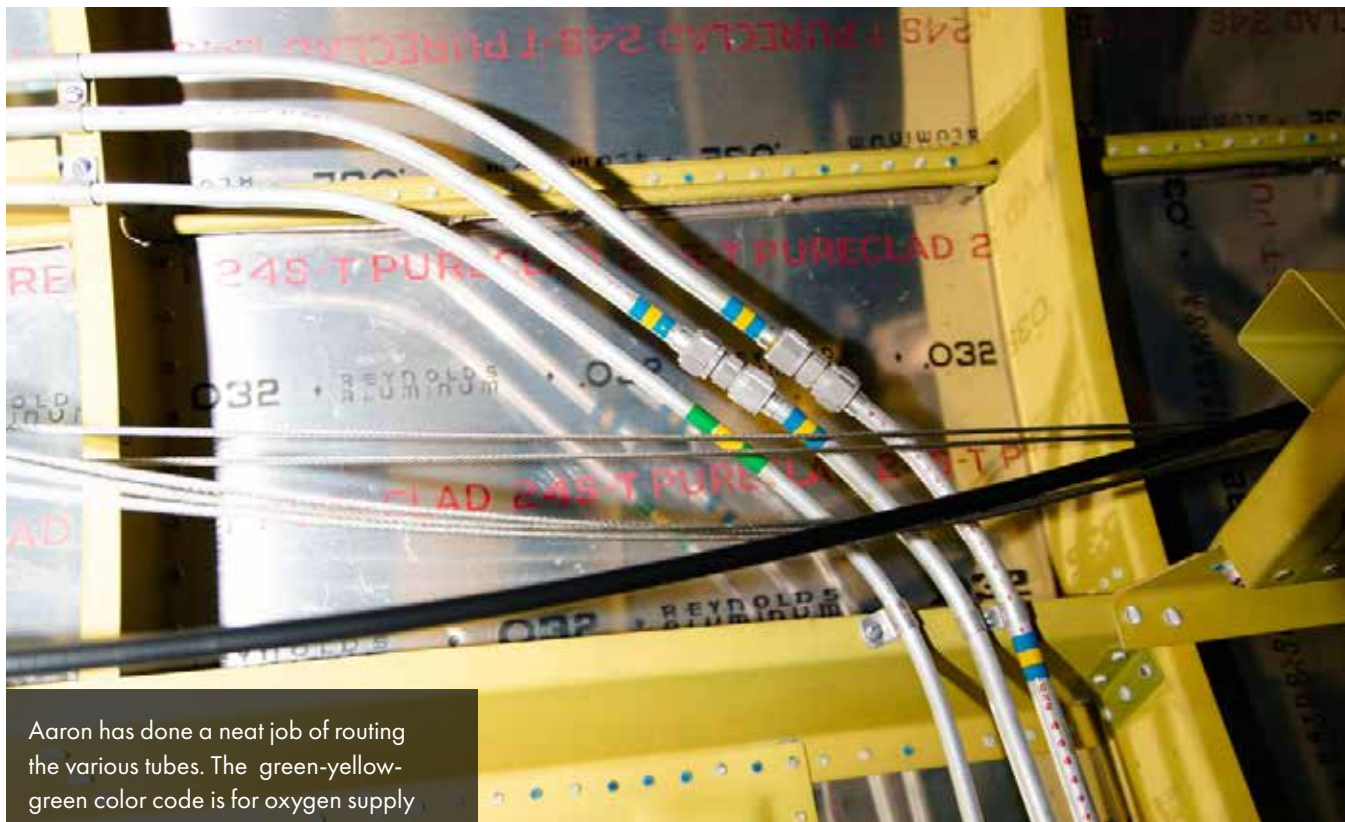
Aaron has done a neat job of routing the various tubes. The green-yellow-green color code is for oxygen supply tubes. The blue-yellow-blue code is for hydraulic oil under pressure.

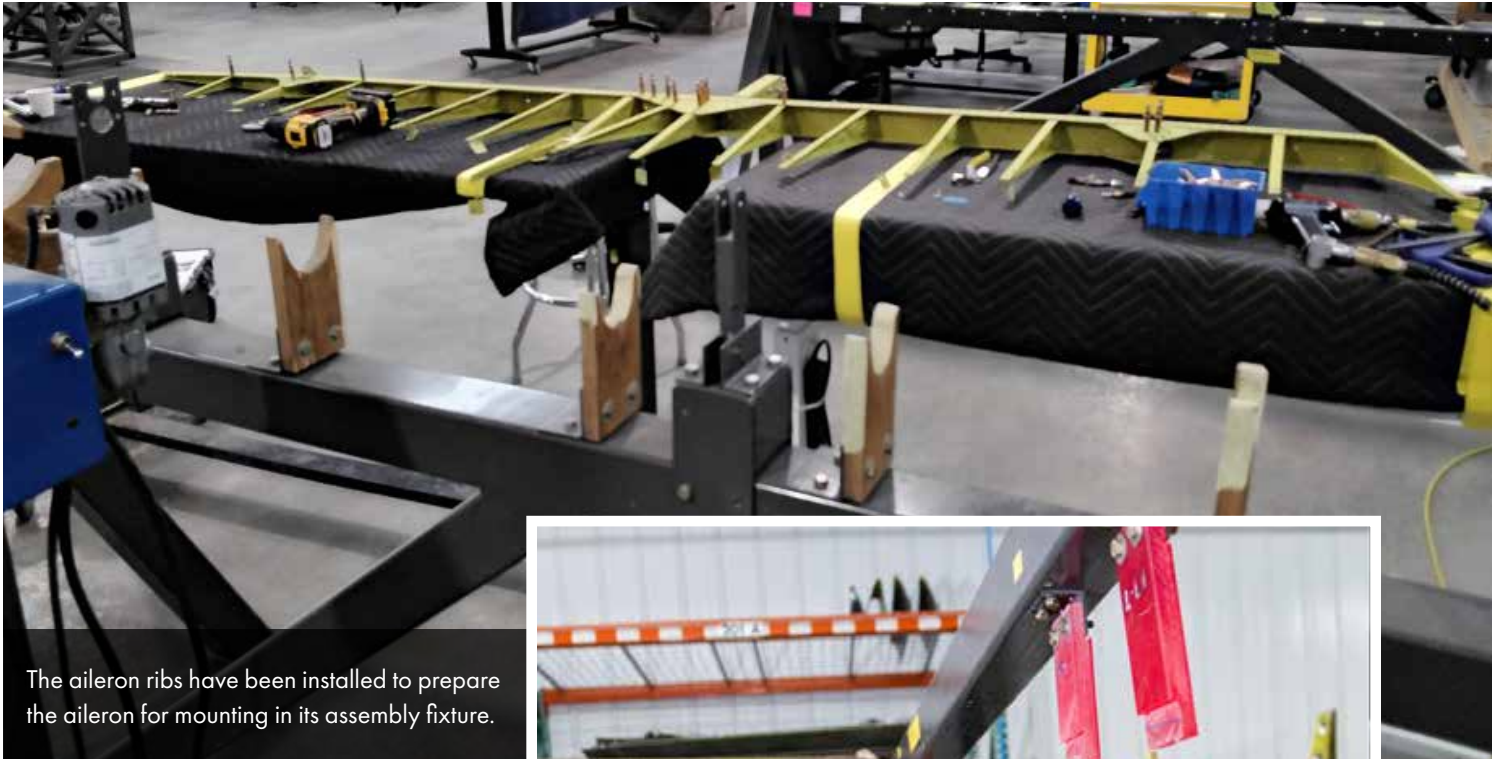
The aileron ribs have been installed to prepare the aileron for mounting in its assembly fixture.

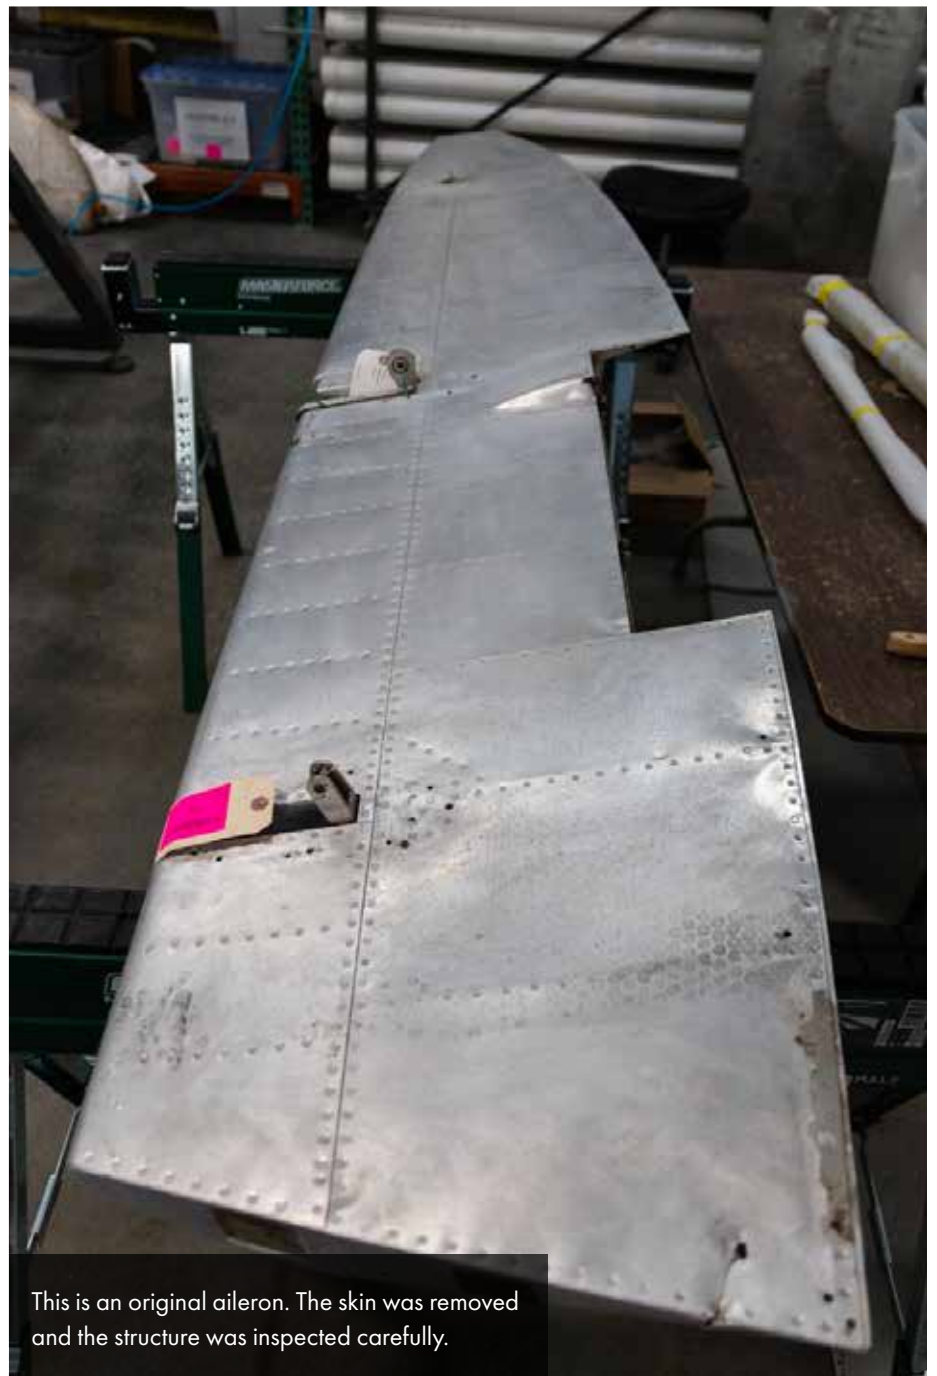
This is an original aileron. The skin was removed and the structure was inspected carefully.

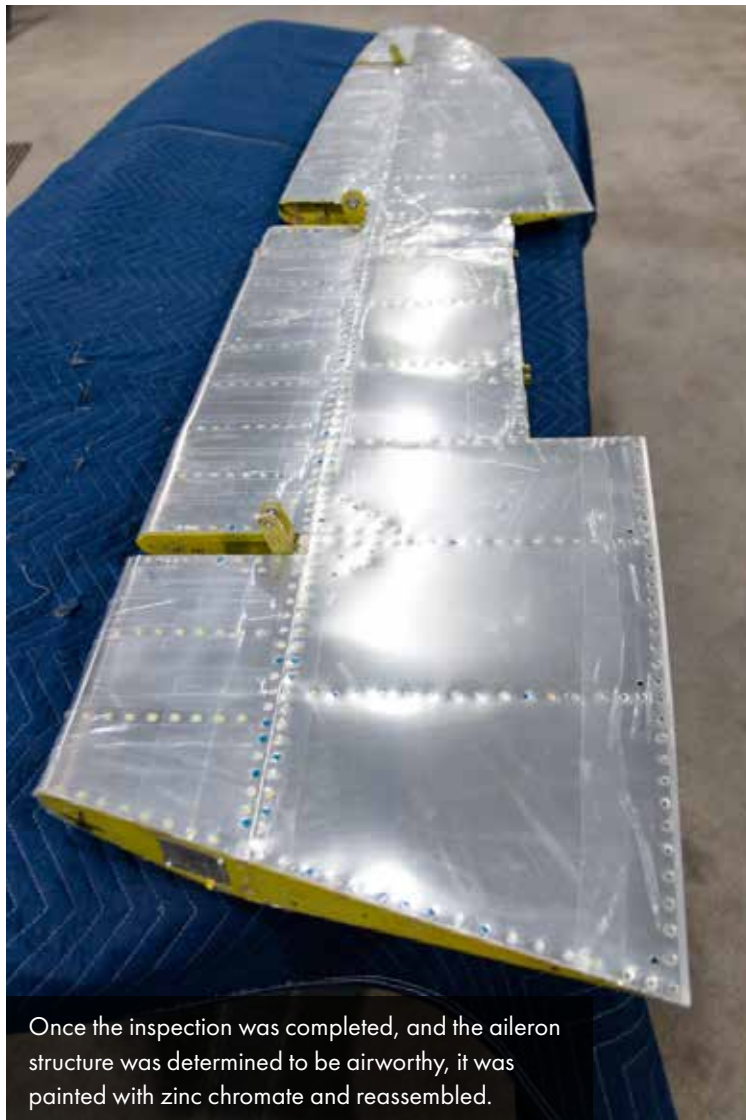
Once the inspection was completed, and the aileron structure was determined to be airworthy, it was painted with zinc chromate and reassembled.
