## P-51 Landing Gear Pivot Shafts

### All P-51 Mustang Variants

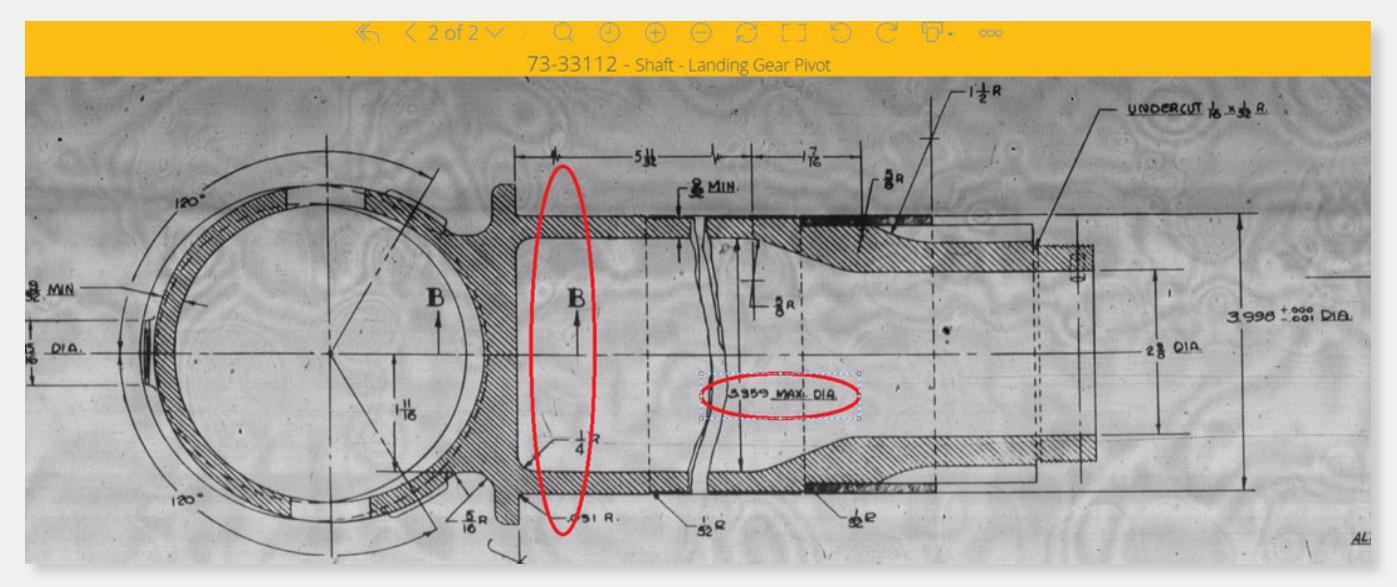
Light pivot shaft drawing 73-33112 - Notice the common cracking point on the left and how inner diameter 3.359" leaves a wall thickness of only 9/32".

Therefore, AirCorps recommends, Following guidance given Military T.O. 01-60JE-47 to replace "light weight" shafts 73-33112 & 66584 as soon as possible or at next inspection. If "light weight" shafts are operated, we recommend immediate magnaflux inspection if not previously inspected by removal and magnaflux.

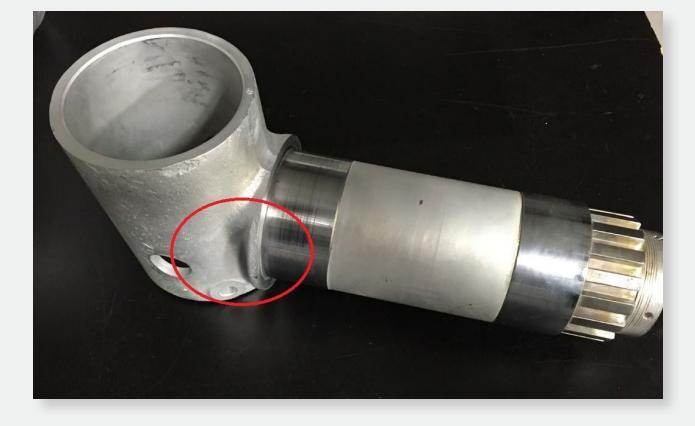
Light pivot shaft - Notice lack of additional material in the cheeks area of the shaft. Only 3 of the 16 light pivot shafts inspected and tested by AirCorps have passed.

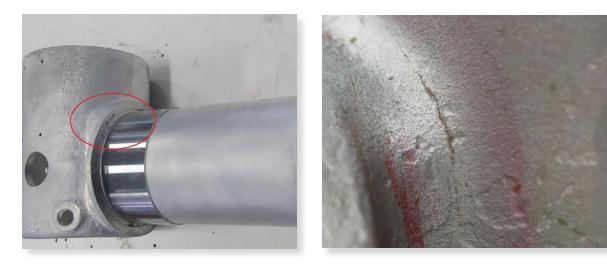
### CRACKING LOCATION #1

Exterior Corner at intersection of pivot and landing gear receptacle on both light and heavy pivot shafts.

Location of external Pivot Shaft Cracking – photo – AirCorps Aviation

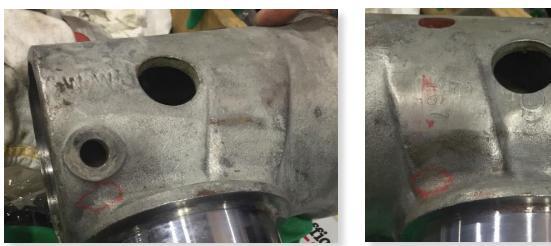
Heavy landing gear pivot shaft cracking circled in red. Photo: Gary Norville

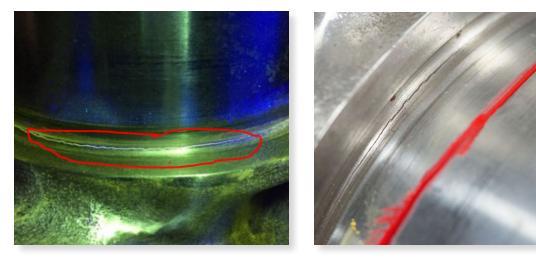
### CRACKING LOCATION #2

Radius of thrust face can be up to 1/4" from face edge of internal radius.

Cracking in Pivot Shaft under magnification - Photo AirCorps Aviation

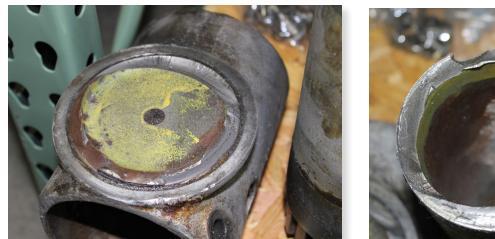
Example of a light pivot shaft that failed on landing - damaging the airframe, prop, and engine. We appreciate photo contribution from Mike Vadeboncouer
