April/May-2018

Texas Flying Legends' P-47 Update
by Chuck Cravens

AIRCORPS AVIATION

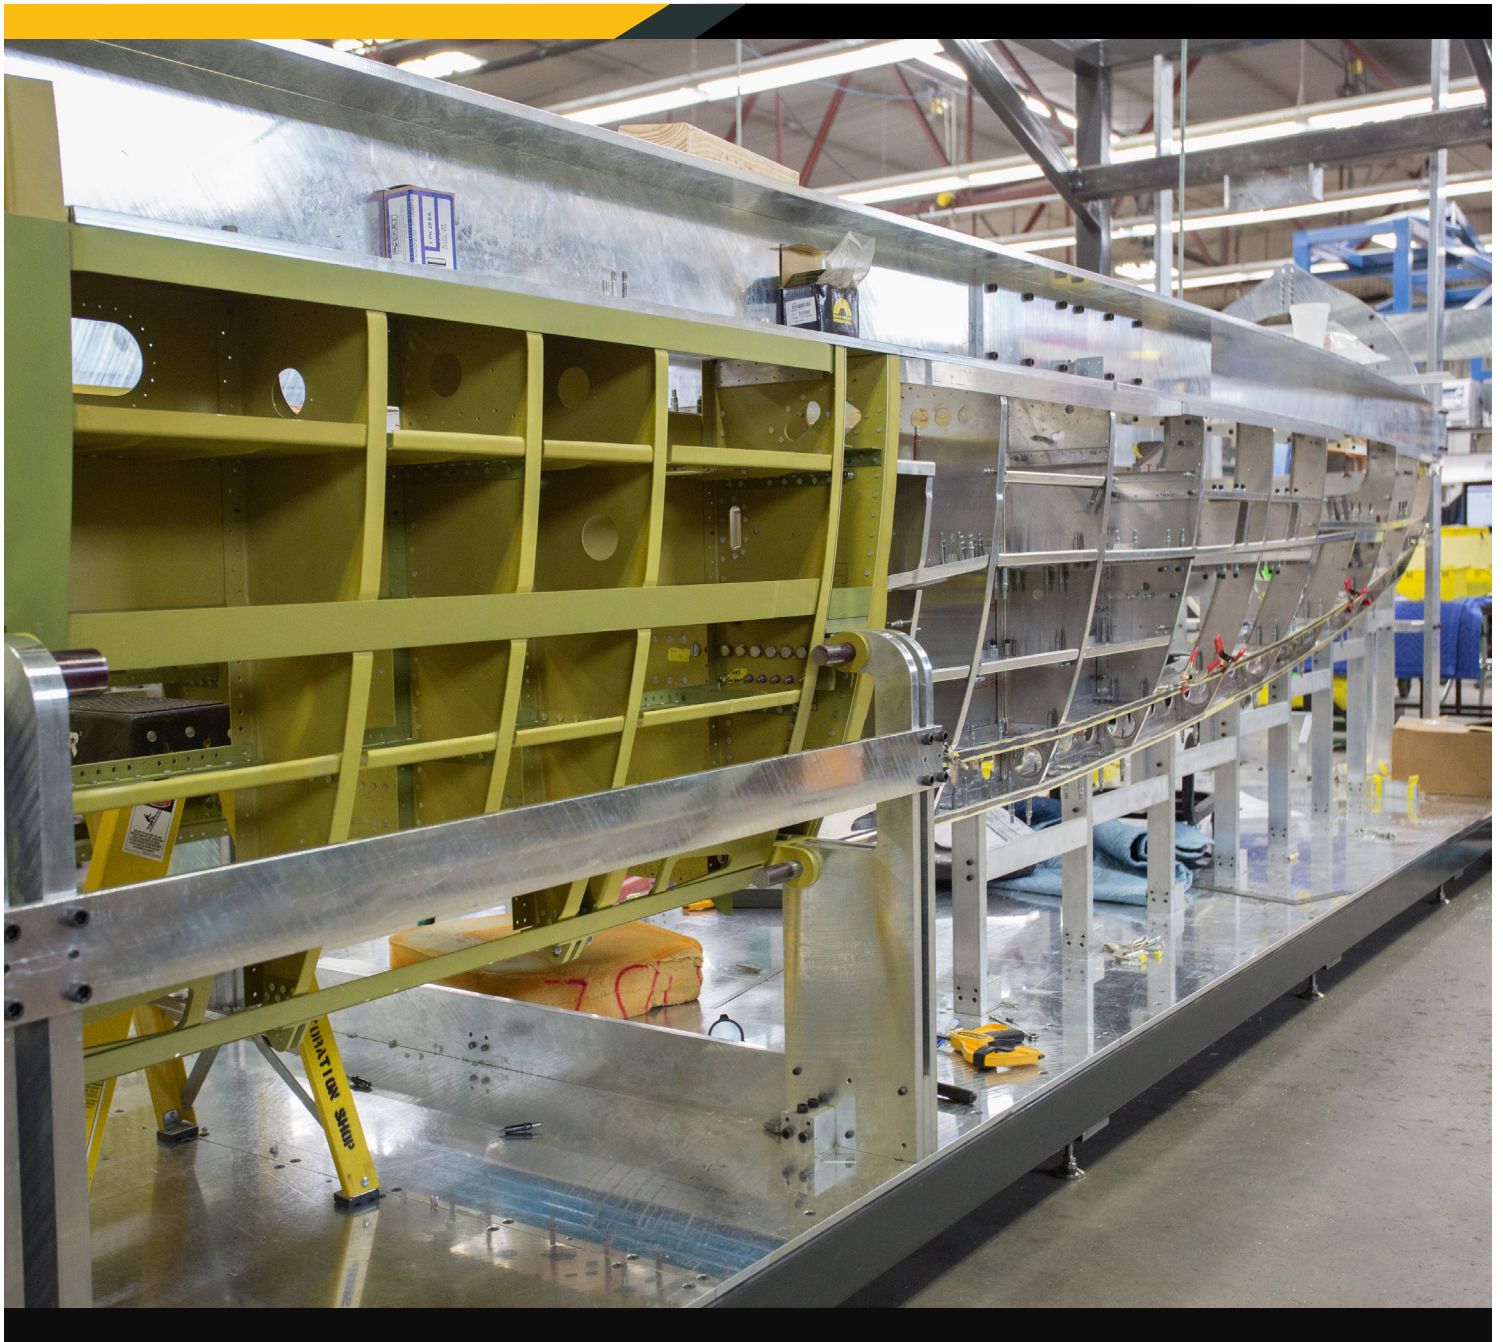
The left side main tank bay shows in the foreground of the fuselage structure with the auxiliary tank bay behind.

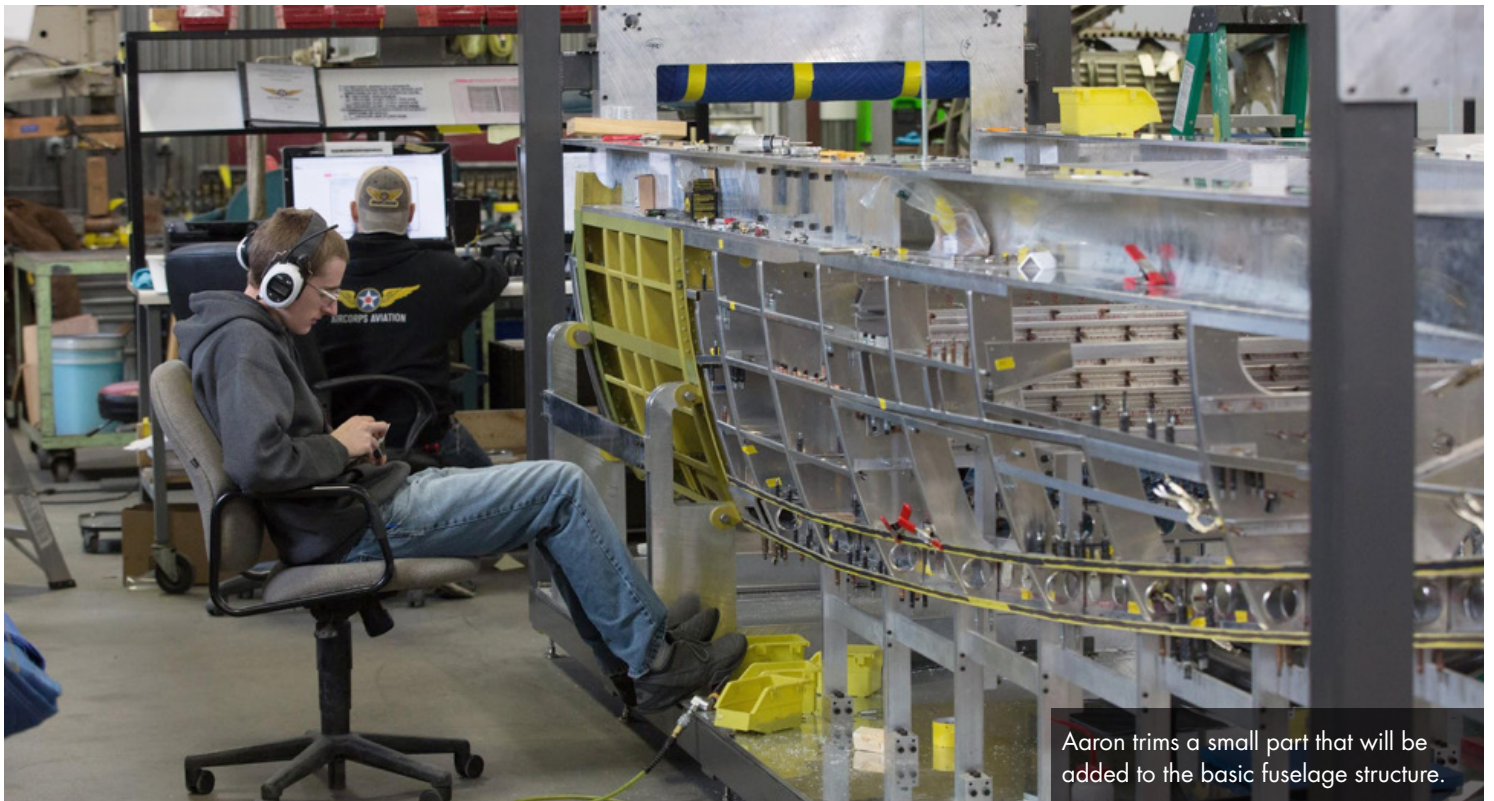
Aaron trims a small part that will be added to the basic fuselage structure.

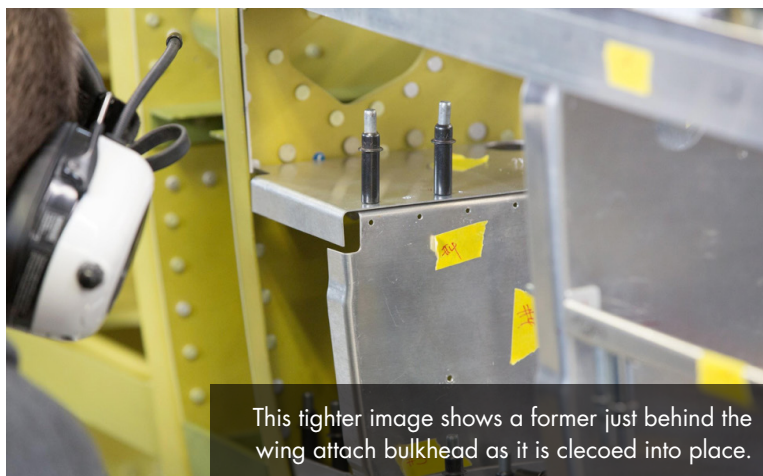
This tighter image shows a former just behind the wing attach bulkhead as it is clecoed into place.

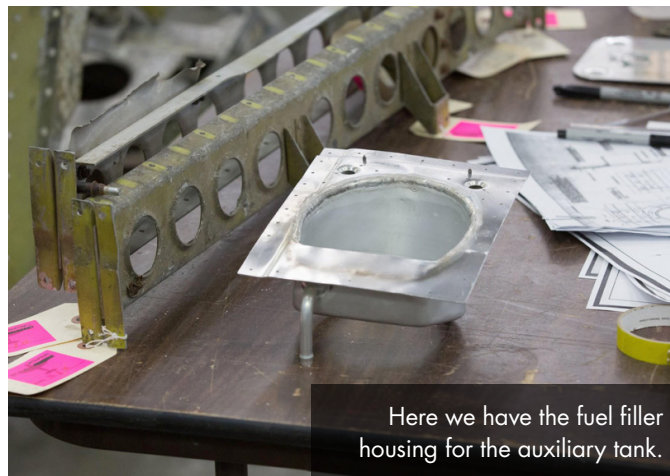
Here we have the fuel filler housing for the auxiliary tank.

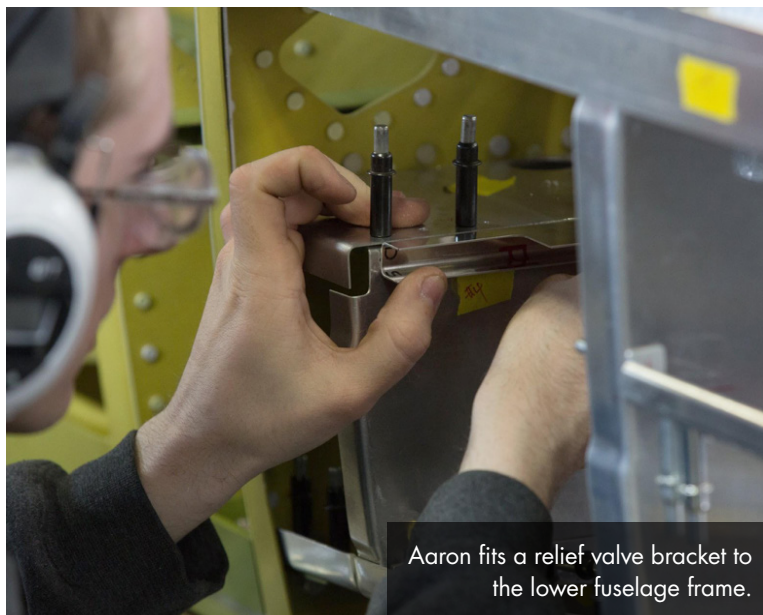
Aaron fits a relief valve bracket to the lower fuselage frame.

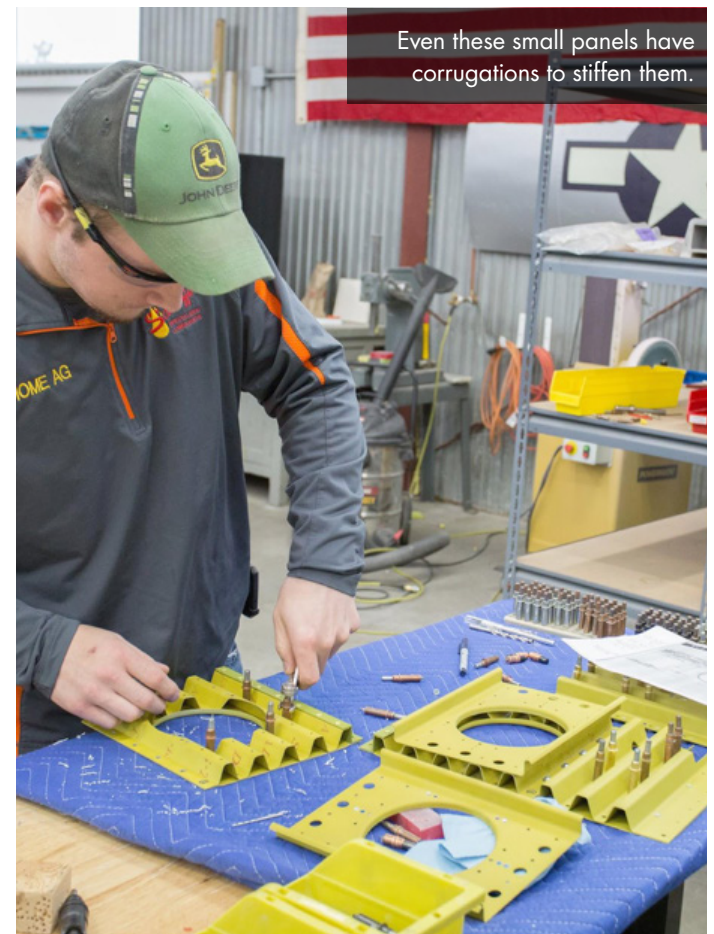
Even these small panels have corrugations to stiffen them.

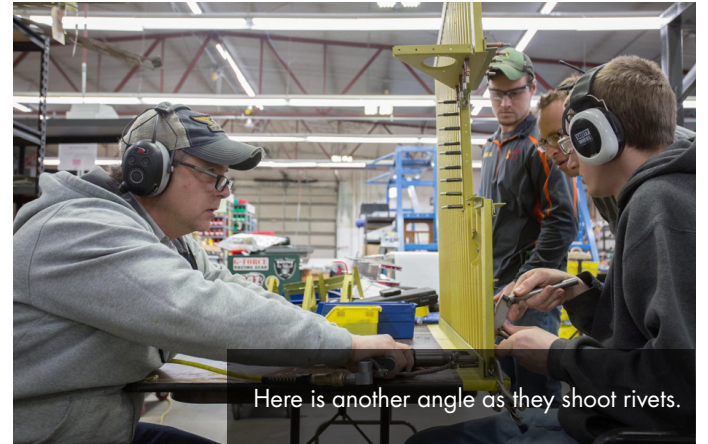
Here is another angle as they shoot rivets.

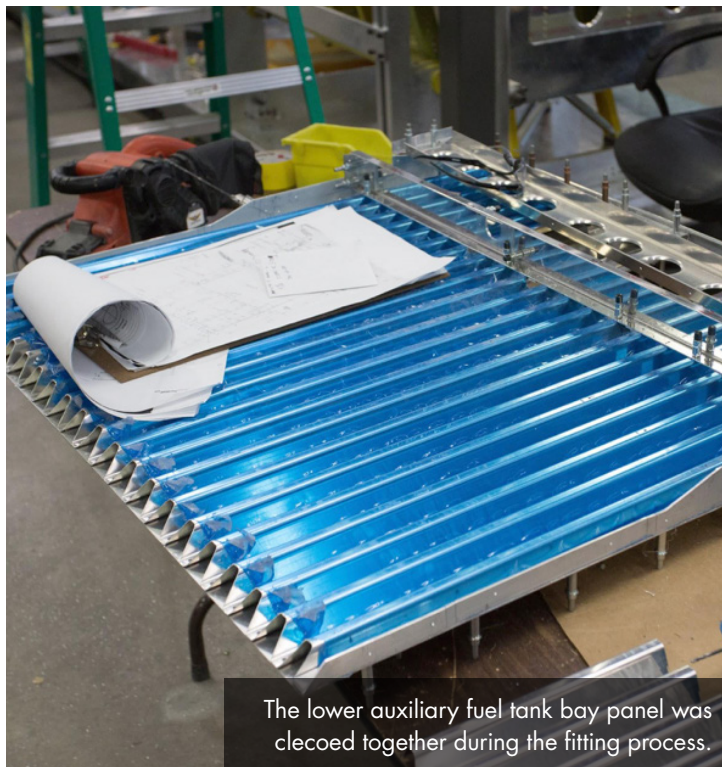
The lower auxiliary fuel tank bay panel was clecoed together during the fitting process.

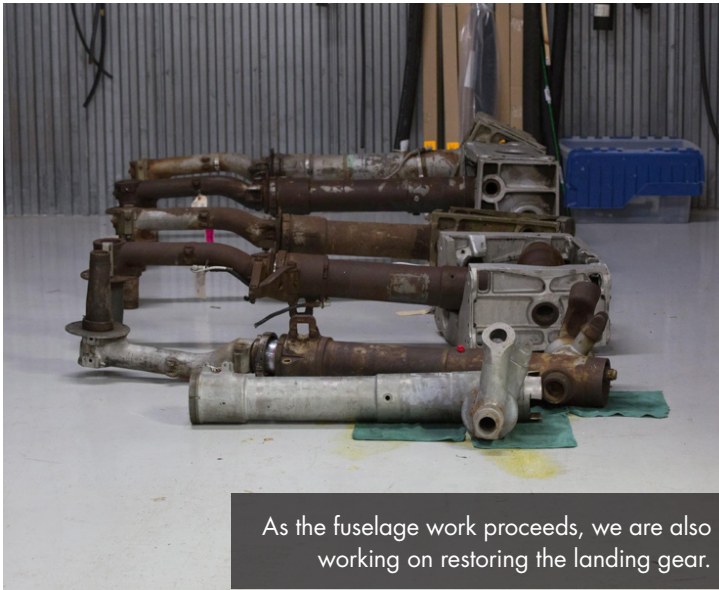
As the fuselage work proceeds, we are also working on restoring the landing gear.

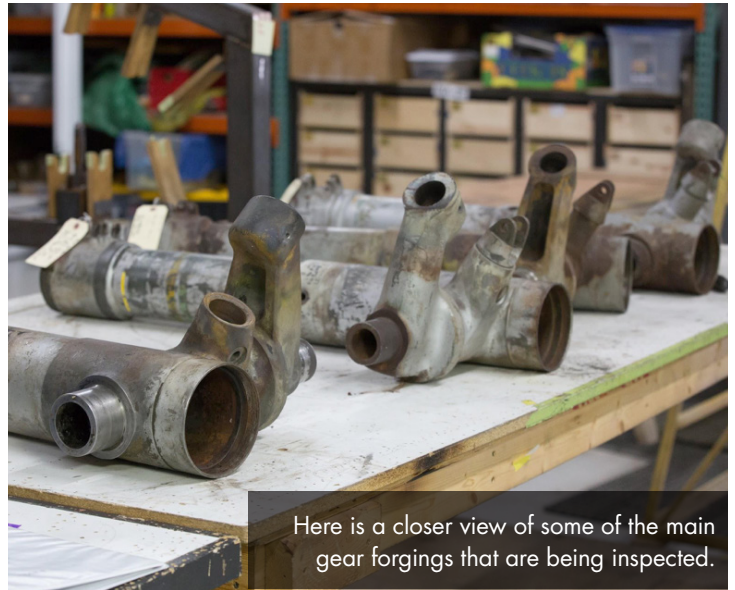
Here is a closer view of some of the main gear forgings that are being inspected.
