Texas Flying Legends' P-47 Update
by Chuck Cravens

AIRCORPS AVIATION

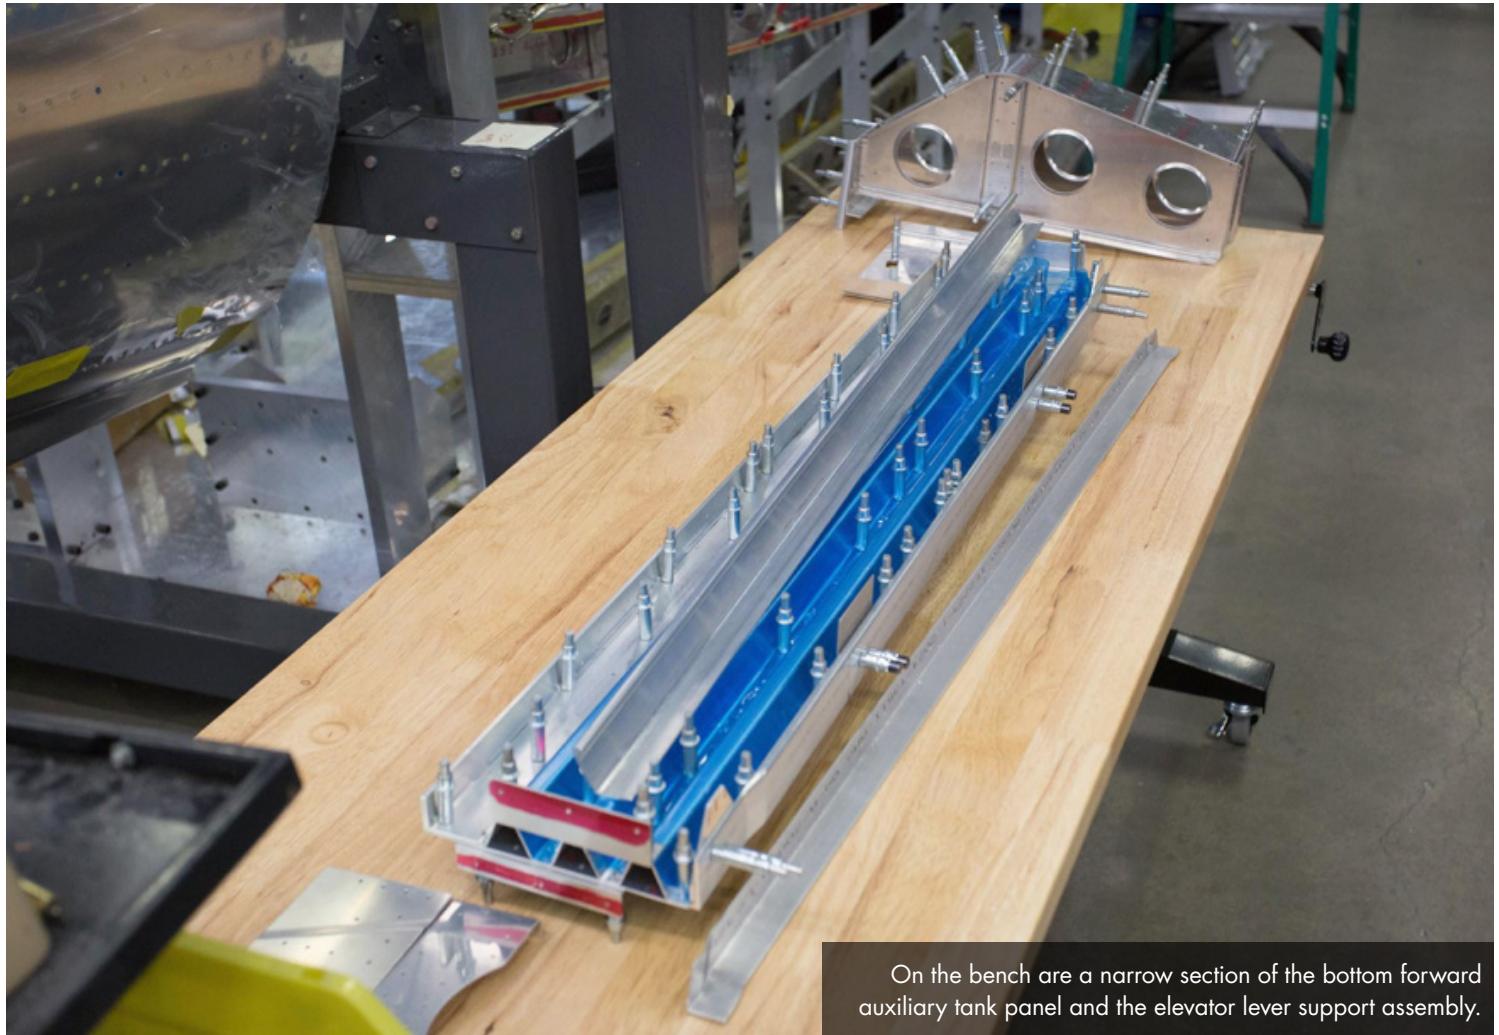
Pilot's Floor

On the bench are a narrow section of the bottom forward auxiliary tank panel and the elevator lever support assembly.

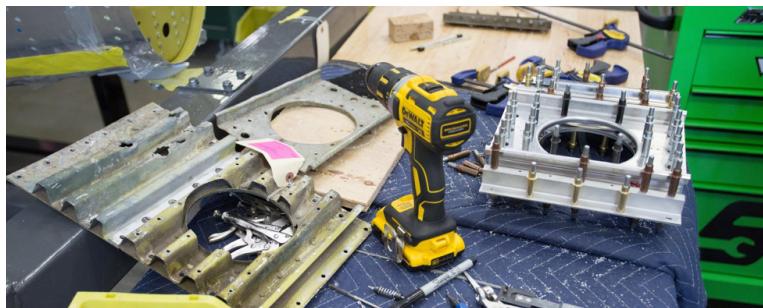
This is a good example of using original assemblies as patterns, salvaging what can be reused, and producing a new assembly that is airworthy.

The clecoed assembly with the large hole is one of two. They are part of the pilot's floor and are located on each side of the control stick assembly. One of them has the drop tank fuel selector mounted in the hole; the other an inspection cover.

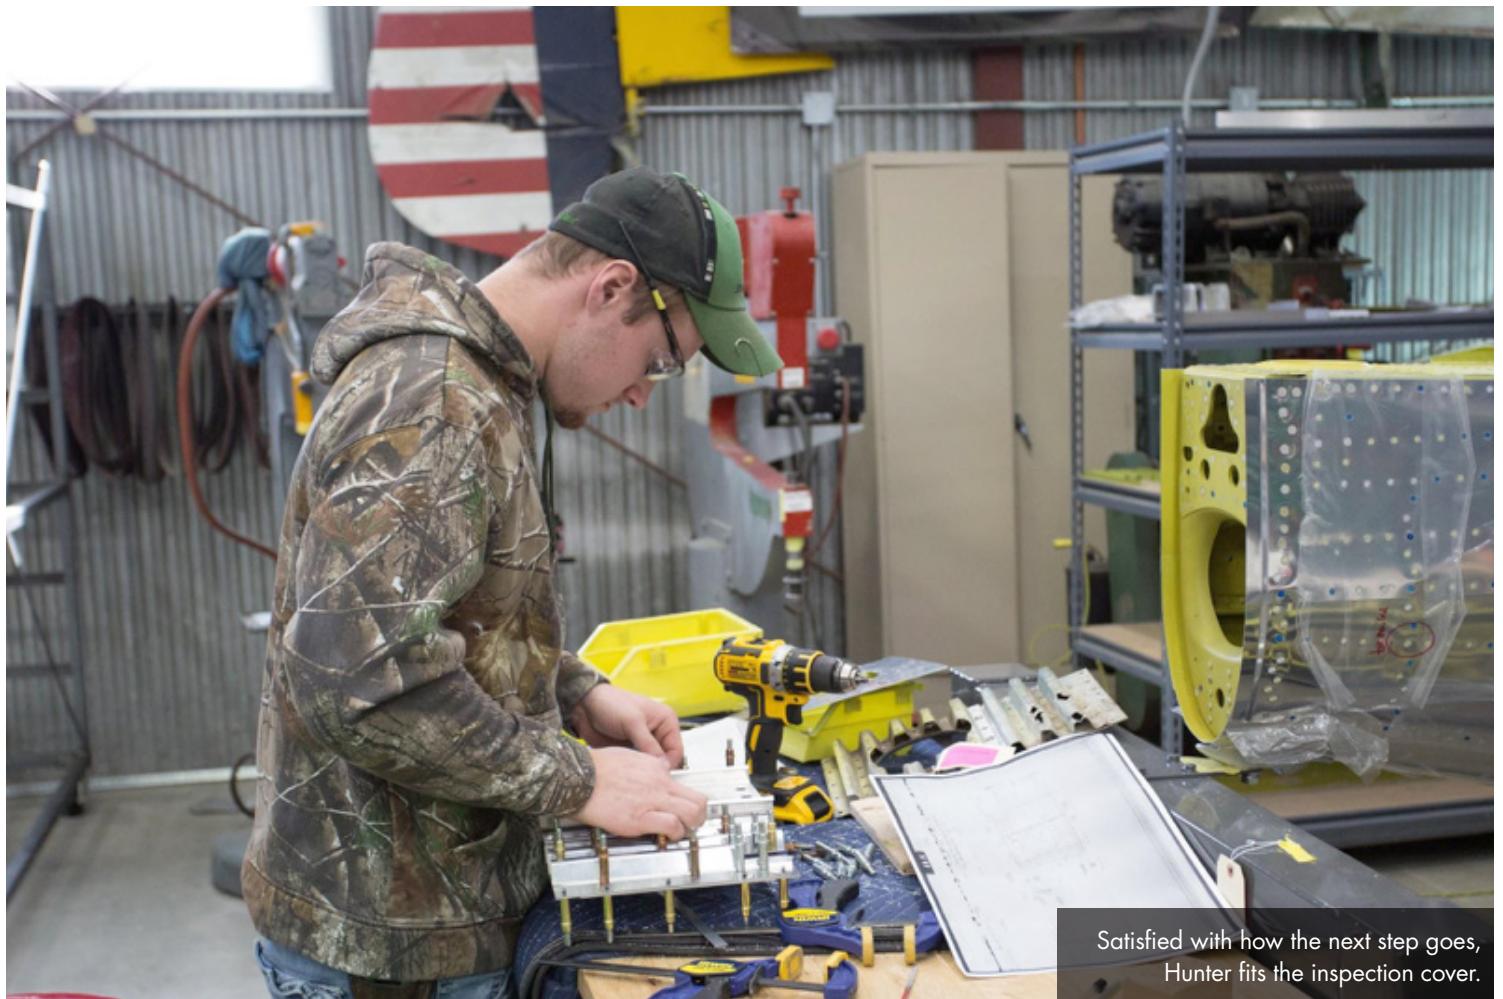
Satisfied with how the next step goes,
Hunter fits the inspection cover.

This section is installed to the right side of the stick assembly, the one with the fuel selector goes on the left side. The "Z" channel extrusion on the far left of the assembly is one of the original parts of 42-27609 that passed inspection and has been reused in the restoration. After 70 years in a wet tropical climate, there aren't a great many usable parts, but every one that can be used will be.

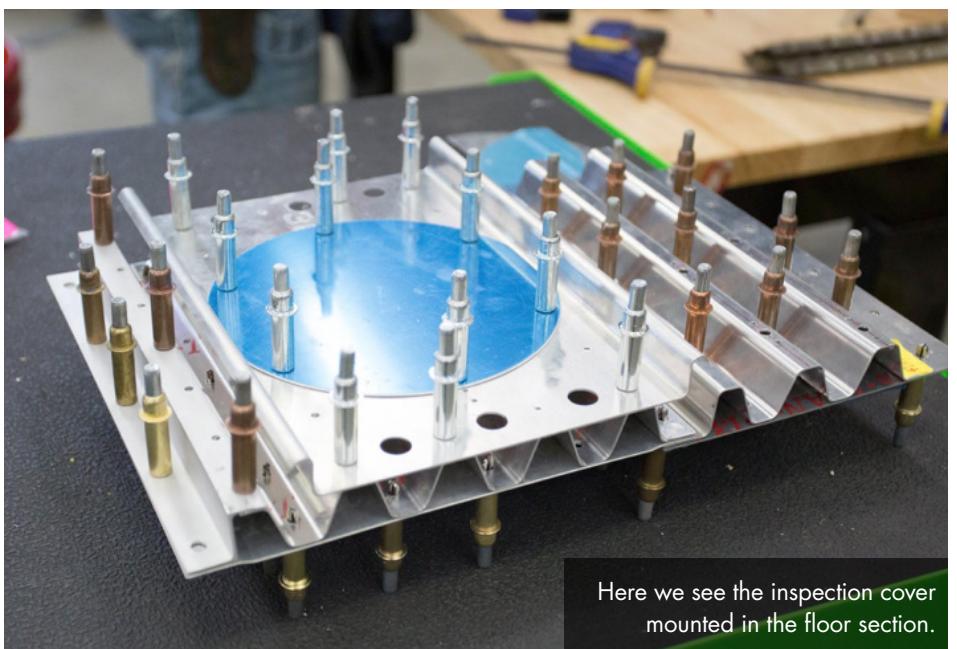
Here we see the inspection cover
mounted in the floor section.

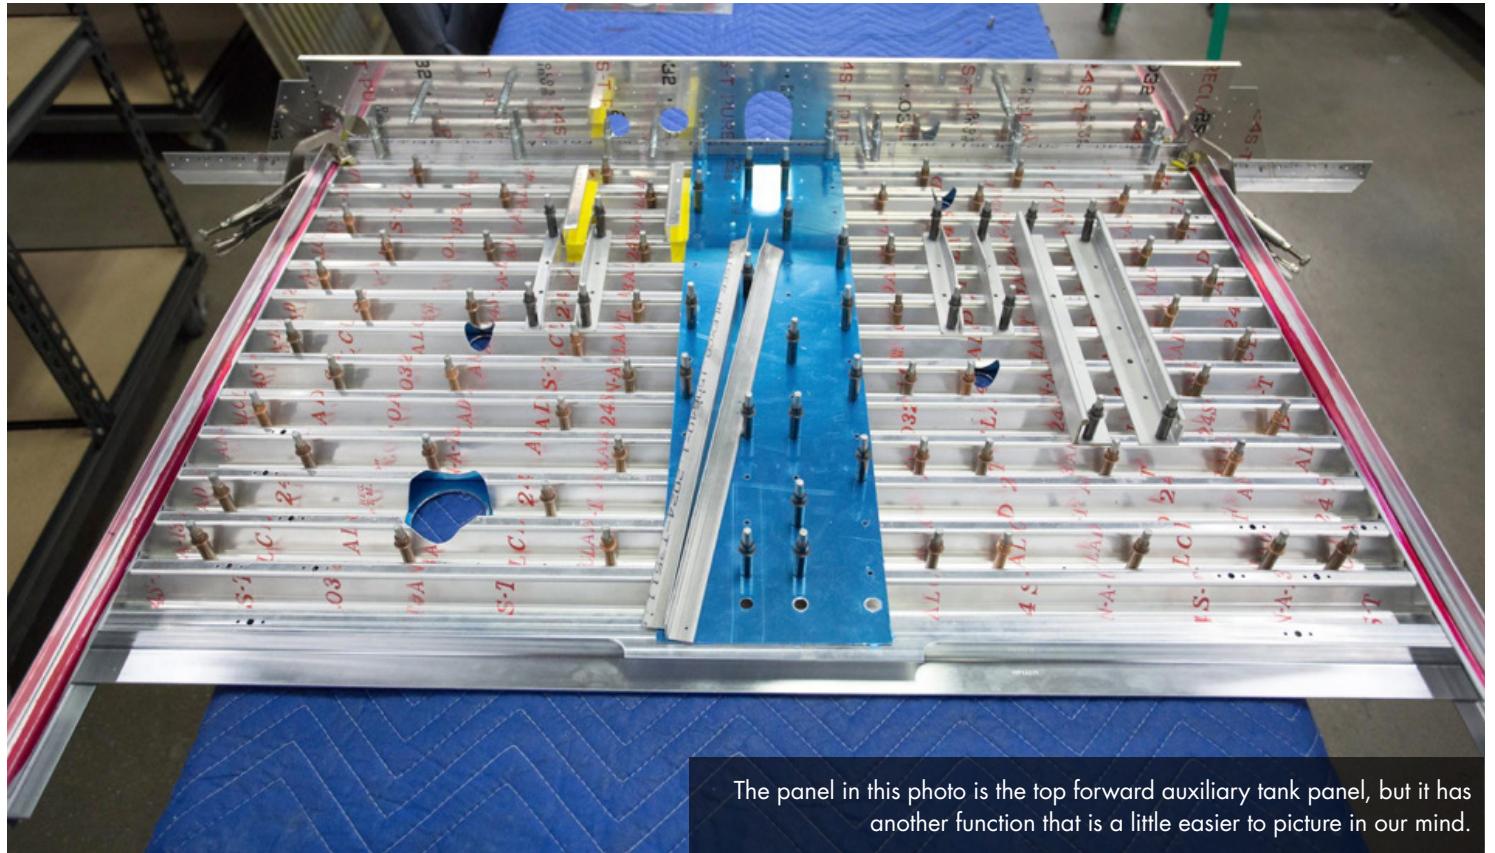
The panel in this photo is the top forward auxiliary tank panel, but it has another function that is a little easier to picture in our mind.

It is the floor under the pilot seat and the shorter brackets visible in this shot are lower pilot's seat tube supports. The longer aluminum angle brackets are for the emergency hydraulic hand pump.

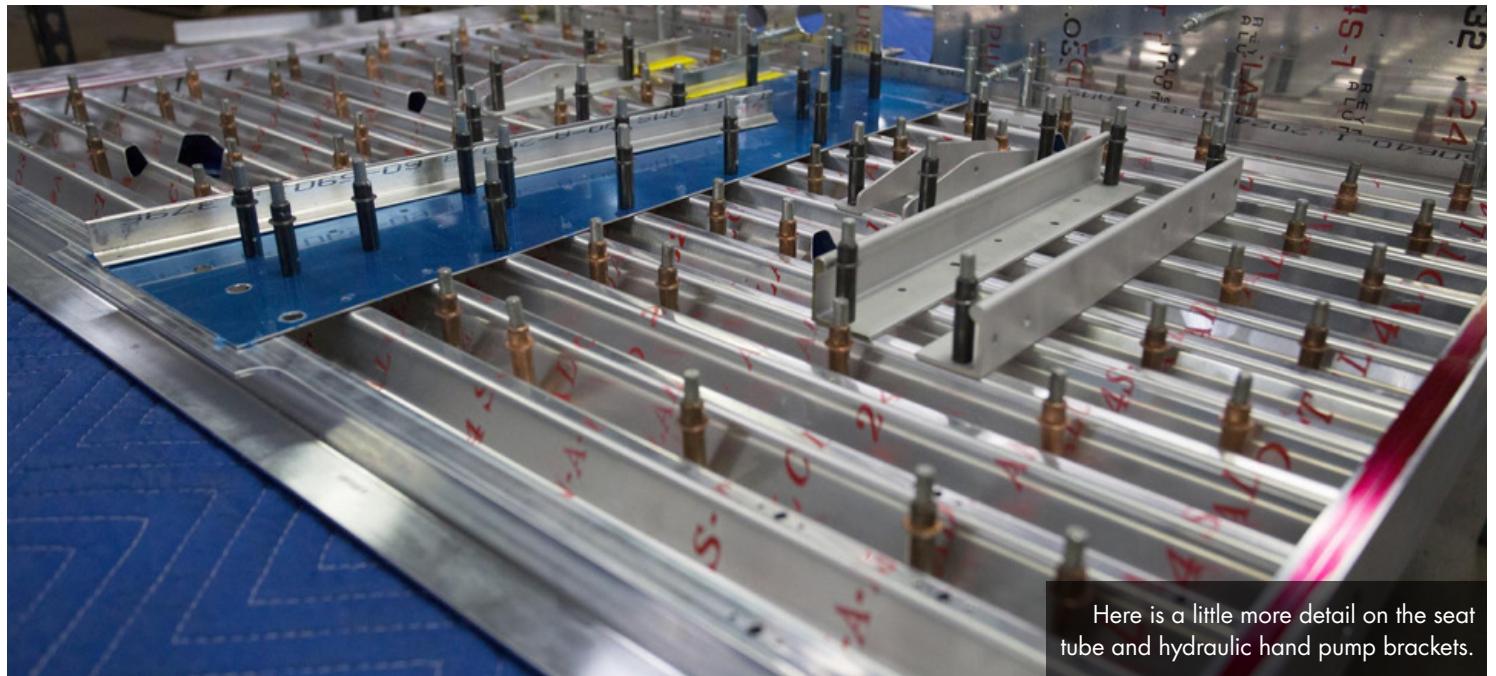
Here is a little more detail on the seat tube and hydraulic hand pump brackets.

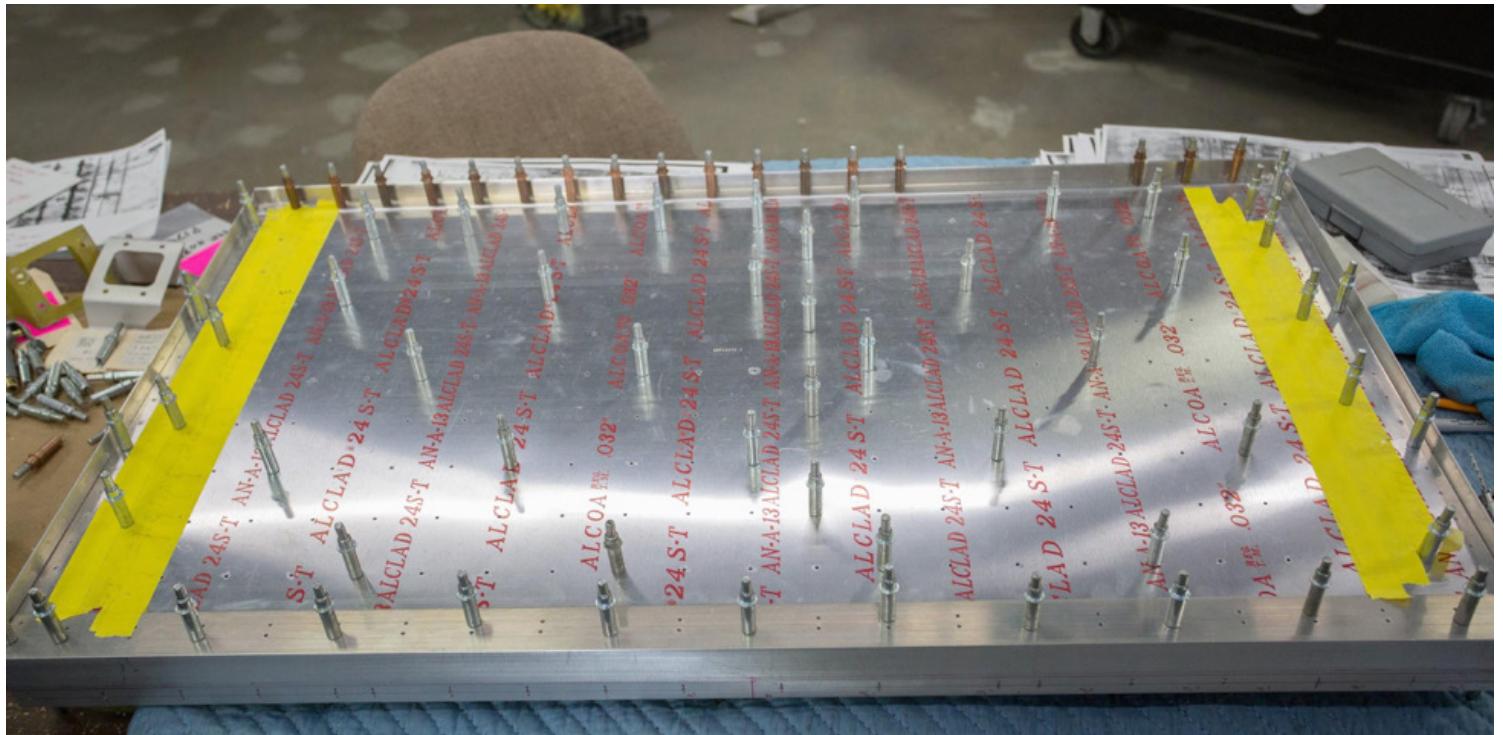
Fuel Tank Bays

This panel fits vertically at the front of the auxiliary fuel tank area. The various tank bay panels could be fabricated later on, but we are doing it now because access is easier. The corrugated panels have been time-consuming and a real challenge to properly fabricate and assemble.

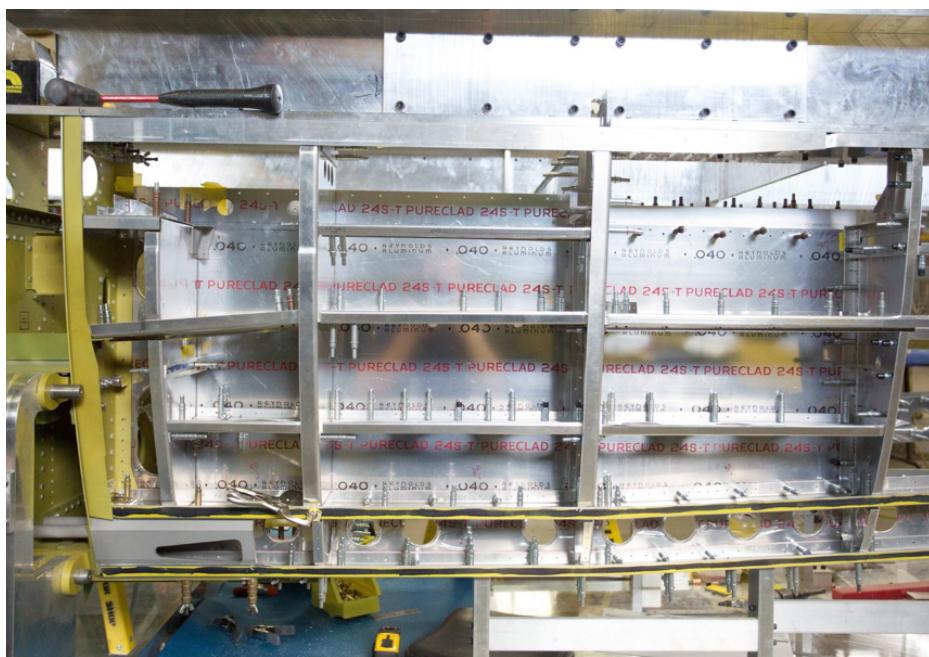
The aluminum sides of the auxiliary fuel tank bay are in place in this image. The auxiliary internal fuel tank on P-47D-23 has a capacity of 100 U.S. gallons.

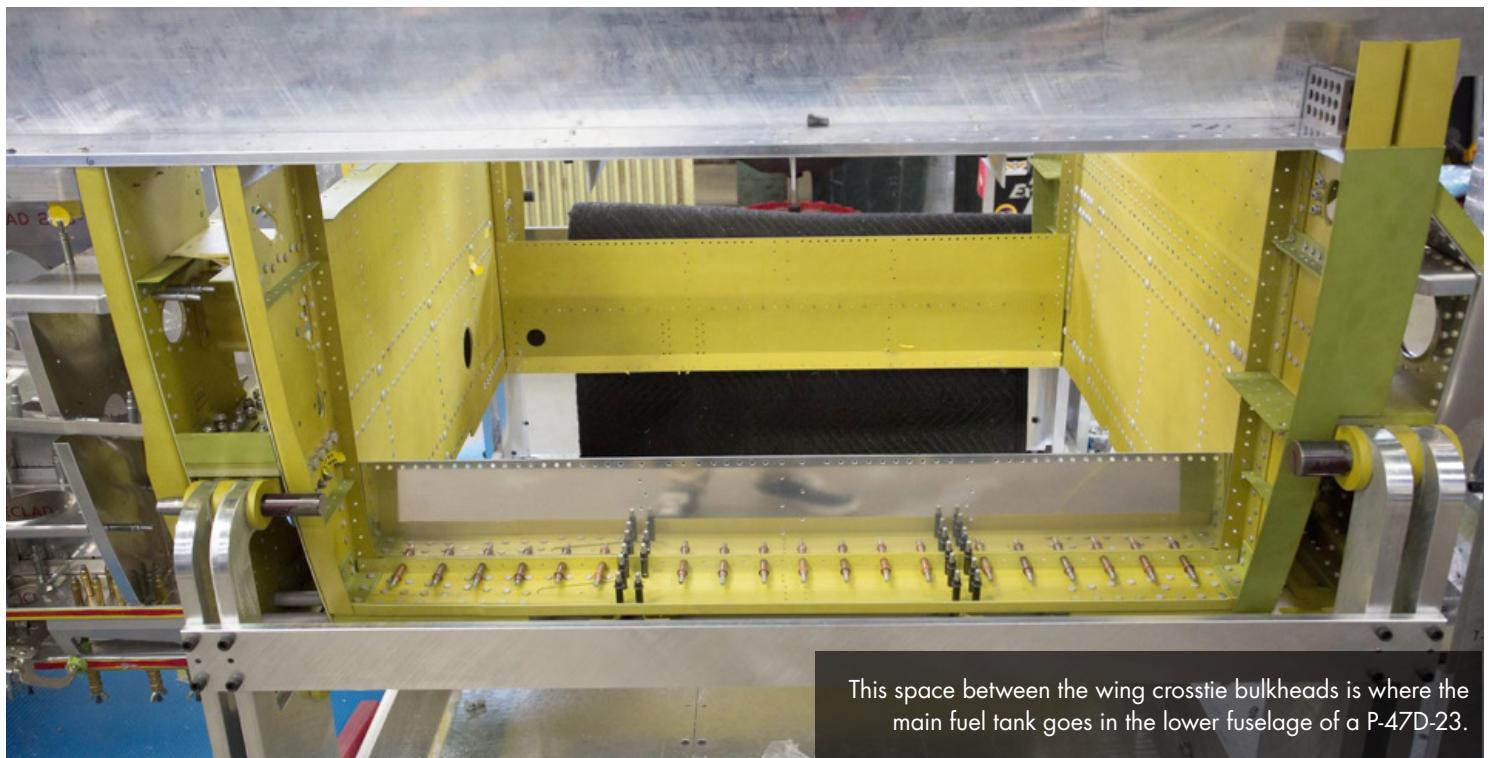
The main internal fuel tank on a P-47D-23 had a capacity of 205 US gallons. That makes the total internal fuel capacity 305 gallons (without drop tanks).

In the Southwest Pacific, some were fitted with a tank behind the cockpit. That field installation was commonly called a "Christmas tree tank" because of its shape. Ours was one of those and the fuel cell is labeled "capacity 42 US Gallons" so, in total, it could have flown with 347 gallons internally.

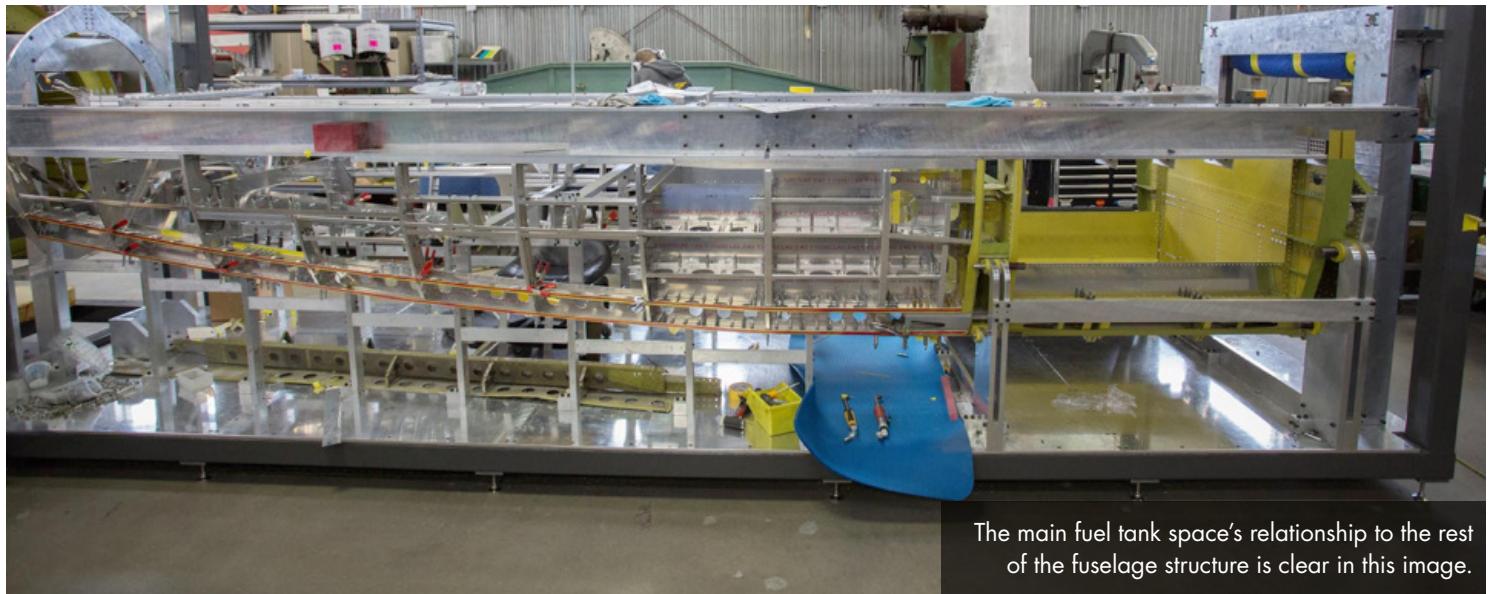
The main fuel tank space's relationship to the rest of the fuselage structure is clear in this image.

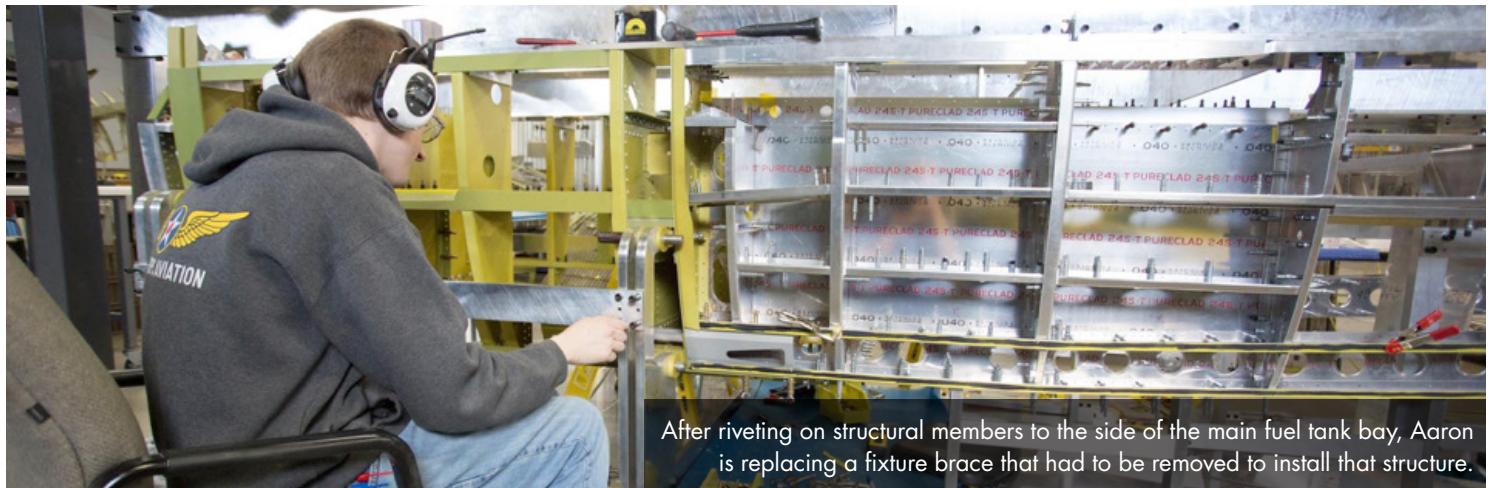
After riveting on structural members to the side of the main fuel tank bay, Aaron is replacing a fixture brace that had to be removed to install that structure.

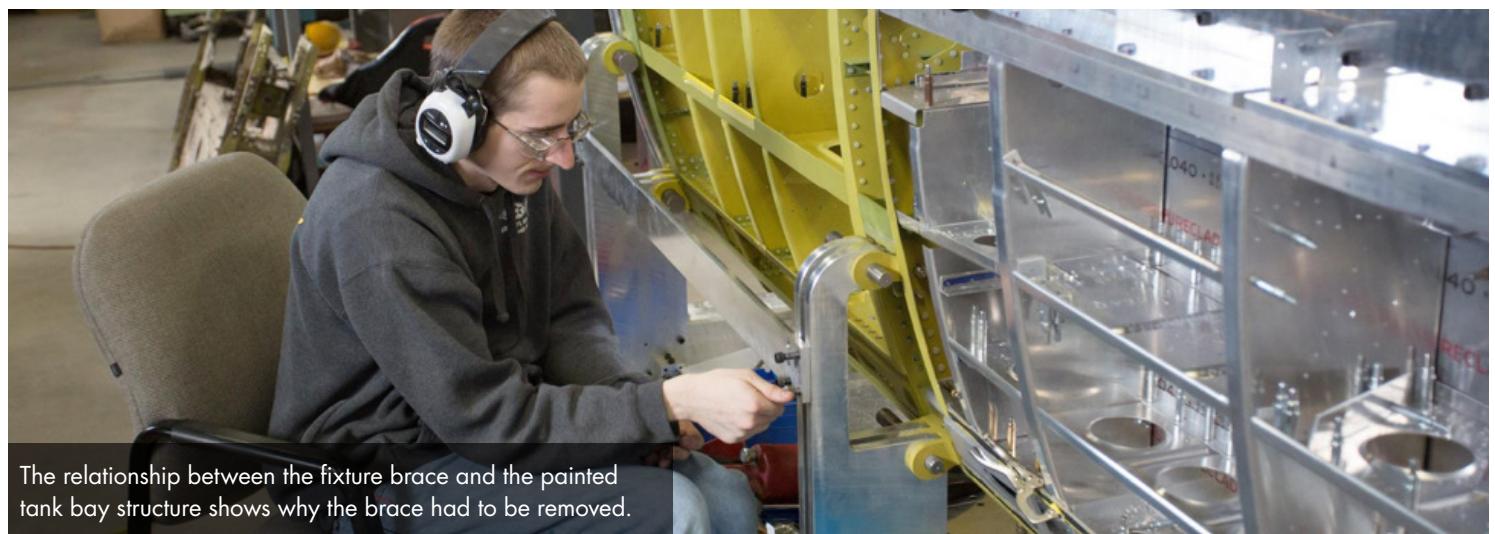
The relationship between the fixture brace and the painted tank bay structure shows why the brace had to be removed.

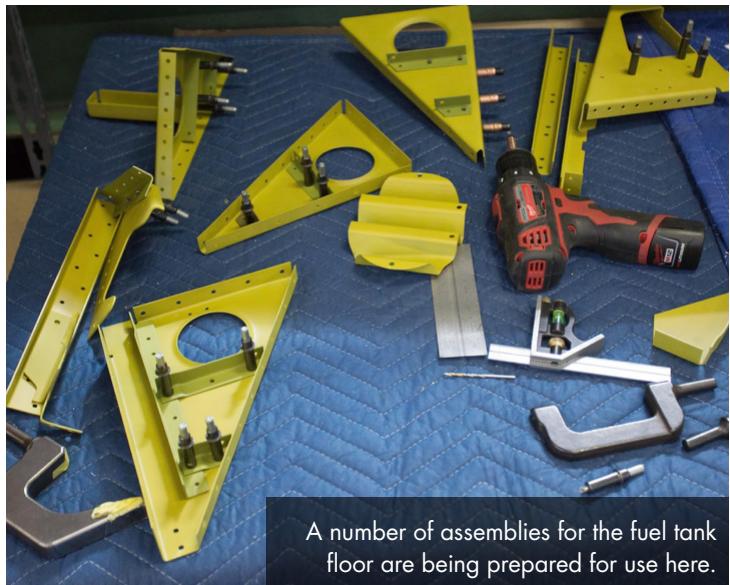
A number of assemblies for the fuel tank floor are being prepared for use here.

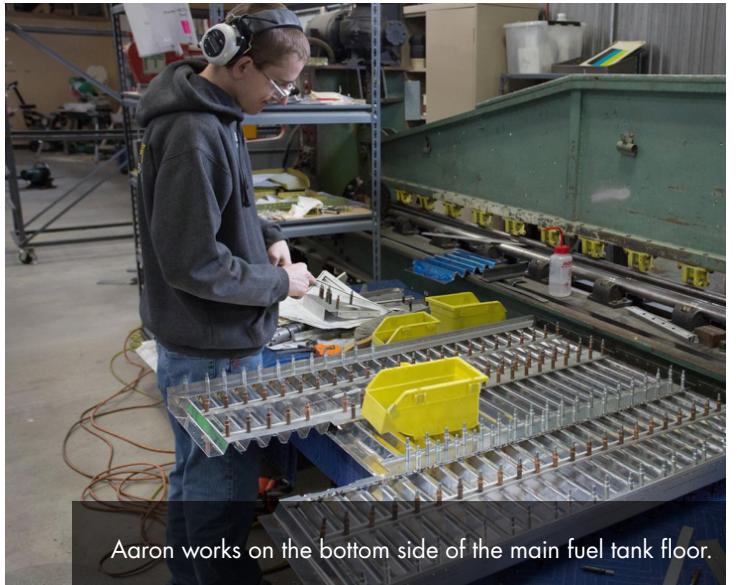
Aaron works on the bottom side of the main fuel tank floor.

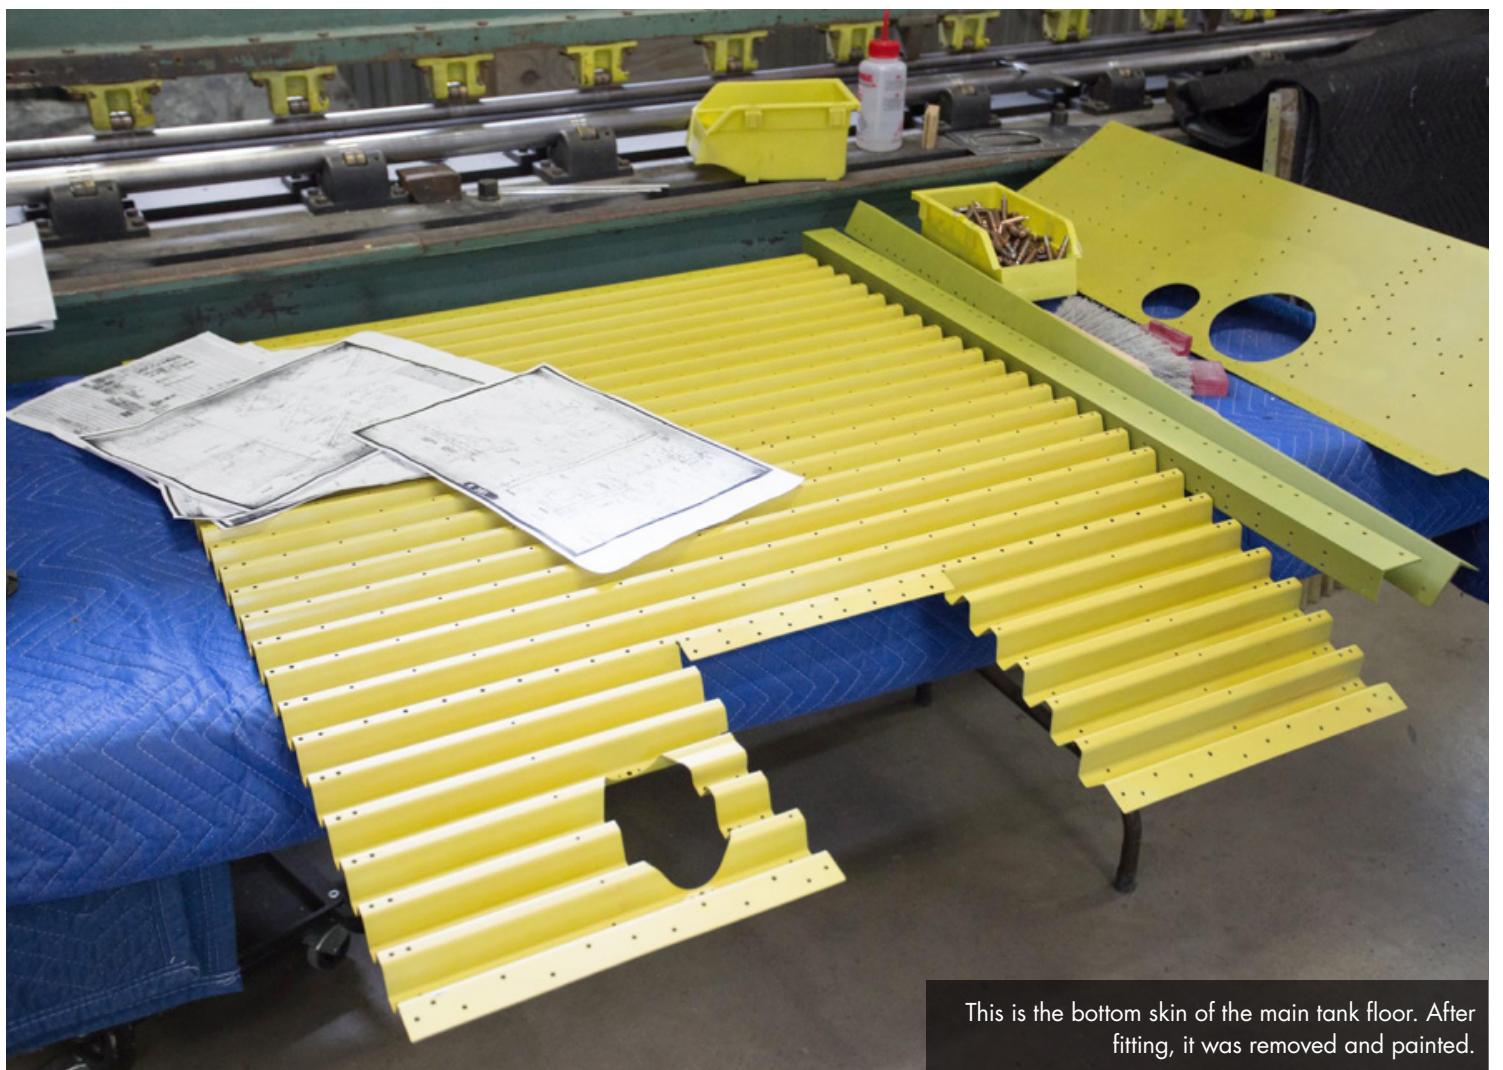
This is the bottom skin of the main tank floor. After fitting, it was removed and painted.

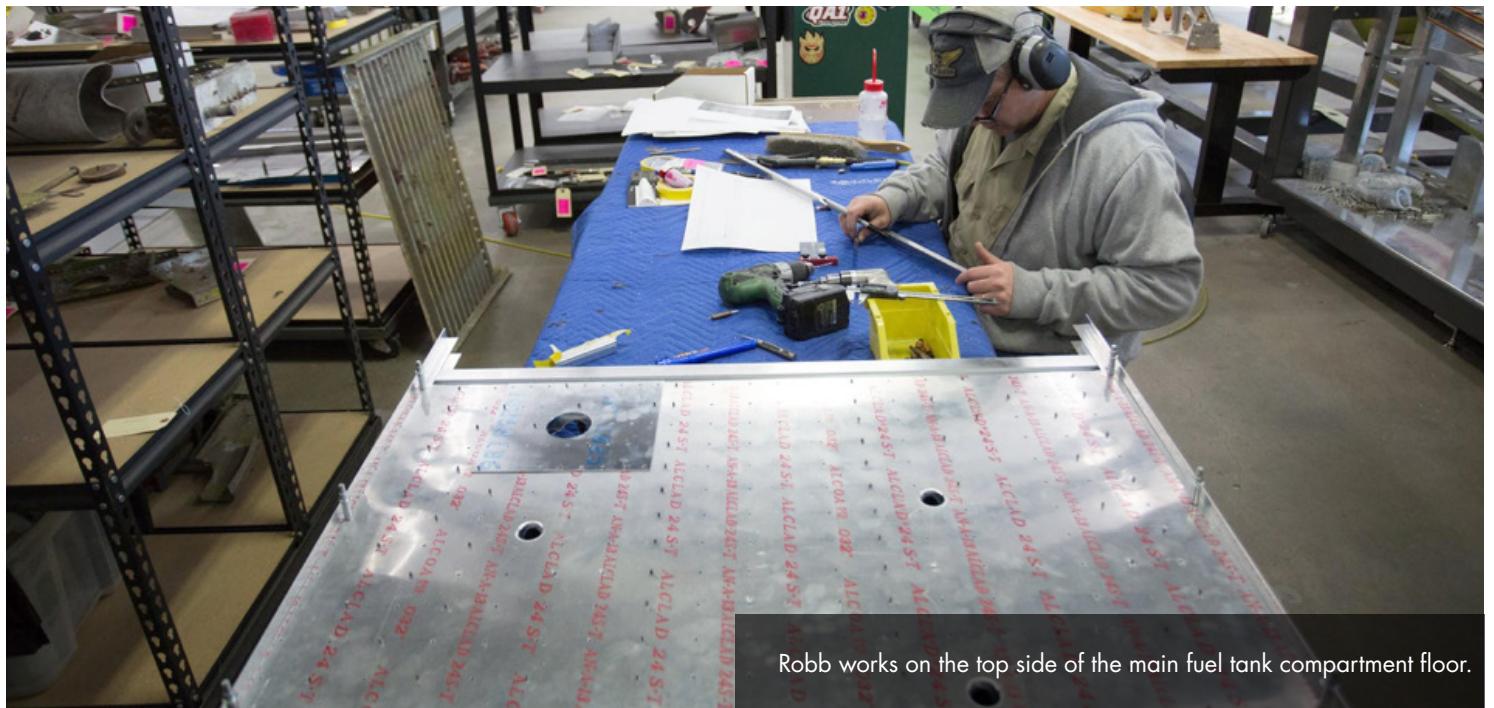
Robb works on the top side of the main fuel tank compartment floor.

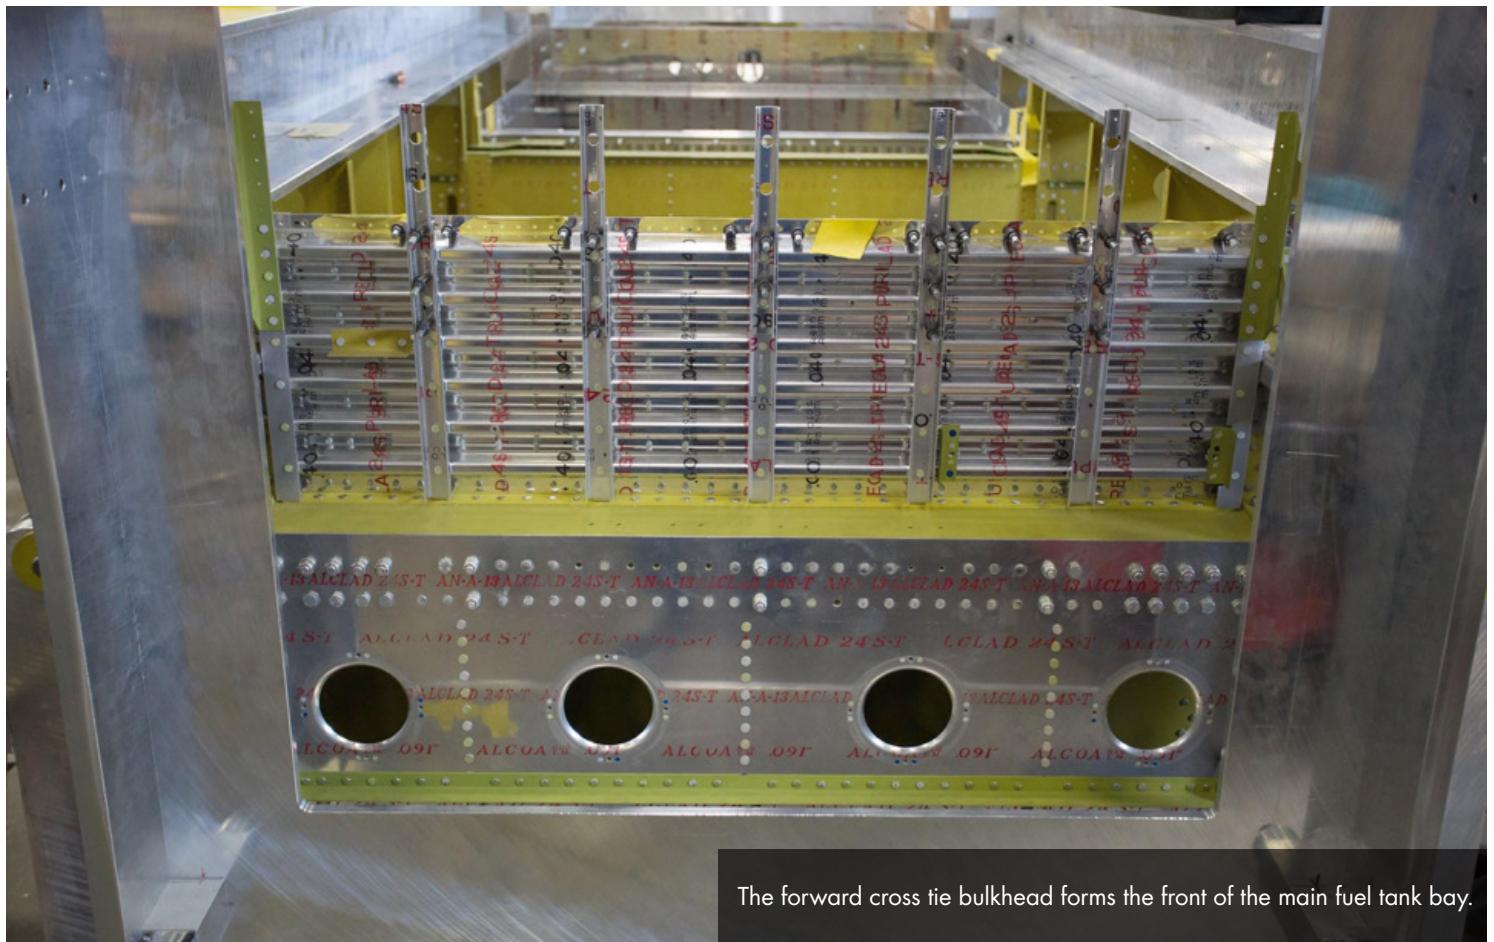
The forward cross tie bulkhead forms the front of the main fuel tank bay.

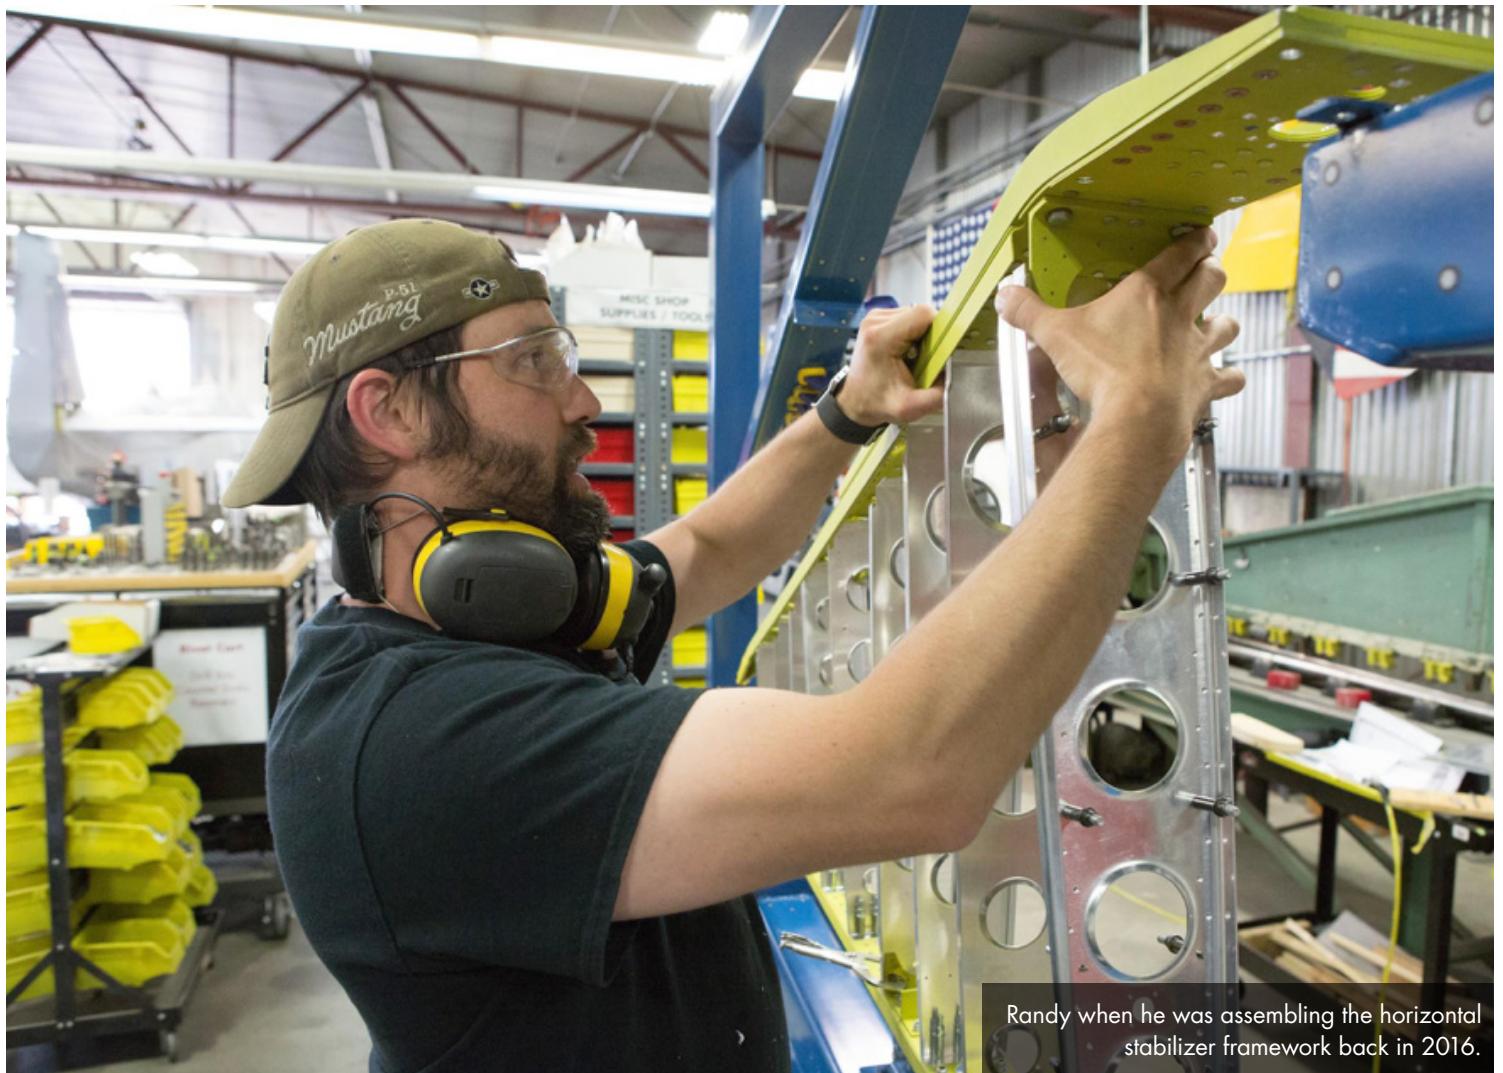
Randy when he was assembling the horizontal stabilizer framework back in 2016.
