Texas Flying Legends' P-47D-23RA
by Chuck Cravens

Update

In October and November, for the first time we began some assembly of the major components of the airframe. Other work on the P-47 this month centered on parts fabrication, disassembling the veteran fuselage, beginning the new fuselage, and assembling the fixed tail surfaces.

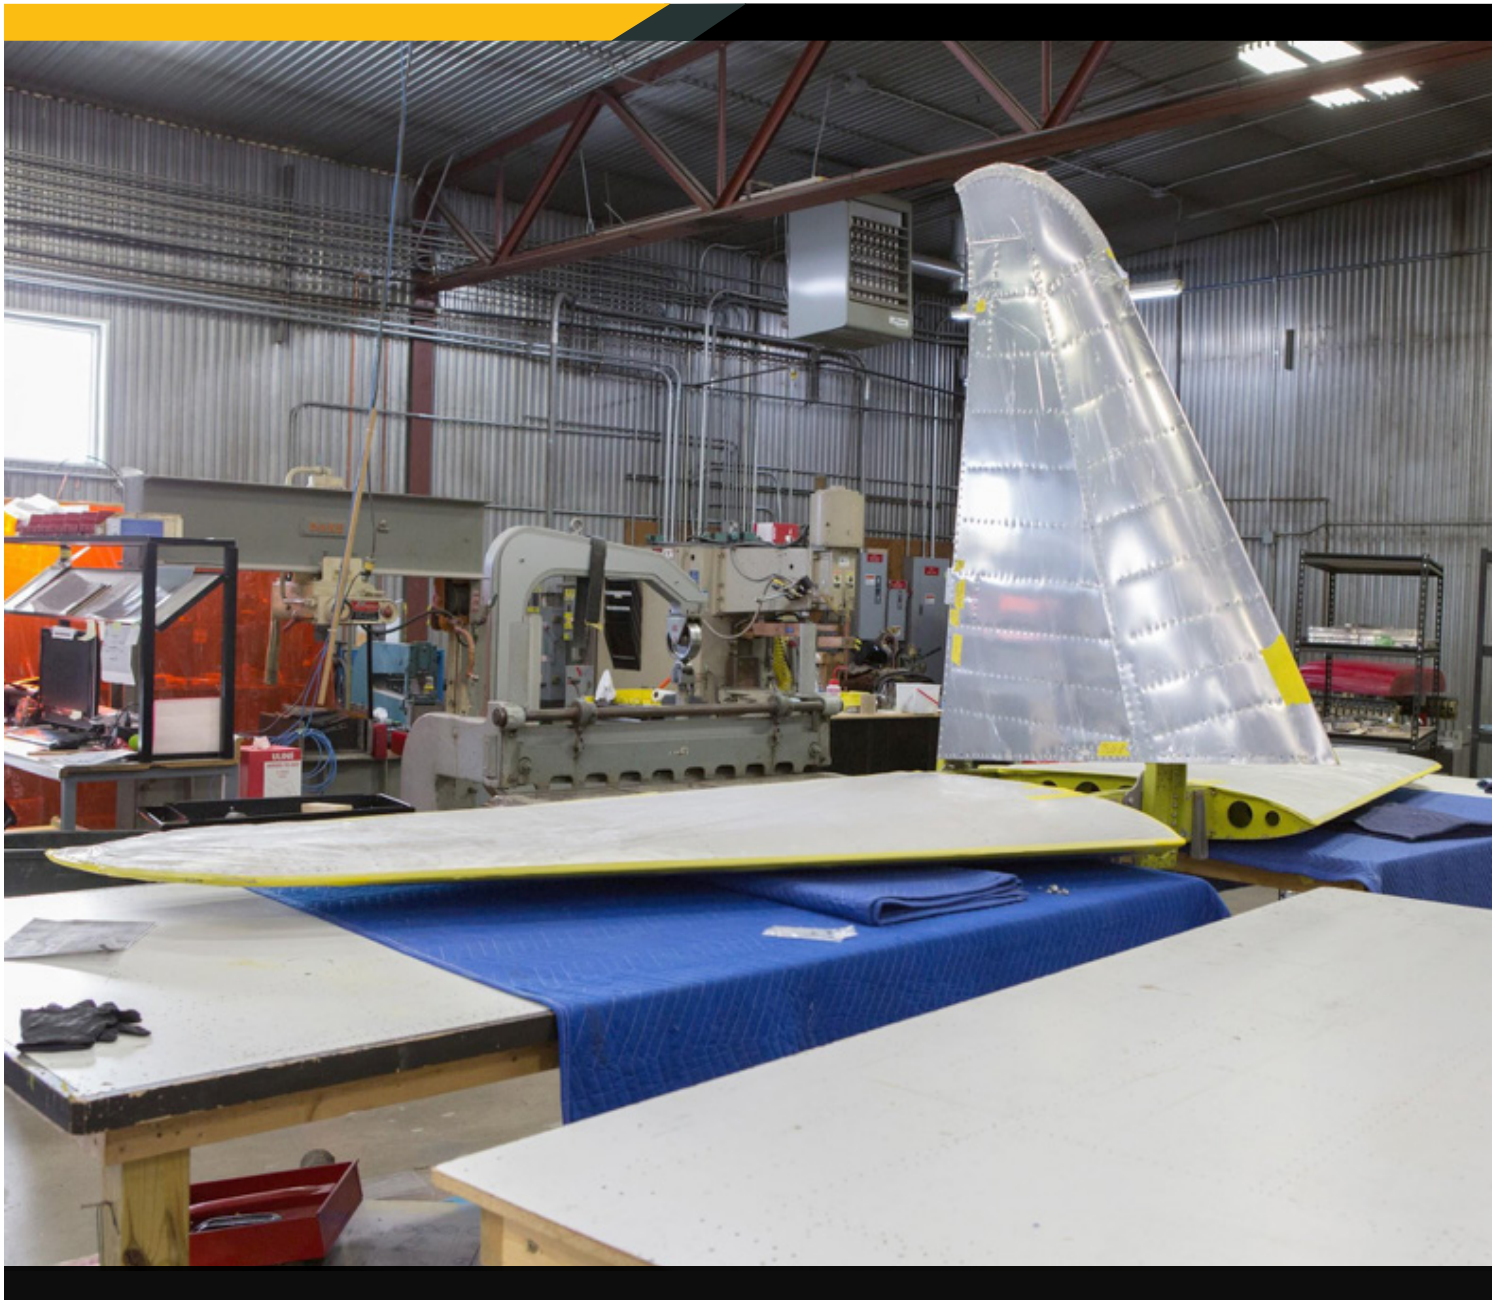
The first joined large assemblies on the bench.

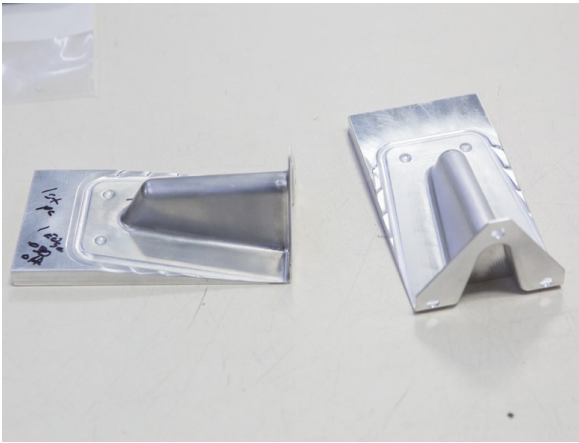
These two are fume seal pulley brackets, tail wheel uplock part number 89M42212. That means they cover the tail wheel uplock pulley bracket to seal off fumes from reaching the cockpit.

In a Thunderbolt, exhaust gas fumes in the ducts back to the turbo supercharger and fuel fumes in the high pressure induction duct running back to the engine can present a problem not common in other fighters. A great deal of engineering went into keeping those fumes where they belong and safely away from the pilot.

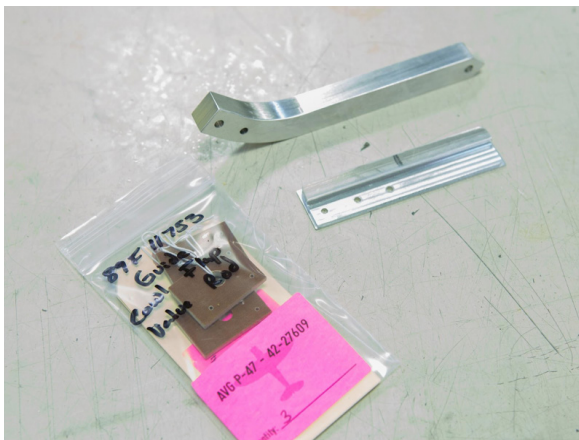
Here are a few parts that are ready. The packaged parts are cowl flap rod guides. Parts fabrication continues as assembly goes on.

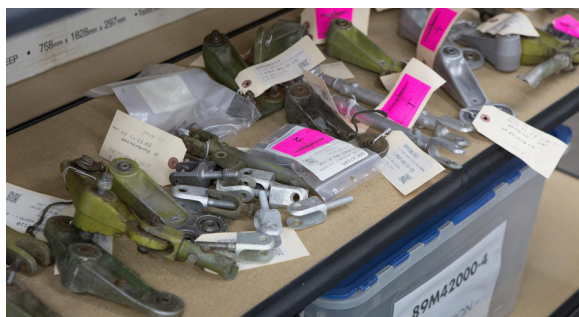
Some control system related parts both new and patterns are visible on this shelf. A few of them are the aileron differential fork assembly, elevator rod assembly, and right elevator control lever assembly.

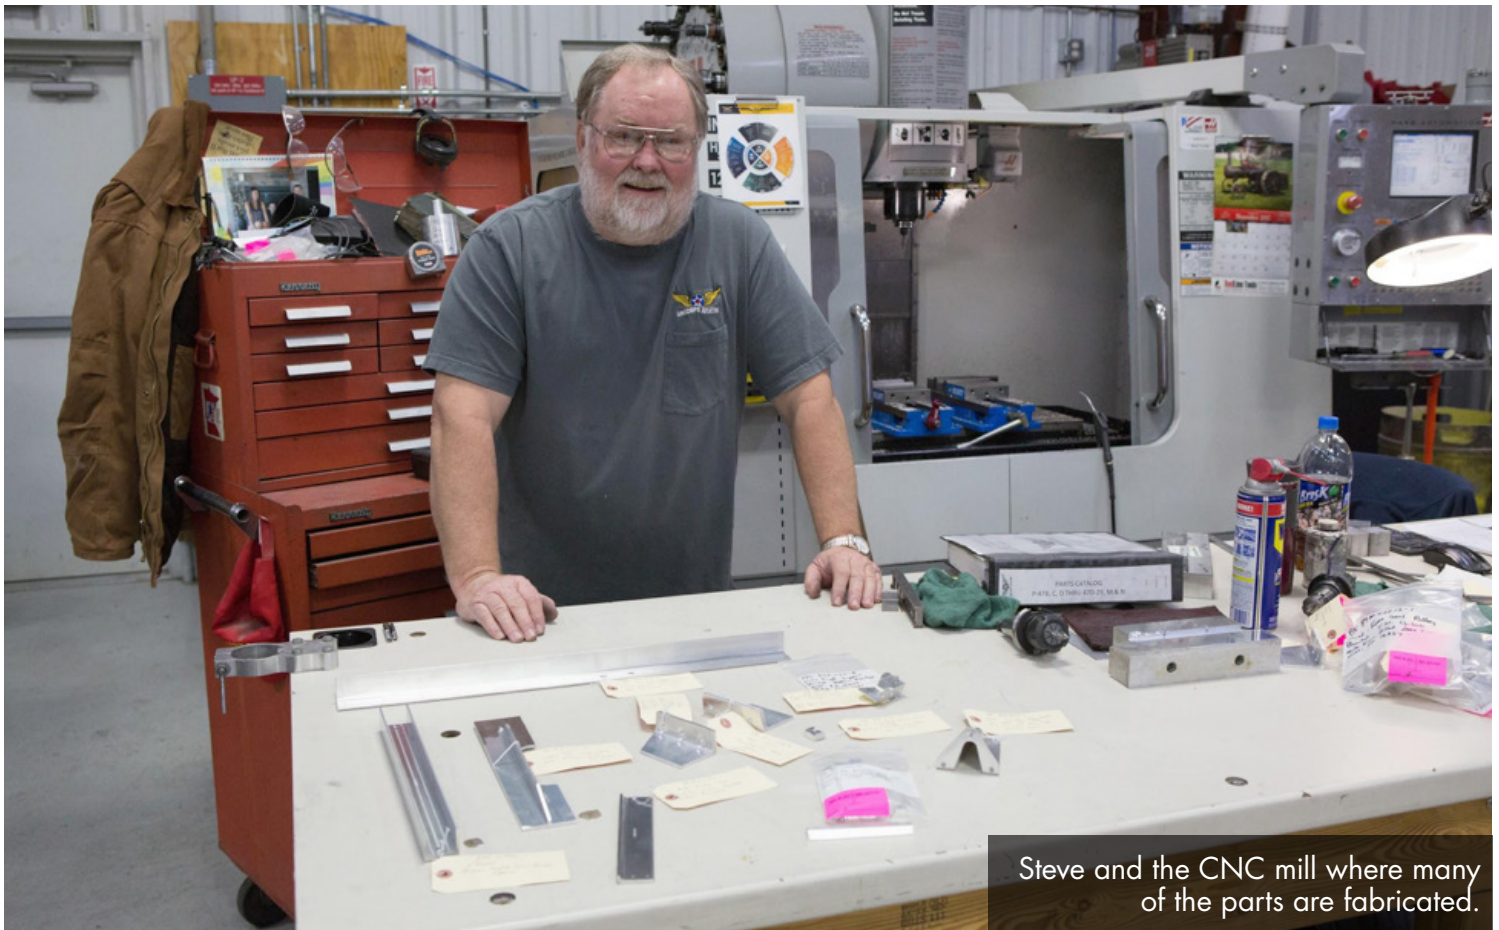
Steve and the CNC mill where many of the parts are fabricated.

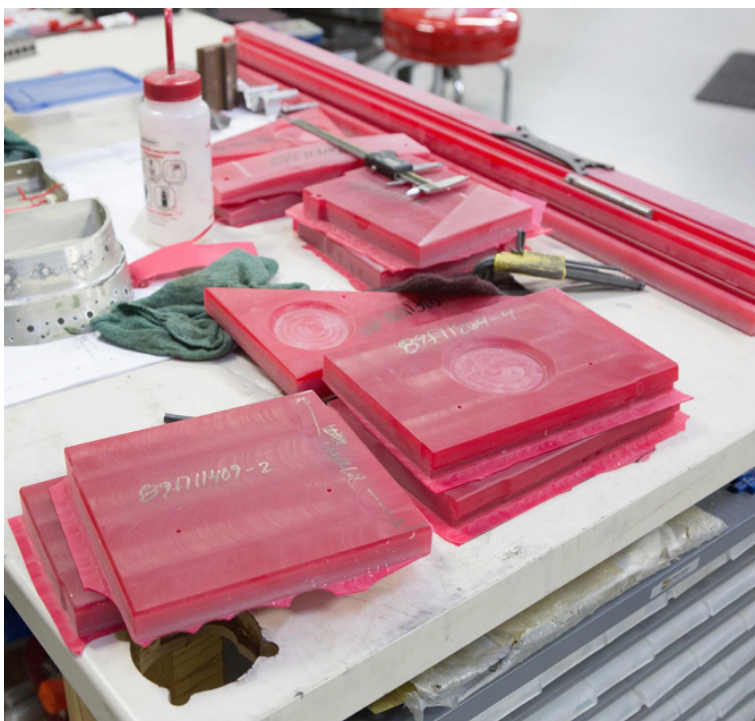
Machined plastic forms for some of the fuselage components will be used as the aluminum is press formed over them to create the part.

The forms with the two visible part numbers are for a fume-proof baffle and a diaphragm in the fuselage. Both are part of the design that is intended to prevent fuel fumes from reaching the pilot.

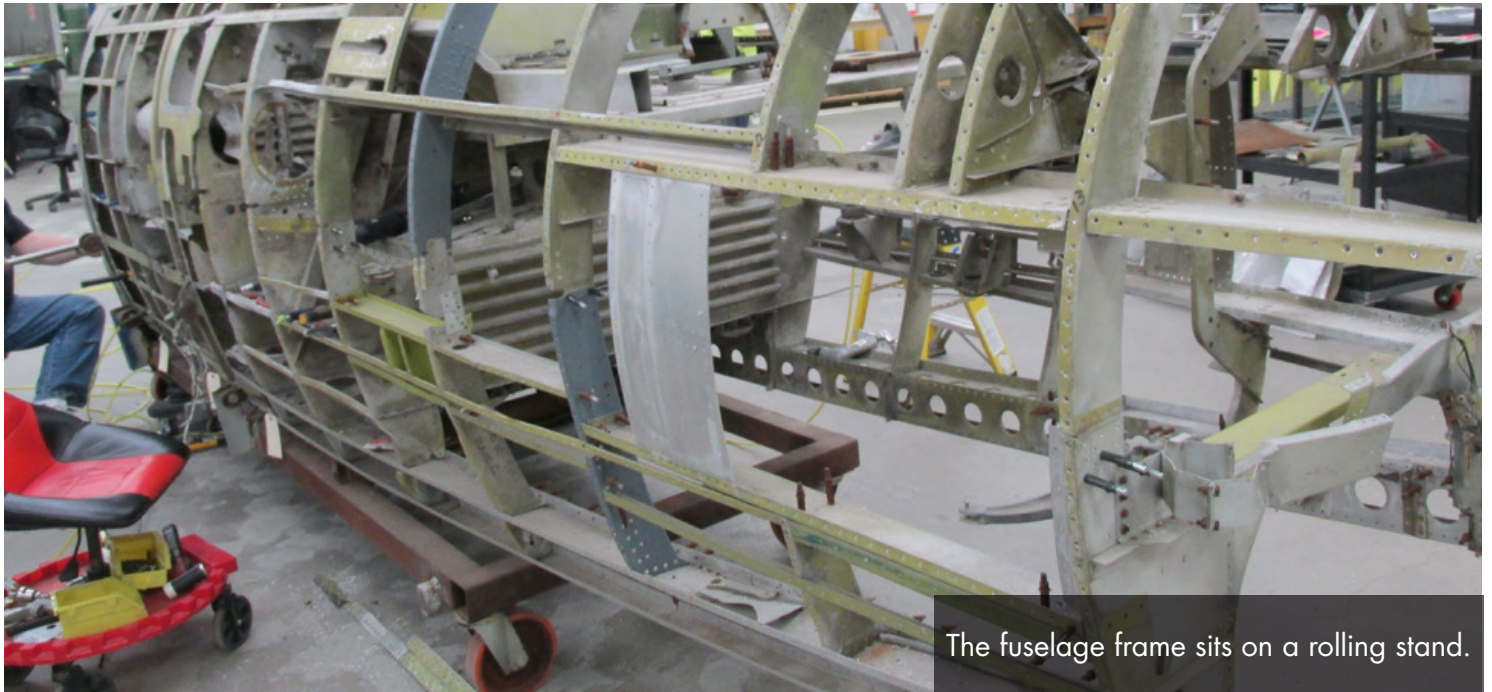
The fuselage frame sits on a rolling stand.

The fuselage was further disassembled in order to use the parts as patterns as we begin assembling the new fuselage in the fixture. Parts that appeared usable were inspected. With the fuselage in sections, various parts and assemblies can be accessed easily while apart or the sections can be set back together for a more overall look.

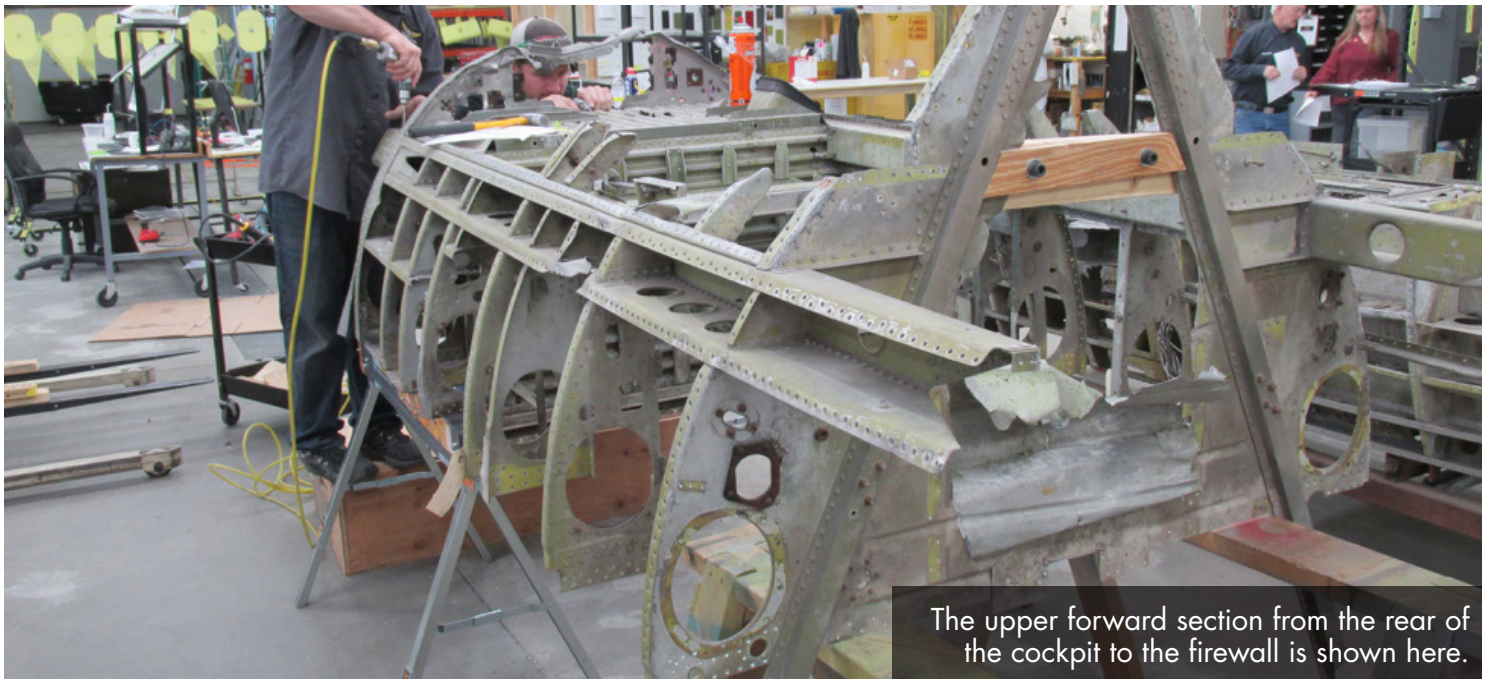
The upper forward section from the rear of the cockpit to the firewall is shown here.

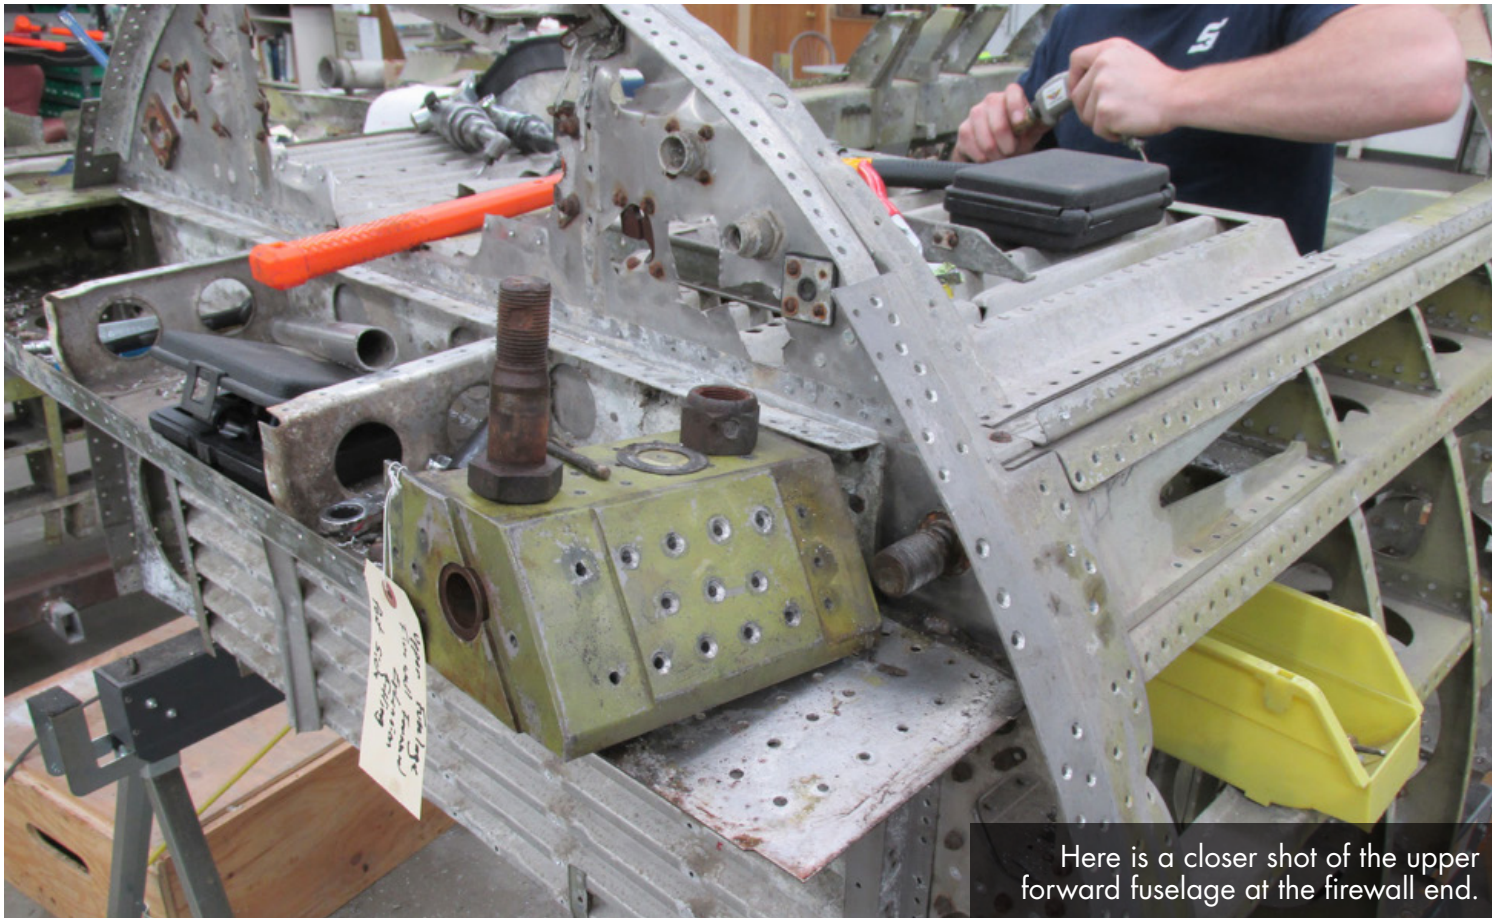
Here is a closer shot of the upper forward fuselage at the firewall end.

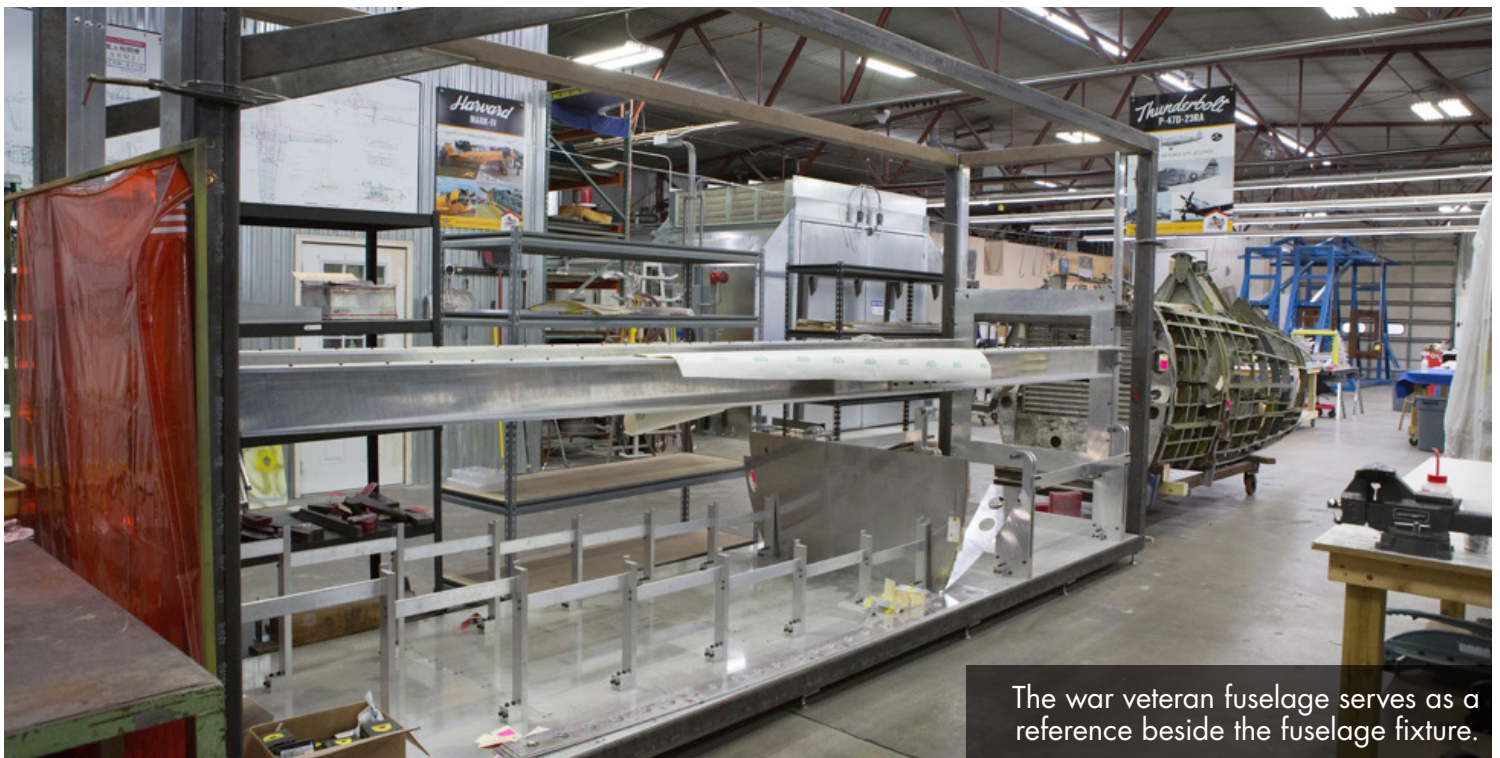
The war veteran fuselage serves as a reference beside the fuselage fixture.

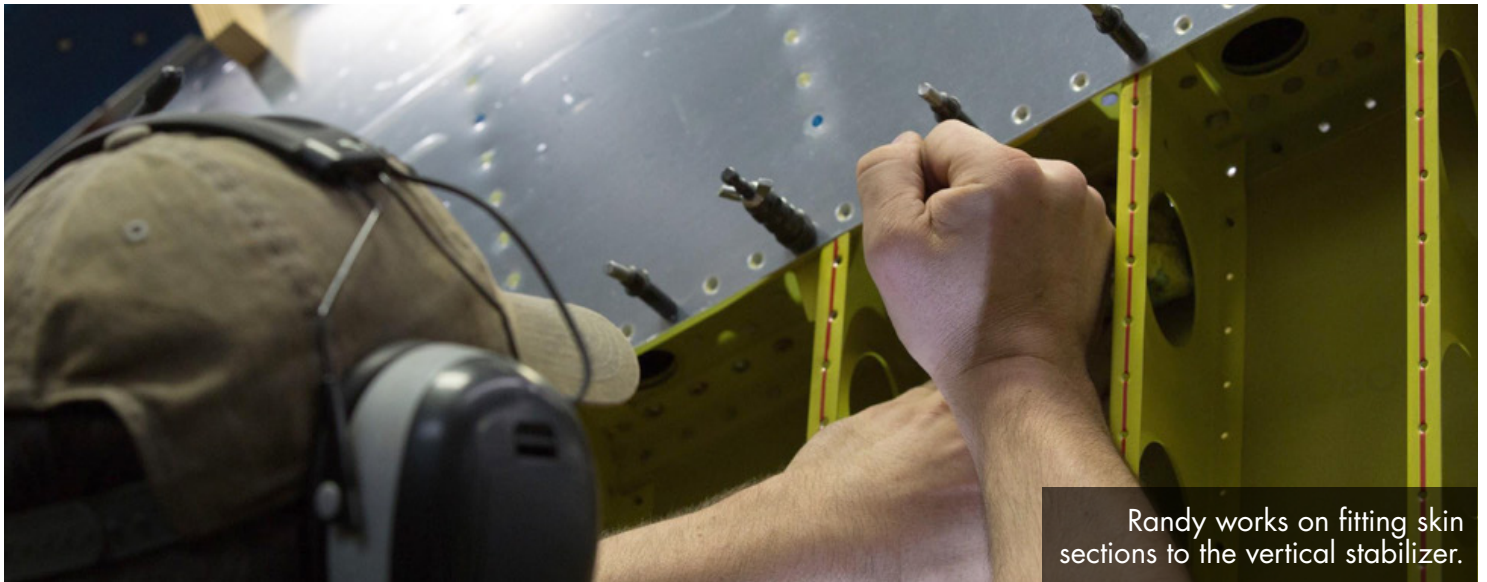
Randy works on fitting skin sections to the vertical stabilizer.

The vertical stabilizer skins were riveted on permanently this month. The horizontal skins have been permanently installed for a while now. Once both were skinned, they were assembled -the first large, identifiable Thunderbolt parts to be put together!

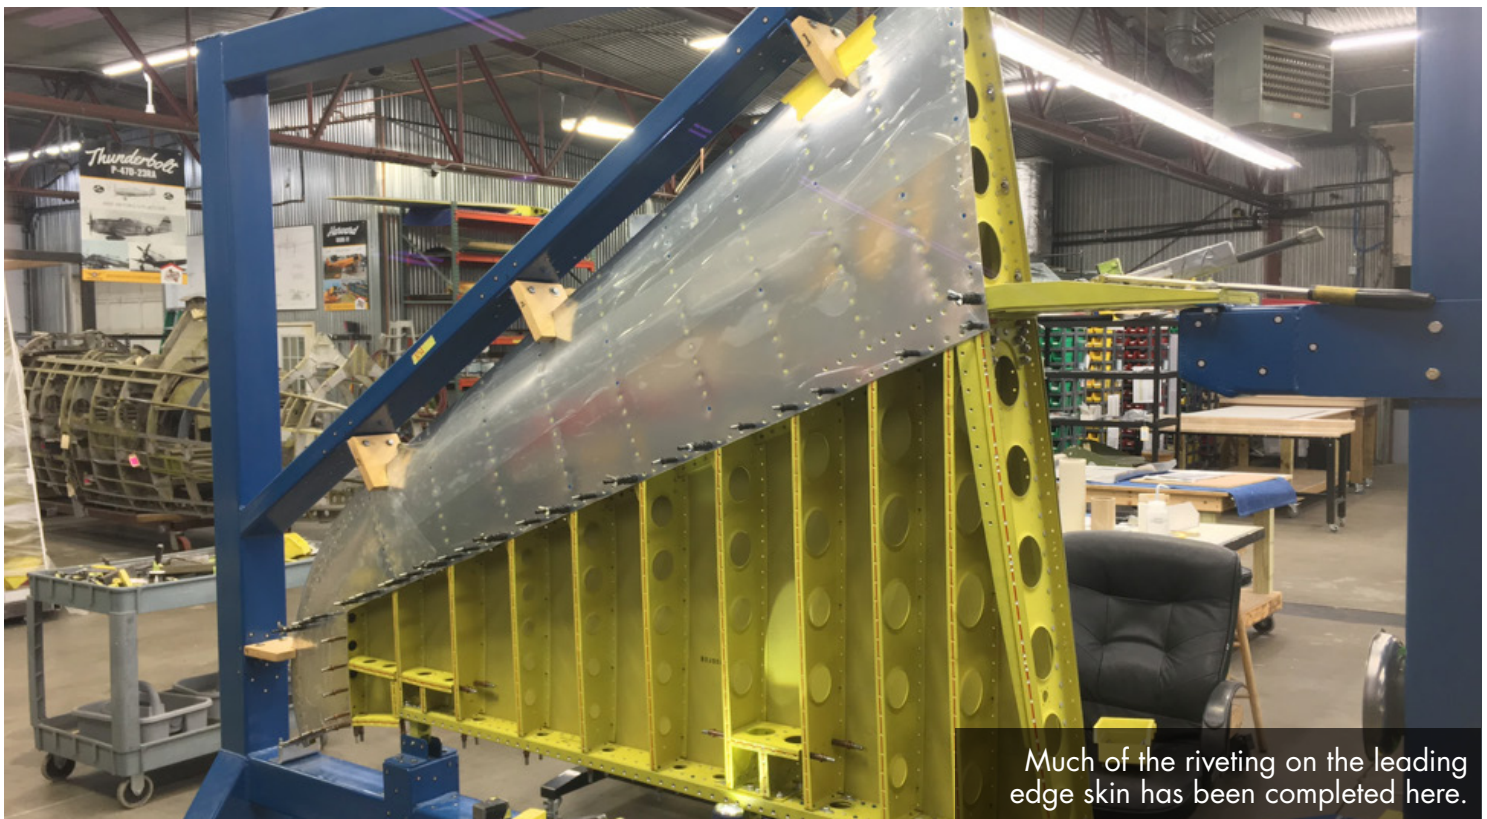
Much of the riveting on the leading edge skin has been completed here.

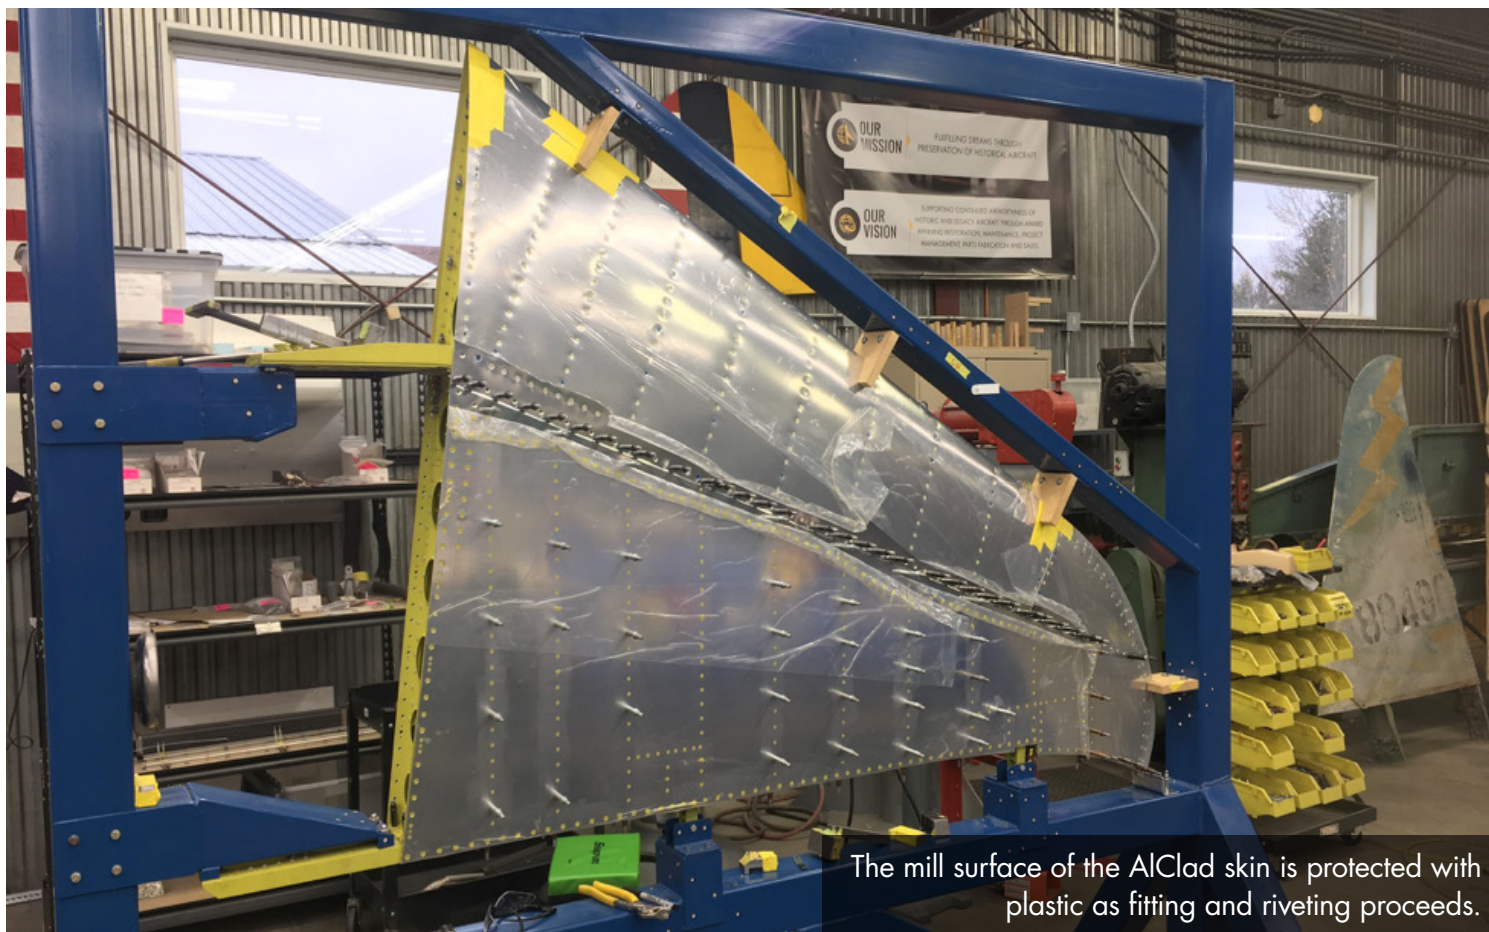
The mill surface of the AlClad skin is protected with plastic as fitting and riveting proceeds.

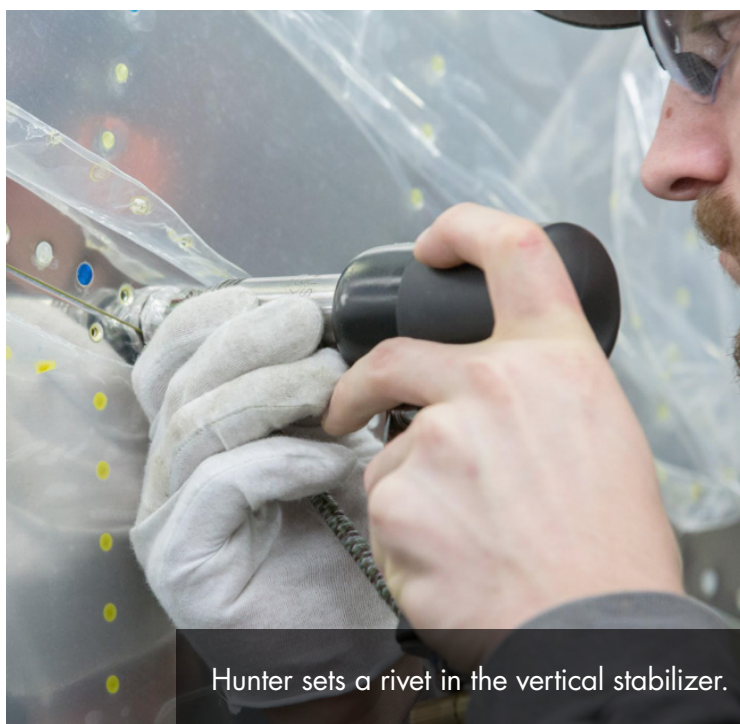
Hunter sets a rivet in the vertical stabilizer.

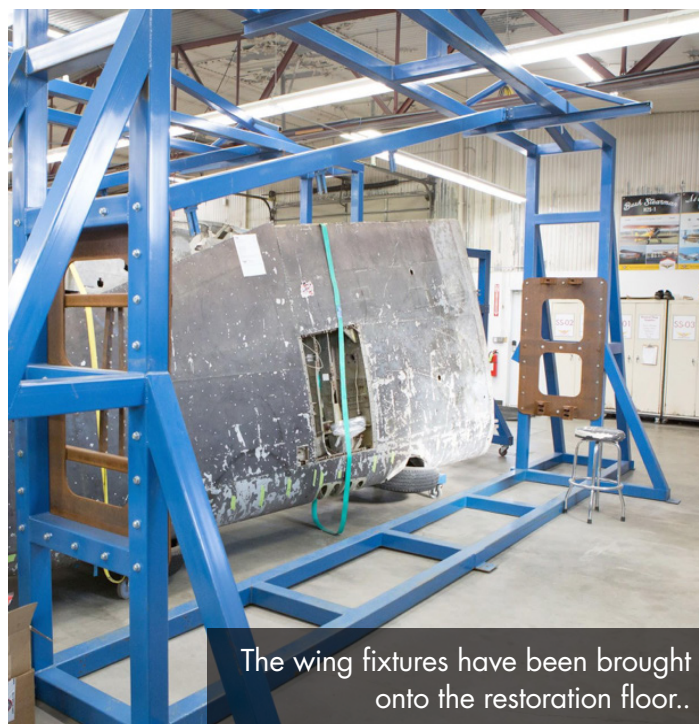
The wing fixtures have been brought onto the restoration floor..

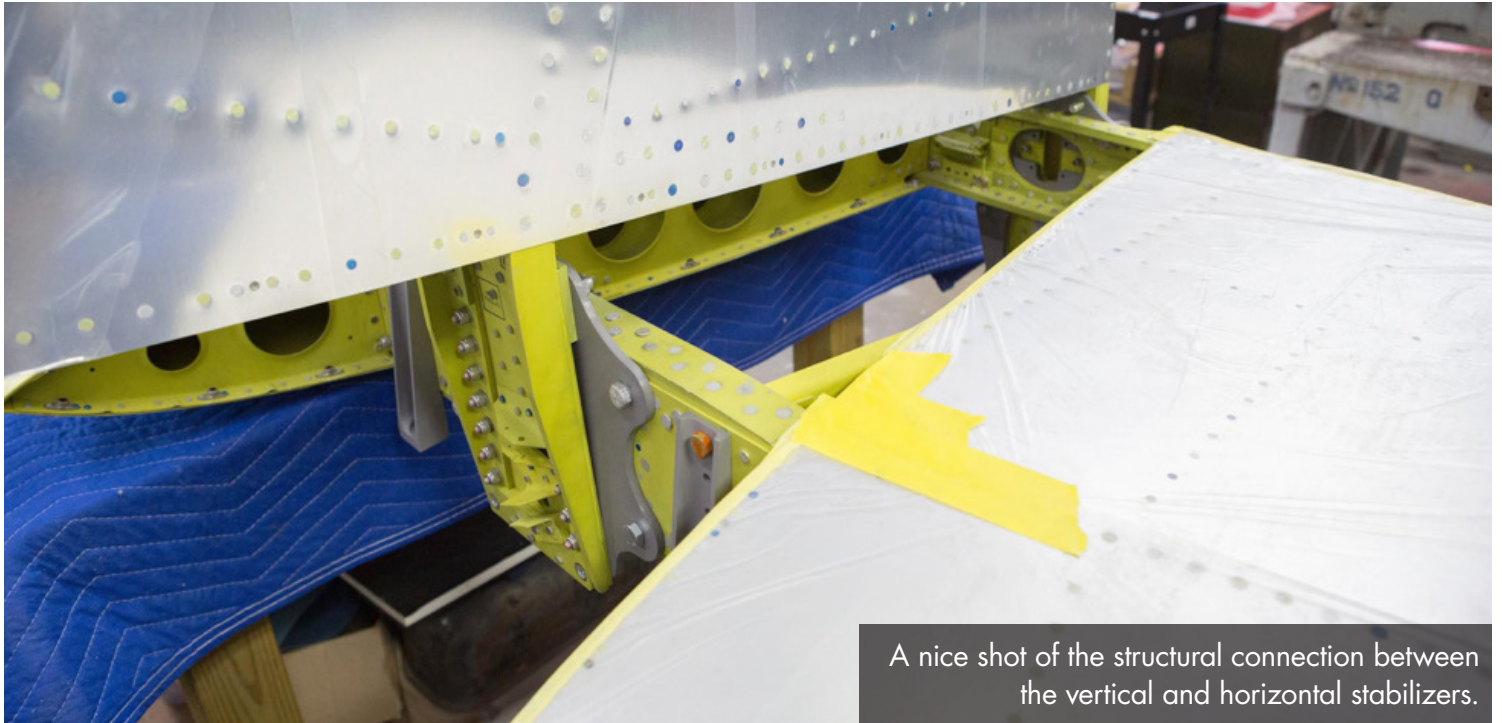
A nice shot of the structural connection between the vertical and horizontal stabilizers.

It is always great to see major, identifiable airplane components come together as a project progresses. This time we have the tail surfaces joined together.

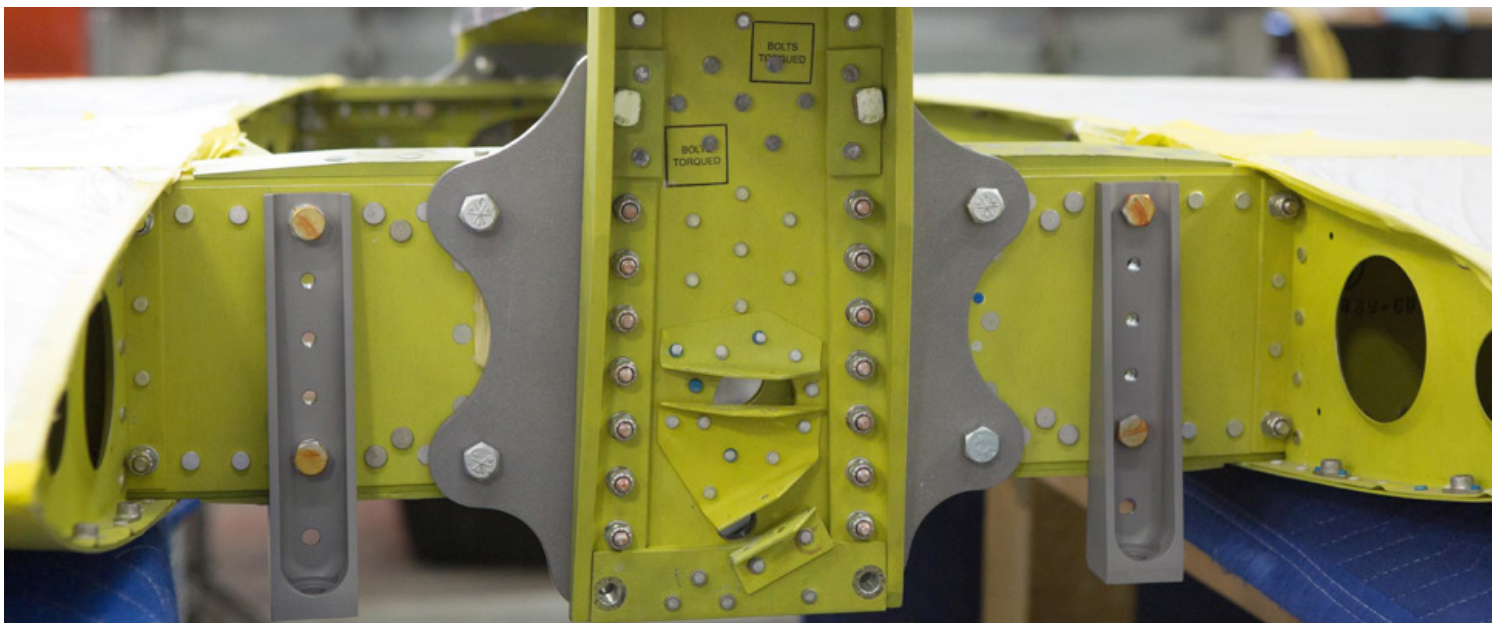
A closer image lets us see the bolts and rivets used to affix the spars together. The gray forgings that protrude beneath the stabilizer are the forward fittings that are used to attach the empennage to the fuselage.

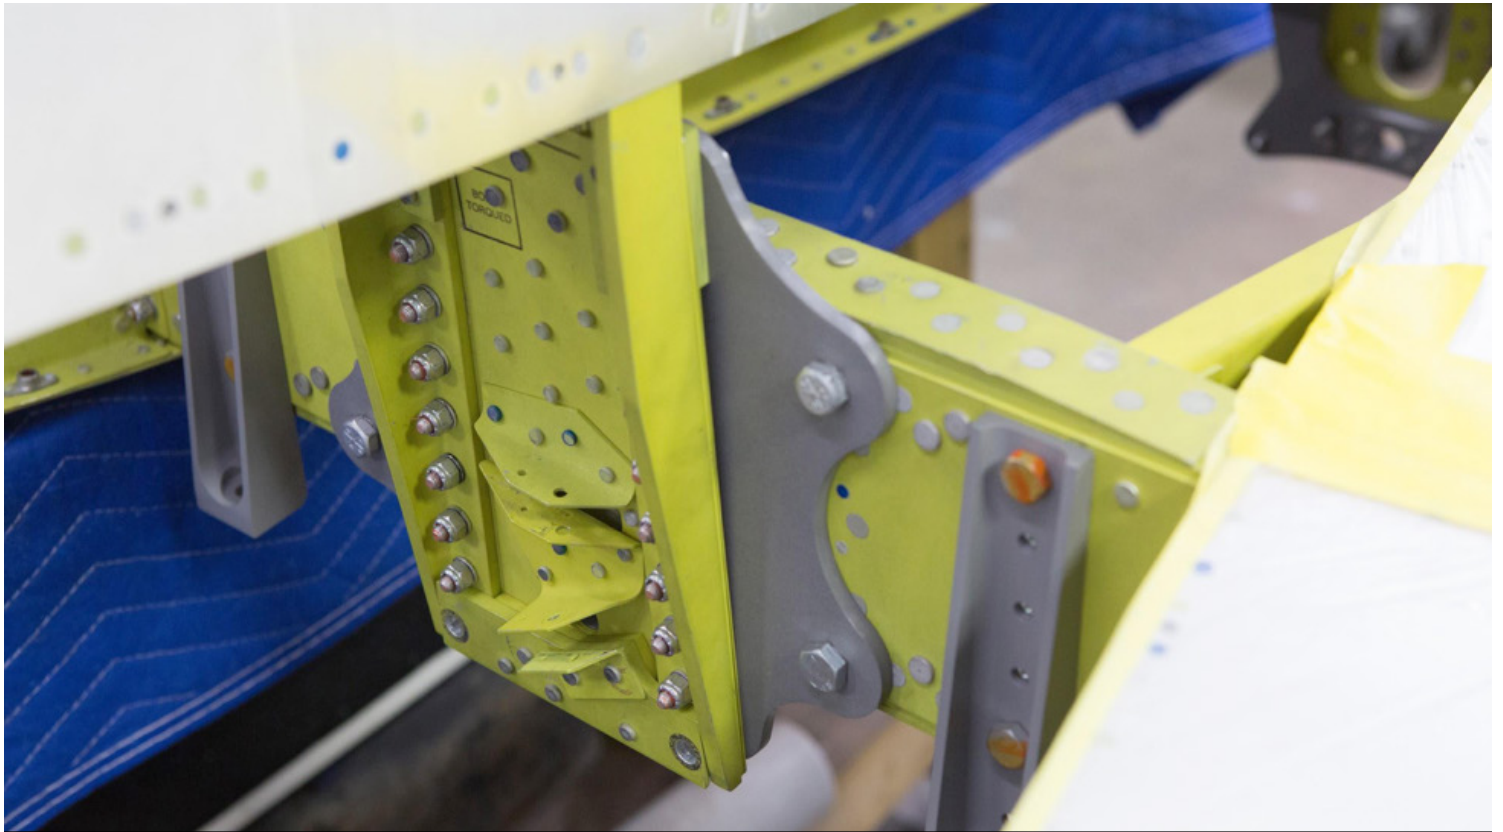
The drilled brackets riveted to the spar will hold pulleys that are part of the trim tab control cable system. The majority of the horizontal spar is one of the original usable parts from 42-27609.

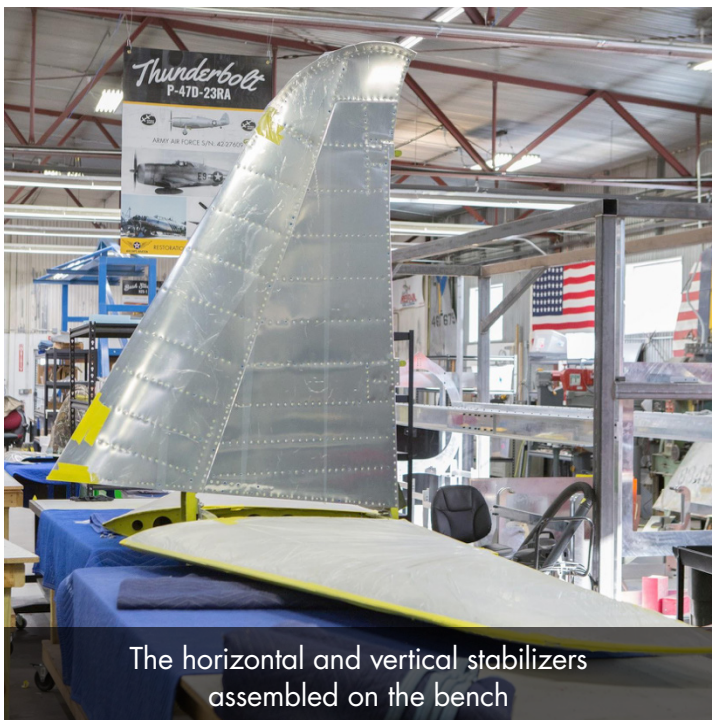
The horizontal and vertical stabilizers assembled on the bench

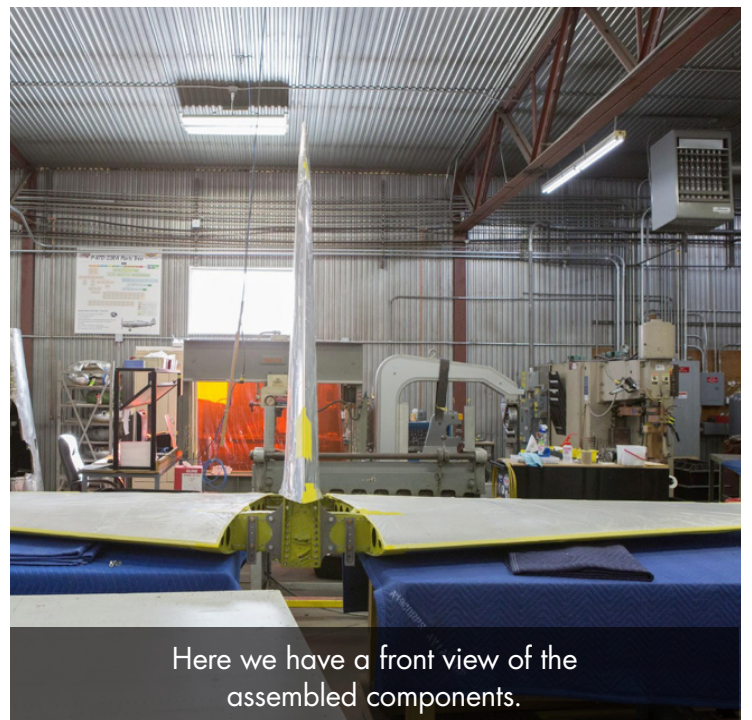
Here we have a front view of the assembled components.
