Fall 2023

AT-10 WICHITA

Cadet Air Corps Museum AT-10 Wichita Restoration

by Chuck Cravens

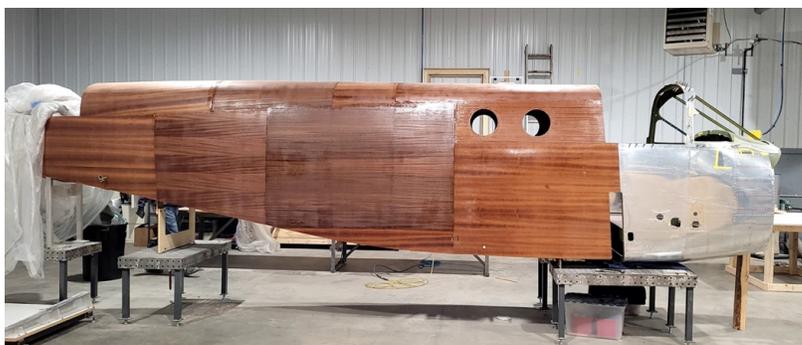
This is a side view of the fuselage with the cockpit area mated to the wood structure.

Work continued on preparing the wooden portion of the fuselage for another coat of protective varnish. A new removable nose section is under fabrication in the restoration shop.

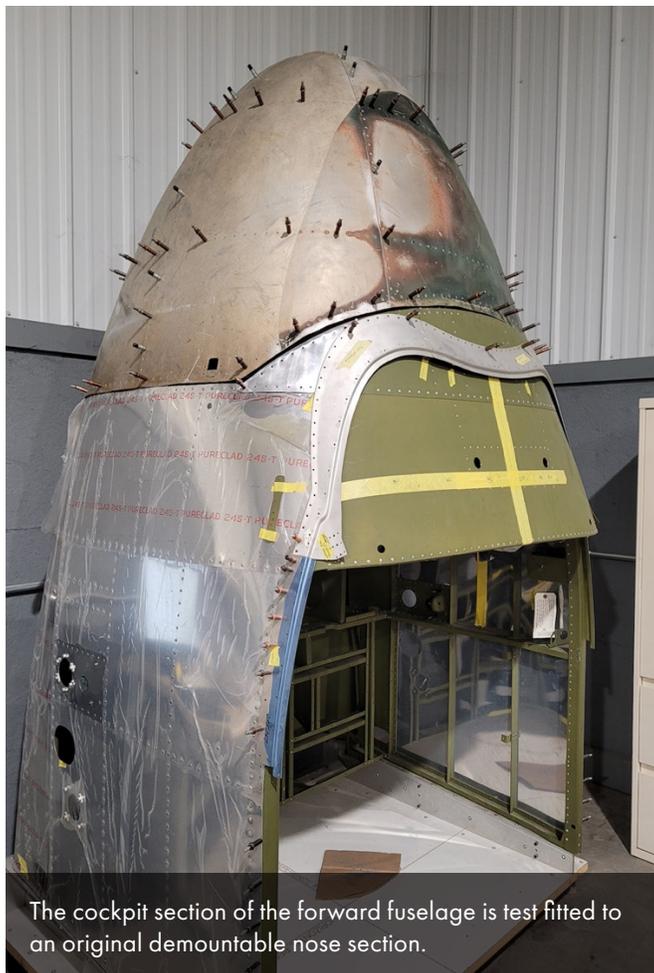
The cockpit section of the forward fuselage is test fitted to an original demountable nose section.

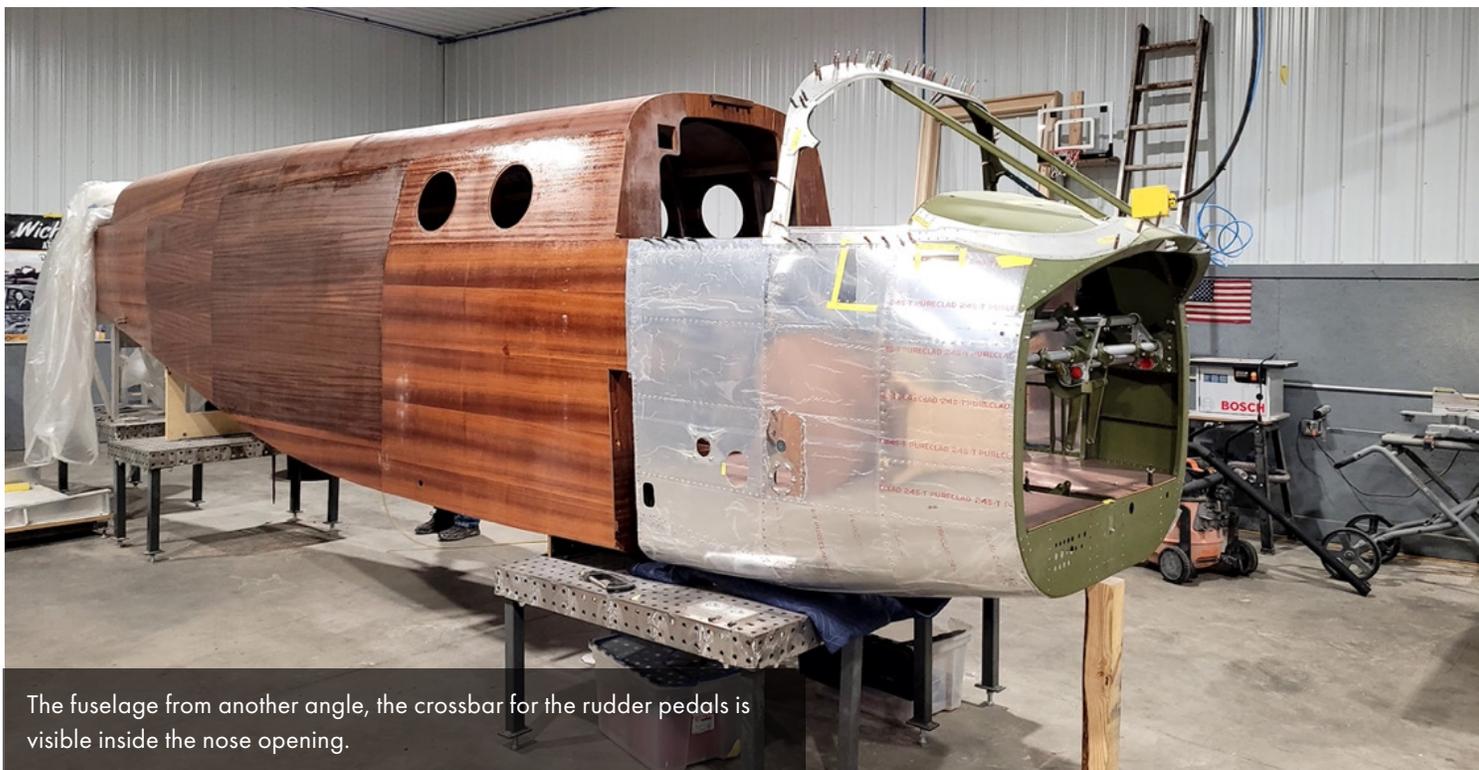
The fuselage from another angle, the crossbar for the rudder pedals is visible inside the nose opening.

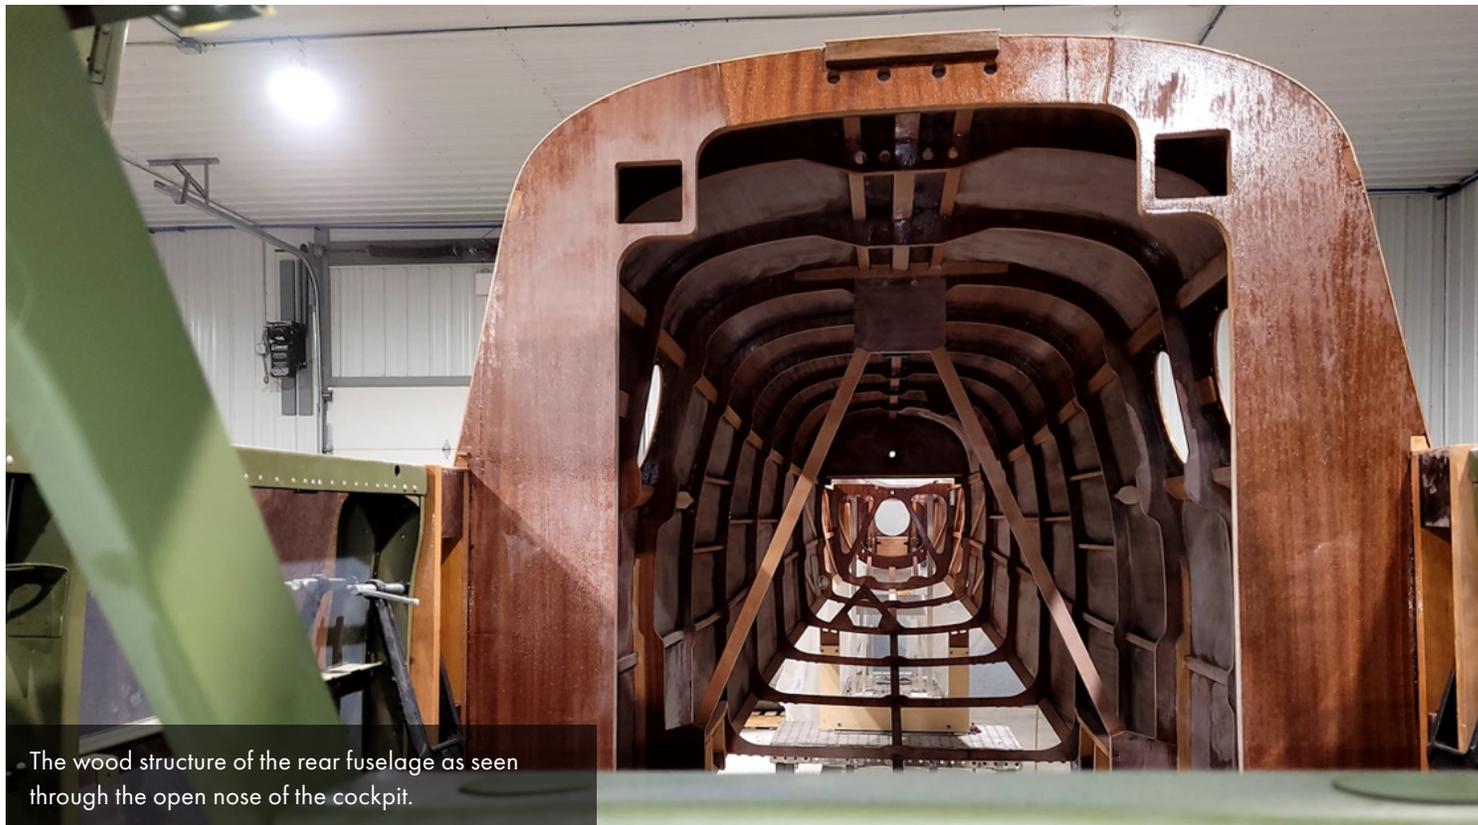
The wood structure of the rear fuselage as seen through the open nose of the cockpit.

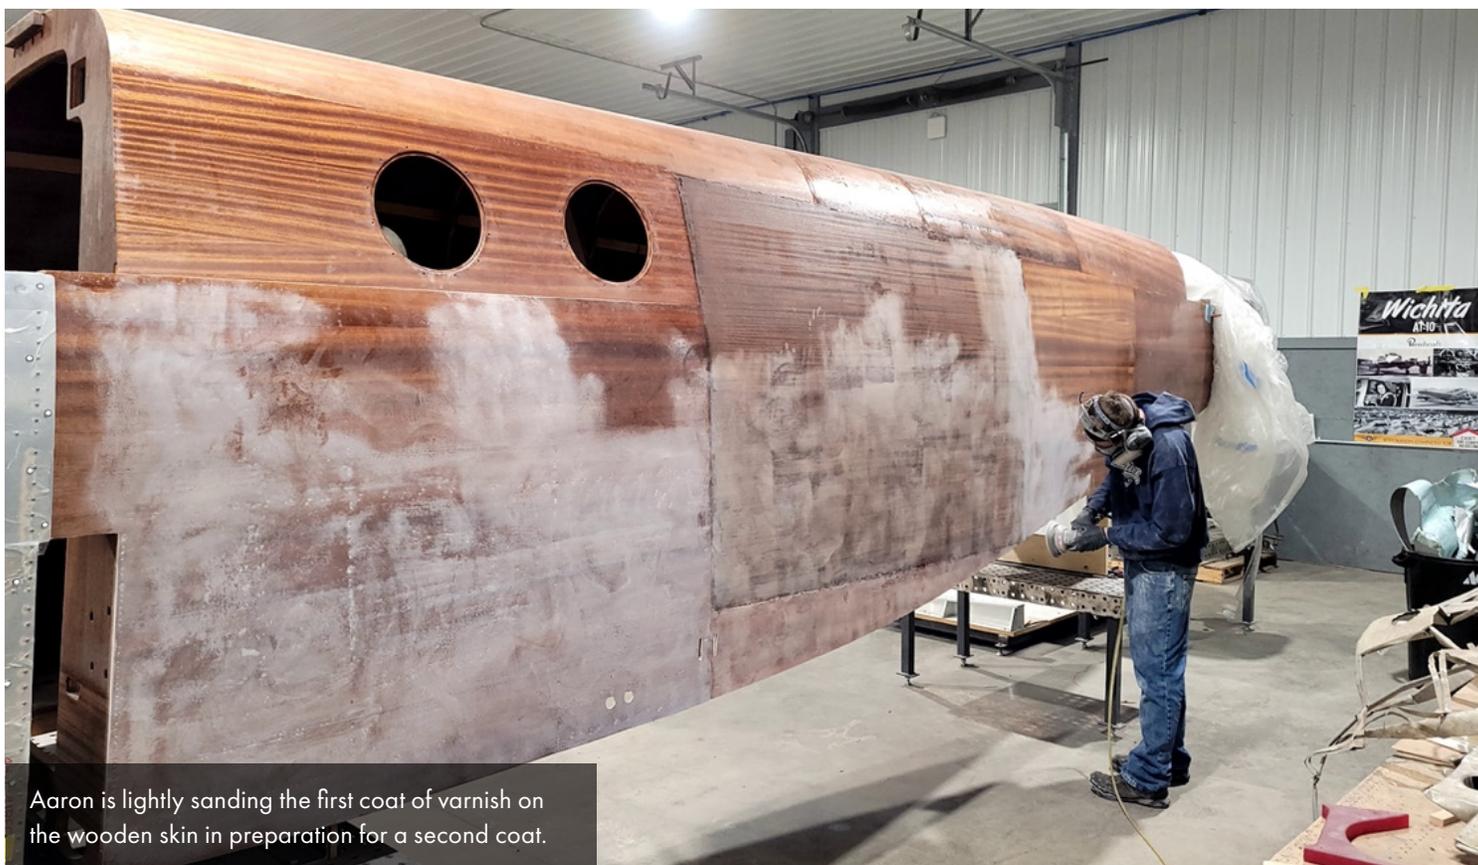
Aaron is lightly sanding the first coat of varnish on the wooden skin in preparation for a second coat.

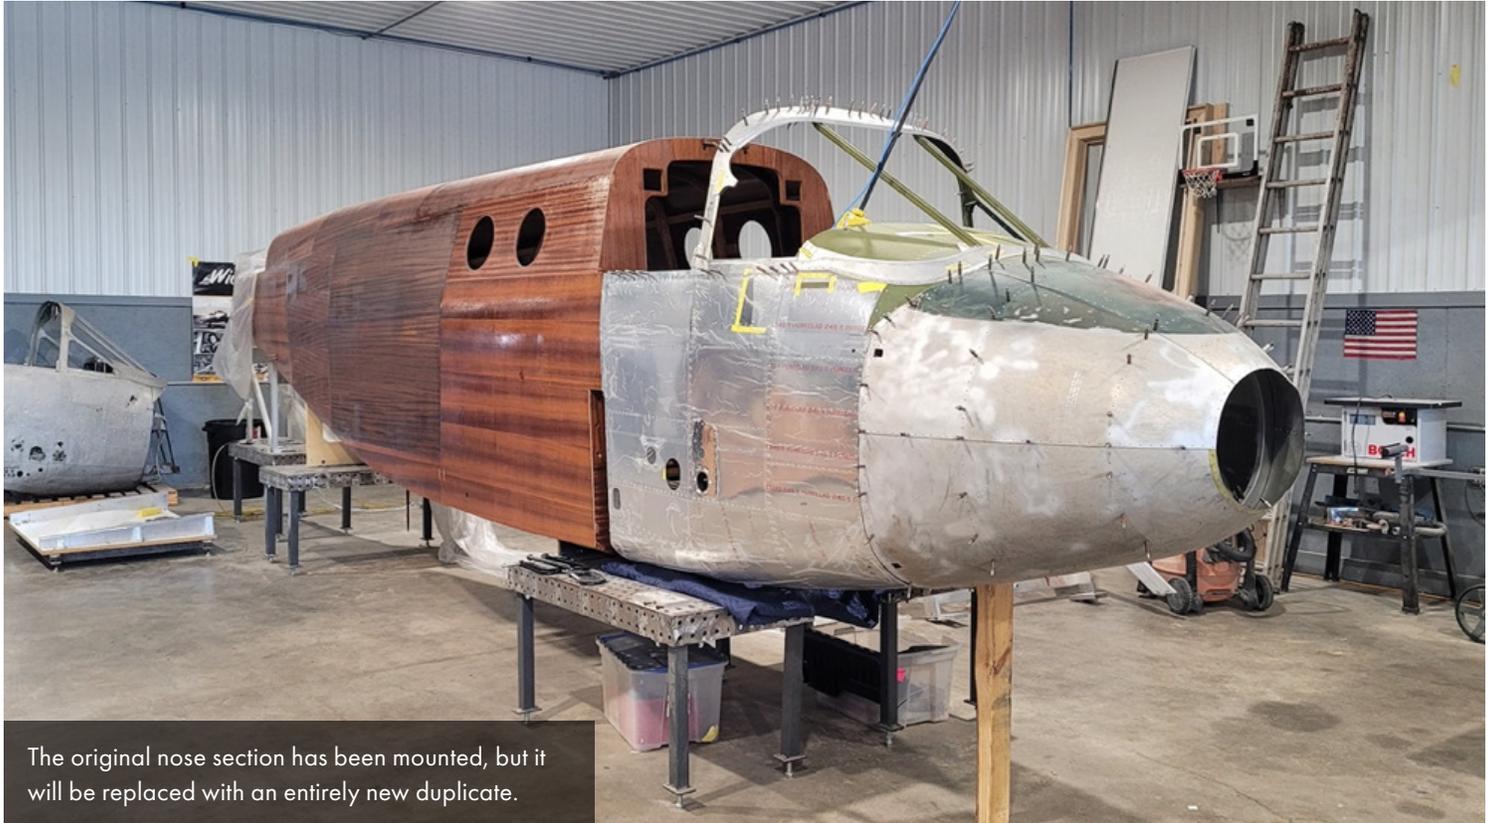
The original nose section has been mounted, but it will be replaced with an entirely new duplicate.

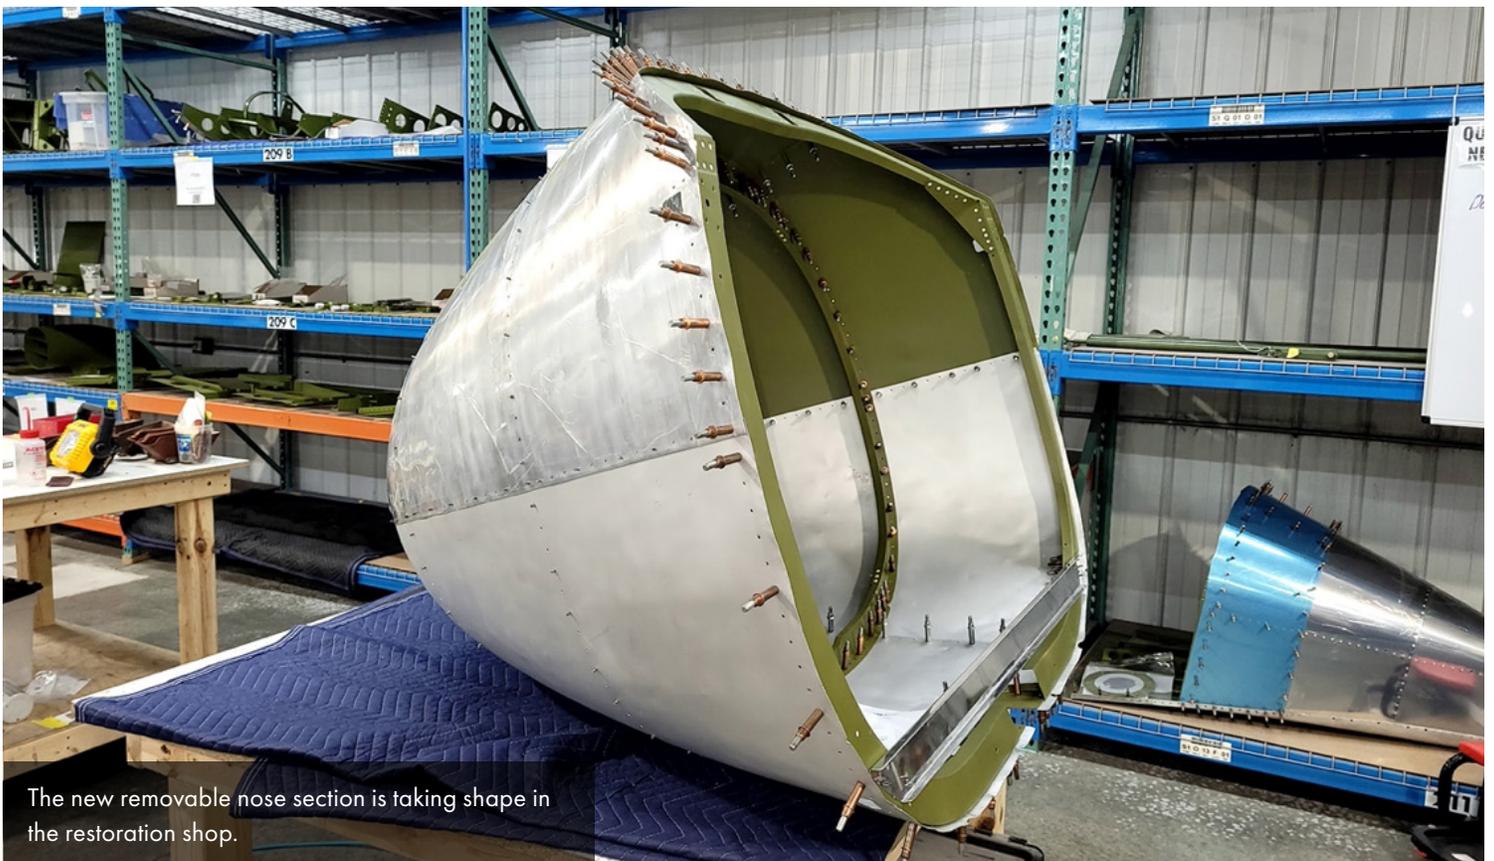
The new removable nose section is taking shape in the restoration shop.

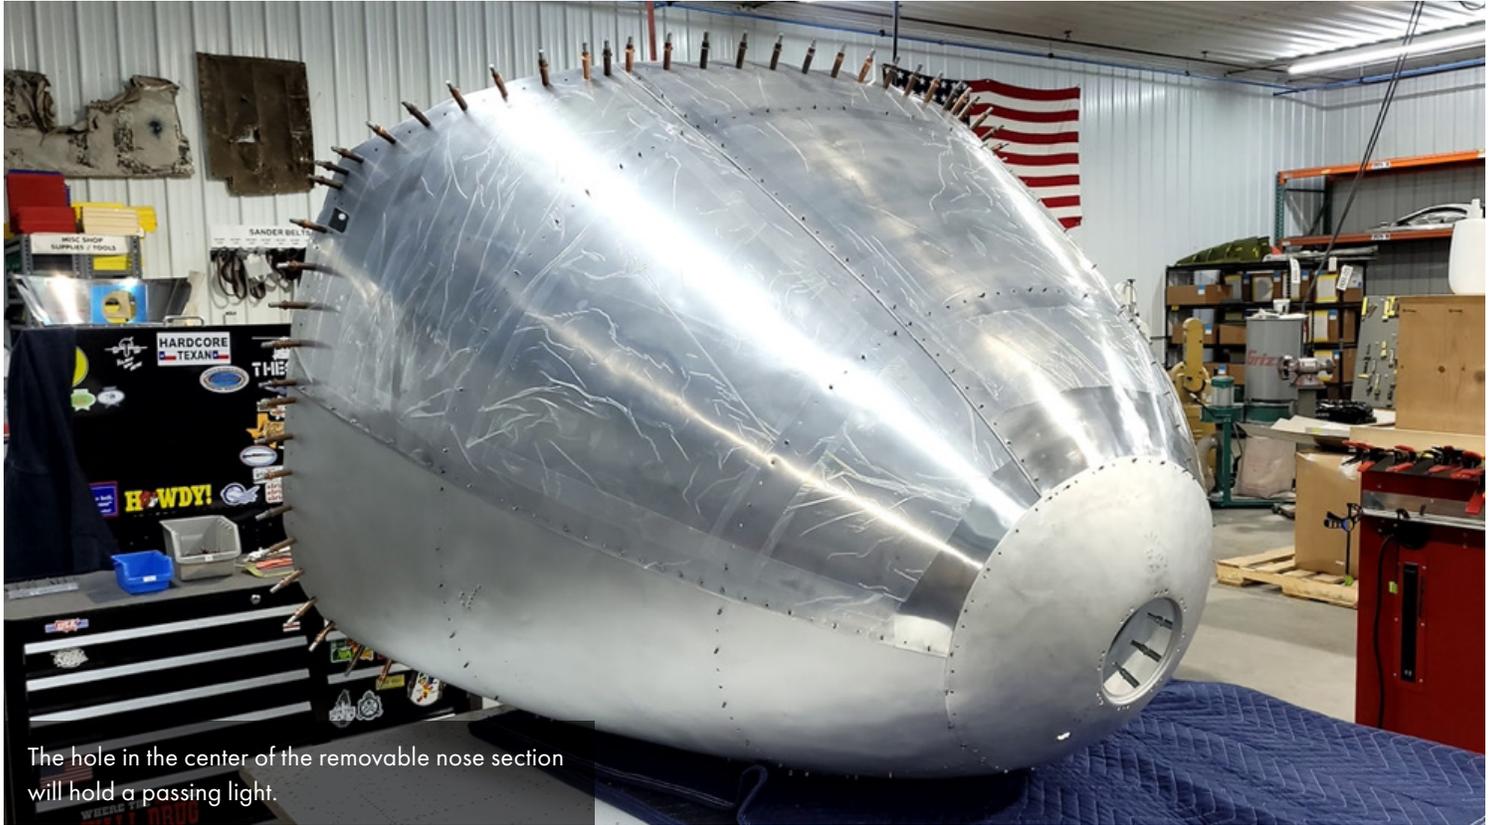
The hole in the center of the removable nose section will hold a passing light.

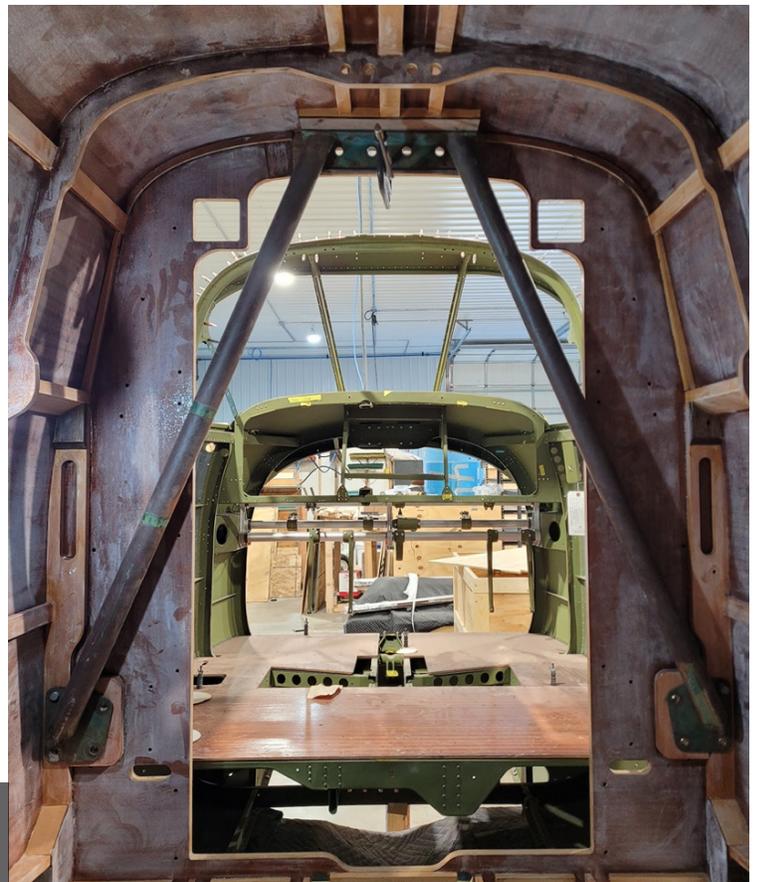
The metal forward fuselage as seen from inside the wooden rear fuselage

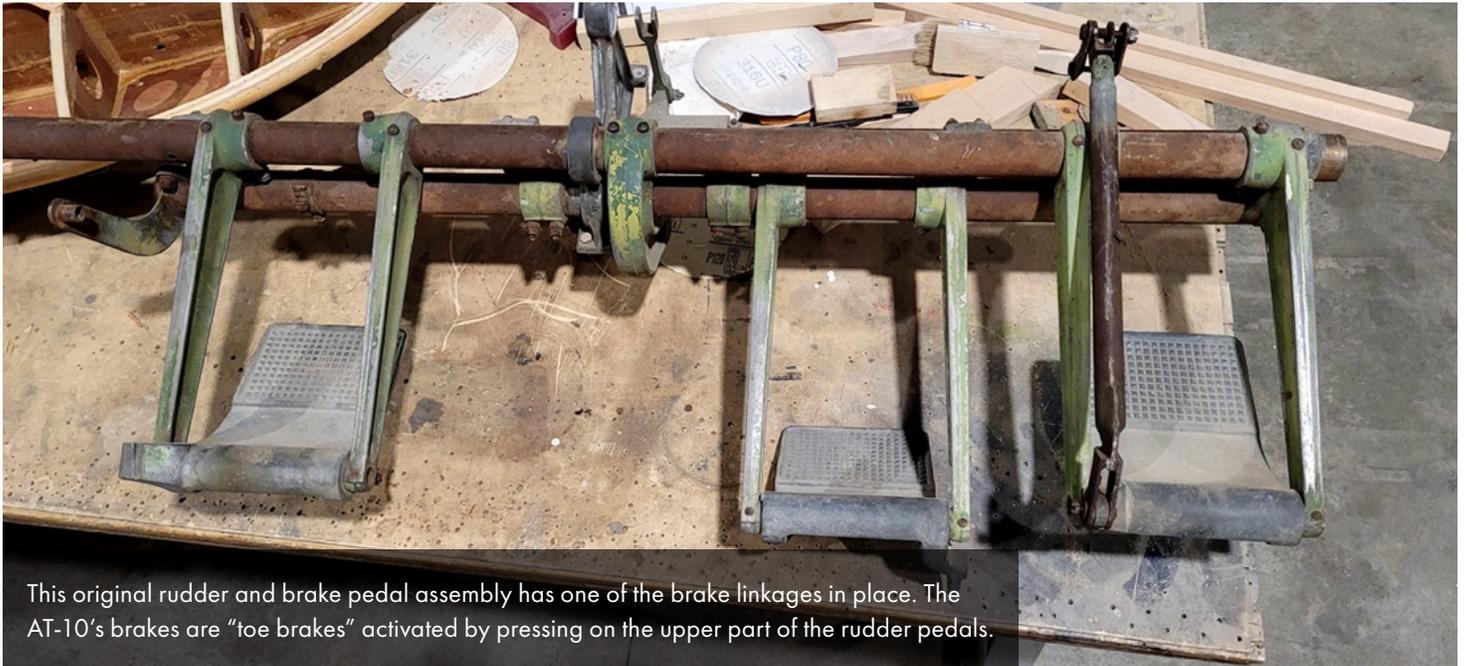
This original rudder and brake pedal assembly has one of the brake linkages in place. The AT-10's brakes are "toe brakes" activated by pressing on the upper part of the rudder pedals.

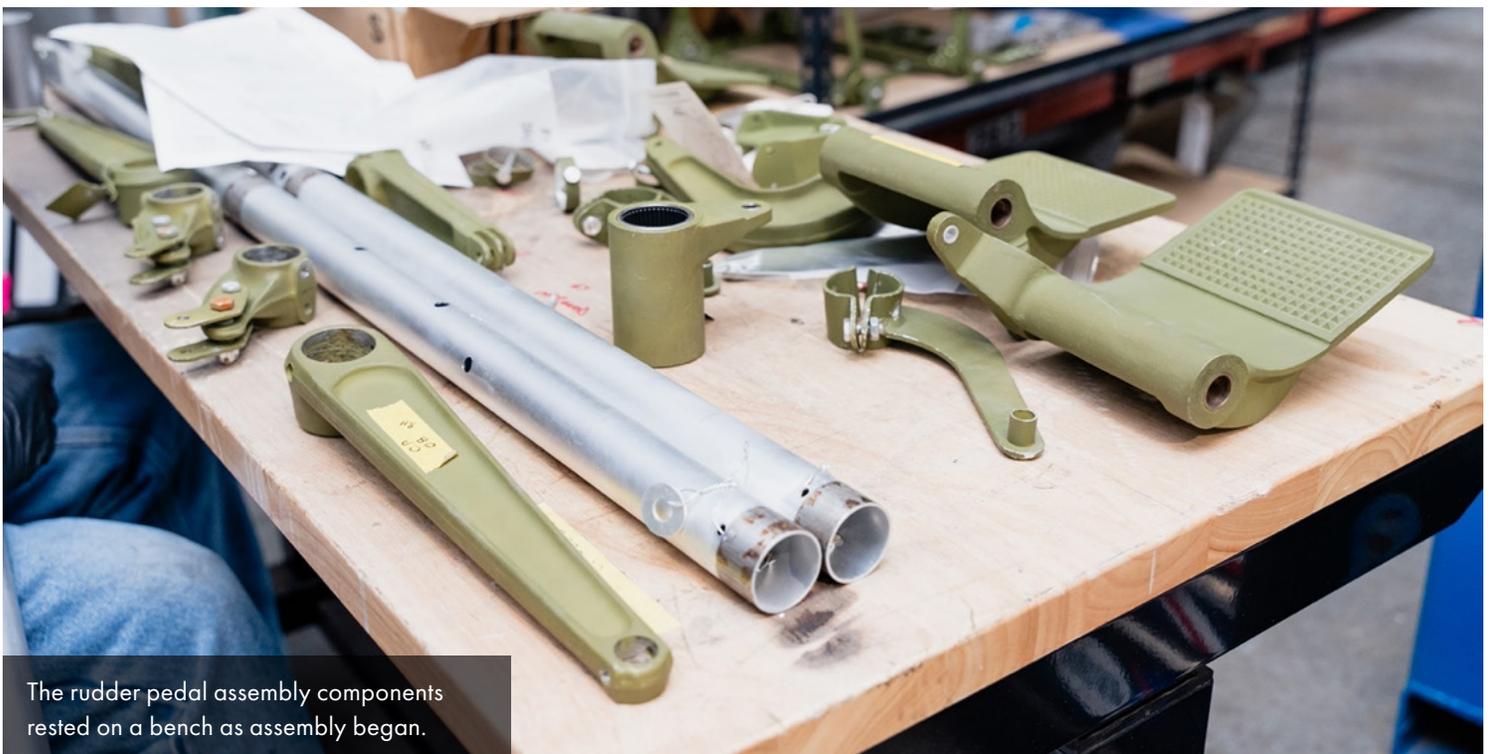
The rudder pedal assembly components rested on a bench as assembly began.

All the component parts of the rudder pedal assembly have been inspected and restored where necessary. Once that process was completed, Aaron began assembling those parts.

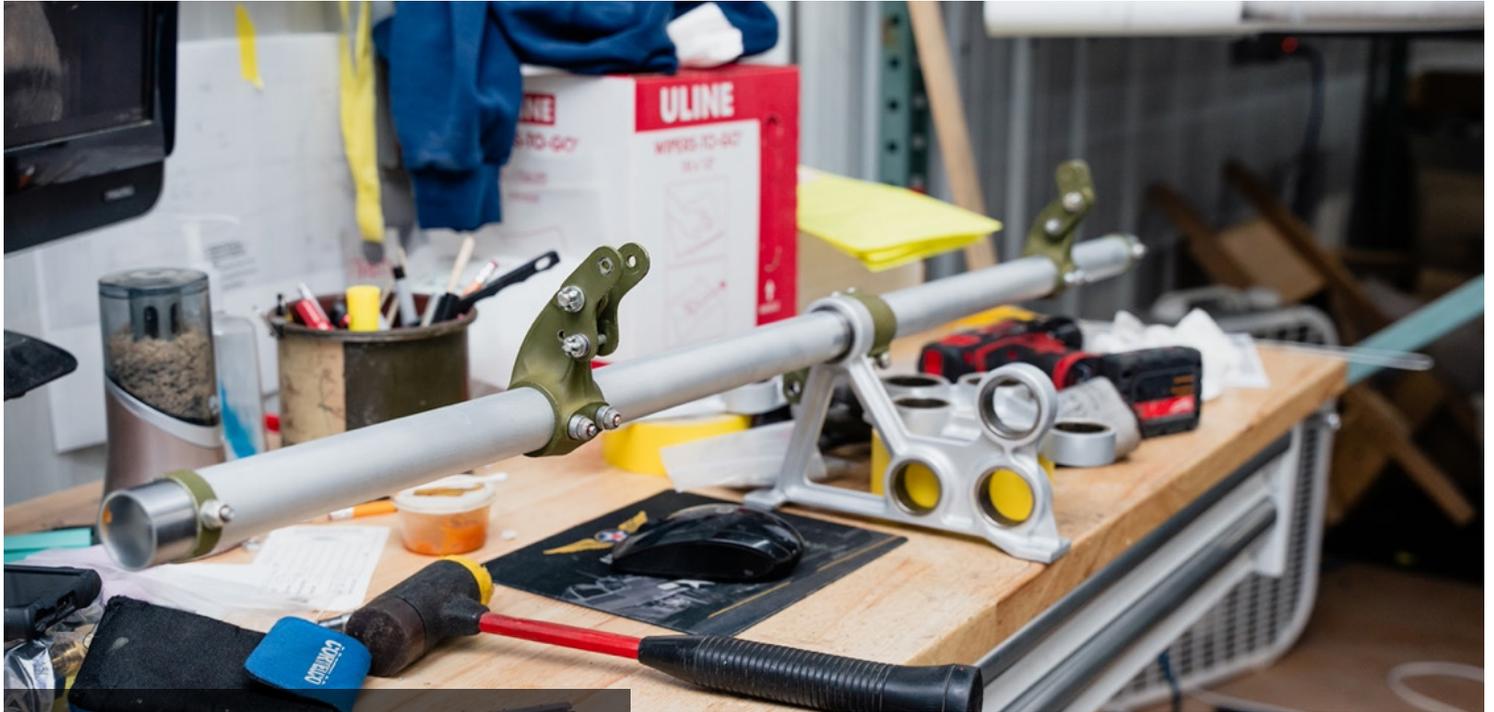
This shaft tube is one of four in the rudder pedal/brake pedal assembly. It is one of two tubes upon which brake linkages are mounted.

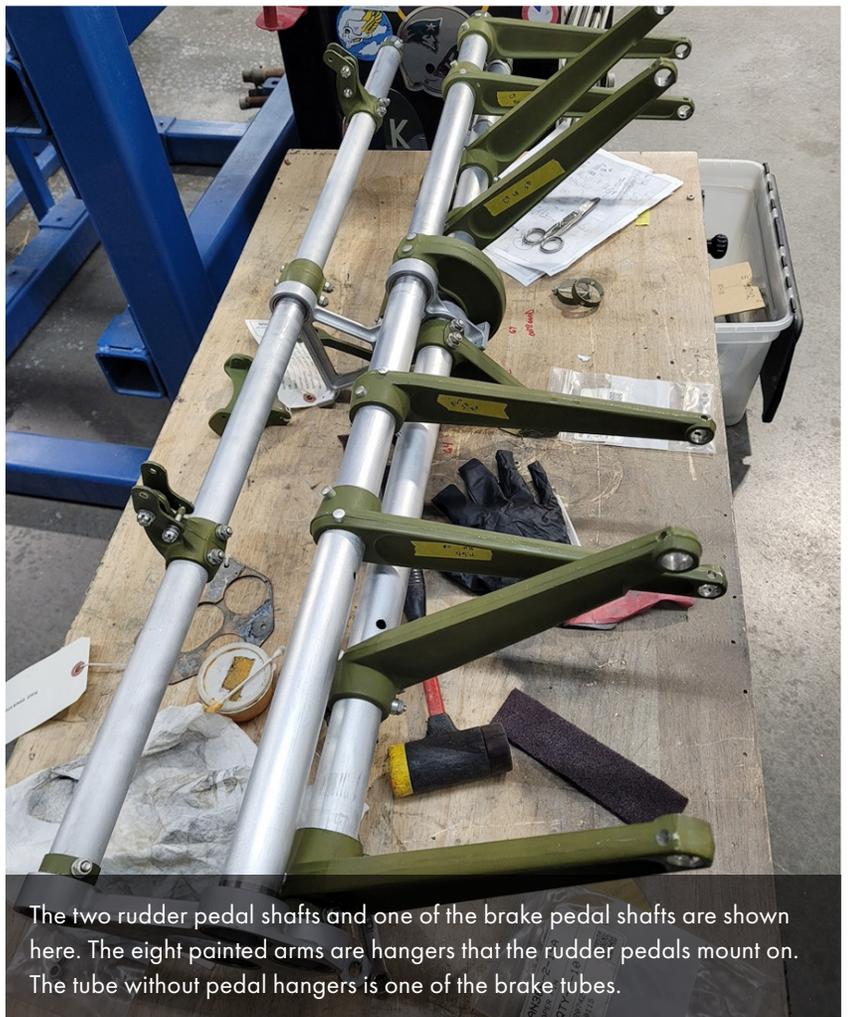
The two rudder pedal shafts and one of the brake pedal shafts are shown here. The eight painted arms are hangers that the rudder pedals mount on. The tube without pedal hangers is one of the brake tubes.

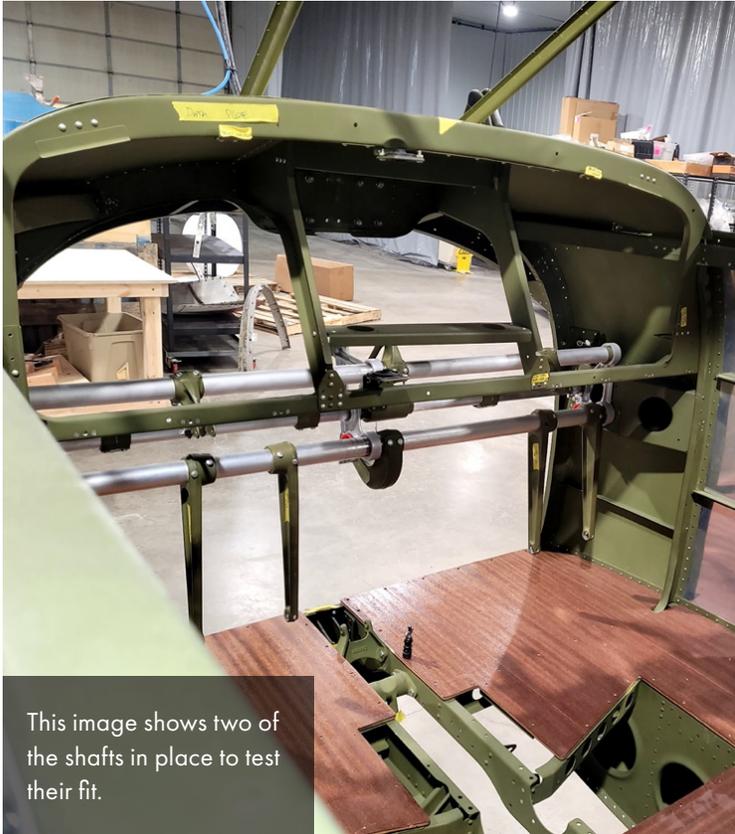
This image shows two of the shafts in place to test their fit.

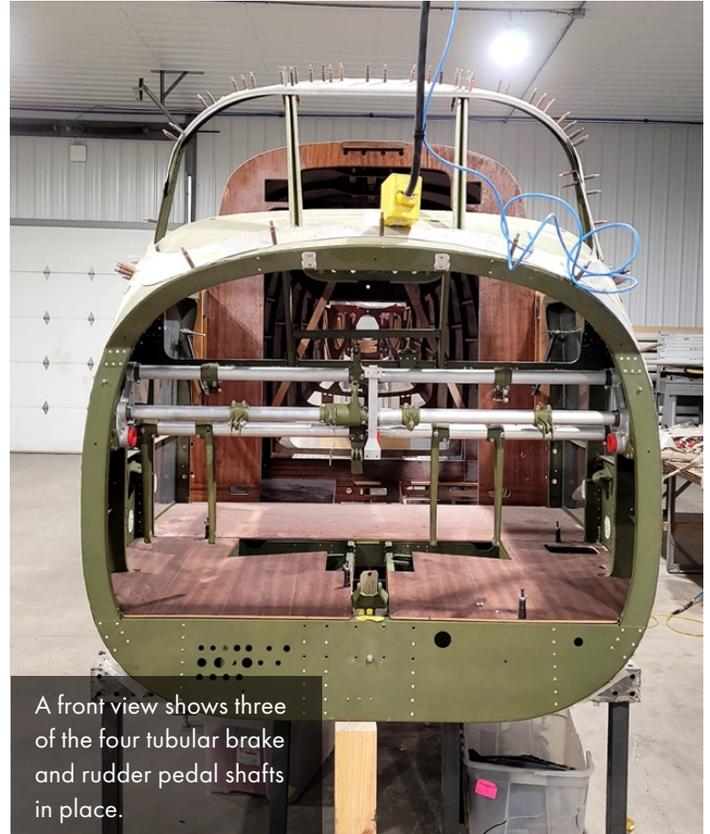
A front view shows three of the four tubular brake and rudder pedal shafts in place.

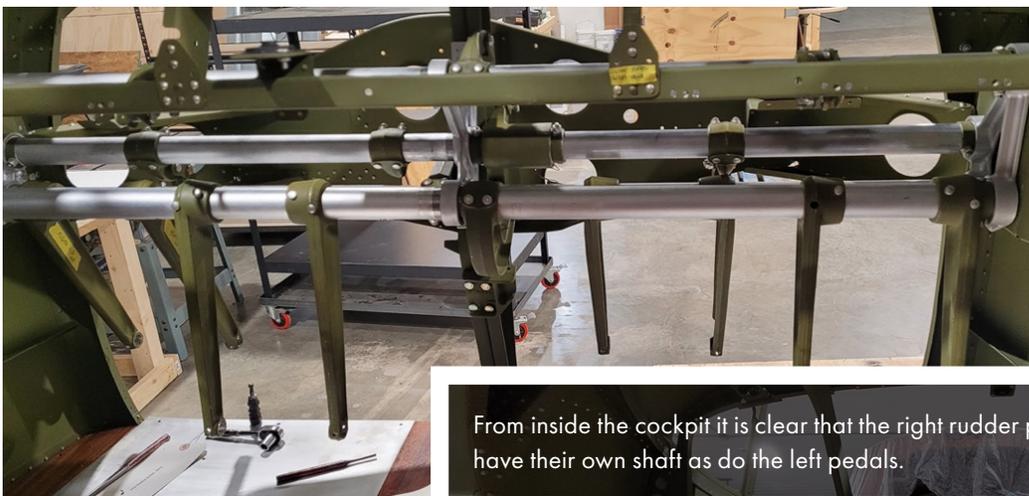
From inside the cockpit it is clear that the right rudder pedals have their own shaft as do the left pedals.

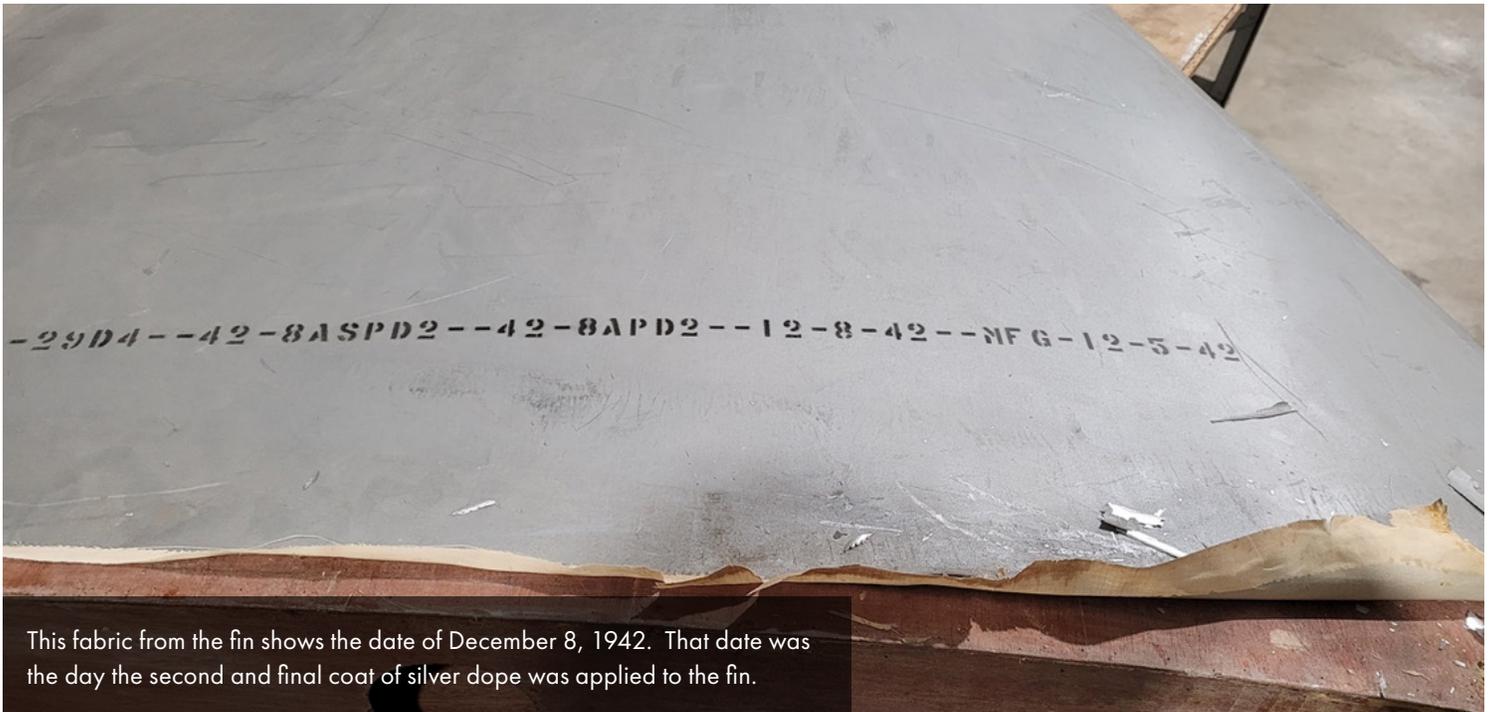
This fabric from the fin shows the date of December 8, 1942. That date was the day the second and final coat of silver dope was applied to the fin.

Another date from inside the vertical indicated the final inspection of the fin before covering was on December 5, 1942.

3:25 pm is the latest time marked inside the vertical. Other time inscriptions for 1:45 and 3:27 pm are also visible but don't show up well in photographs.

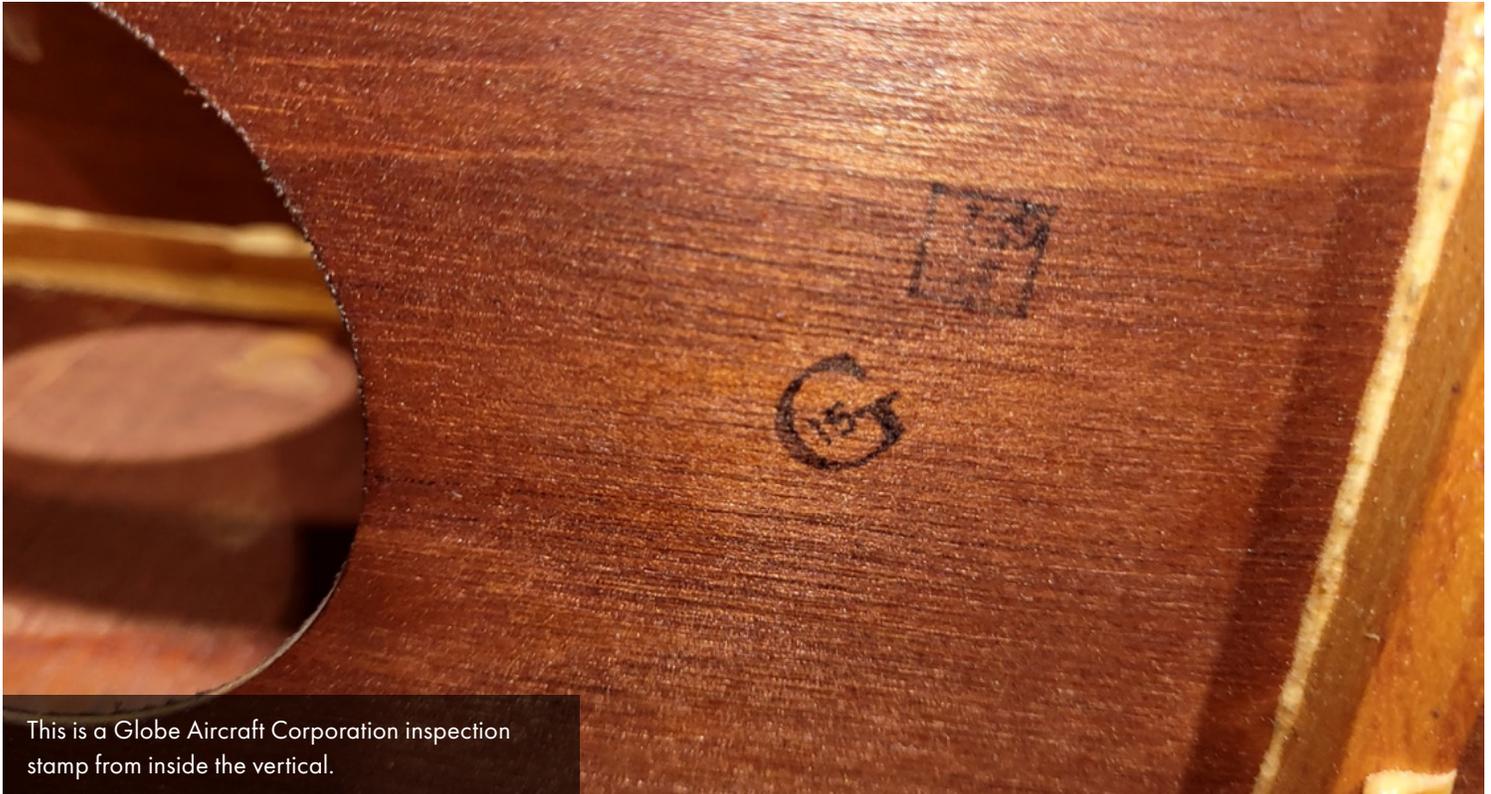
This is a Globe Aircraft Corporation inspection stamp from inside the vertical.

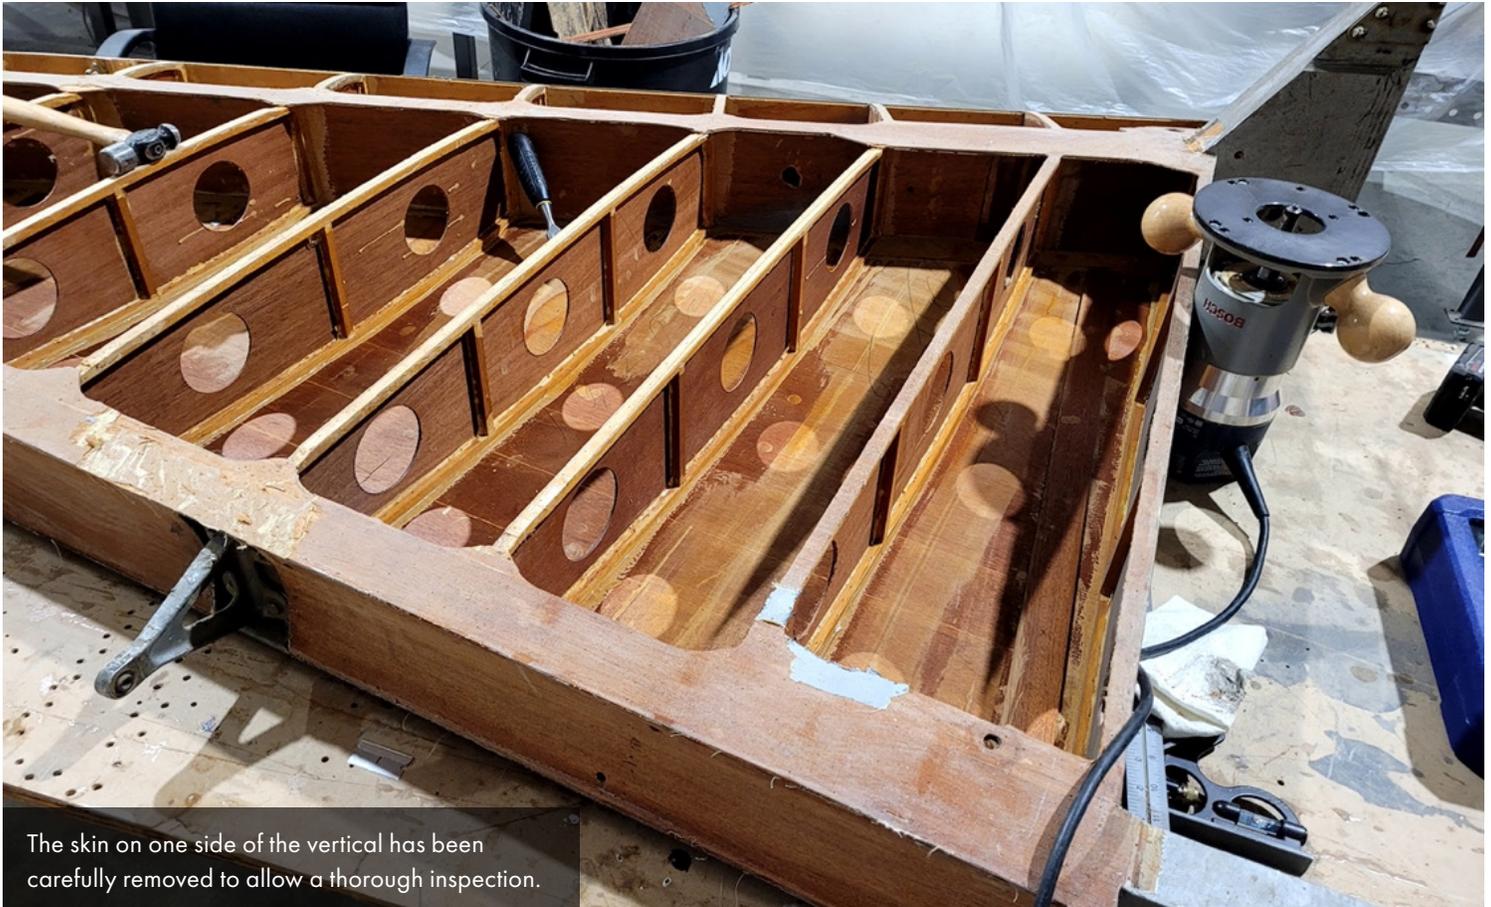
The skin on one side of the vertical has been carefully removed to allow a thorough inspection.

Remarkably, an unused new old stock vertical fin was obtained for the AT-10 restoration. Though new, the skin had to be removed to thoroughly inspect the fin for ravages of time that could have occurred over the 81 years since it was built. Assemblies like this sometimes tell us their story from the marks, dates, and messages the factory workers leave behind inside the structure. That was true in this case, as Aaron found marks that indicate this fin was built by the Globe Aircraft Corporation rather than Beech. Globe built 600 AT-10s under contract.

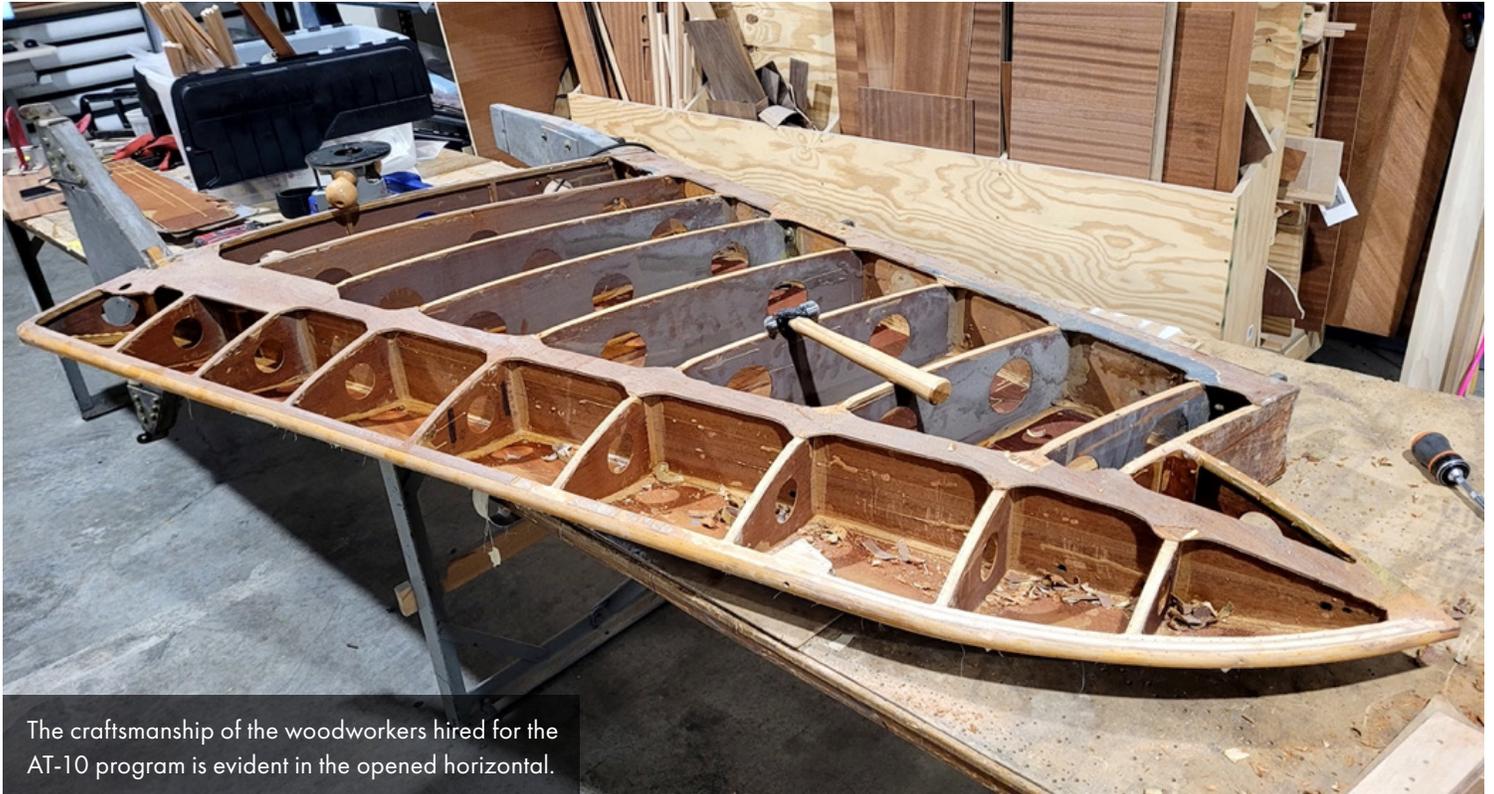
The craftsmanship of the woodworkers hired for the AT-10 program is evident in the opened horizontal.

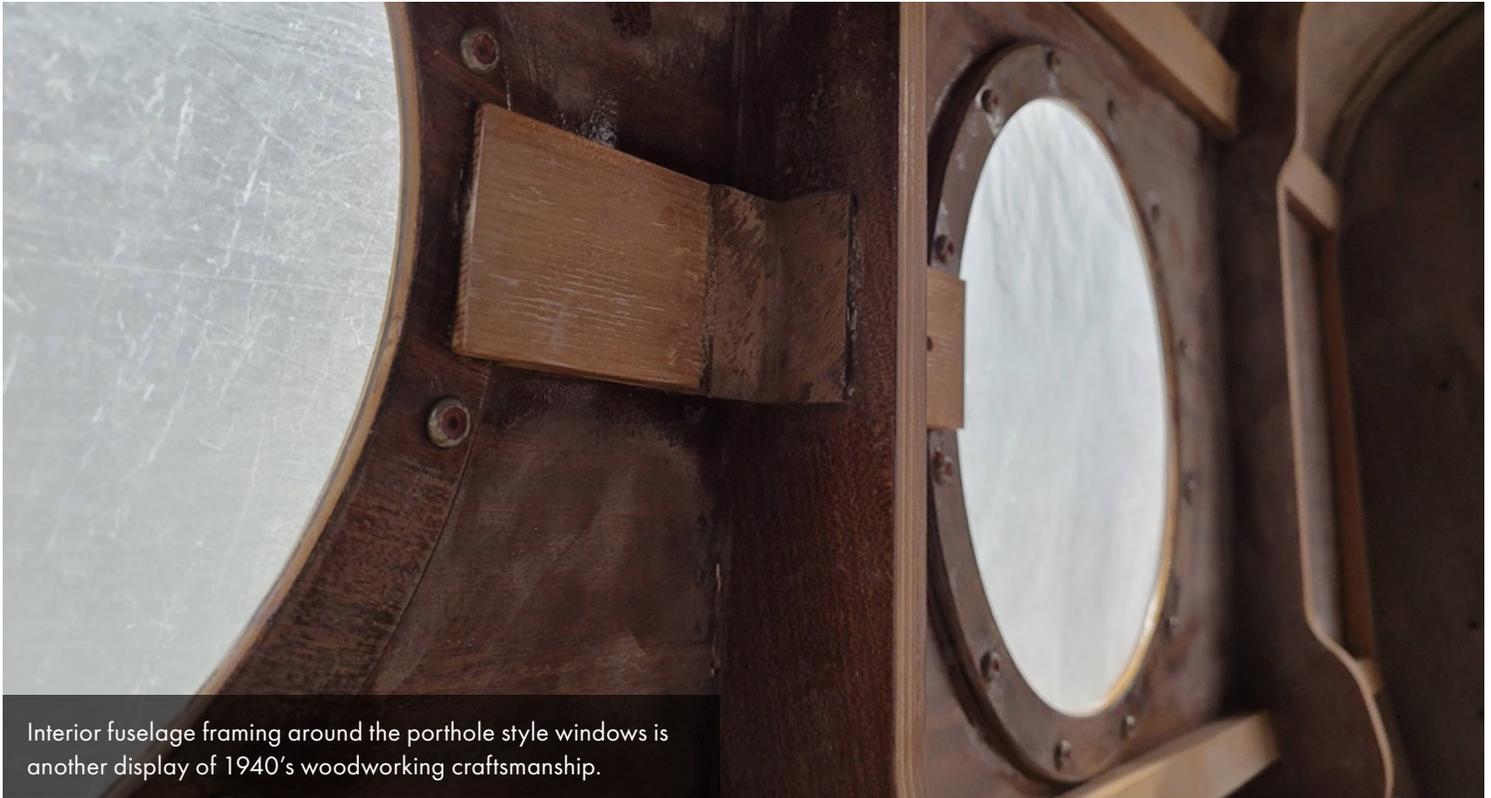
Interior fuselage framing around the porthole style windows is another display of 1940's woodworking craftsmanship.

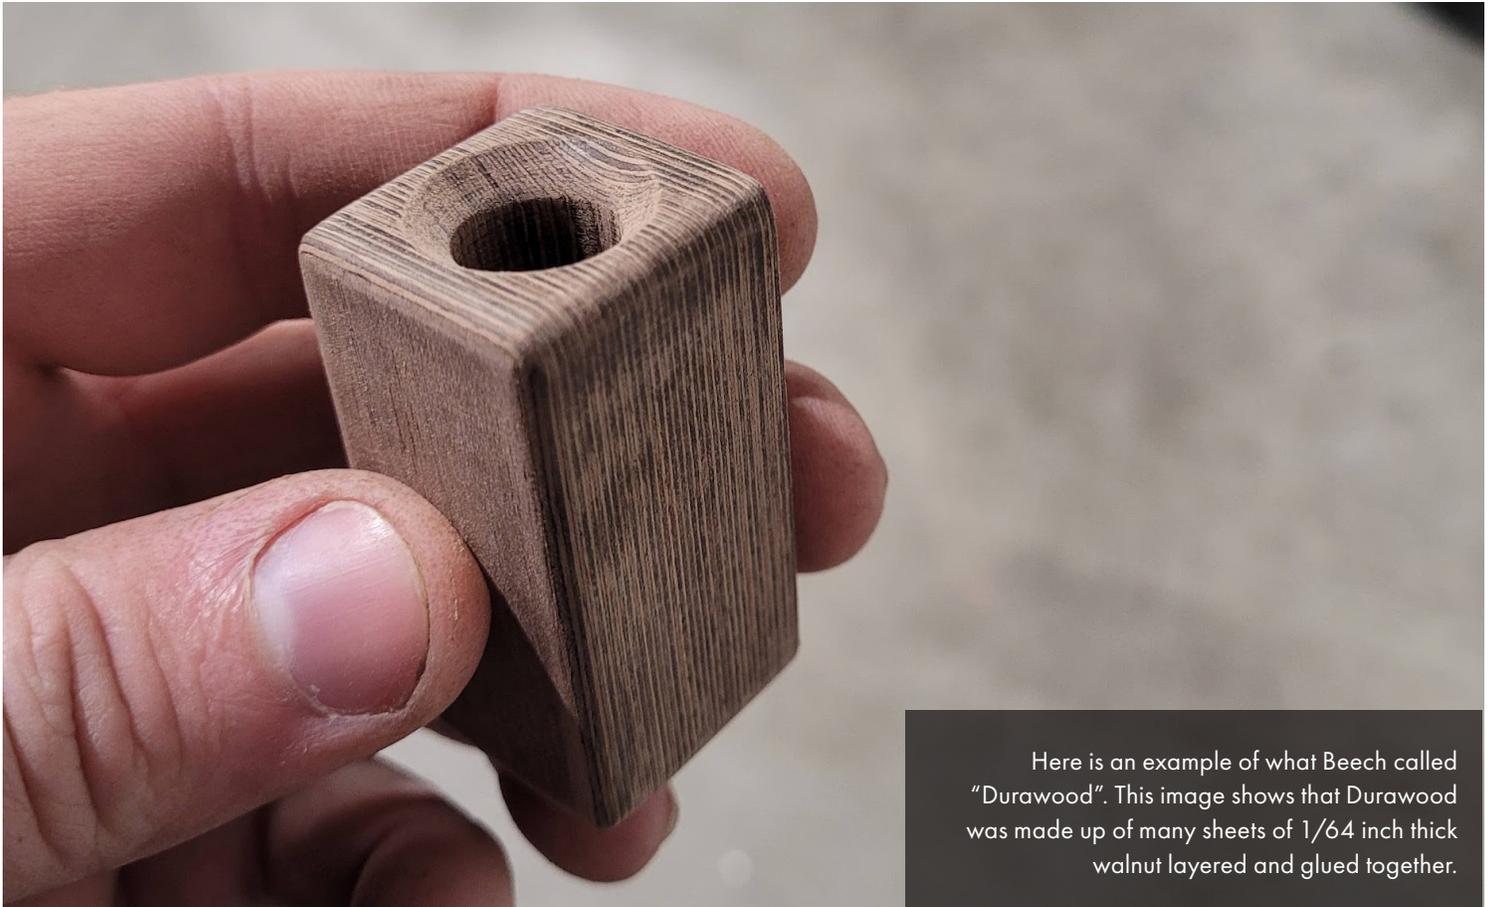
Here is an example of what Beech called "Durawood". This image shows that Durawood was made up of many sheets of 1/64 inch thick walnut layered and glued together.
