Fall 2023

AT-10 WICHITA

Cadet Air Corps Museum AT-10 Wichita Restoration

by Chuck Cravens

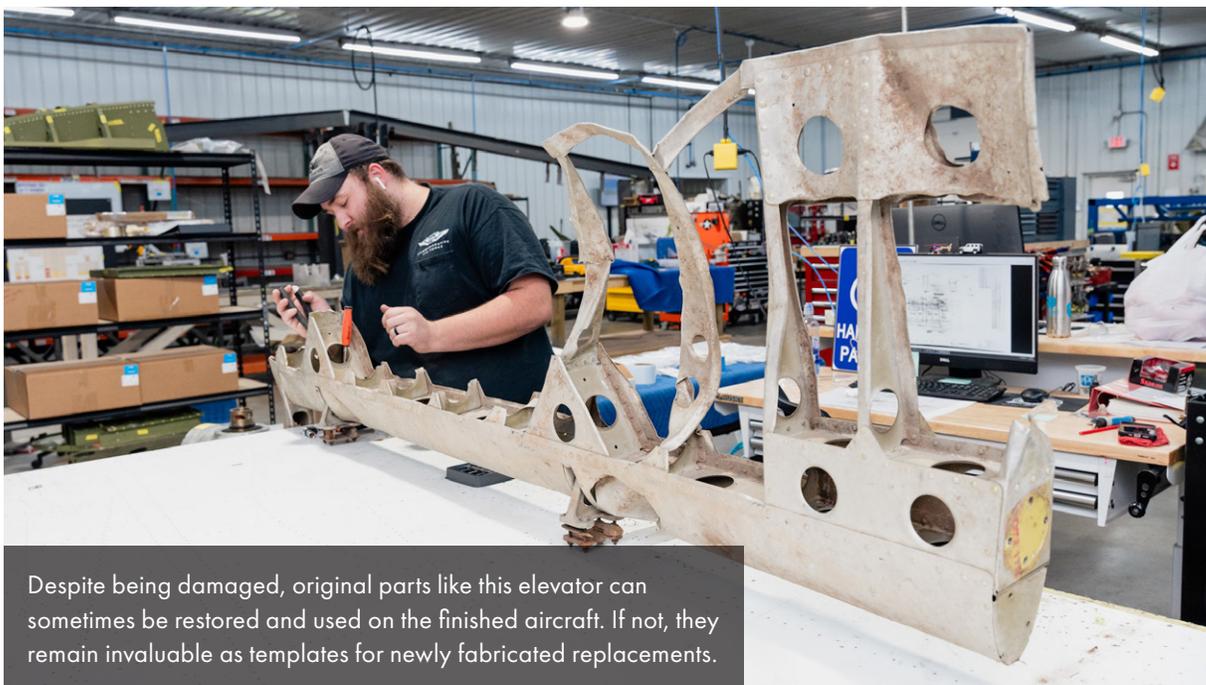
Despite being damaged, original parts like this elevator can sometimes be restored and used on the finished aircraft. If not, they remain invaluable as templates for newly fabricated replacements.

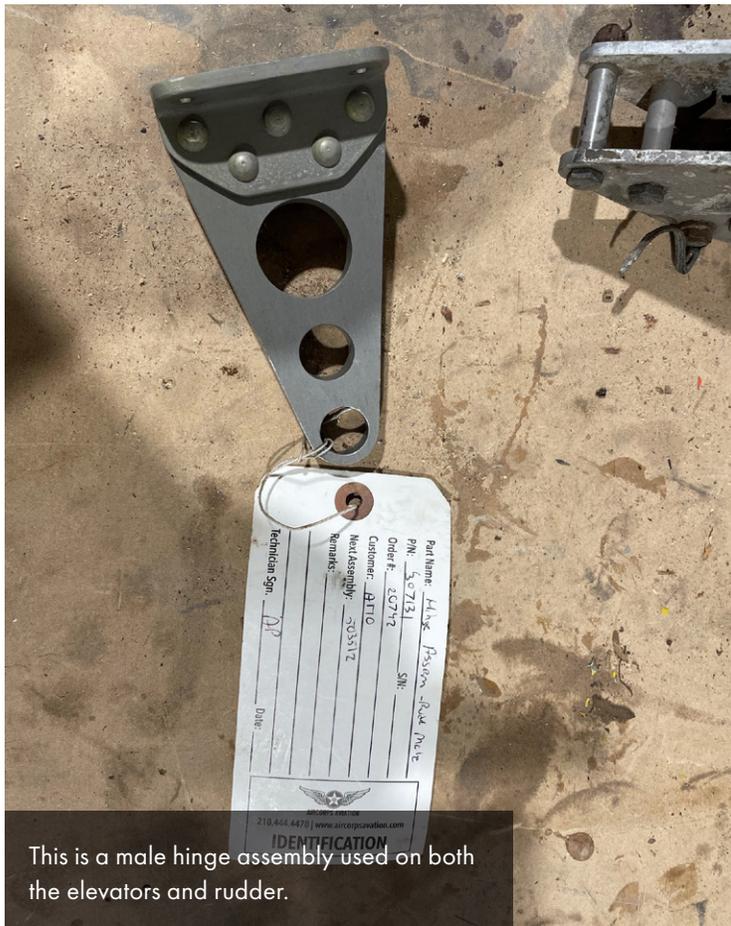
This is a male hinge assembly used on both the elevators and rudder.

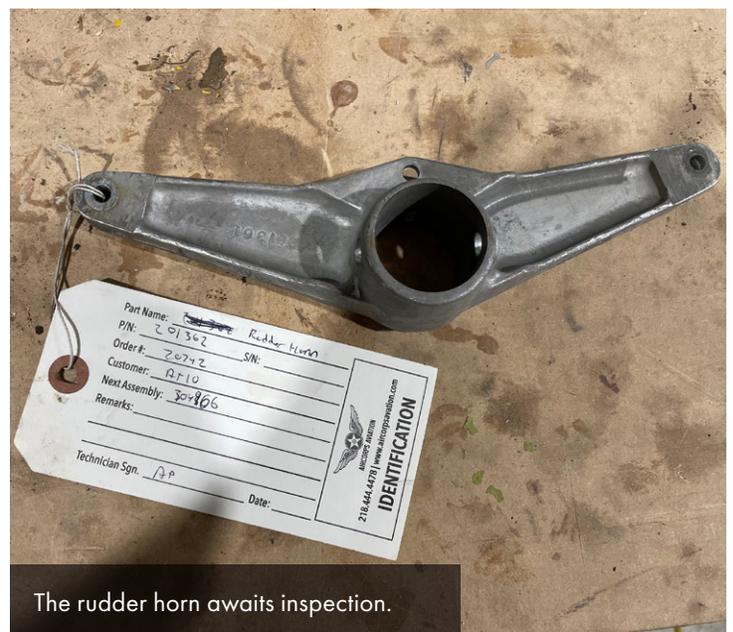
The rudder horn awaits inspection.

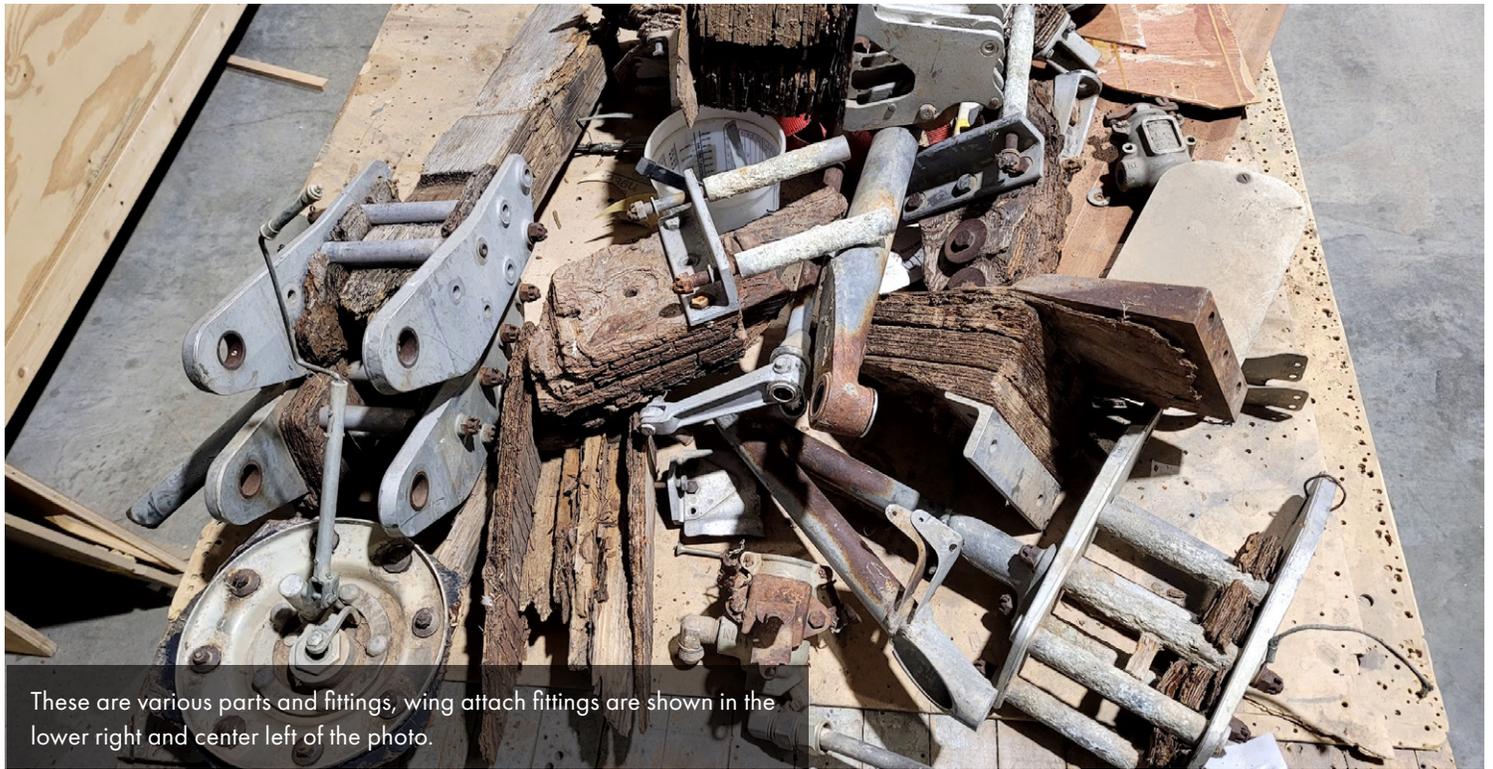
These are various parts and fittings, wing attach fittings are shown in the lower right and center left of the photo.

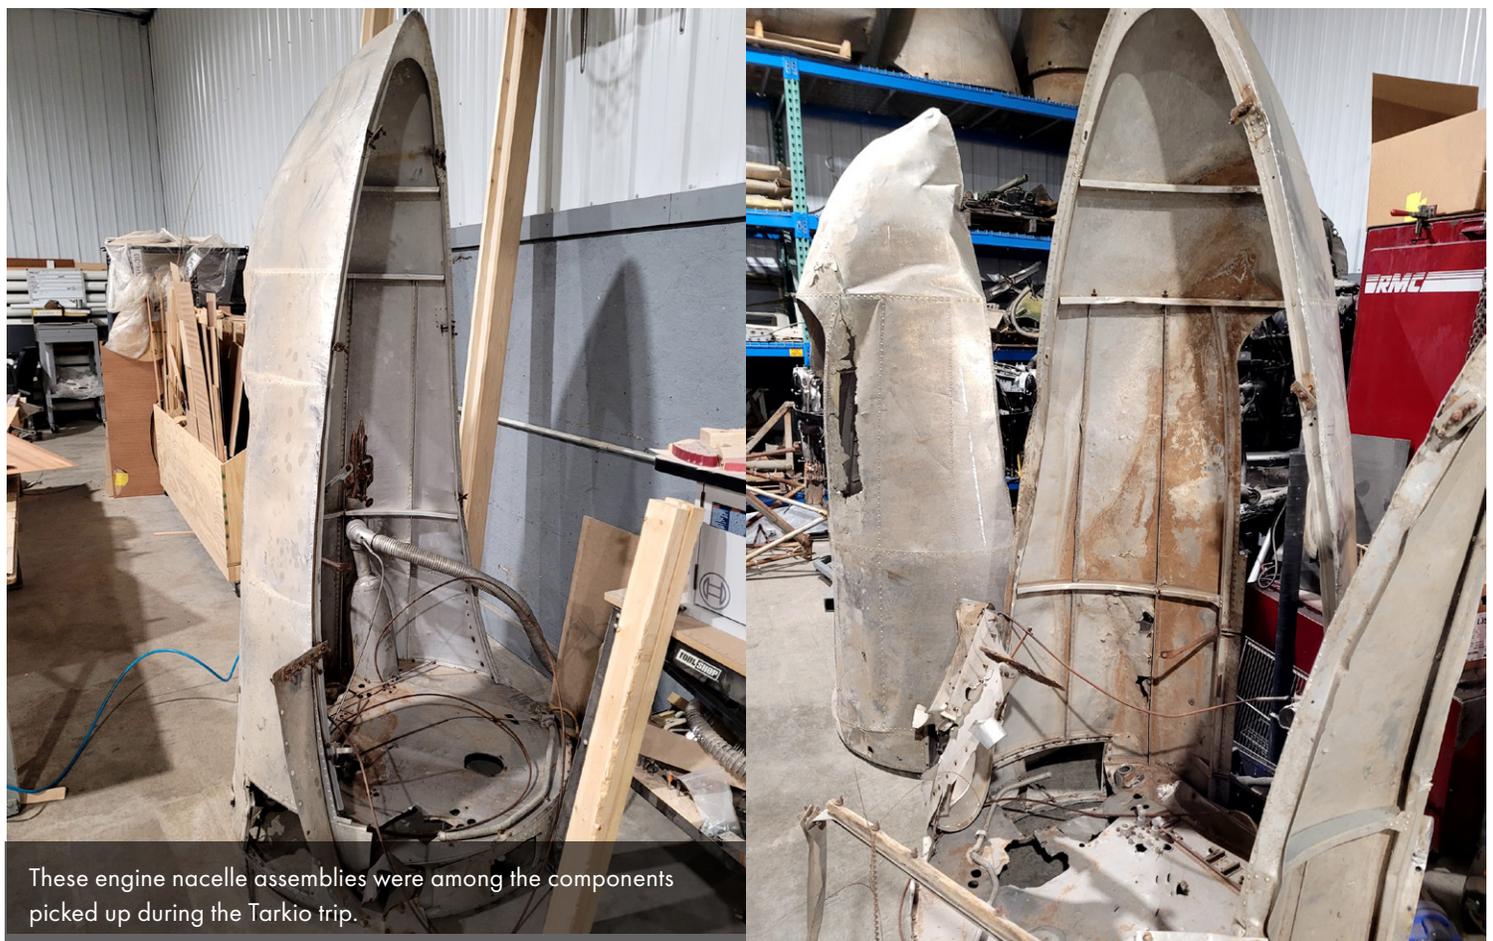
These engine nacelle assemblies were among the components picked up during the Tarkio trip.

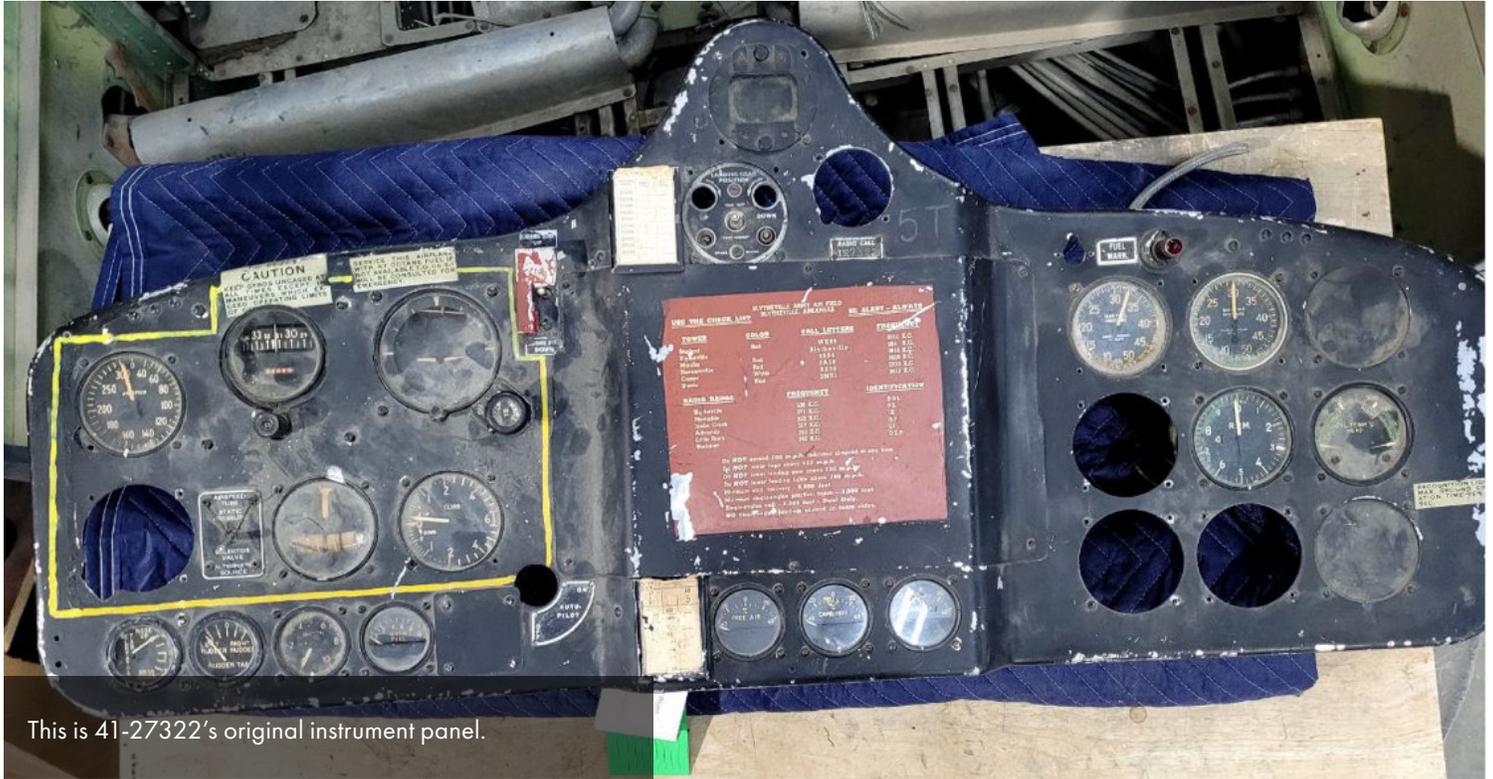
This is 41-27322's original instrument panel.

Several instrument panels were brought back to the AirCorps restoration shop. Fortunately, the original instrument panel from the AT-10 (41-27322) project was in place, and it will be restored and used in the finished aircraft.

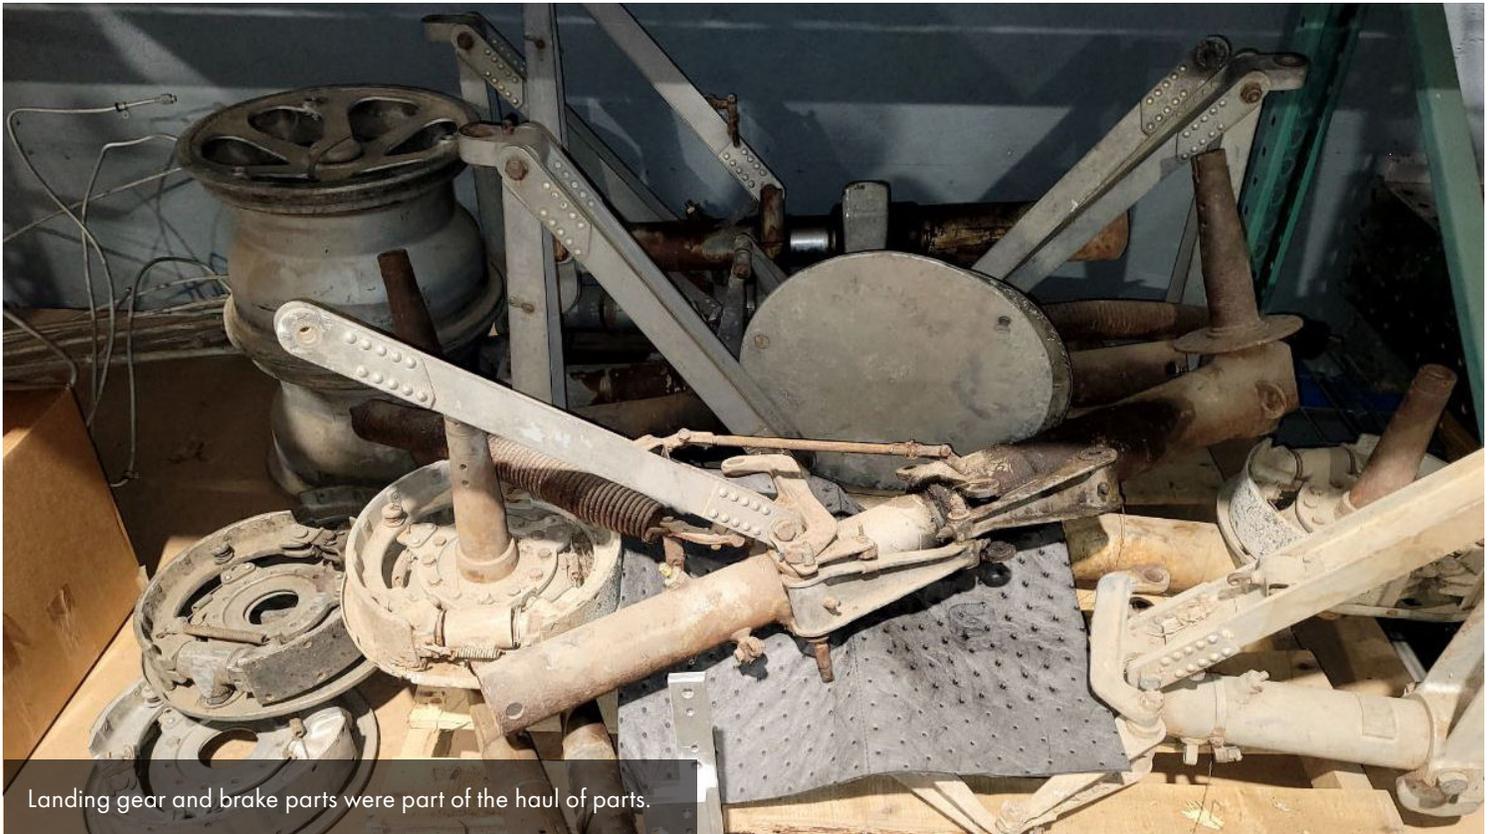
Landing gear and brake parts were part of the haul of parts.

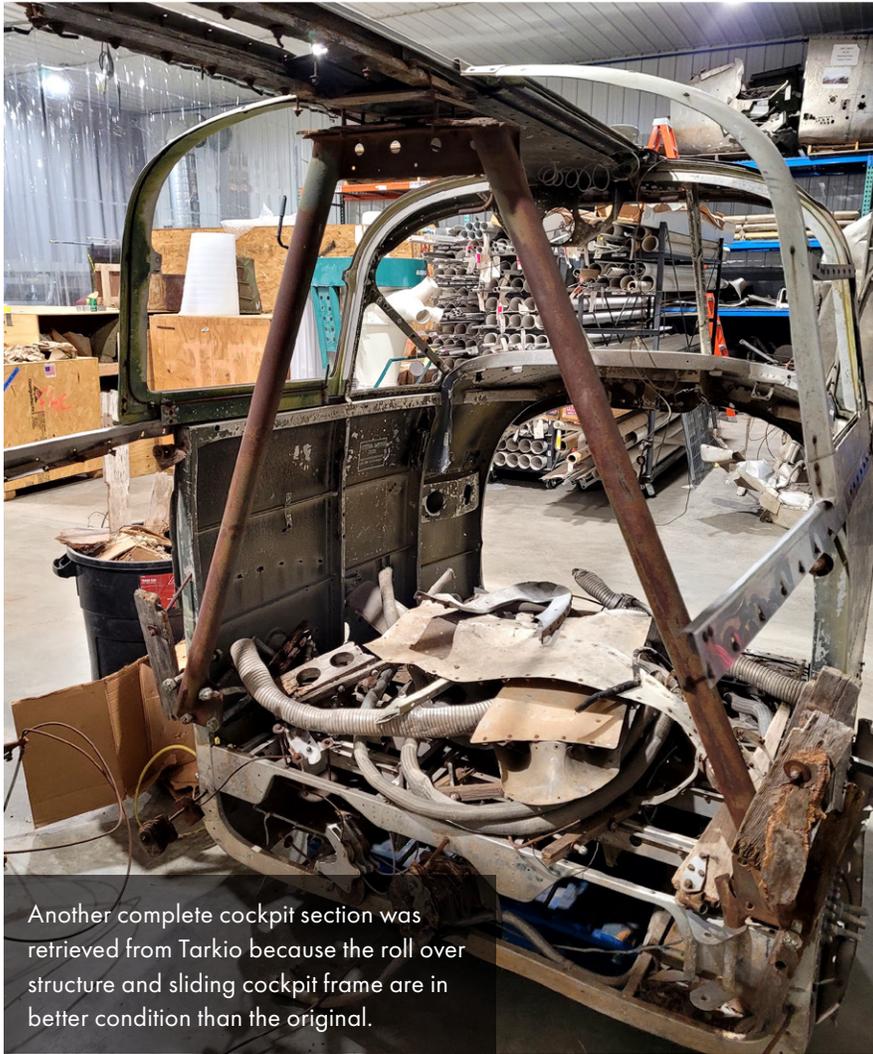
Another complete cockpit section was retrieved from Tarkio because the roll over structure and sliding cockpit frame are in better condition than the original.

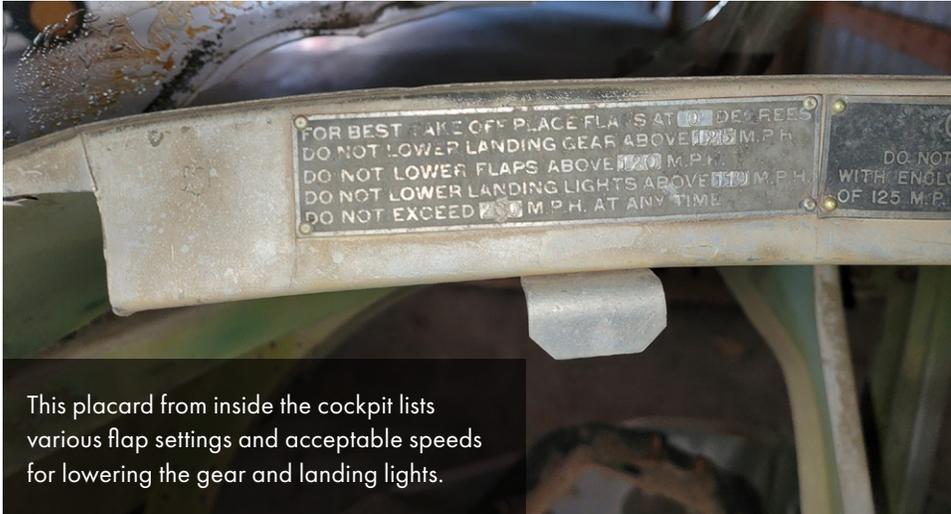
This placard from inside the cockpit lists various flap settings and acceptable speeds for lowering the gear and landing lights.

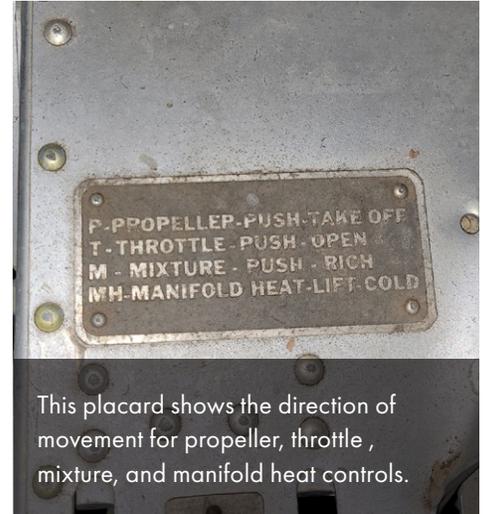
This placard shows the direction of movement for propeller, throttle, mixture, and manifold heat controls.

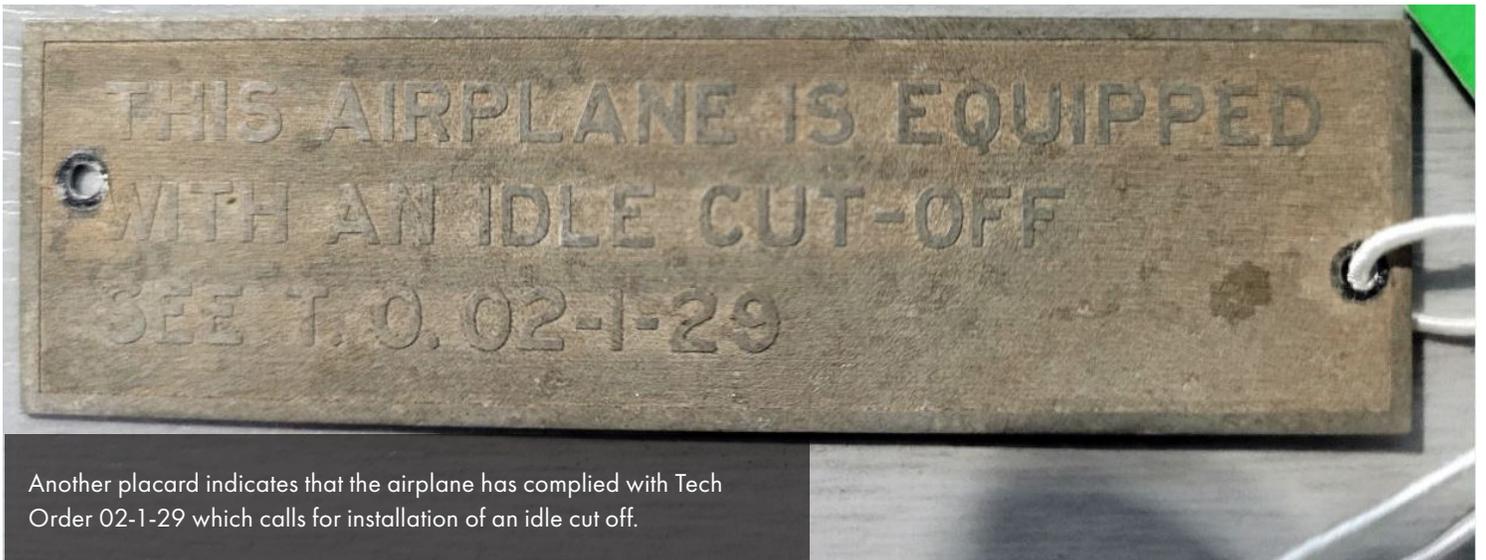
Another placard indicates that the airplane has complied with Tech Order 02-1-29 which calls for installation of an idle cut off.

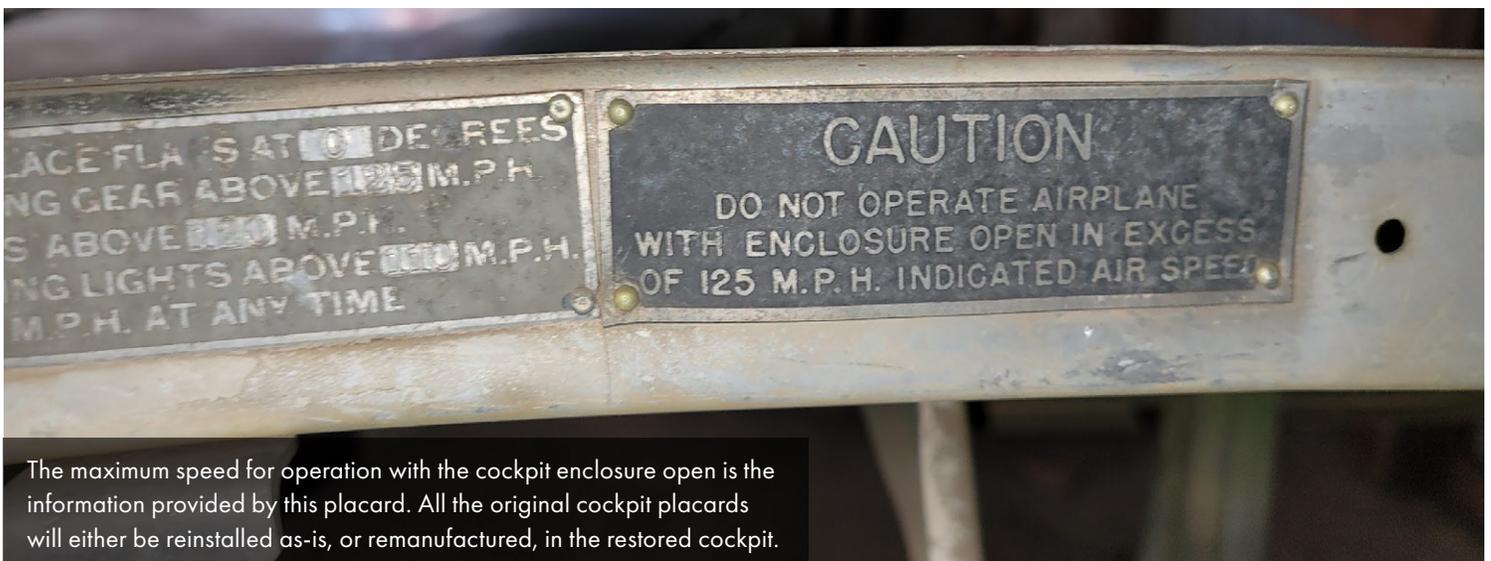
The maximum speed for operation with the cockpit enclosure open is the information provided by this placard. All the original cockpit placards will either be reinstalled as-is, or remanufactured, in the restored cockpit.

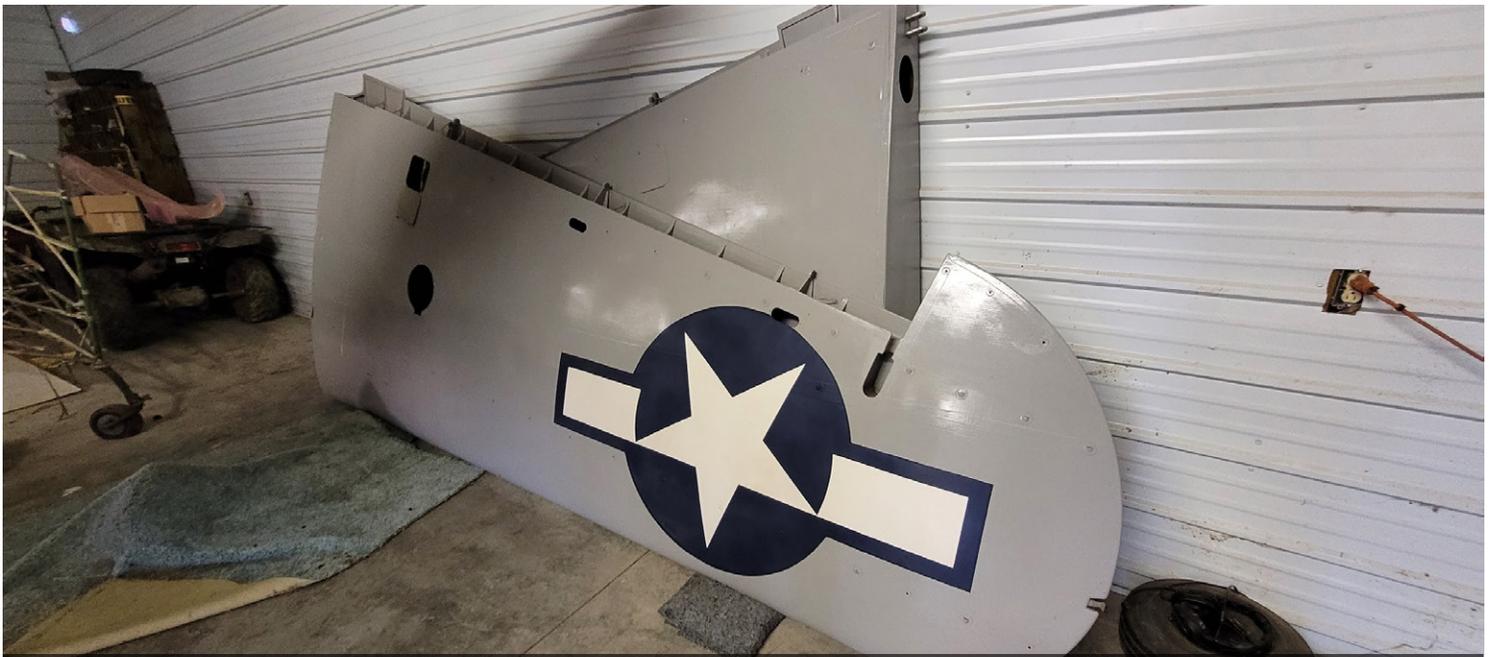
These are a set of NOS wings with the original fabric and dope finish in excellent condition. Not only is the finish original, but all the control pulleys and wiring inside the wing are in new, unused condition. Unfortunately, despite never having been used, the wings will still need to be rebuilt.

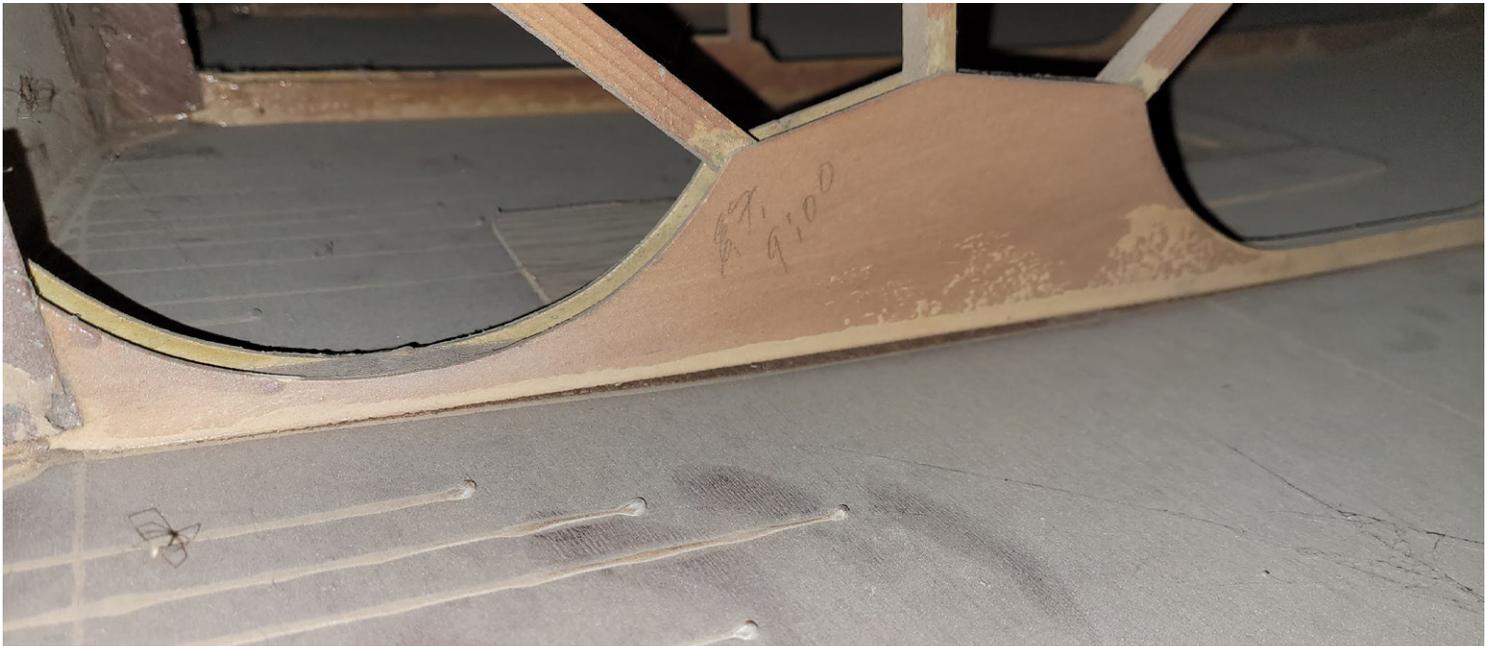
A look inside one of the NOS wings shows why it will have to be rebuilt. Even though these wings have never been used, some of the glue joints have delaminated over the 80 years since they were built.

The wings will be carefully reskinned on one side with the original skin in place on the other surface. Once the first skin is in place, the second side will be removed and replaced. This procedure keeps the wing in alignment throughout reskinning, acting as its own fixture.

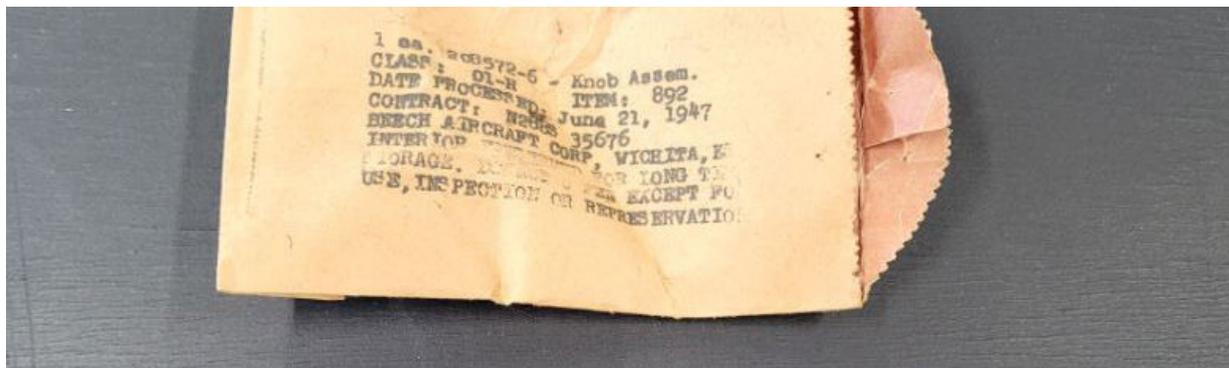
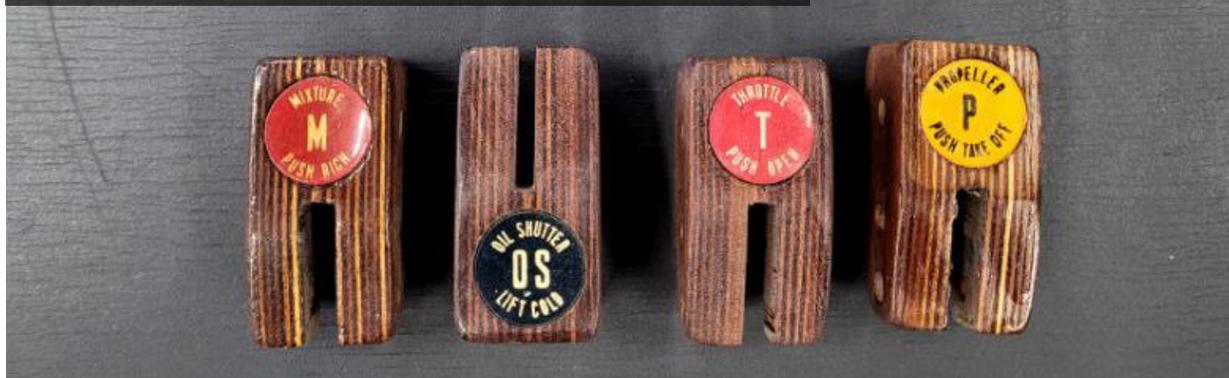
These new, unused original knobs were found and purchased by Sam Graves for the project. They are knobs for the mixture, oil shutter, throttle, and propeller controls. They came in the original parts envelope.

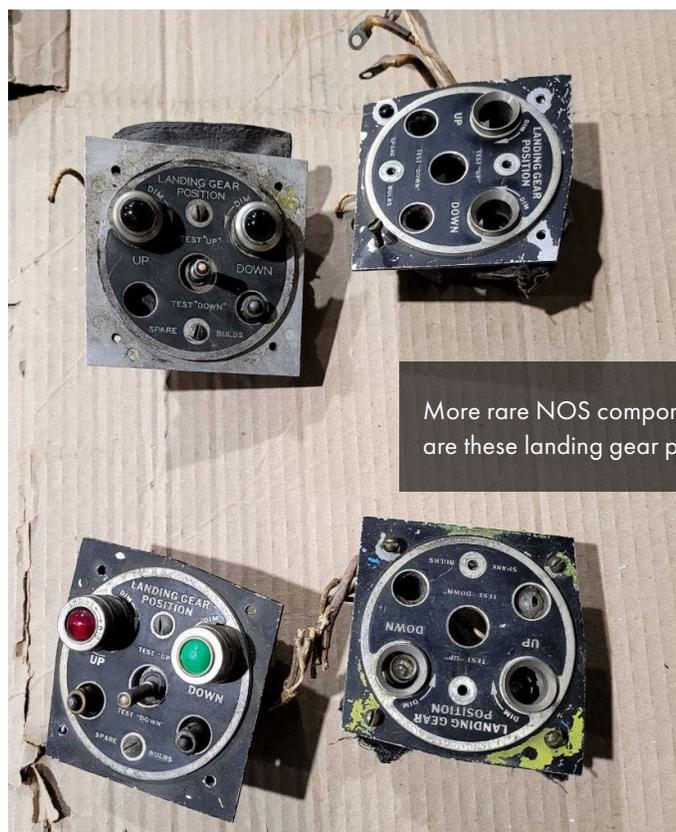
More rare NOS components that Sam has collected are these landing gear position indicator lights.
