Winter 2024

AT-10 WICHITA

Cadet Air Corps Museum AT-10 Wichita Restoration

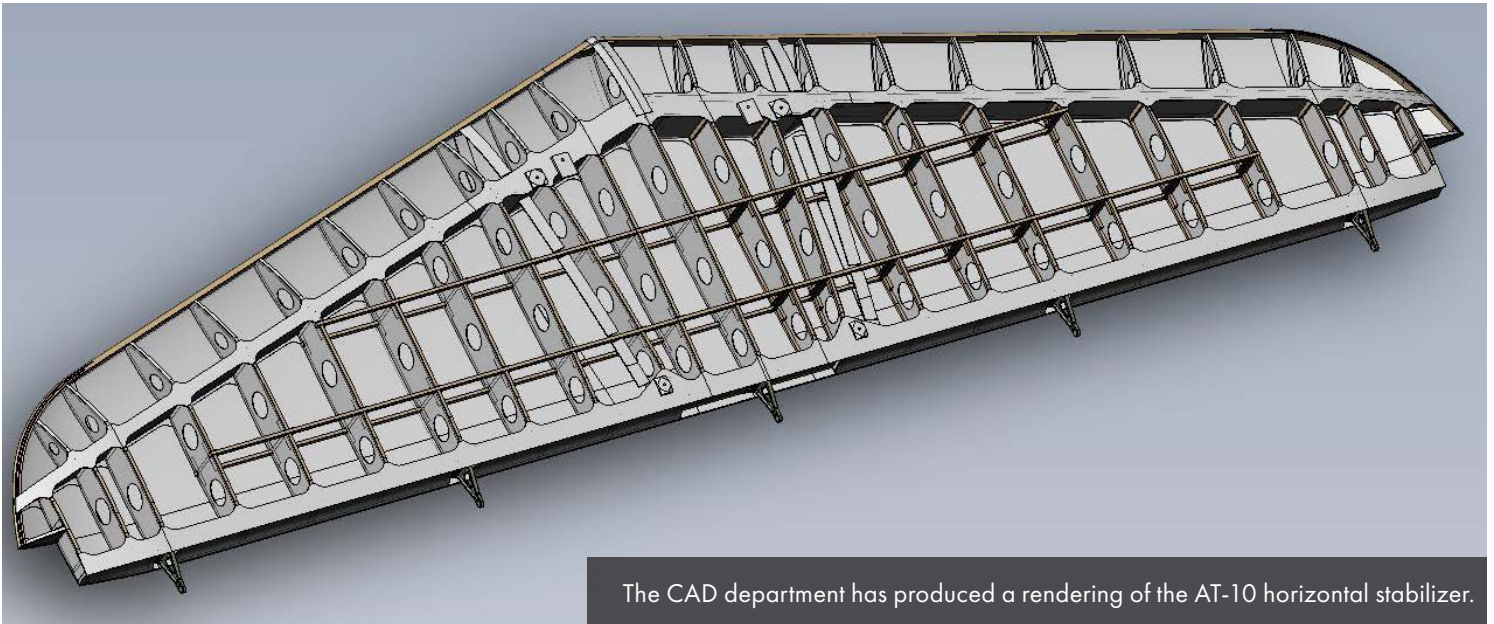
The CAD department has produced a rendering of the AT-10 horizontal stabilizer.

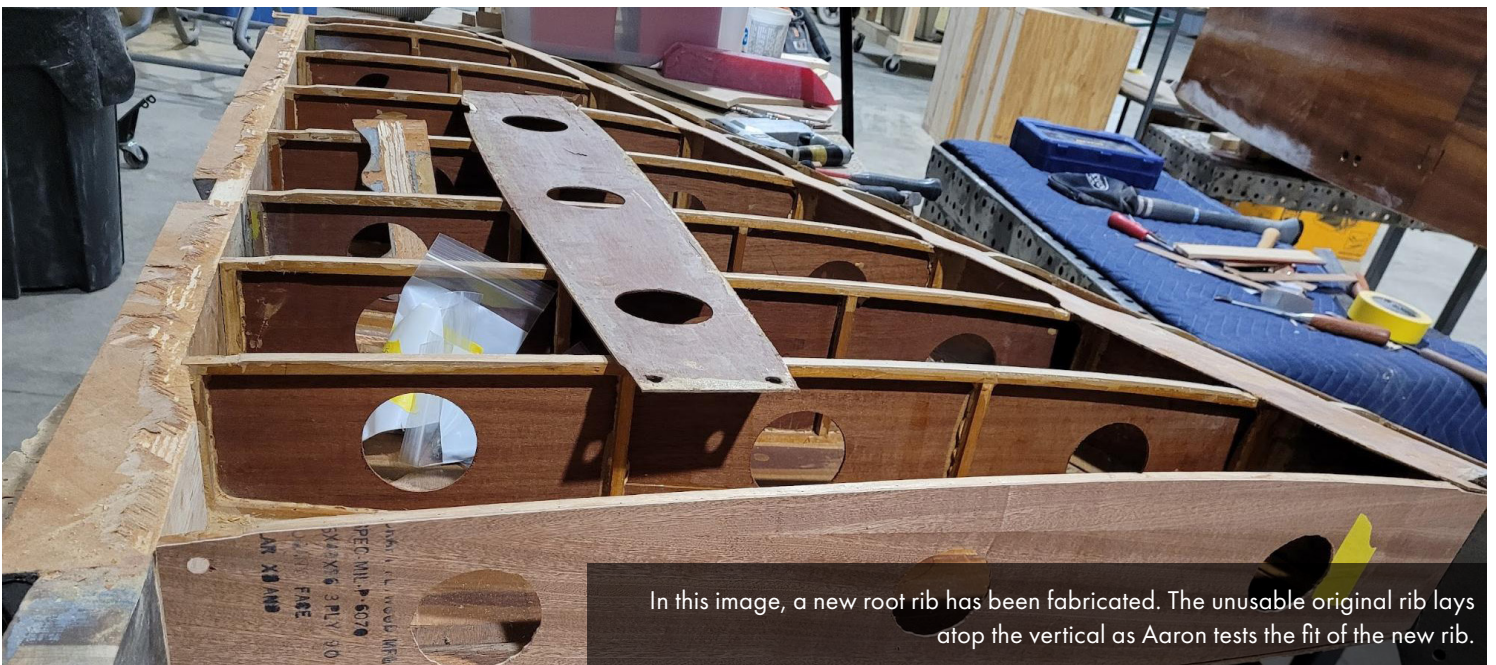
In this image, a new root rib has been fabricated. The unusable original rib lays atop the vertical as Aaron tests the fit of the new rib.

As Aaron inspected the empennage, it became clear that the vast majority of the glue joints would have to be separated and reglued. But much of the wood of the inner structure is in good shape. So Aaron is using a procedure to restore the vertical stabilizer without the need for a fixture. He removes one rib and makes that rib airworthy by separating then regluing the joints, or in 2 cases on the vertical, making a new rib.

The now airworthy rib is reinstalled before the next rib is removed. Because only one component is removed at a time, the structure maintains alignment.

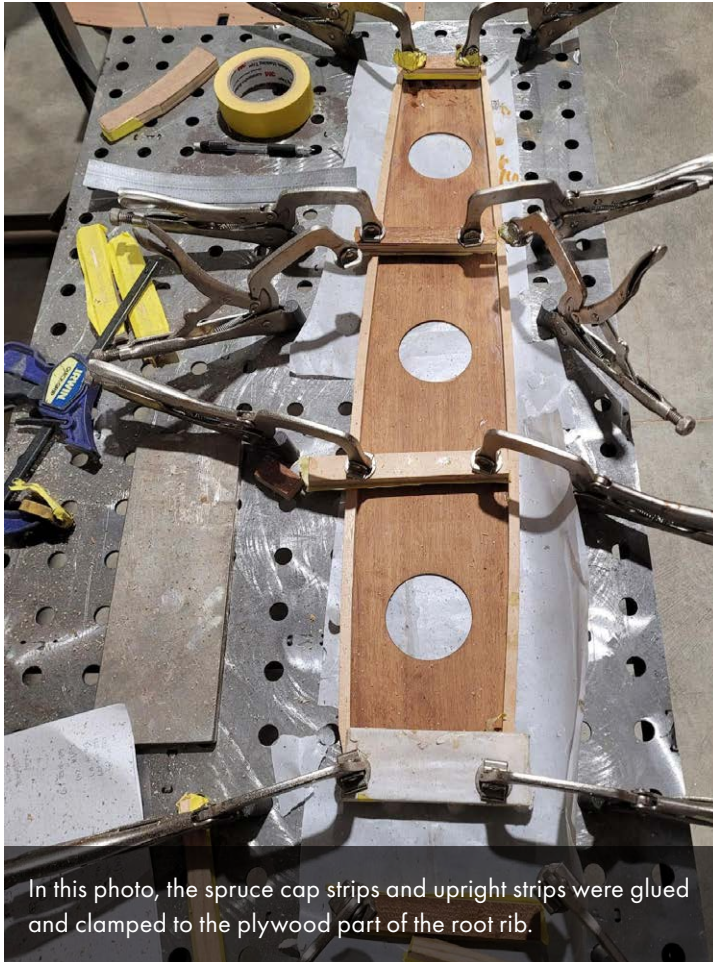
In this photo, the spruce cap strips and upright strips were glued and clamped to the plywood part of the root rib.

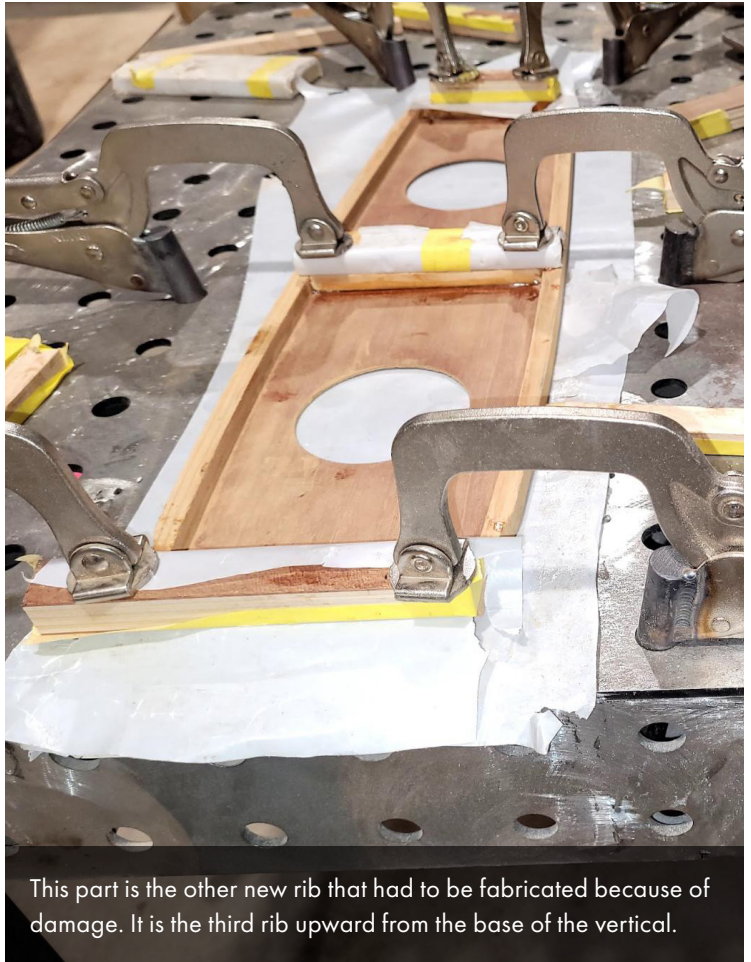
This part is the other new rib that had to be fabricated because of damage. It is the third rib upward from the base of the vertical.

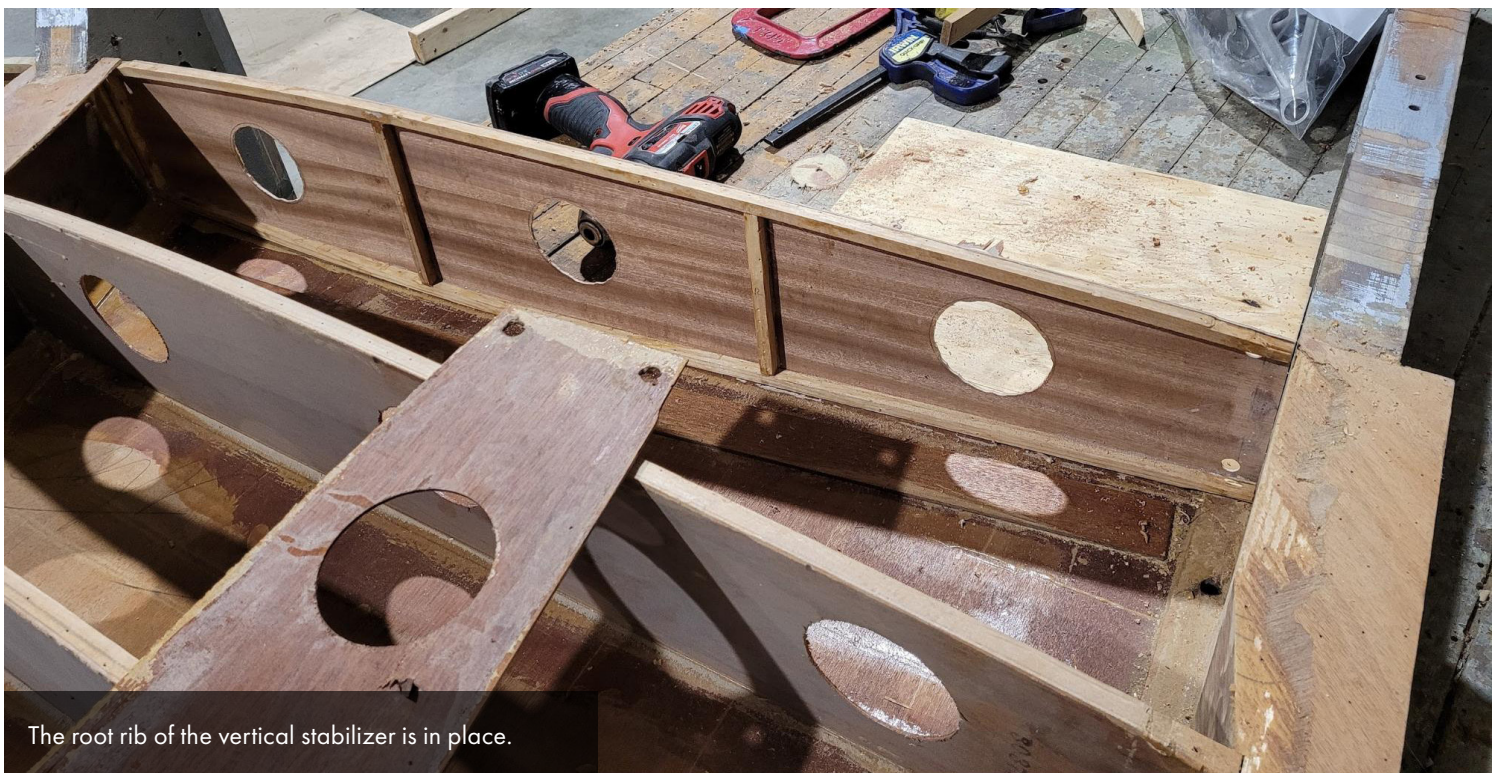
The root rib of the vertical stabilizer is in place.

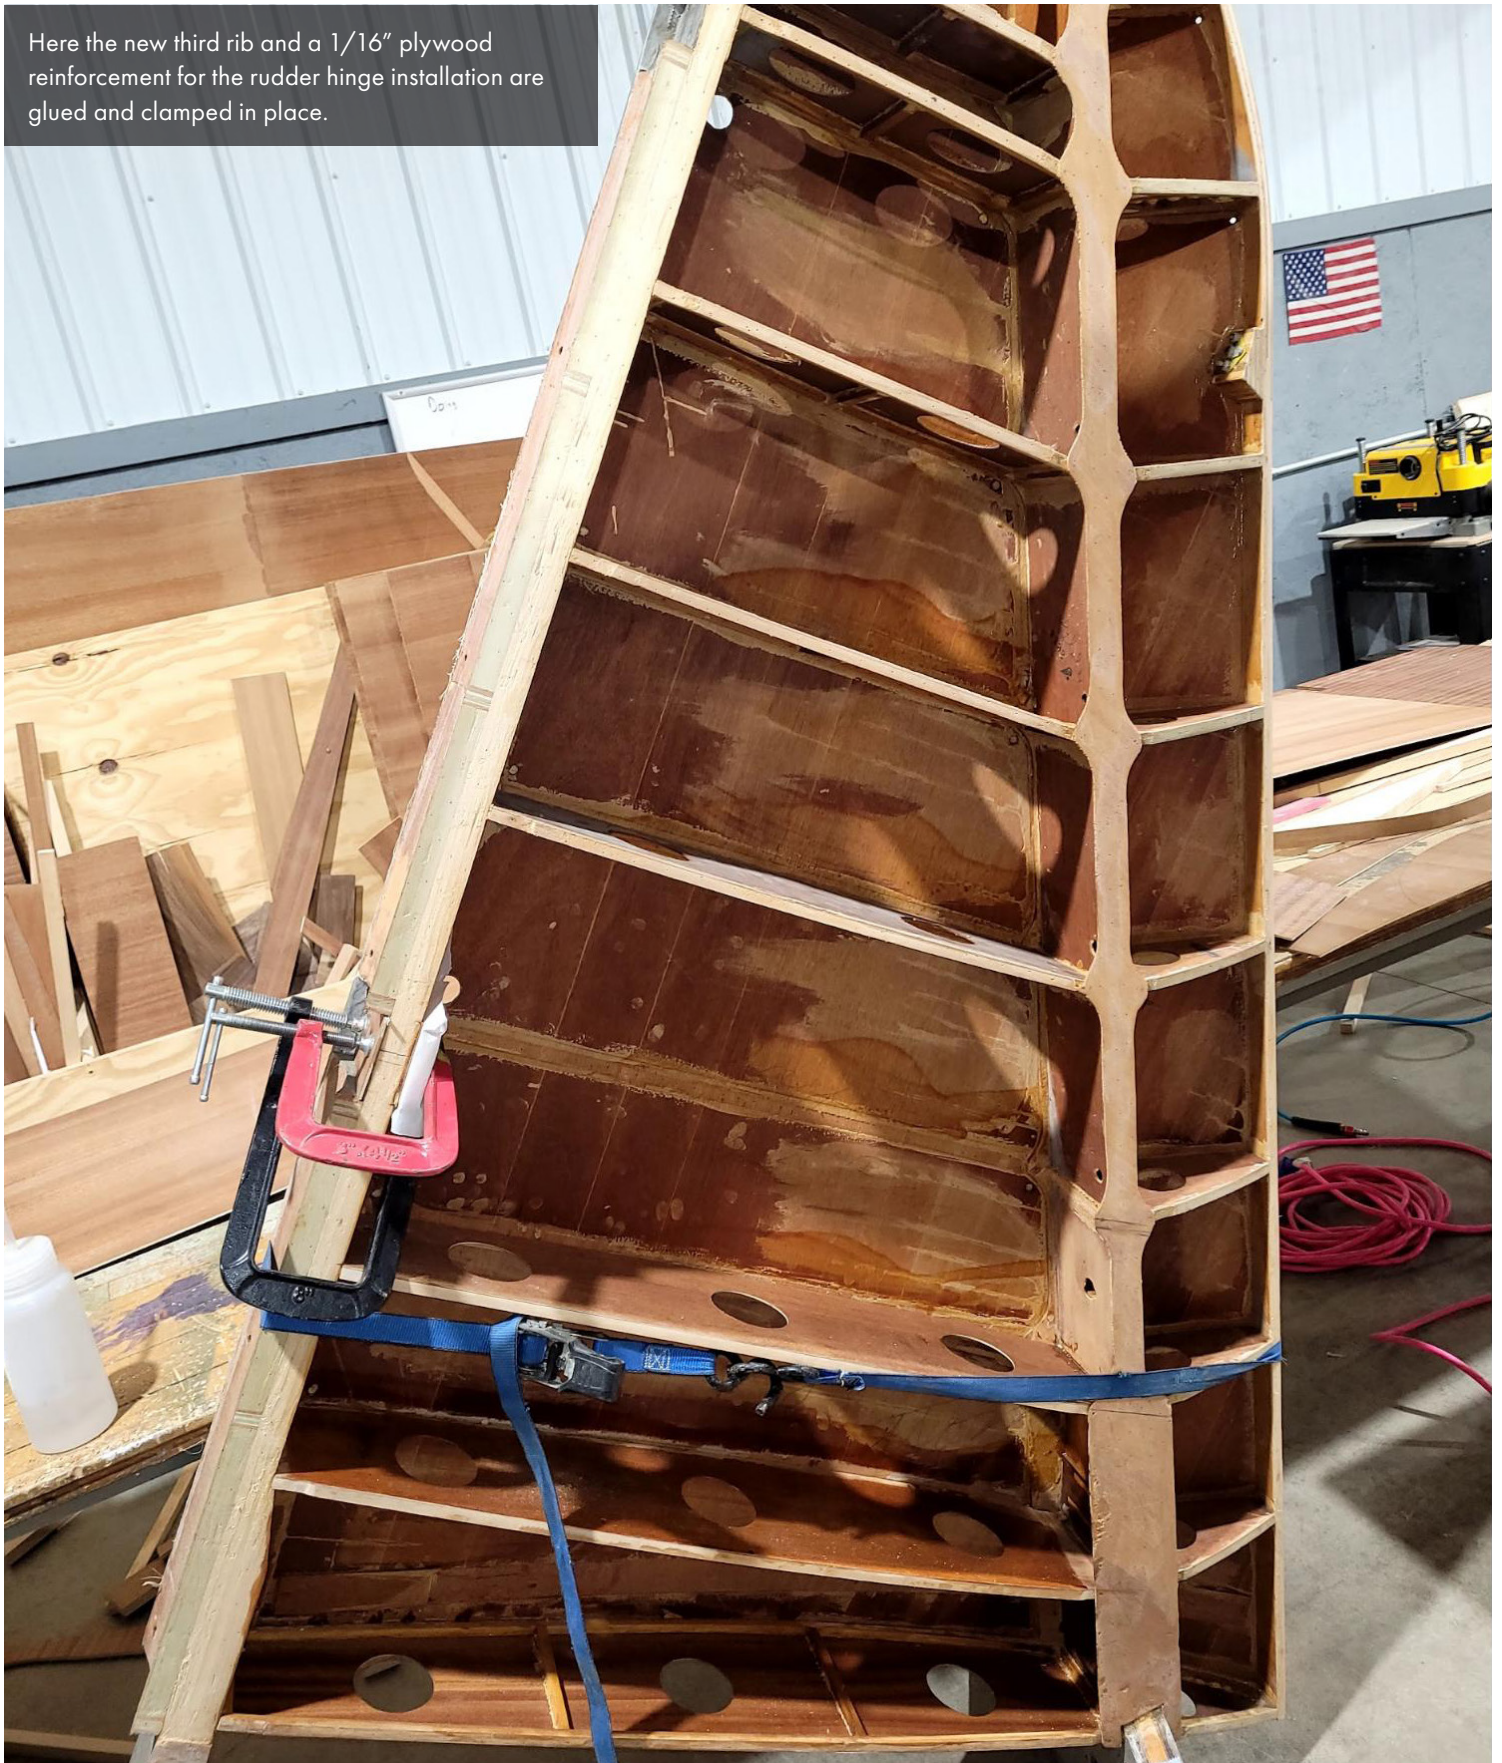
Here the new third rib and a 1/16" plywood reinforcement for the rudder hinge installation are glued and clamped in place.

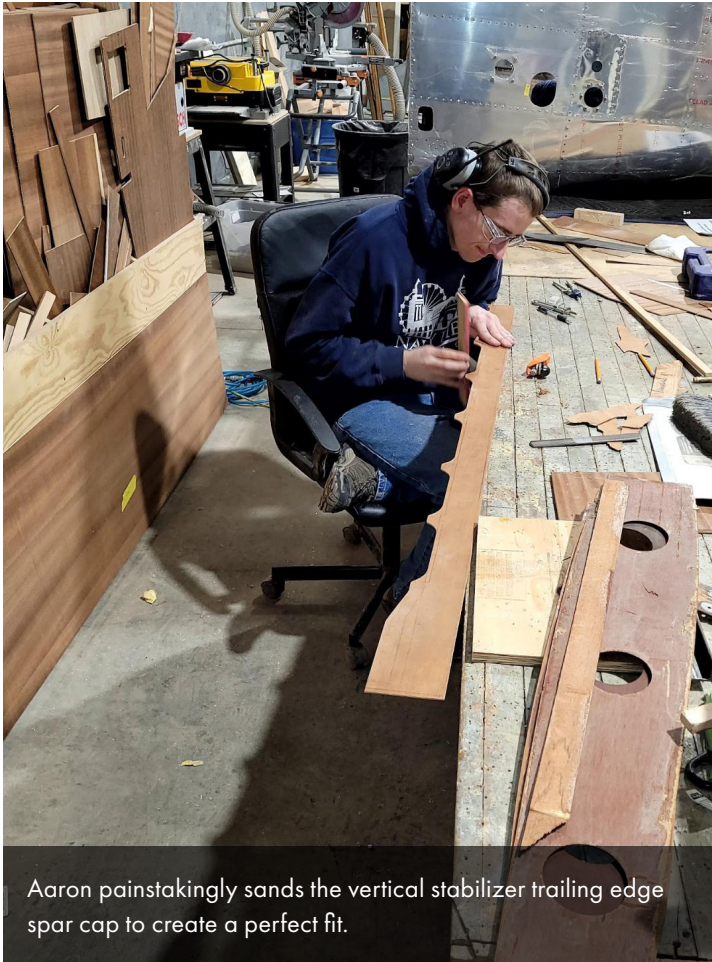
Aaron painstakingly sands the vertical stabilizer trailing edge spar cap to create a perfect fit.

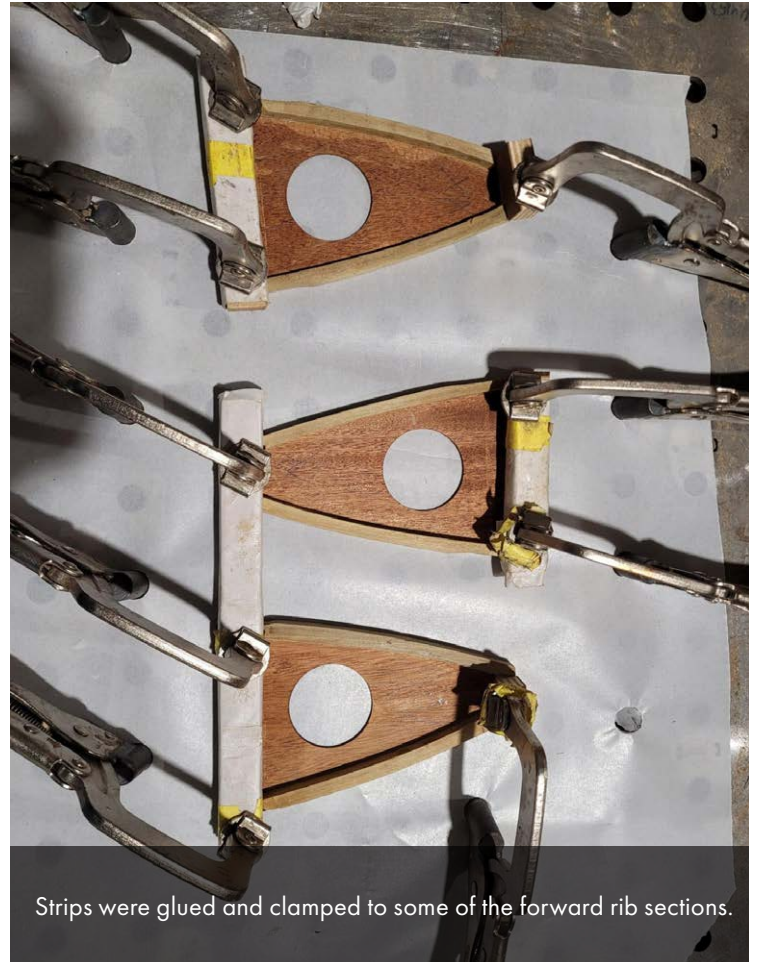
Strips were glued and clamped to some of the forward rib sections.

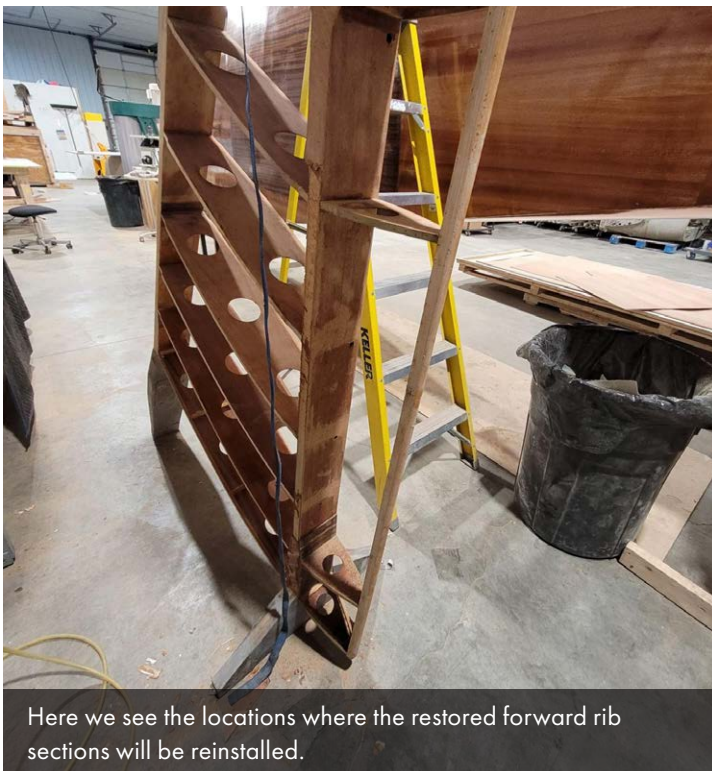
Here we see the locations where the restored forward rib sections will be reinstalled.

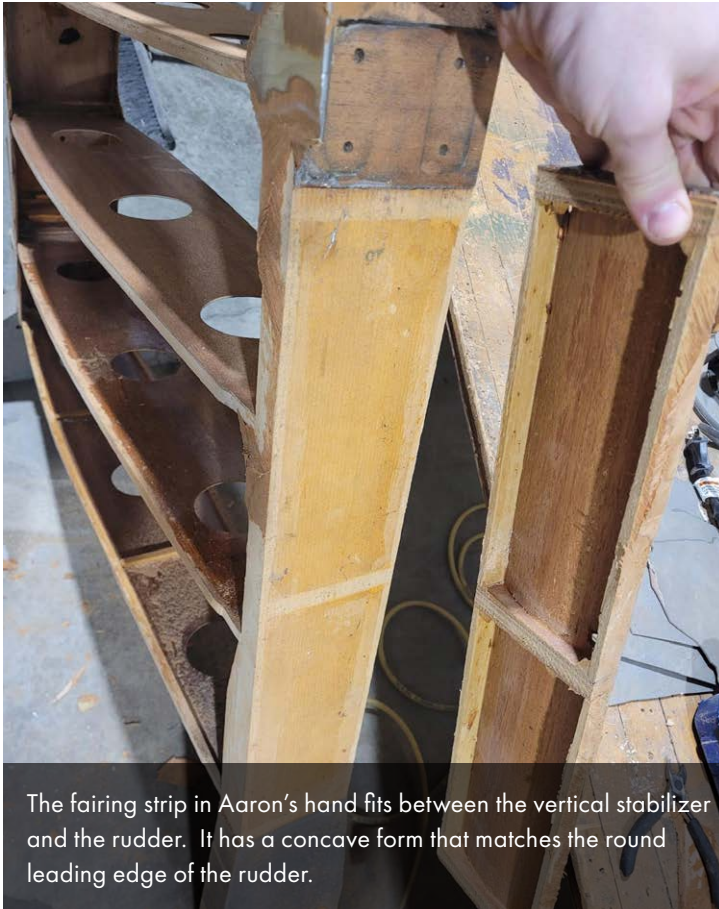
The fairing strip in Aaron's hand fits between the vertical stabilizer and the rudder. It has a concave form that matches the round leading edge of the rudder.

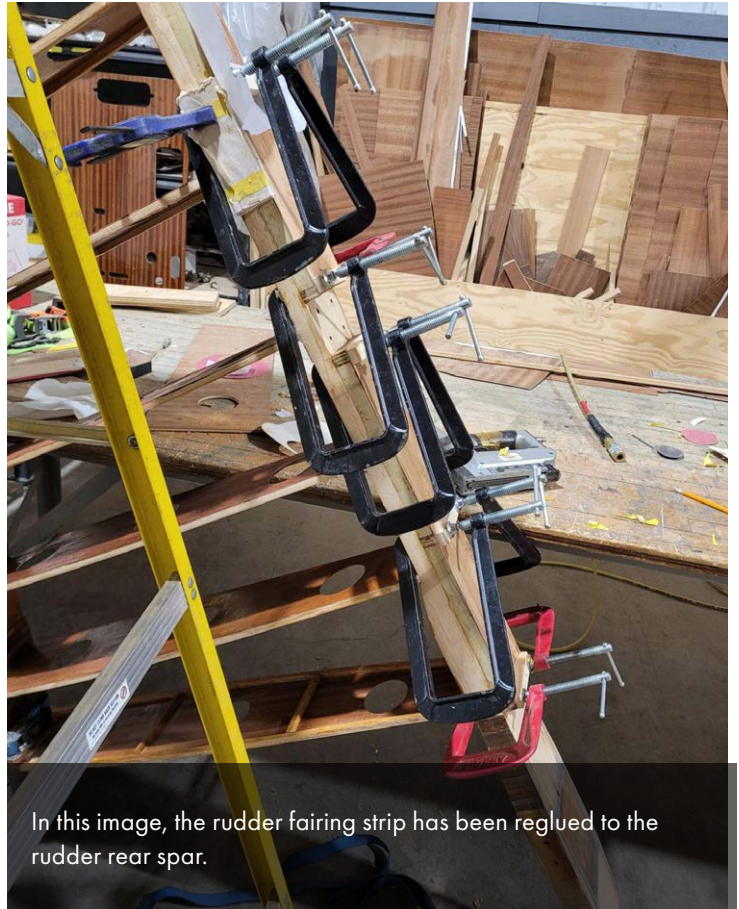
In this image, the rudder fairing strip has been reglued to the rudder rear spar.

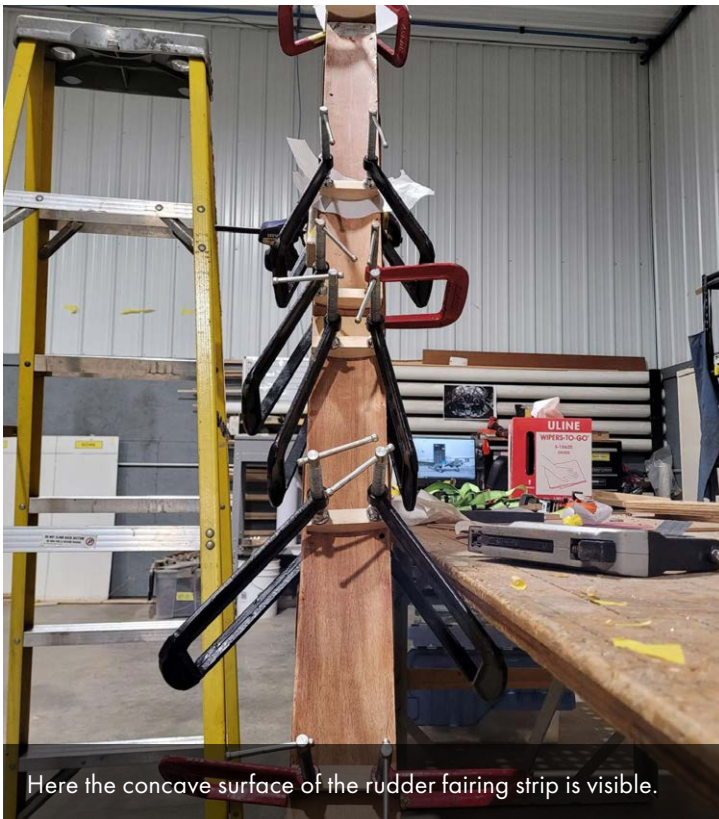
Here the concave surface of the rudder fairing strip is visible.

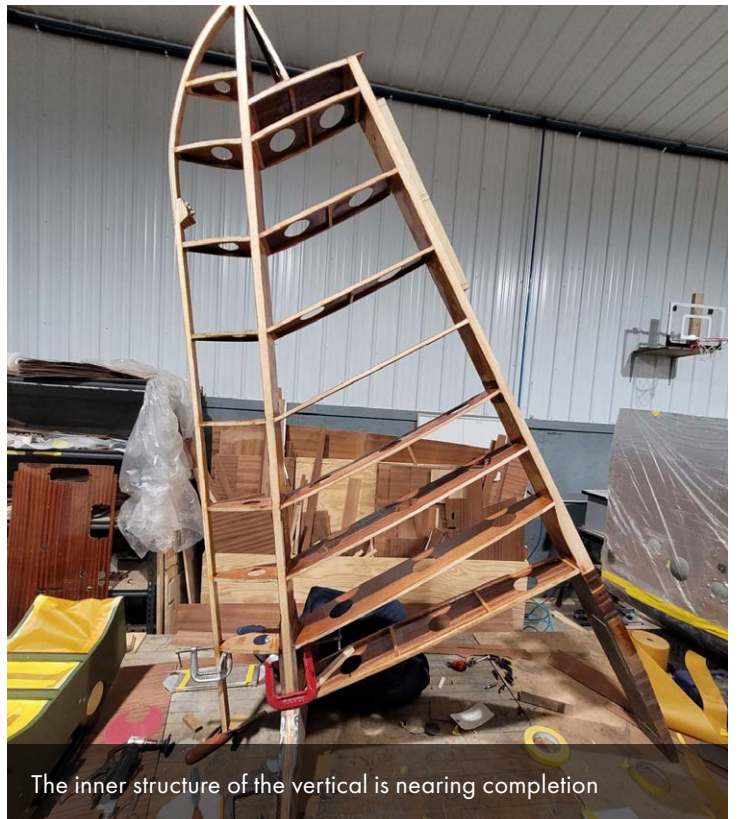
The inner structure of the vertical is nearing completion

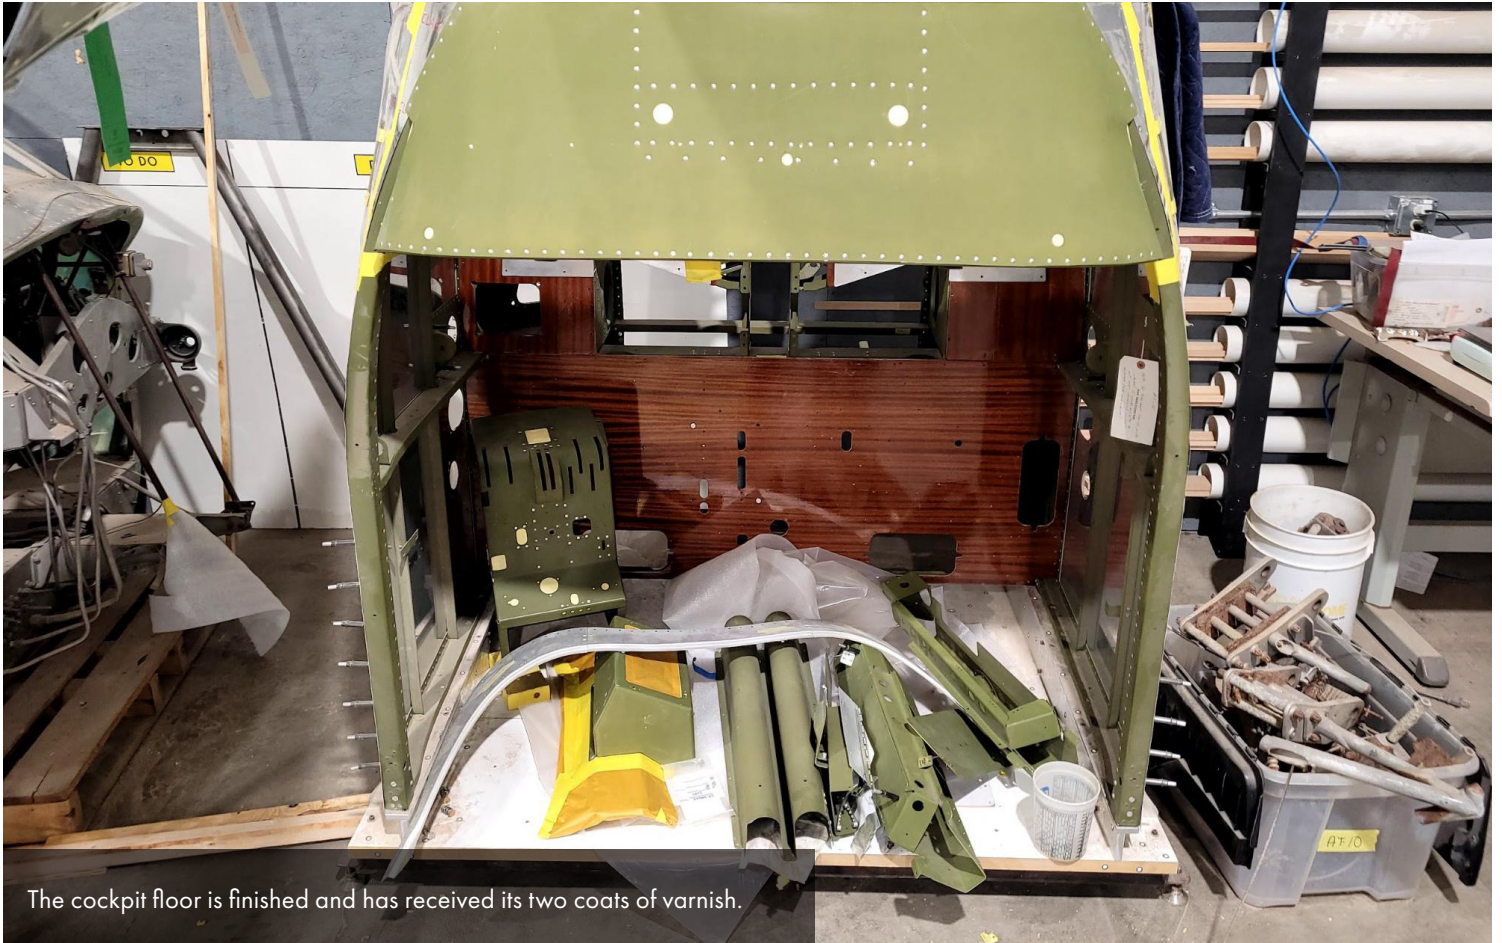
The cockpit floor is finished and has received its two coats of varnish.

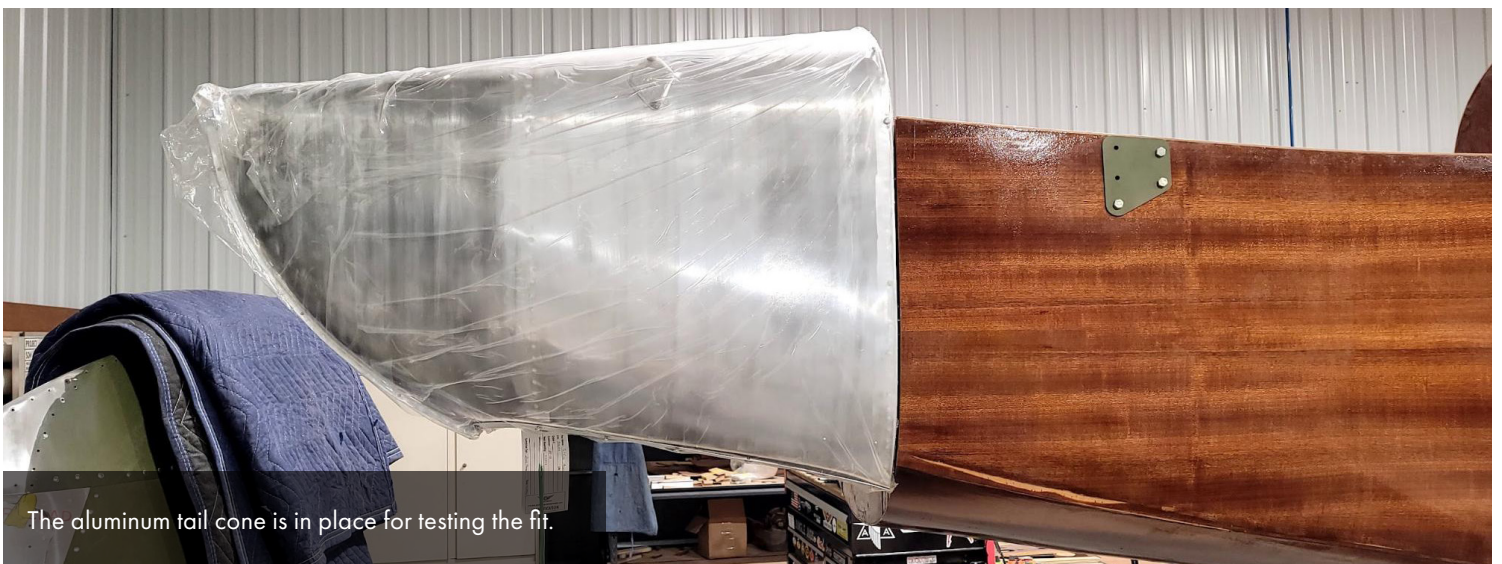
The aluminum tail cone is in place for testing the fit.

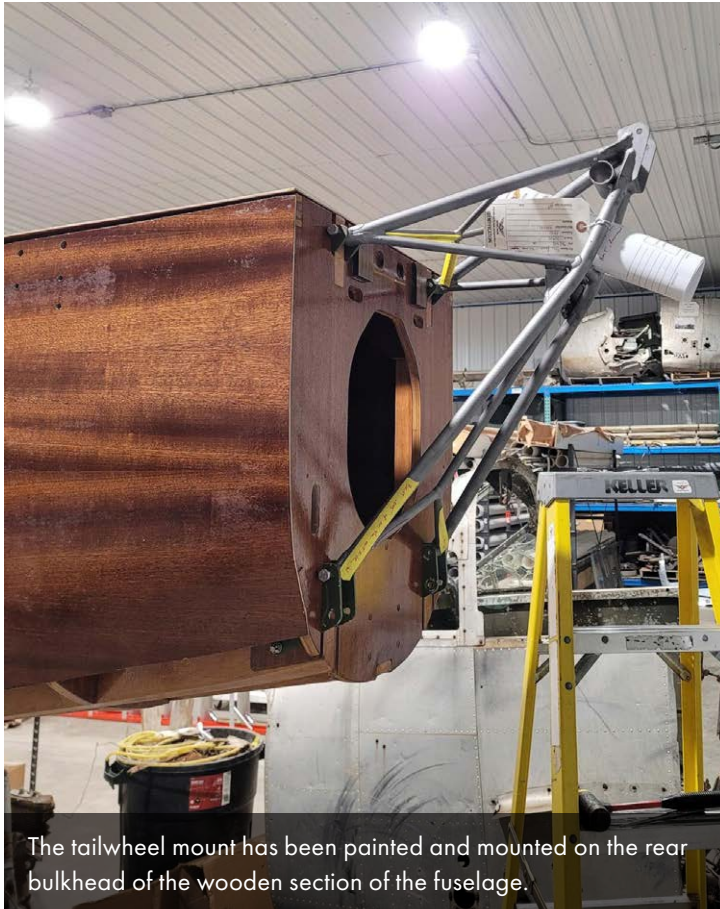
The tailwheel mount has been painted and mounted on the rear bulkhead of the wooden section of the fuselage.

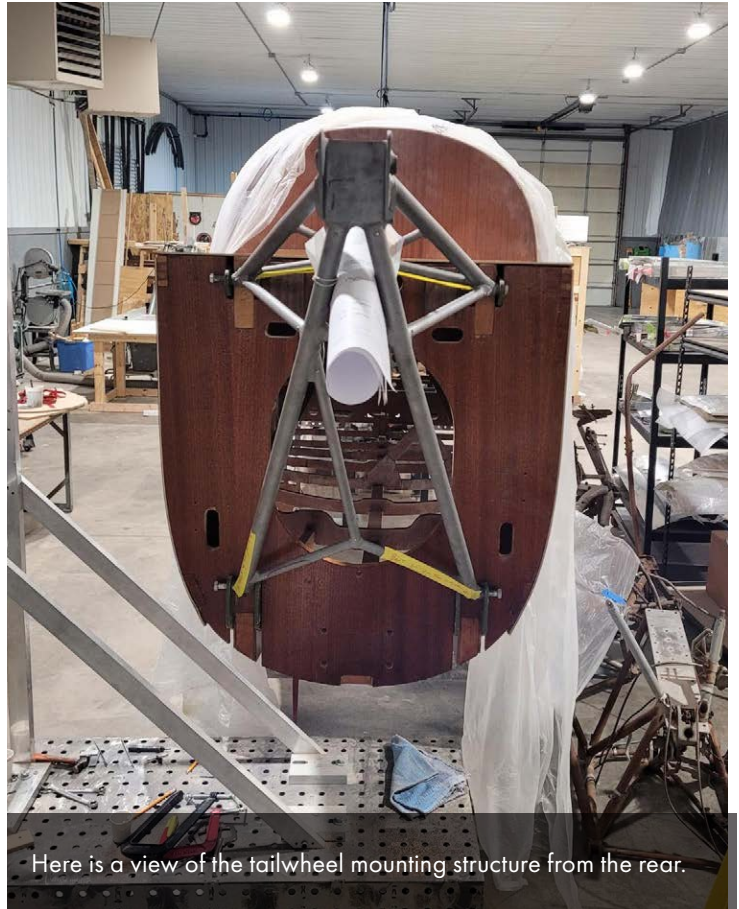
Here is a view of the tailwheel mounting structure from the rear.

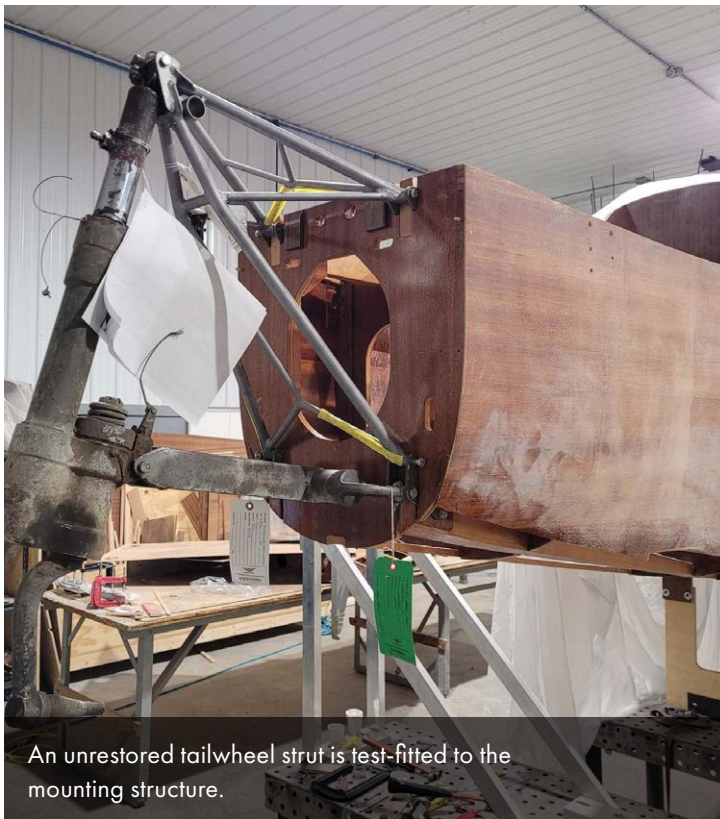
An unrestored tailwheel strut is test-fitted to the mounting structure.

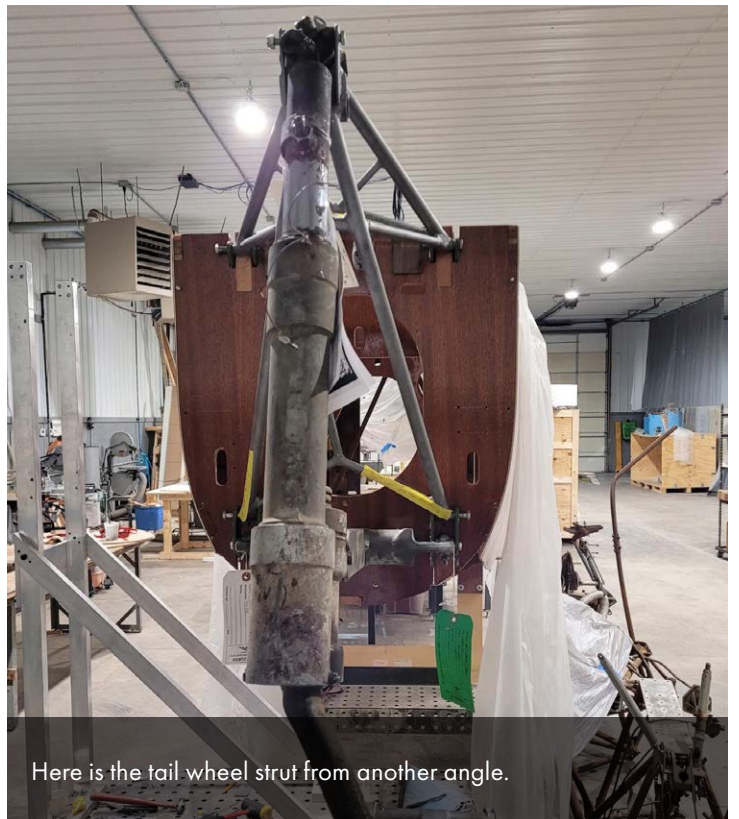
Here is the tail wheel strut from another angle.

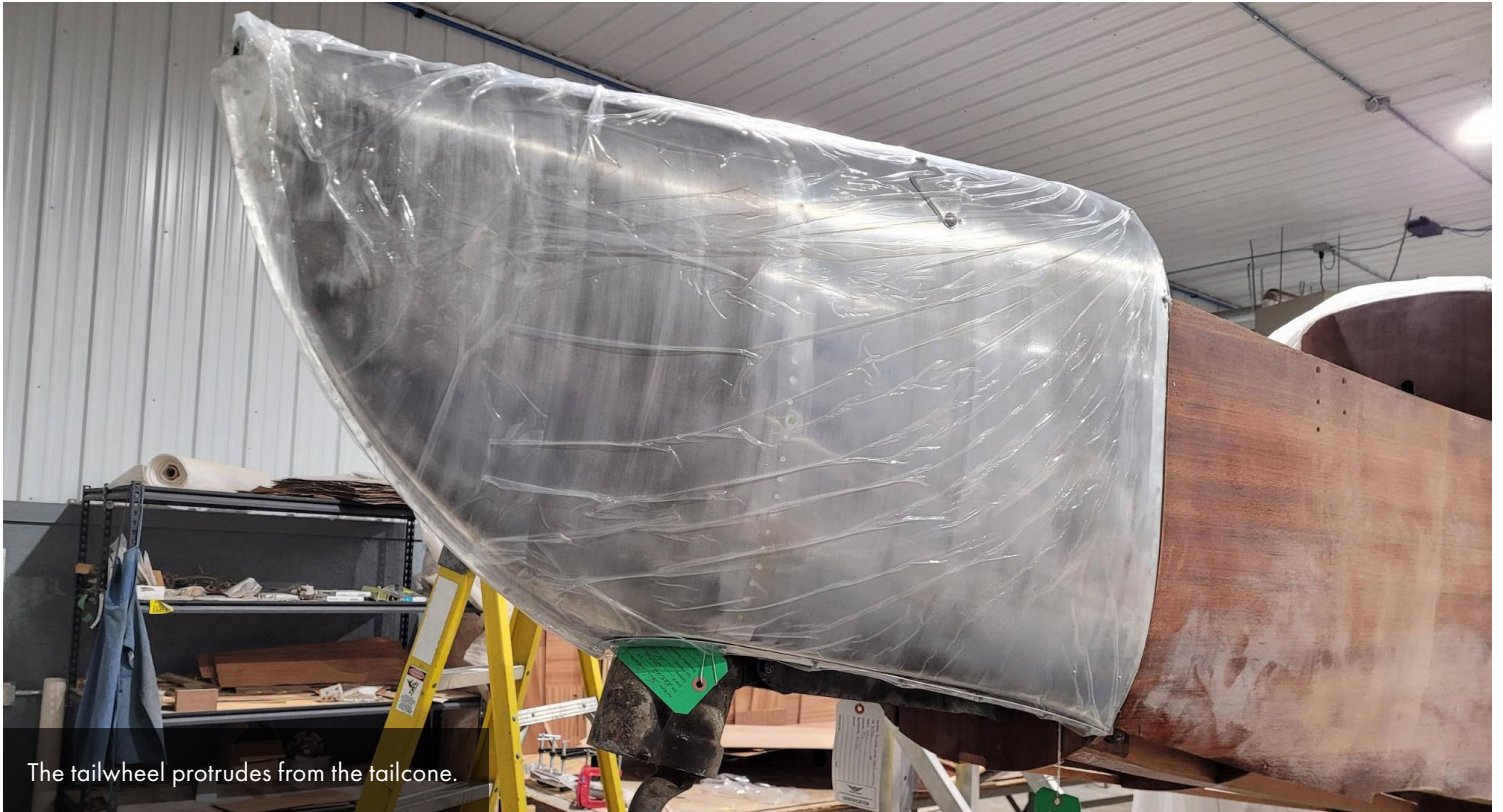
The tailwheel protrudes from the tailcone.

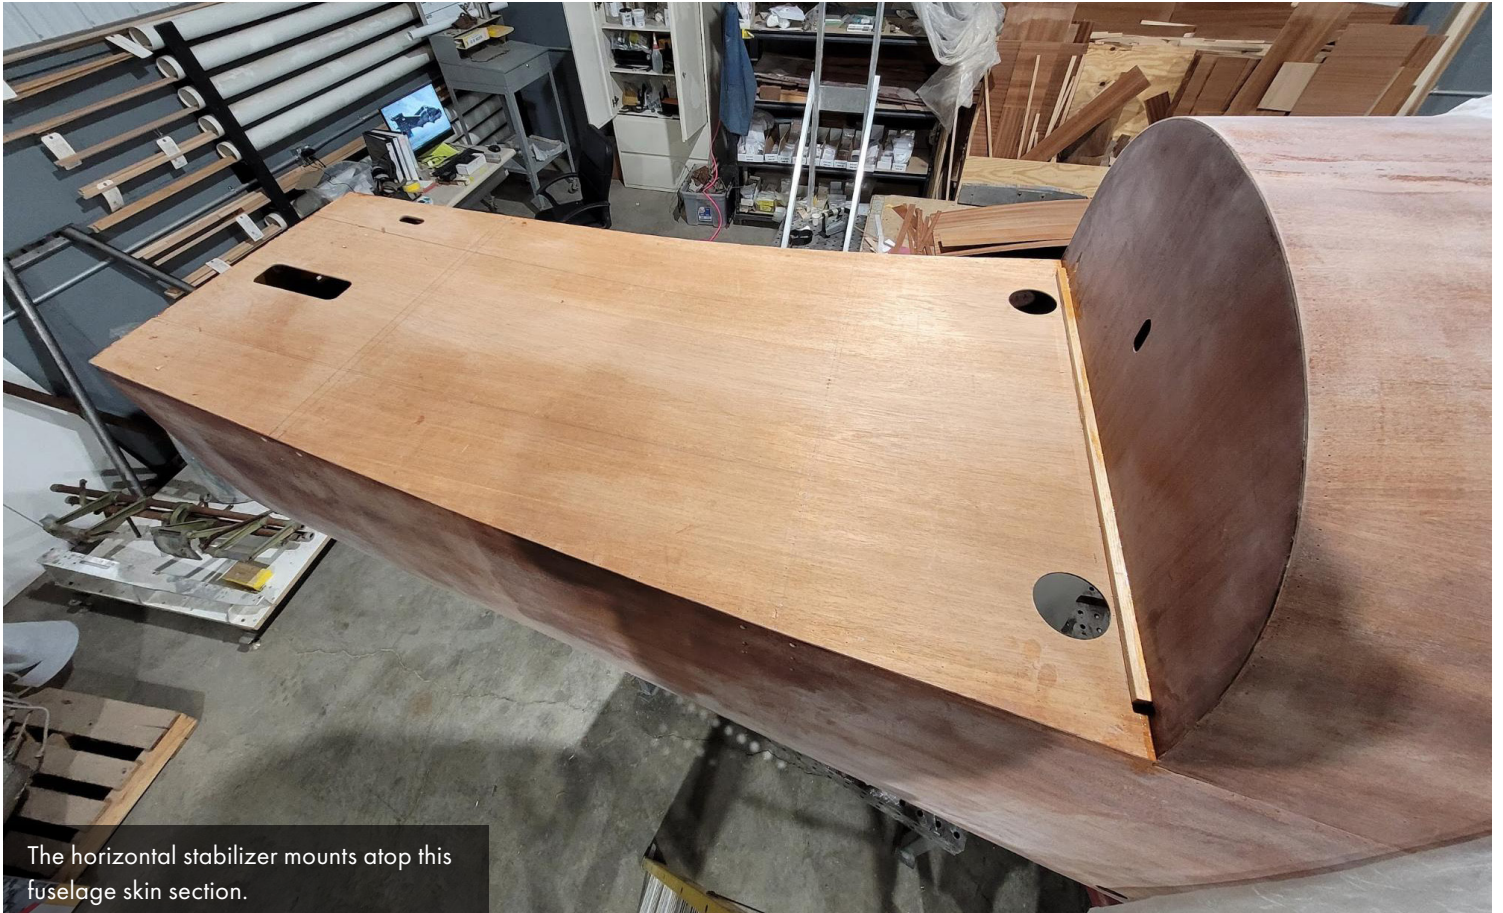
The horizontal stabilizer mounts atop this fuselage skin section.

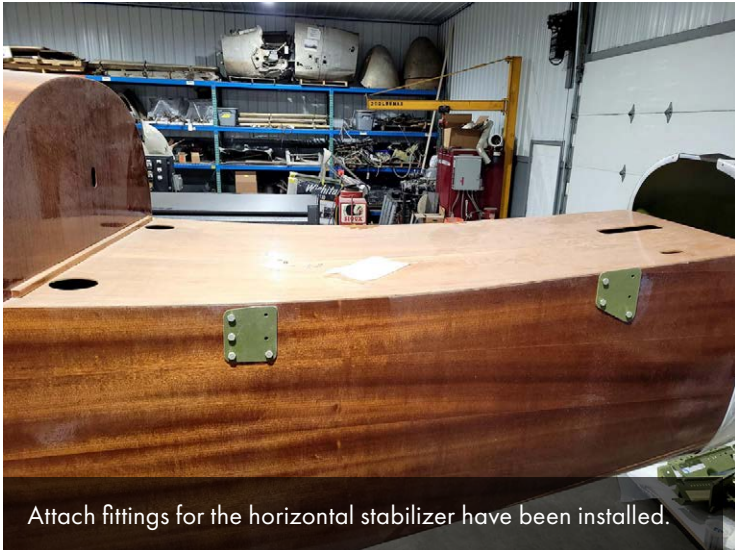
Attach fittings for the horizontal stabilizer have been installed.

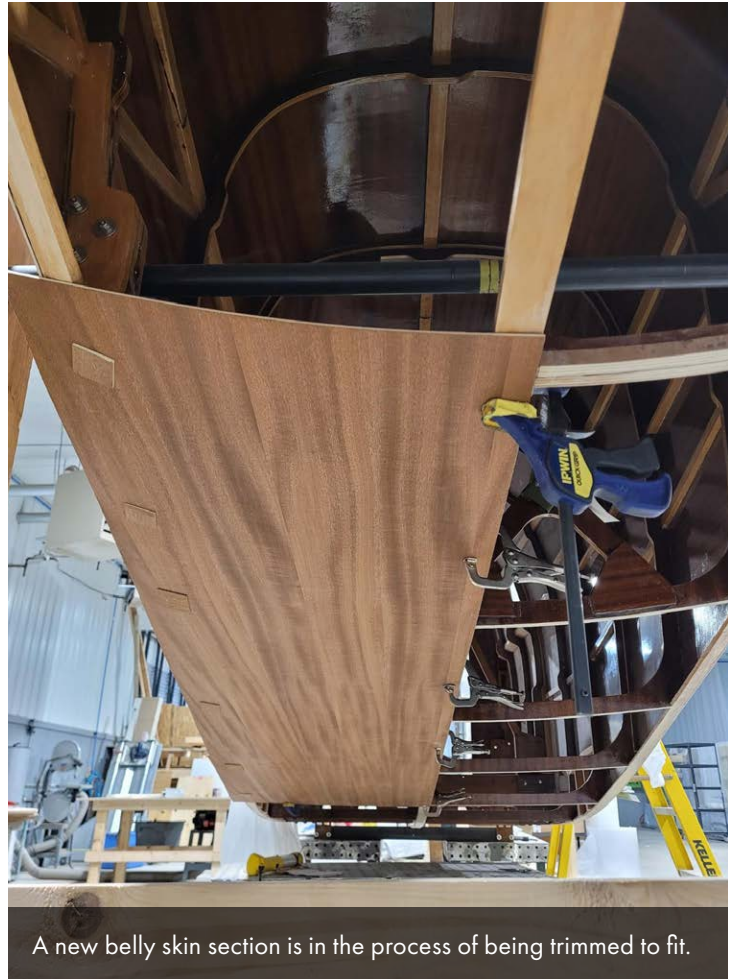
A new belly skin section is in the process of being trimmed to fit.

These brackets will hold pulleys for the control system. The brackets on the left and right are for rudder control cable pulleys. The center bracket holds the elevator control cable pulley.

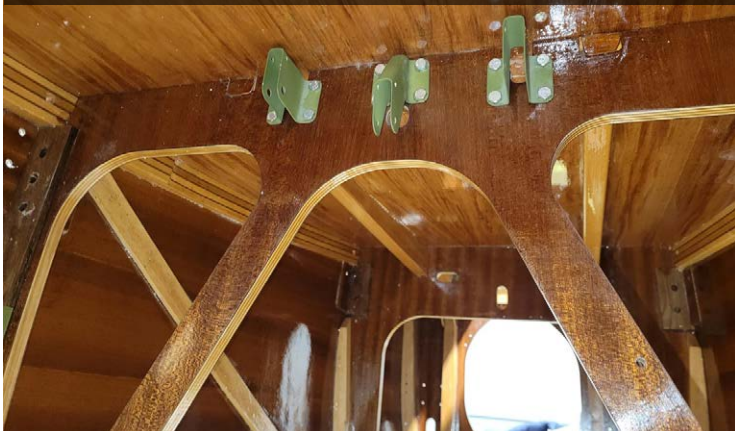
This bracket is for a trim cable pulley.

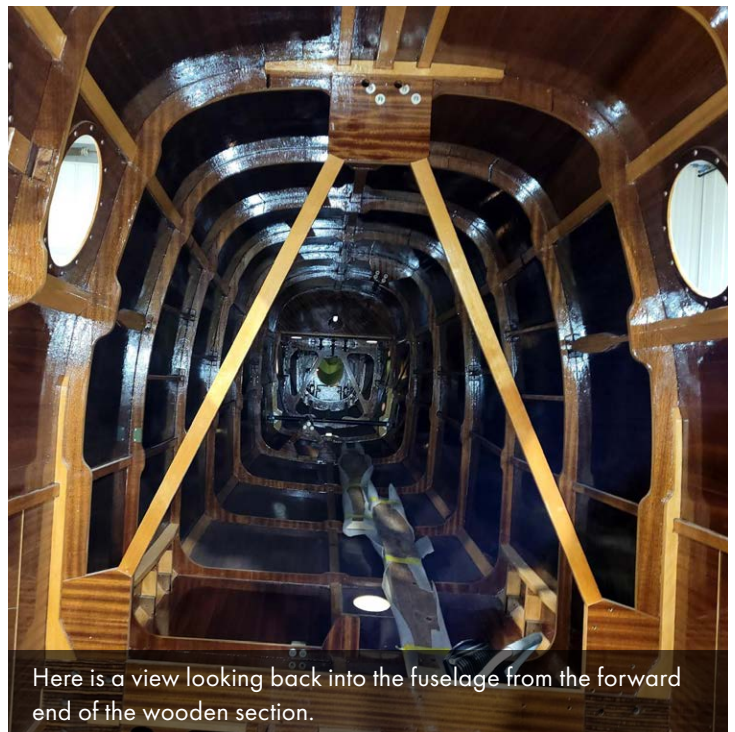
Here is a view looking back into the fuselage from the forward end of the wooden section.

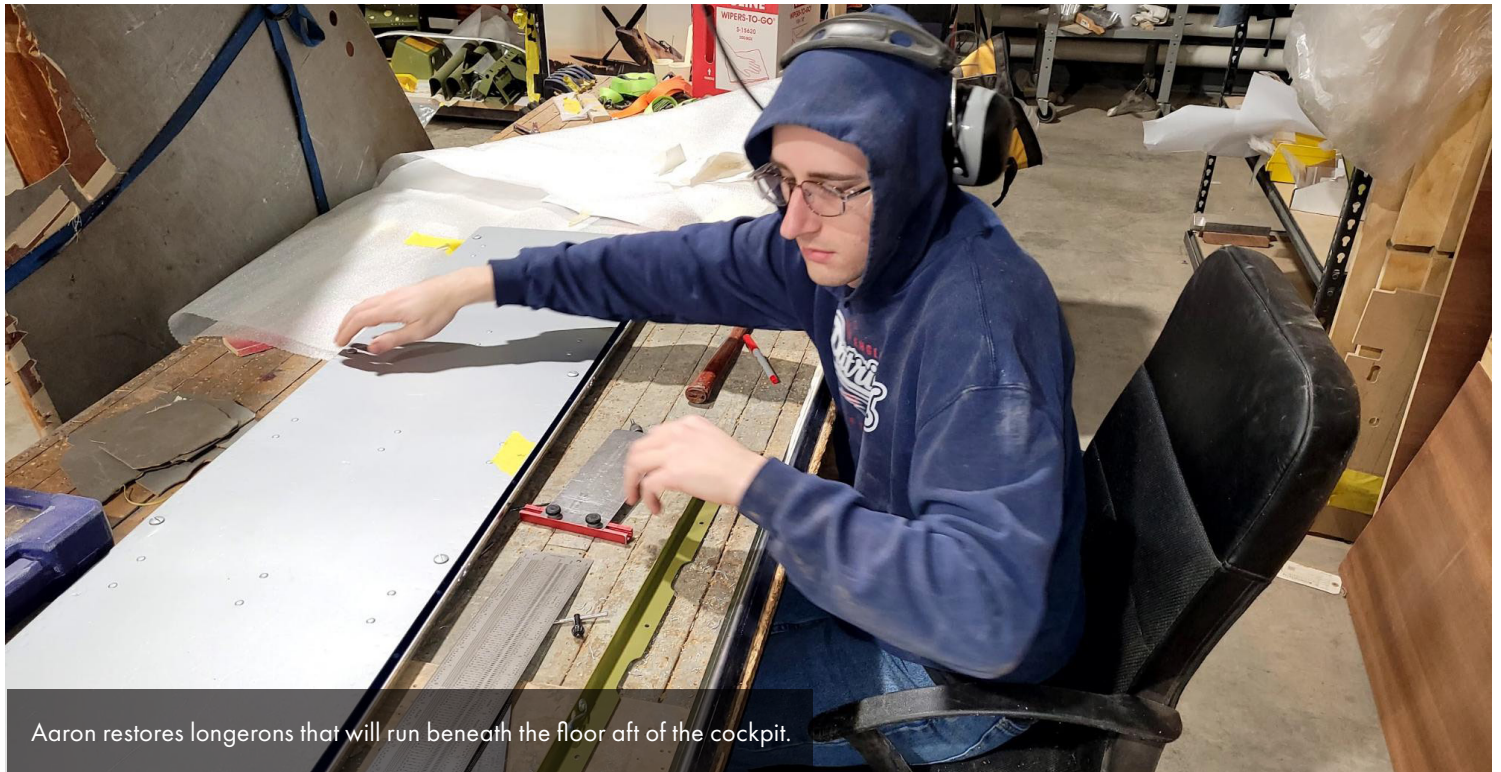
Aaron restores longerons that will run beneath the floor aft of the cockpit.
