Winter 2024

AT-10 WICHITA

Cadet Air Corps Museum AT-10 Wichita Restoration

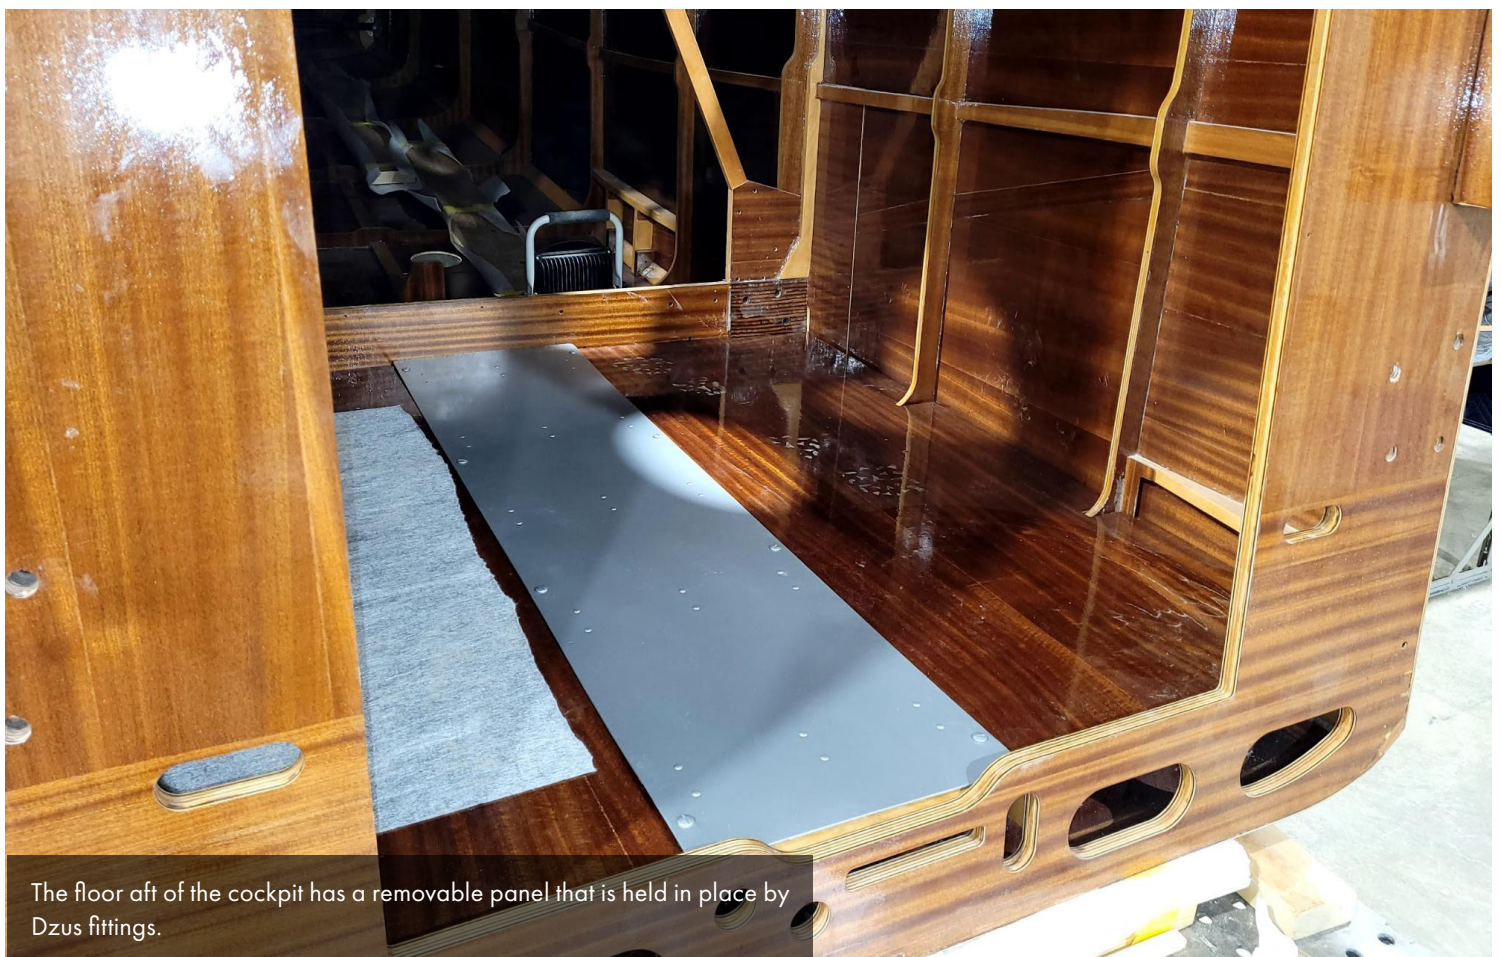
The floor aft of the cockpit has a removable panel that is held in place by Dzus fittings.

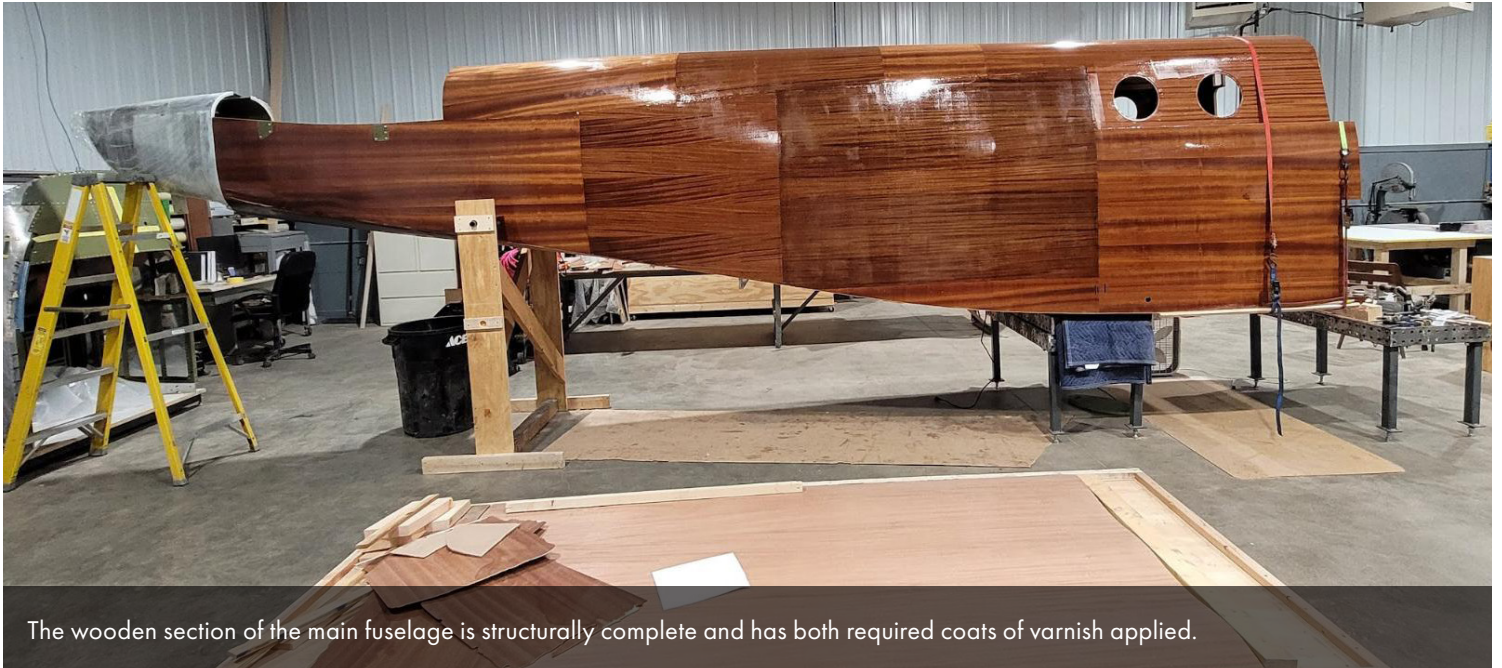
The wooden section of the main fuselage is structurally complete and has both required coats of varnish applied.

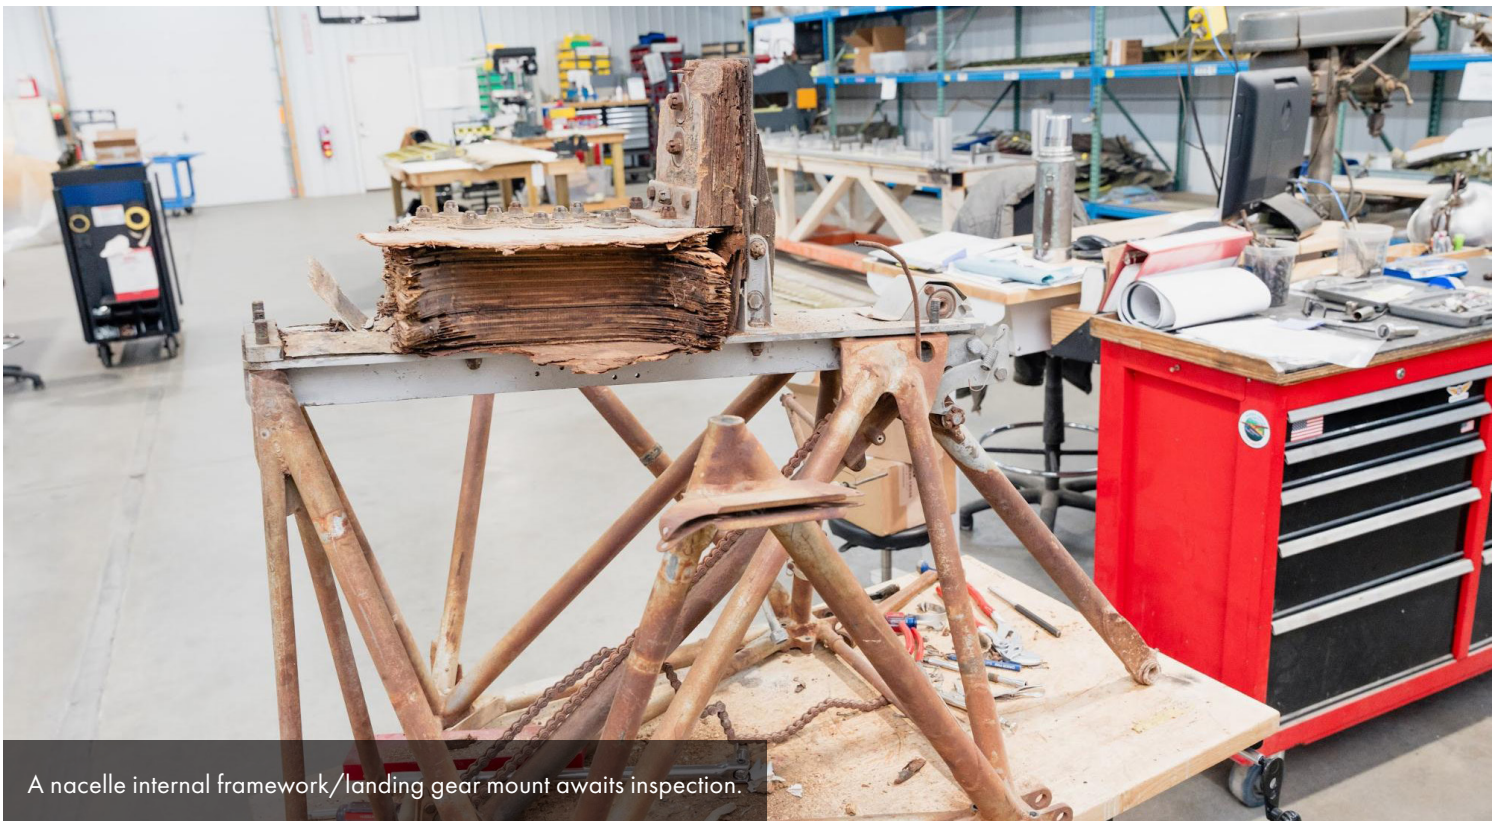
A nacelle internal framework/landing gear mount awaits inspection.

There are several landing gear mounts available to choose from, so after each is inspected, the best two will become part of the restored AT-10.

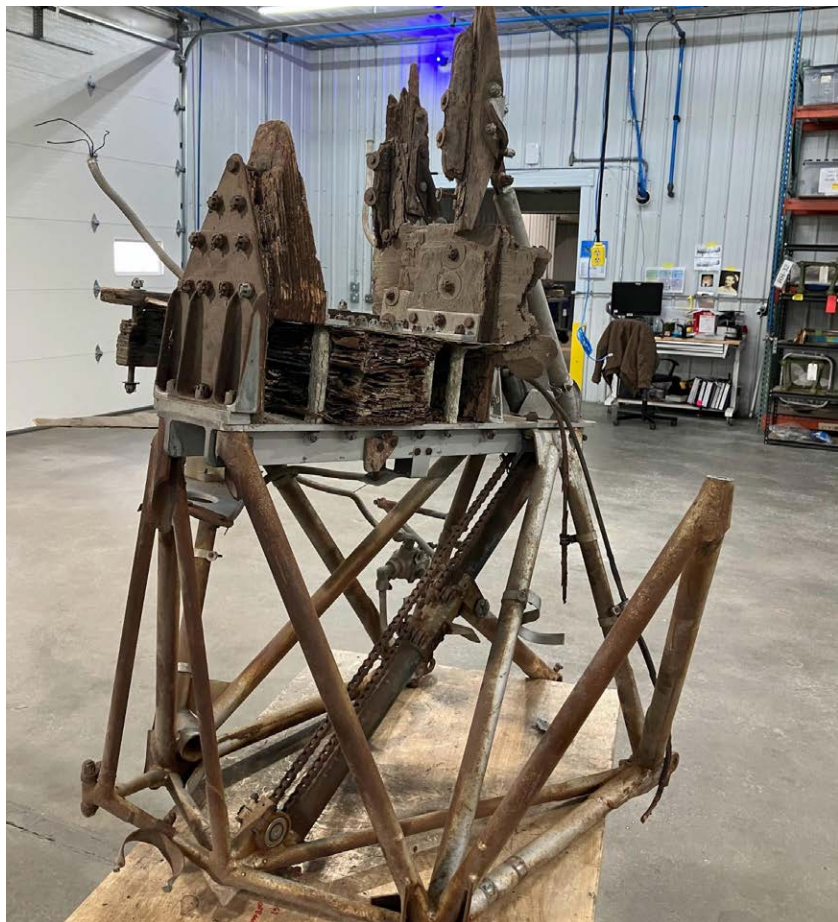
Here's another landing gear mount/ internal nacelle structure. The tubular component with a chain running above it is the retract slide tube.
