Texas Flying Legend Museum's Lope's Hope 3rd P-51C
by Chuck Cravens

AIRCORPS AVIATION

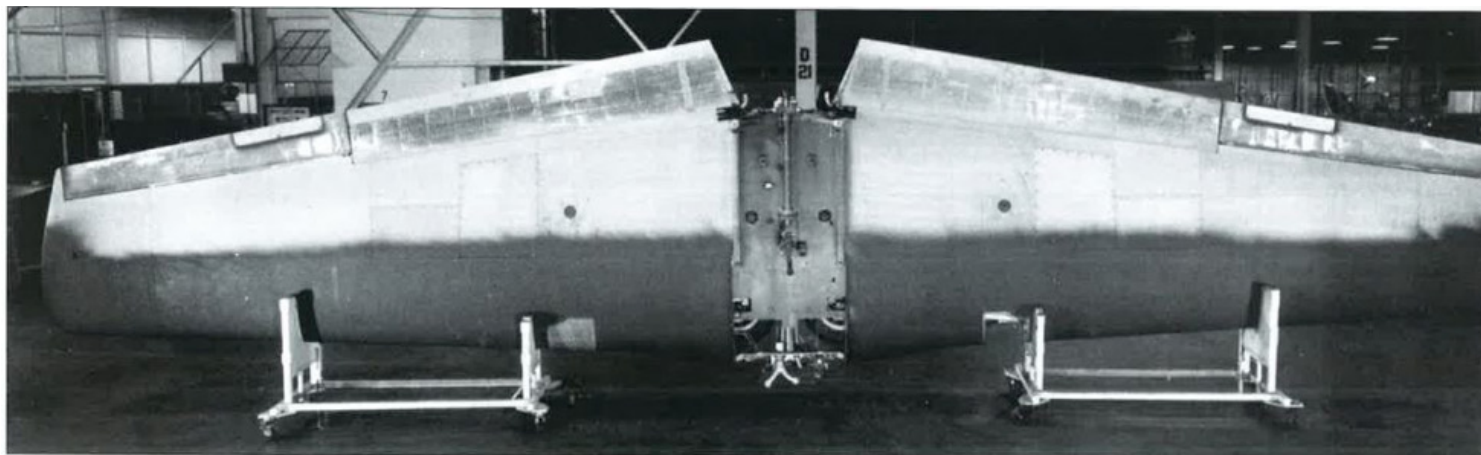
Nearly complete P-51 wing (even with stick and control tube attached) is moved to the fuselage mating area on twin dollies. The first 40 percent of the wing had been filled, sanded, and primed. Oddly, the wing has not been marked with its individual numbers.

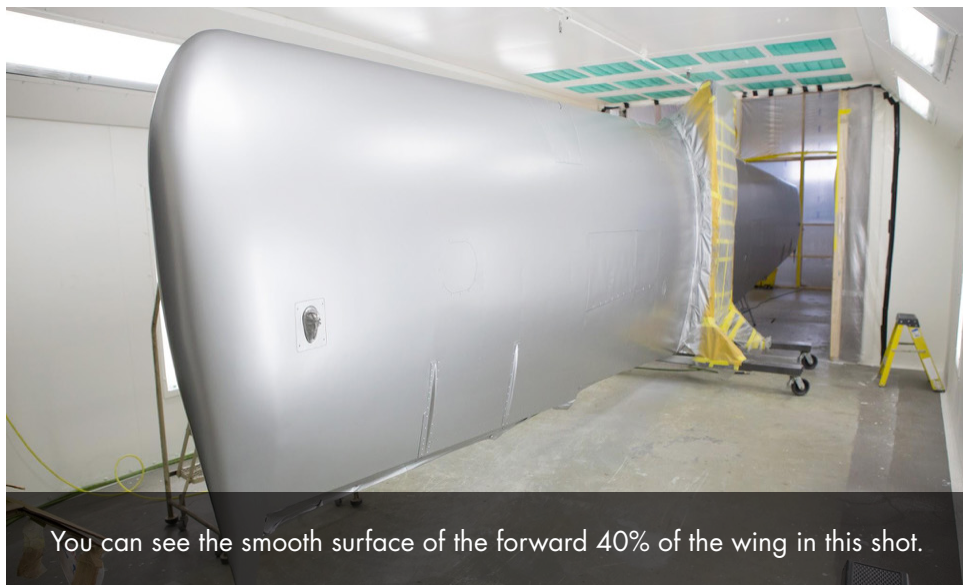
You can see the smooth surface of the forward 40% of the wing in this shot.

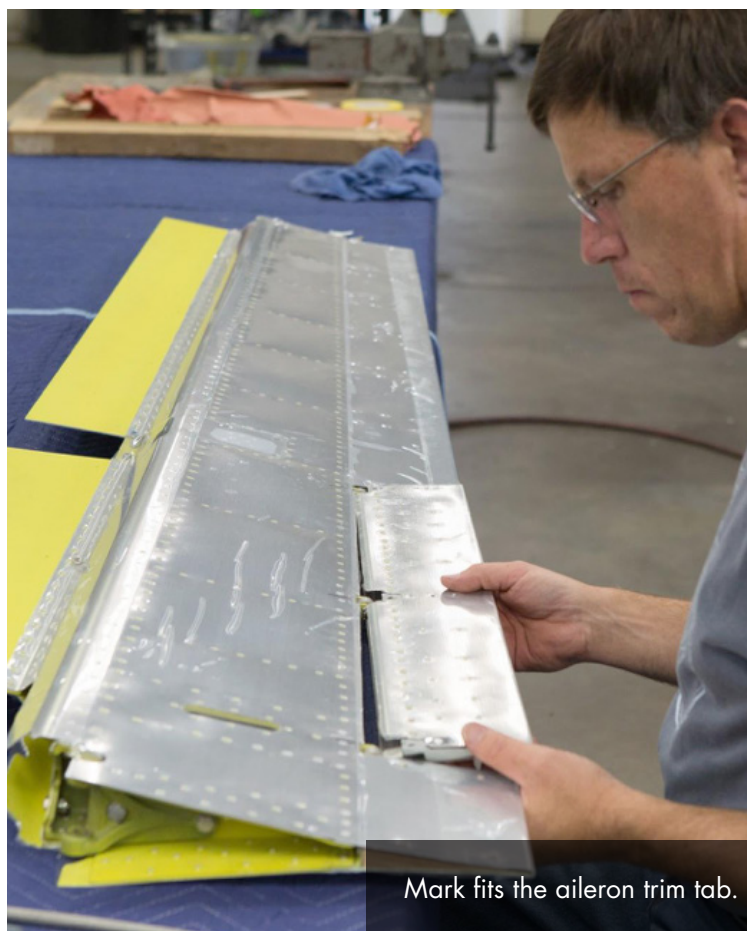
Mark fits the aileron trim tab.

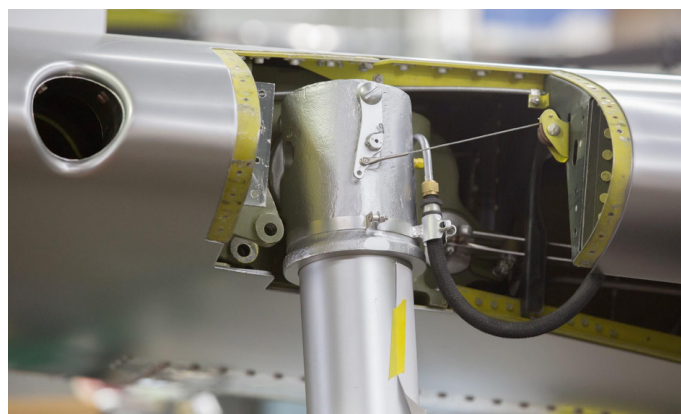
This image shows a particularly critical part on Mustangs. The pivot shaft casting is a part that is both difficult to make from scratch and a part that tends to need replacement in service. The small diameter cable attached to the gear leg is the landing gear door timing link cable. It connects the gear strut to a valve that times the sequence of the gear fairing doors throughout the retraction cycle.

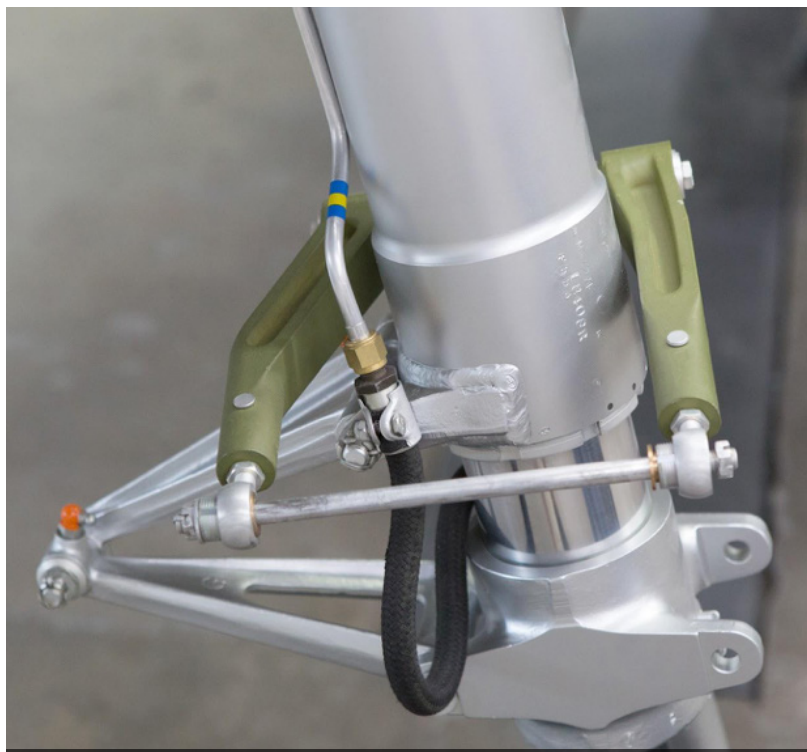
The Bendix landing gear shock strut is painted silver and the green linkage is used to connect the outer gear doors to the shock strut.

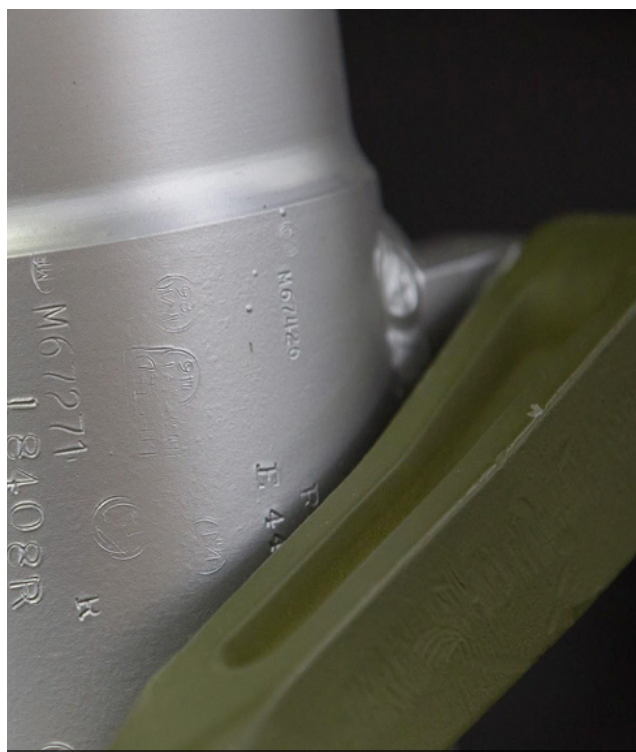
Here is a tight view of the strut and linkage.

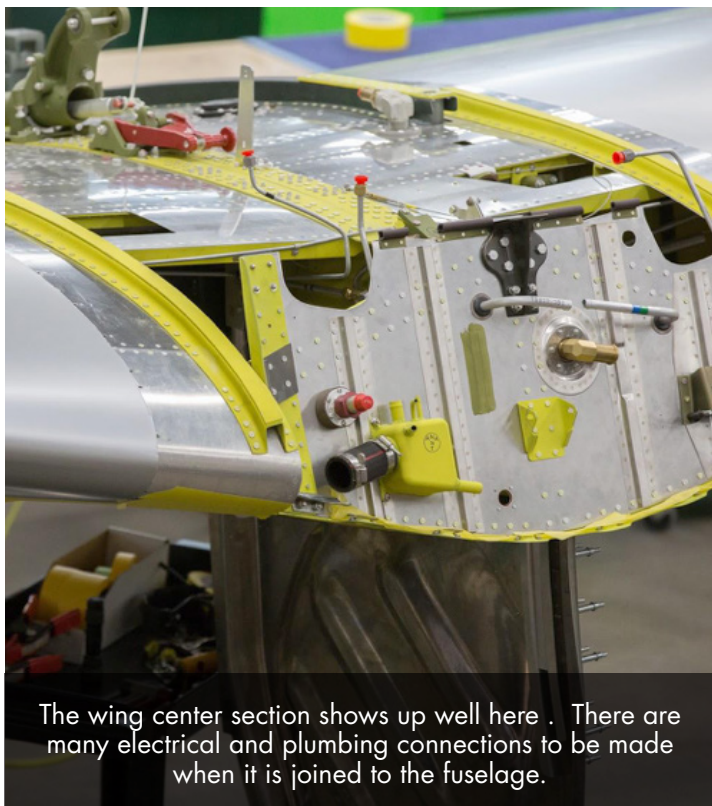
The wing center section shows up well here . There are many electrical and plumbing connections to be made when it is joined to the fuselage.

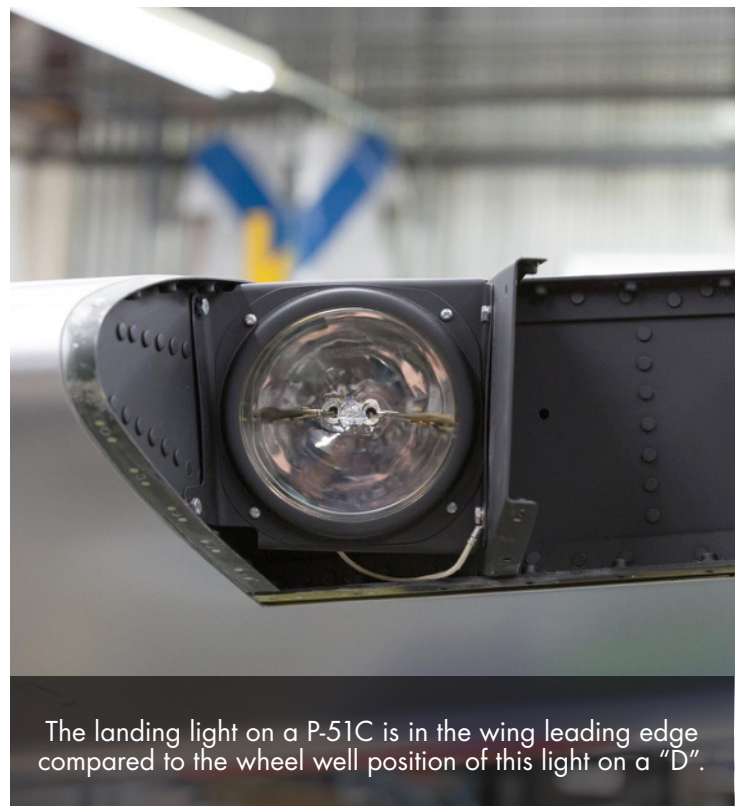
The landing light on a P-51C is in the wing leading edge compared to the wheel well position of this light on a "D".

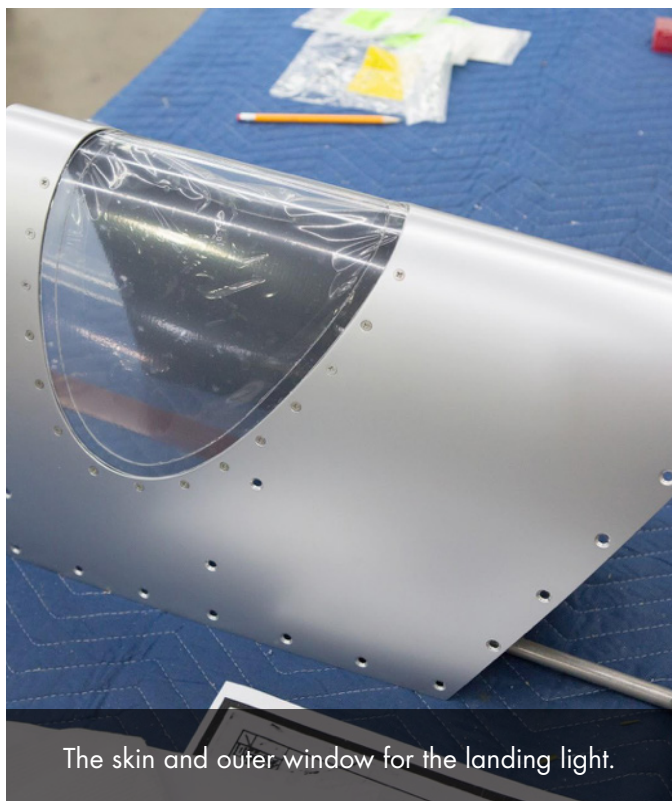
The skin and outer window for the landing light.

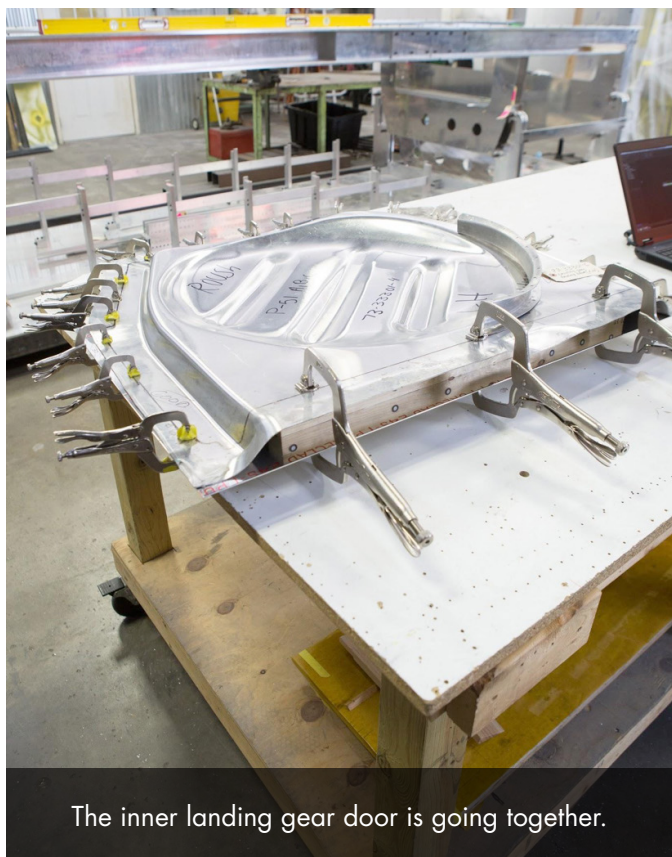
The inner landing gear door is going together.

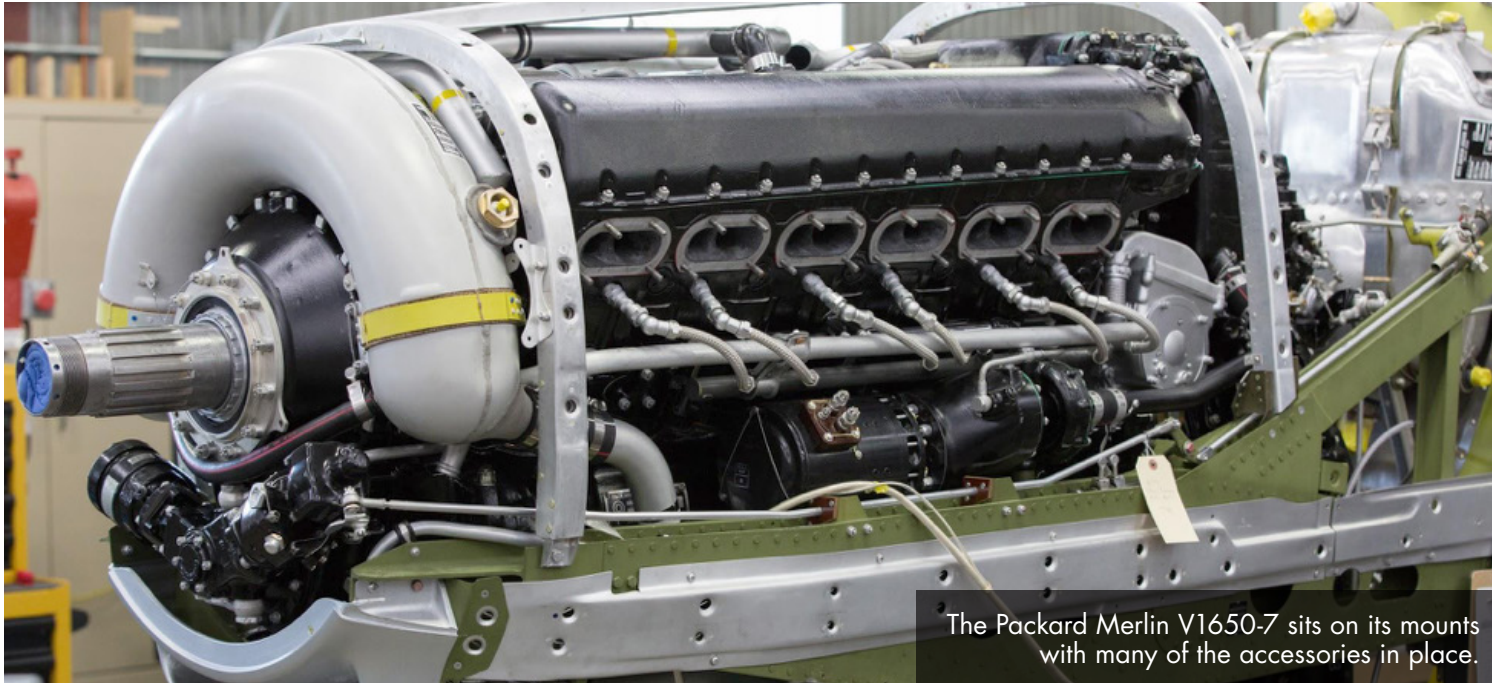
The Packard Merlin V1650-7 sits on its mounts with many of the accessories in place.

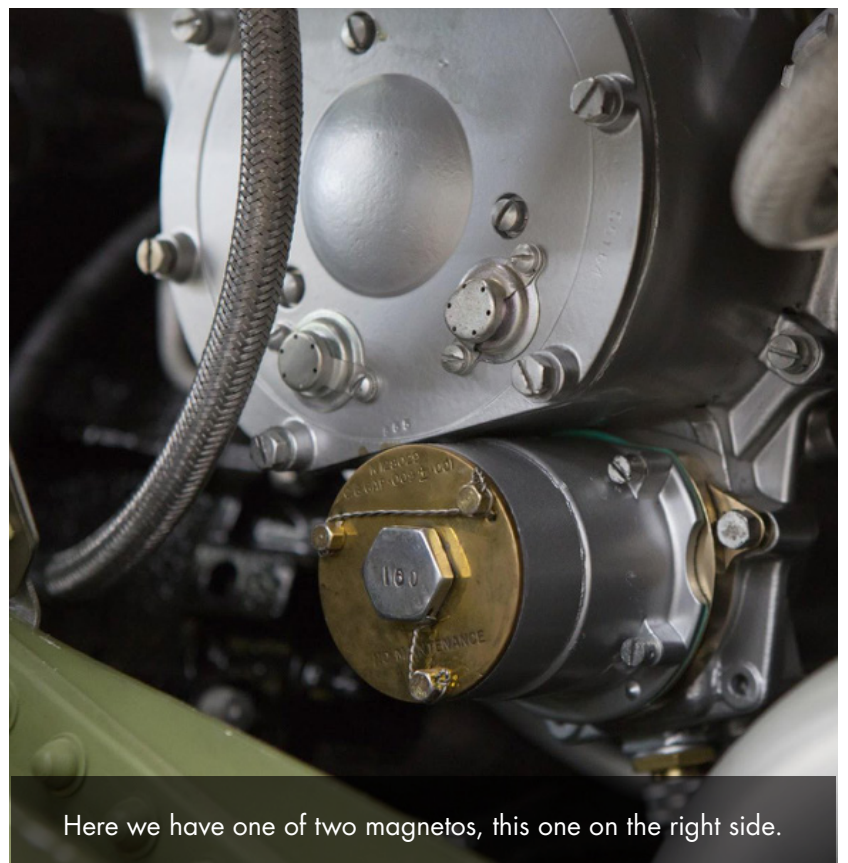
Here we have one of two magnetos, this one on the right side.

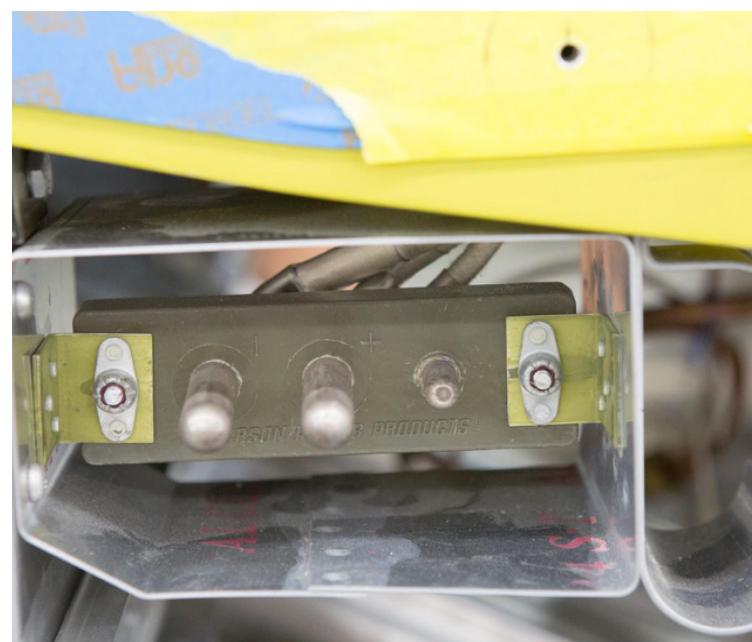
This box houses the ground power plug connector.

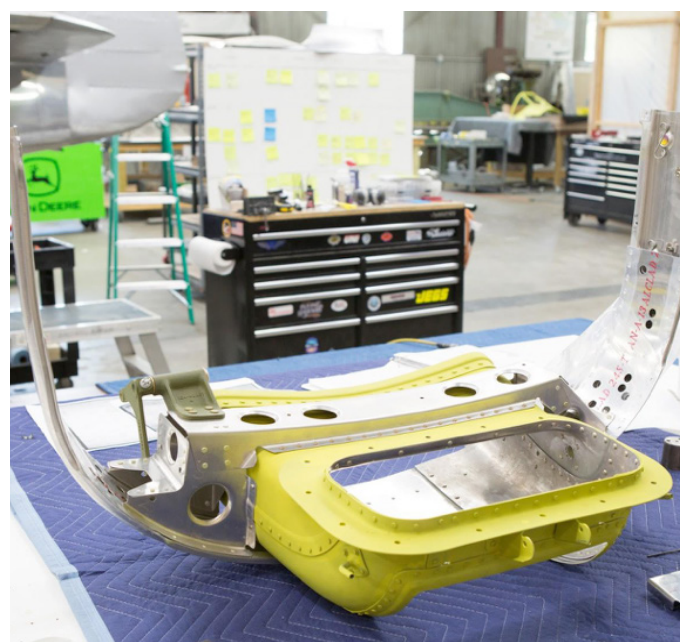
This induction elbow connects to the carburetor.

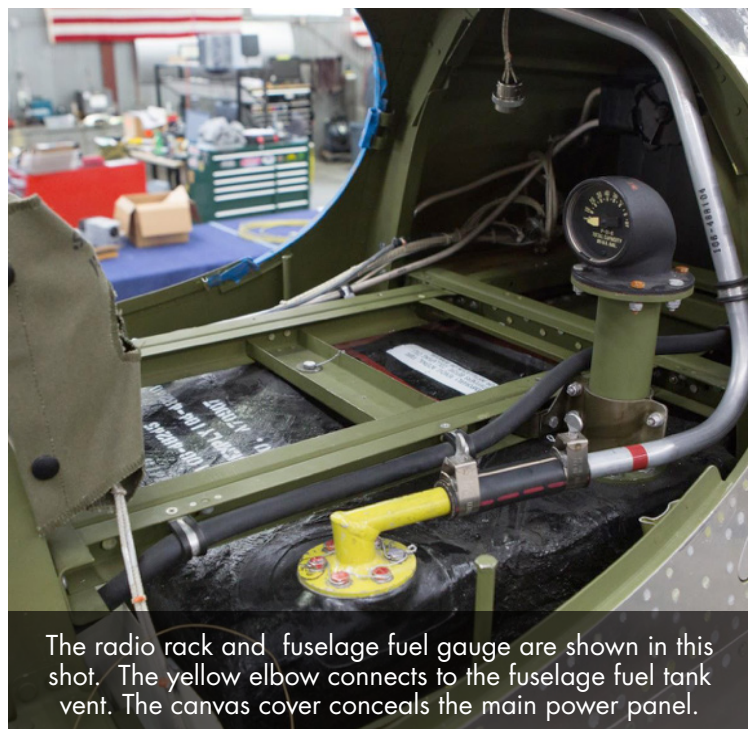
The radio rack and fuselage fuel gauge are shown in this shot. The yellow elbow connects to the fuselage fuel tank vent. The canvas cover conceals the main power panel.

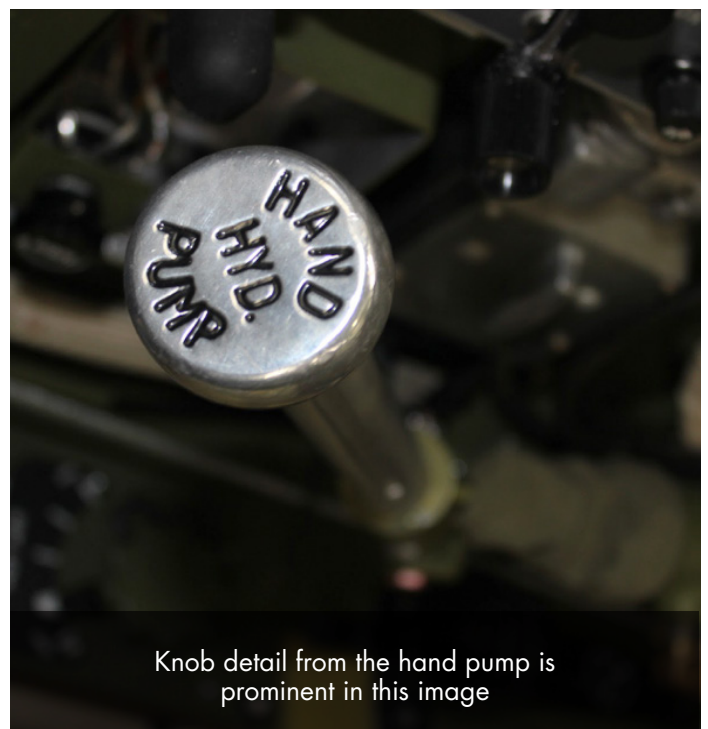
Knob detail from the hand pump is prominent in this image

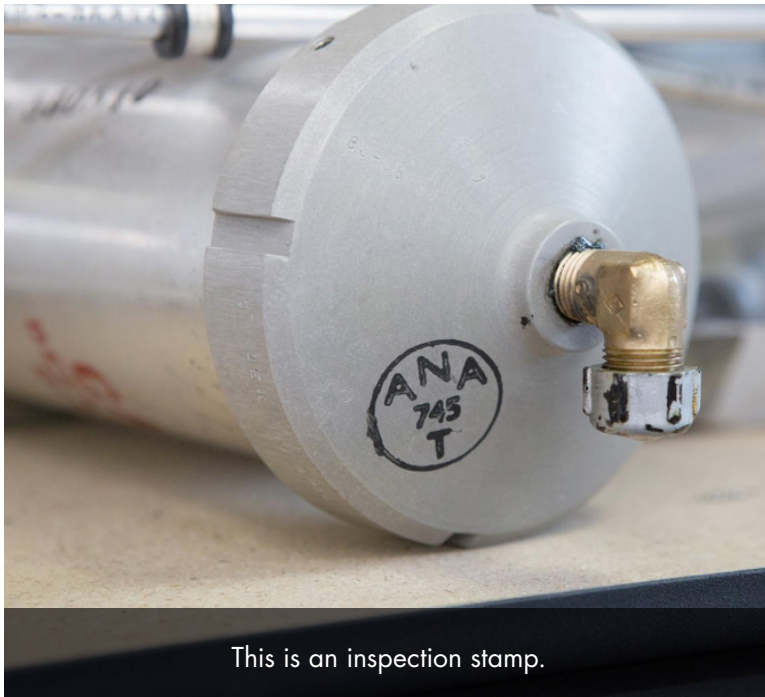
This is an inspection stamp.

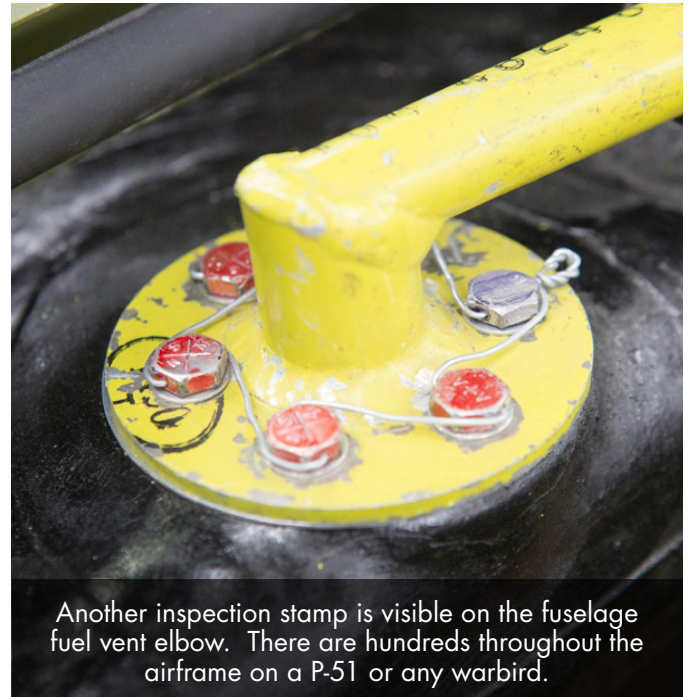
Another inspection stamp is visible on the fuselage fuel vent elbow. There are hundreds throughout the airframe on a P-51 or any warbird.

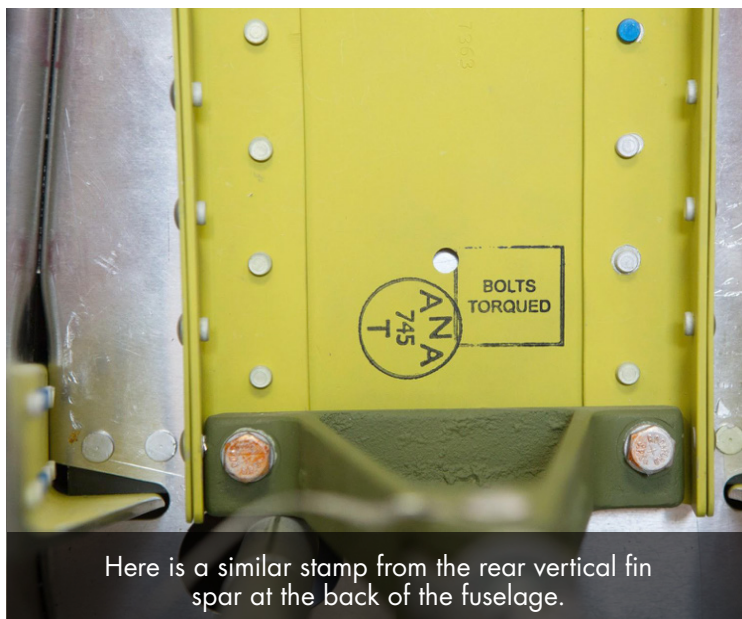
Here is a similar stamp from the rear vertical fin spar at the back of the fuselage.

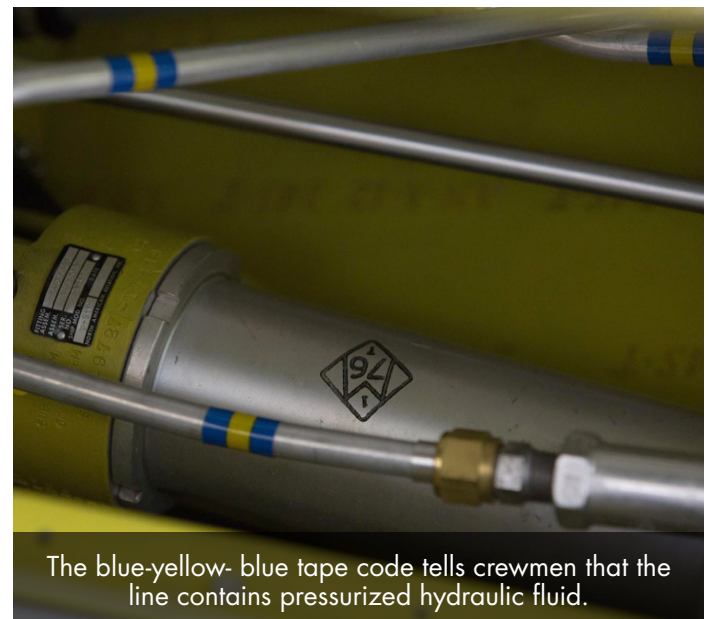
The blue-yellow-blue tape code tells crewmen that the line contains pressurized hydraulic fluid.

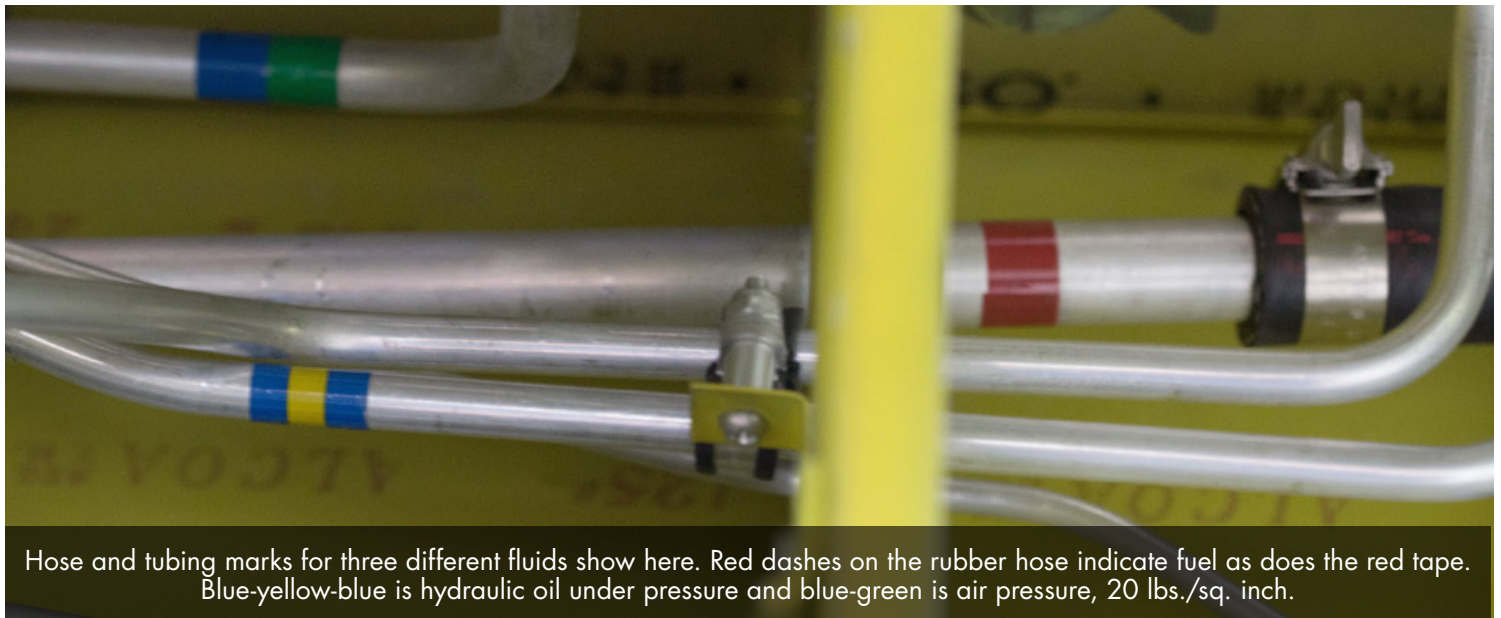
Hose and tubing marks for three different fluids show here. Red dashes on the rubber hose indicate fuel as does the red tape. Blue-yellow-blue is hydraulic oil under pressure and blue-green is air pressure, 20 lbs./sq. inch.

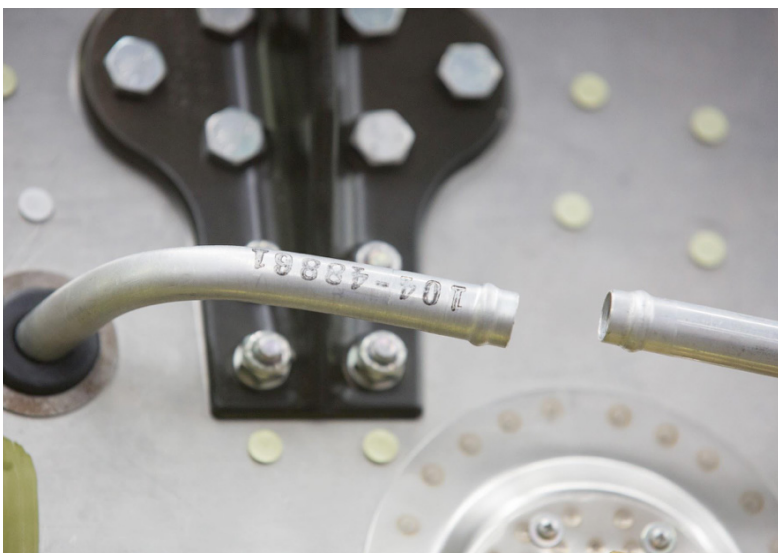
A rubber stamp was used to mark the part number on this tubing, identifying it as "line assembly-combat- fuel pressure system right". 104 is a part number prefix identifying a part first used on a "B" model. 103 would be "C" model, but because B and C model Mustangs for the most part differed only in which location they were built, many parts were used on both.

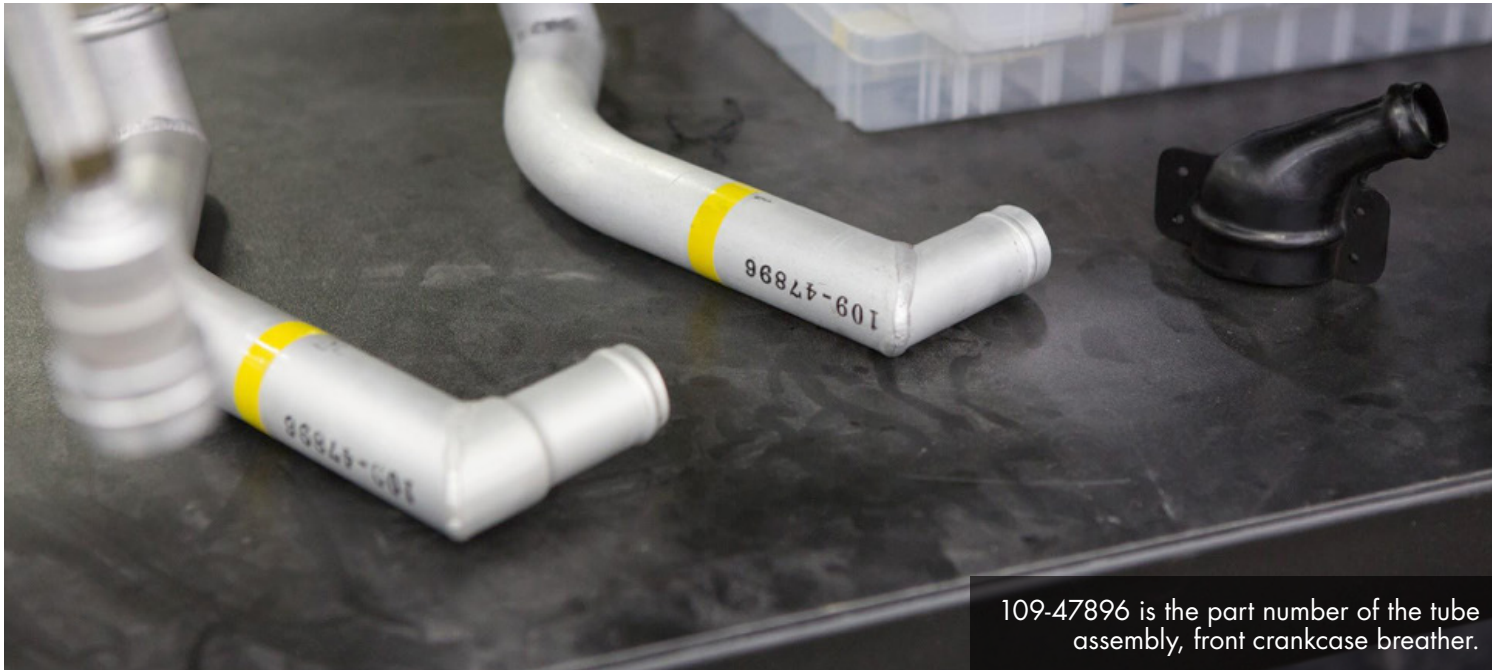
109-47896 is the part number of the tube assembly, front crankcase breather.

Normally we see a 109 prefix on a part number for an early D model. There was Tech Order TO 01-60JD-37 for C models produced before 43-24902 mandating a change in oil breather systems. 43-24902 and subsequent serial numbers (like our restoration airframe 43-24907, 5 airplanes later) got the new version on the assembly line. That explains the part number puzzle. Late Cs and early D models were often on the factory floor at the same time in 1944. It also explains why our restoration doesn't have an oil breather hole on the right side as the original Lope's Hope 3rd had. The TO changed from two outlets to one.

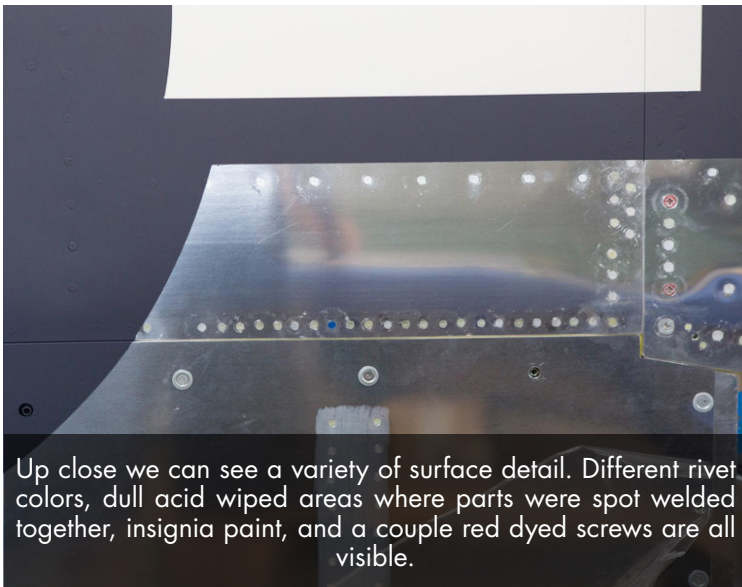
Up close we can see a variety of surface detail. Different rivet colors, dull acid wiped areas where parts were spot welded together, insignia paint, and a couple red dyed screws are all visible.

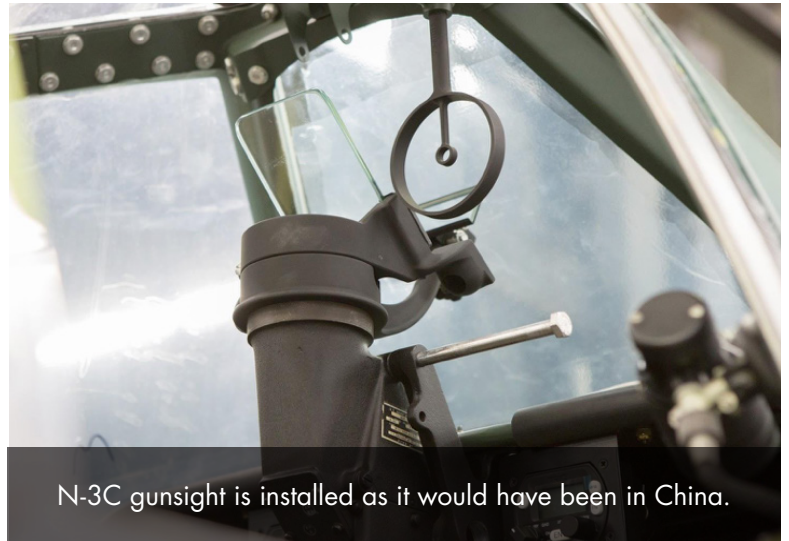
N-3C gunsight is installed as it would have been in China.

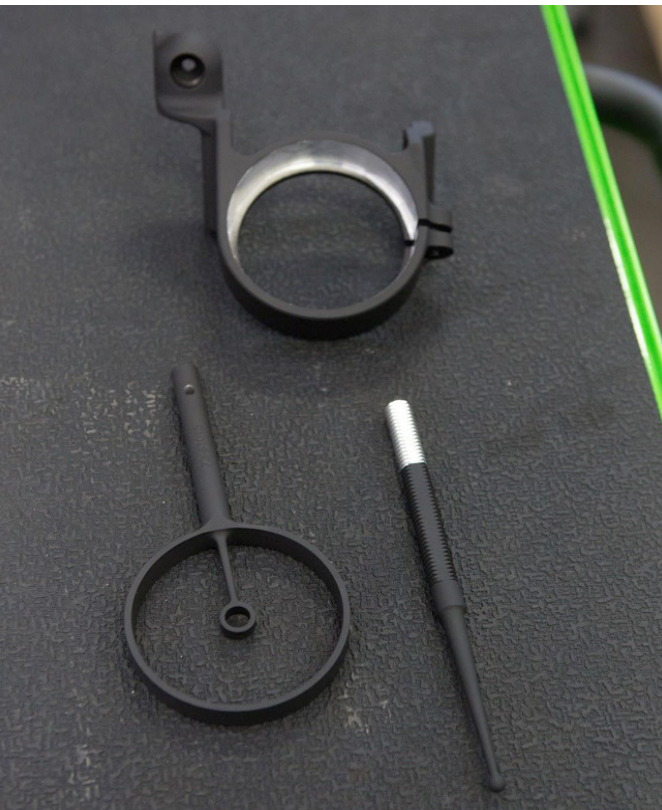
Auxiliary gun sights; the bead sight is mounted to the firewall and sticks up from the top cowl. If the bulb burned out in the optical sight, or other damage occurred, the pilot still had a way to aim his four 50 caliber guns.

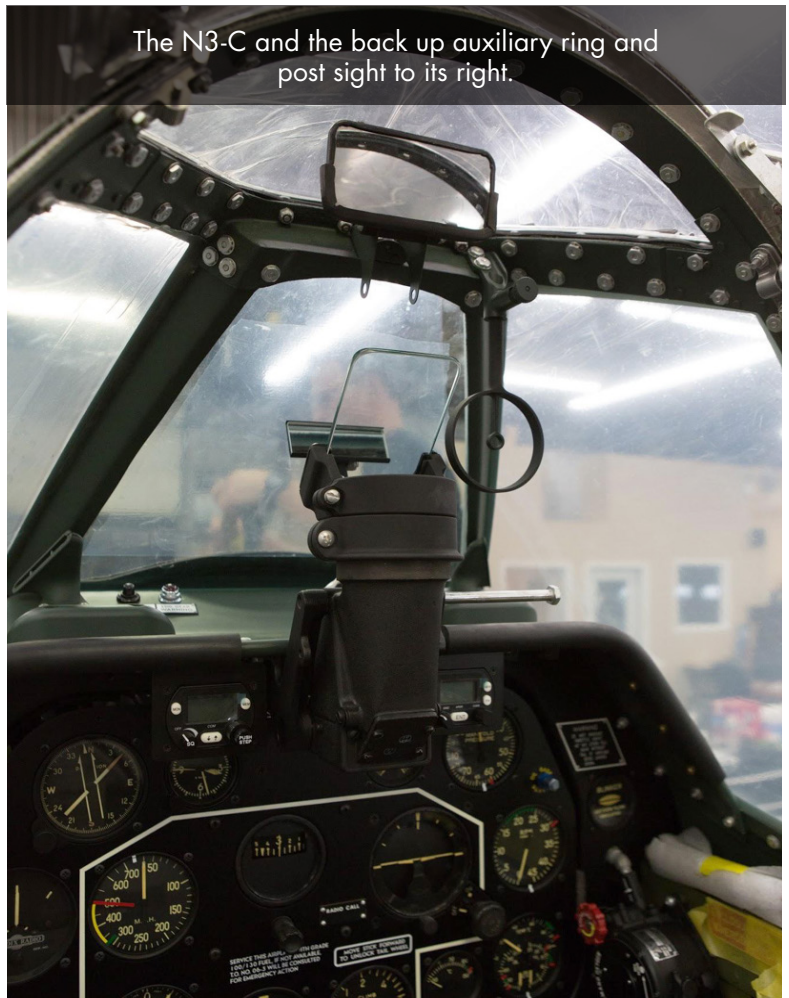
The N3-C and the back up auxiliary ring and post sight to its right.

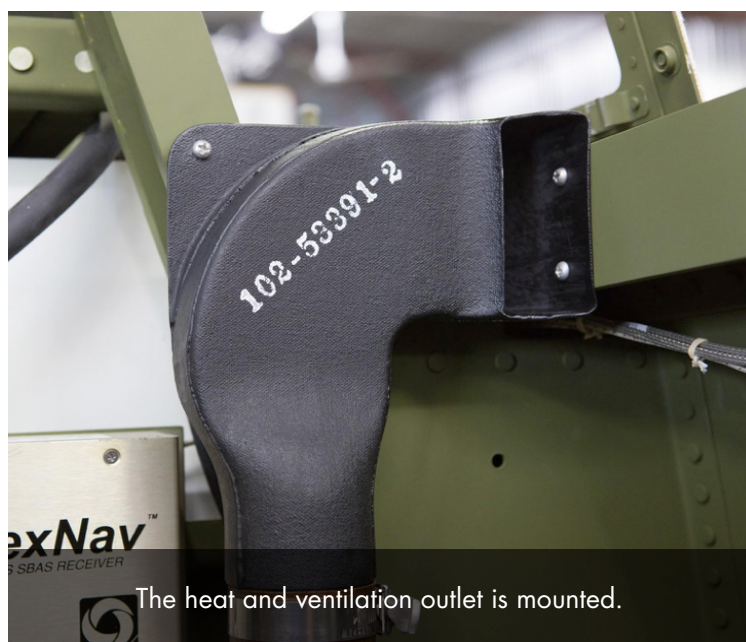
The heat and ventilation outlet is mounted.

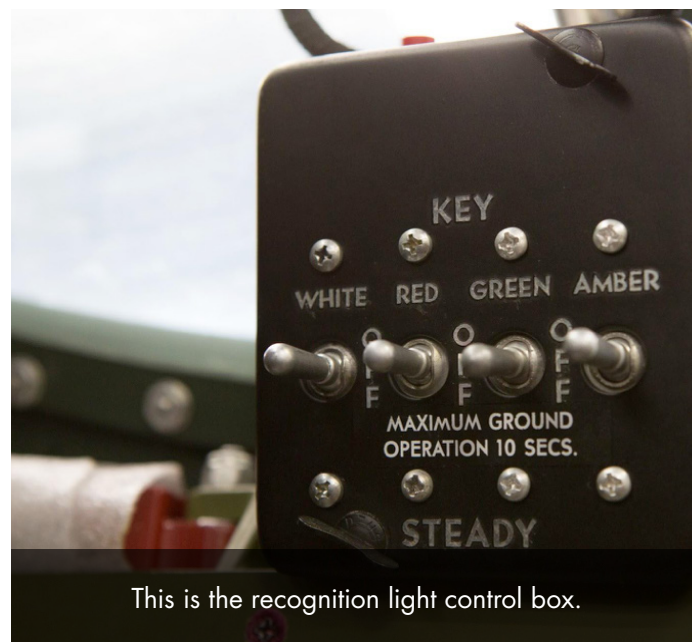
This is the recognition light control box.

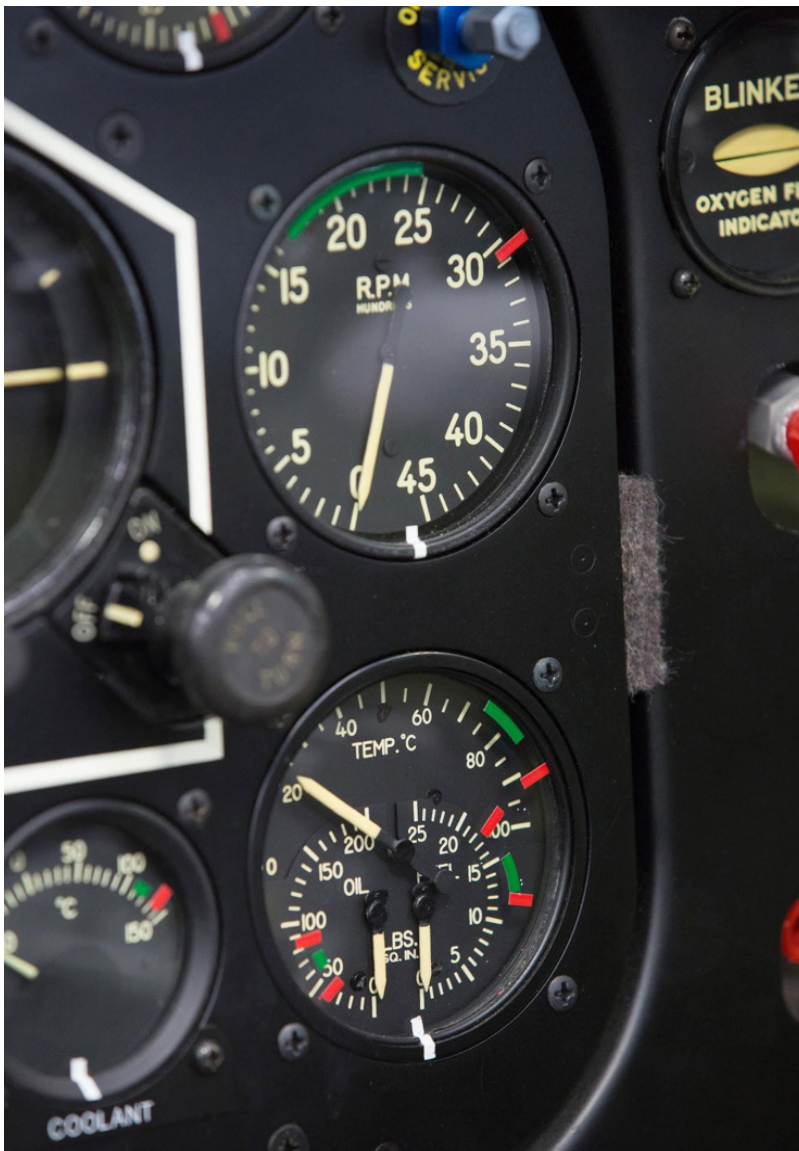
The upper gauge is the tachometer with the rpm redline and green normal operating range. The lower gauge is a three in one affair with oil temperature across the top and oil pressure on the bottom left, fuel pressure bottom right.

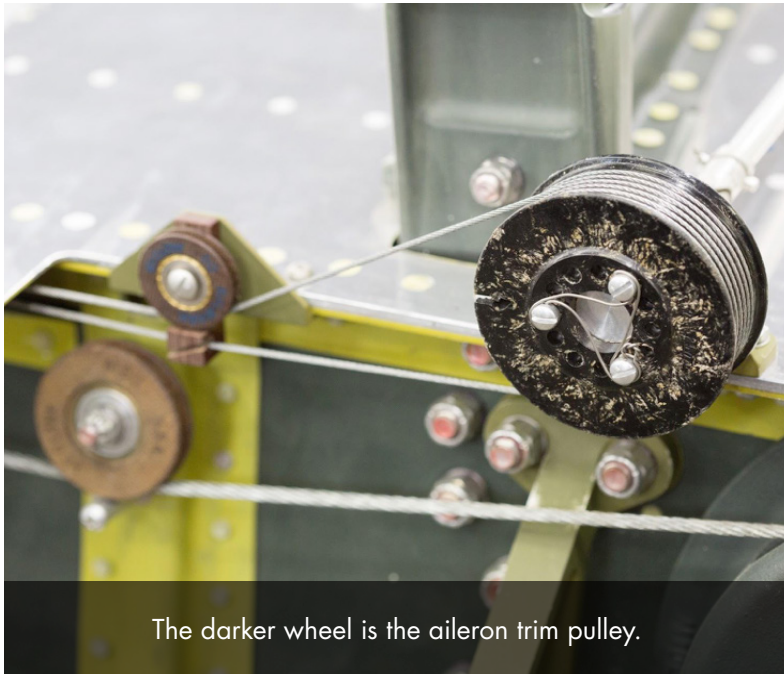
The darker wheel is the aileron trim pulley.

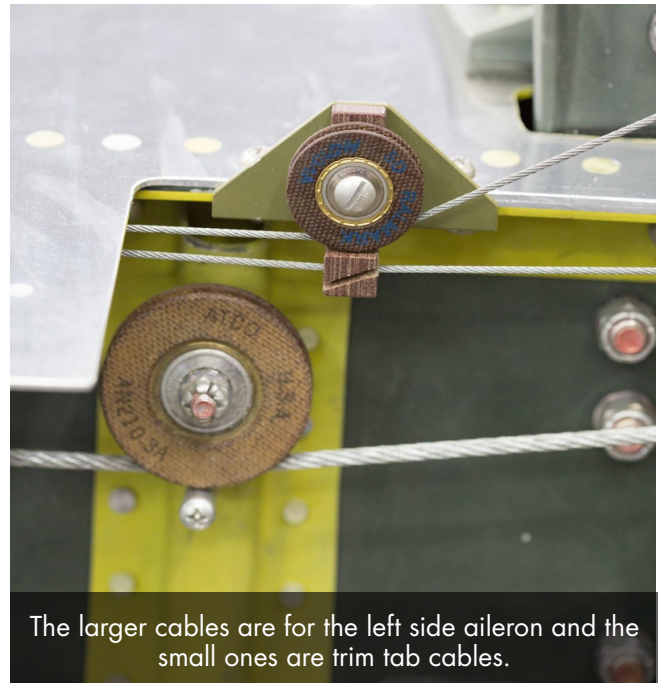
The larger cables are for the left side aileron and the small ones are trim tab cables.

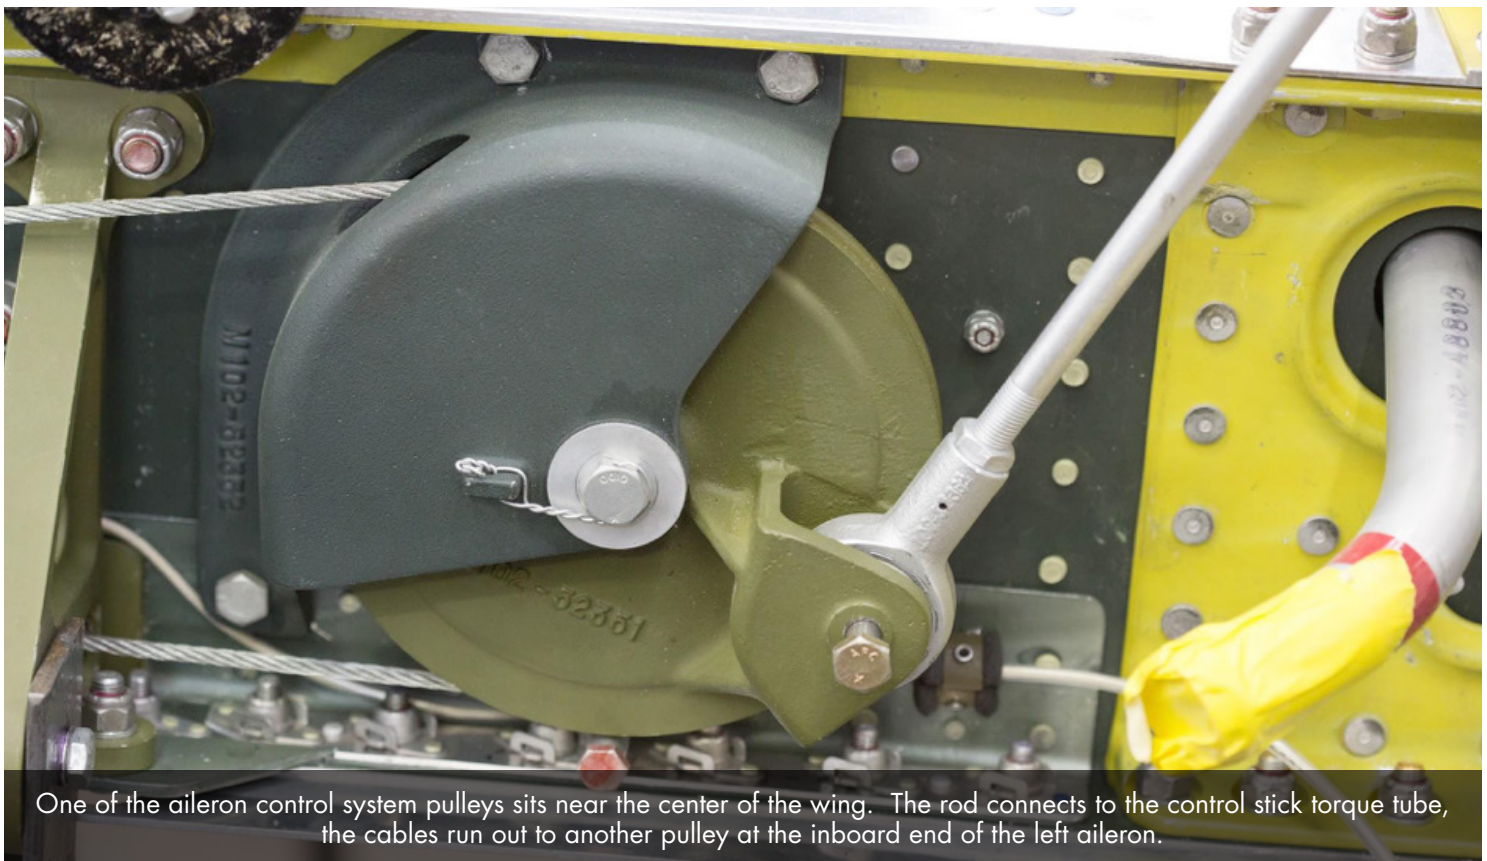
One of the aileron control system pulleys sits near the center of the wing. The rod connects to the control stick torque tube, the cables run out to another pulley at the inboard end of the left aileron.
