Dakota Territory Air Museum's P-47 Update

by Chuck Cravens

## Update

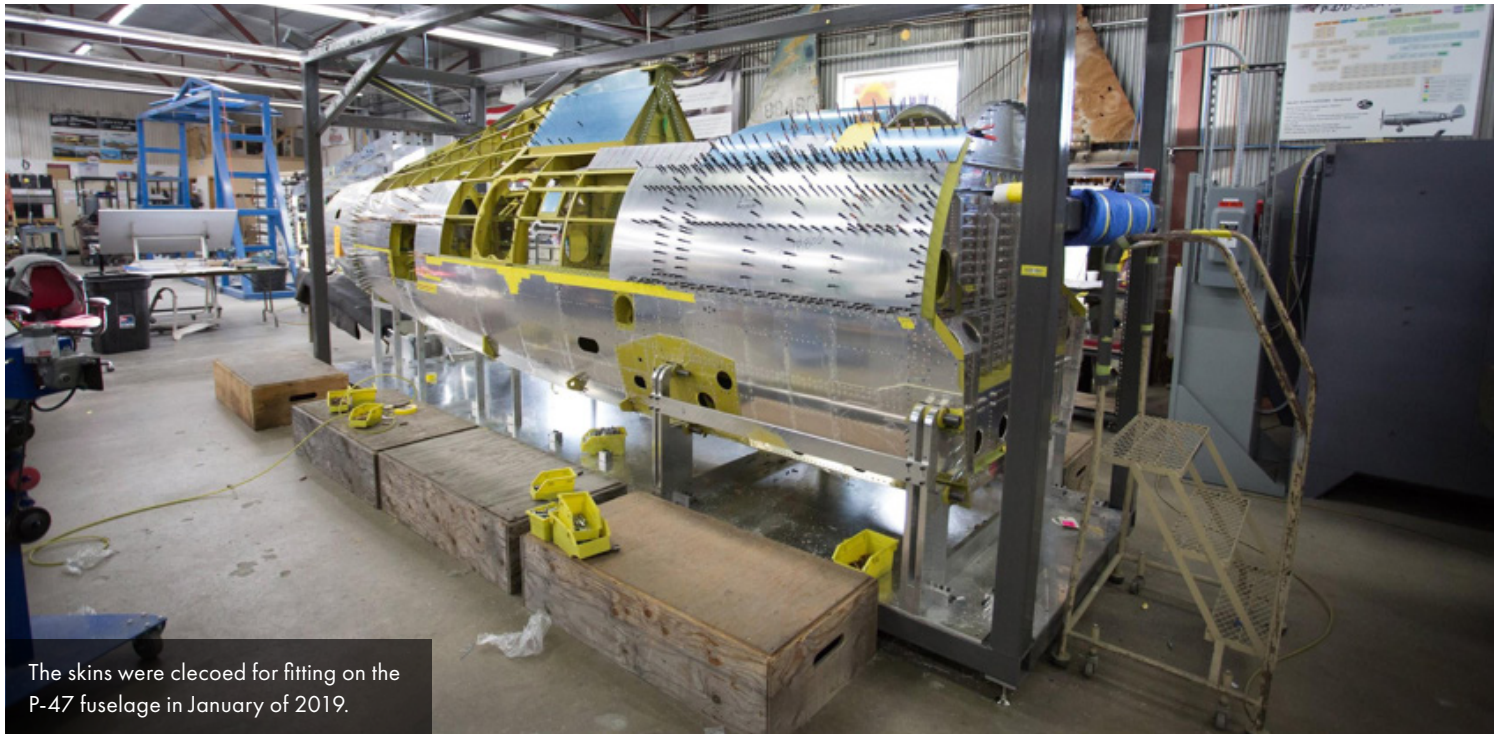
The skins were clecoed for fitting on the P-47 fuselage in January of 2019.

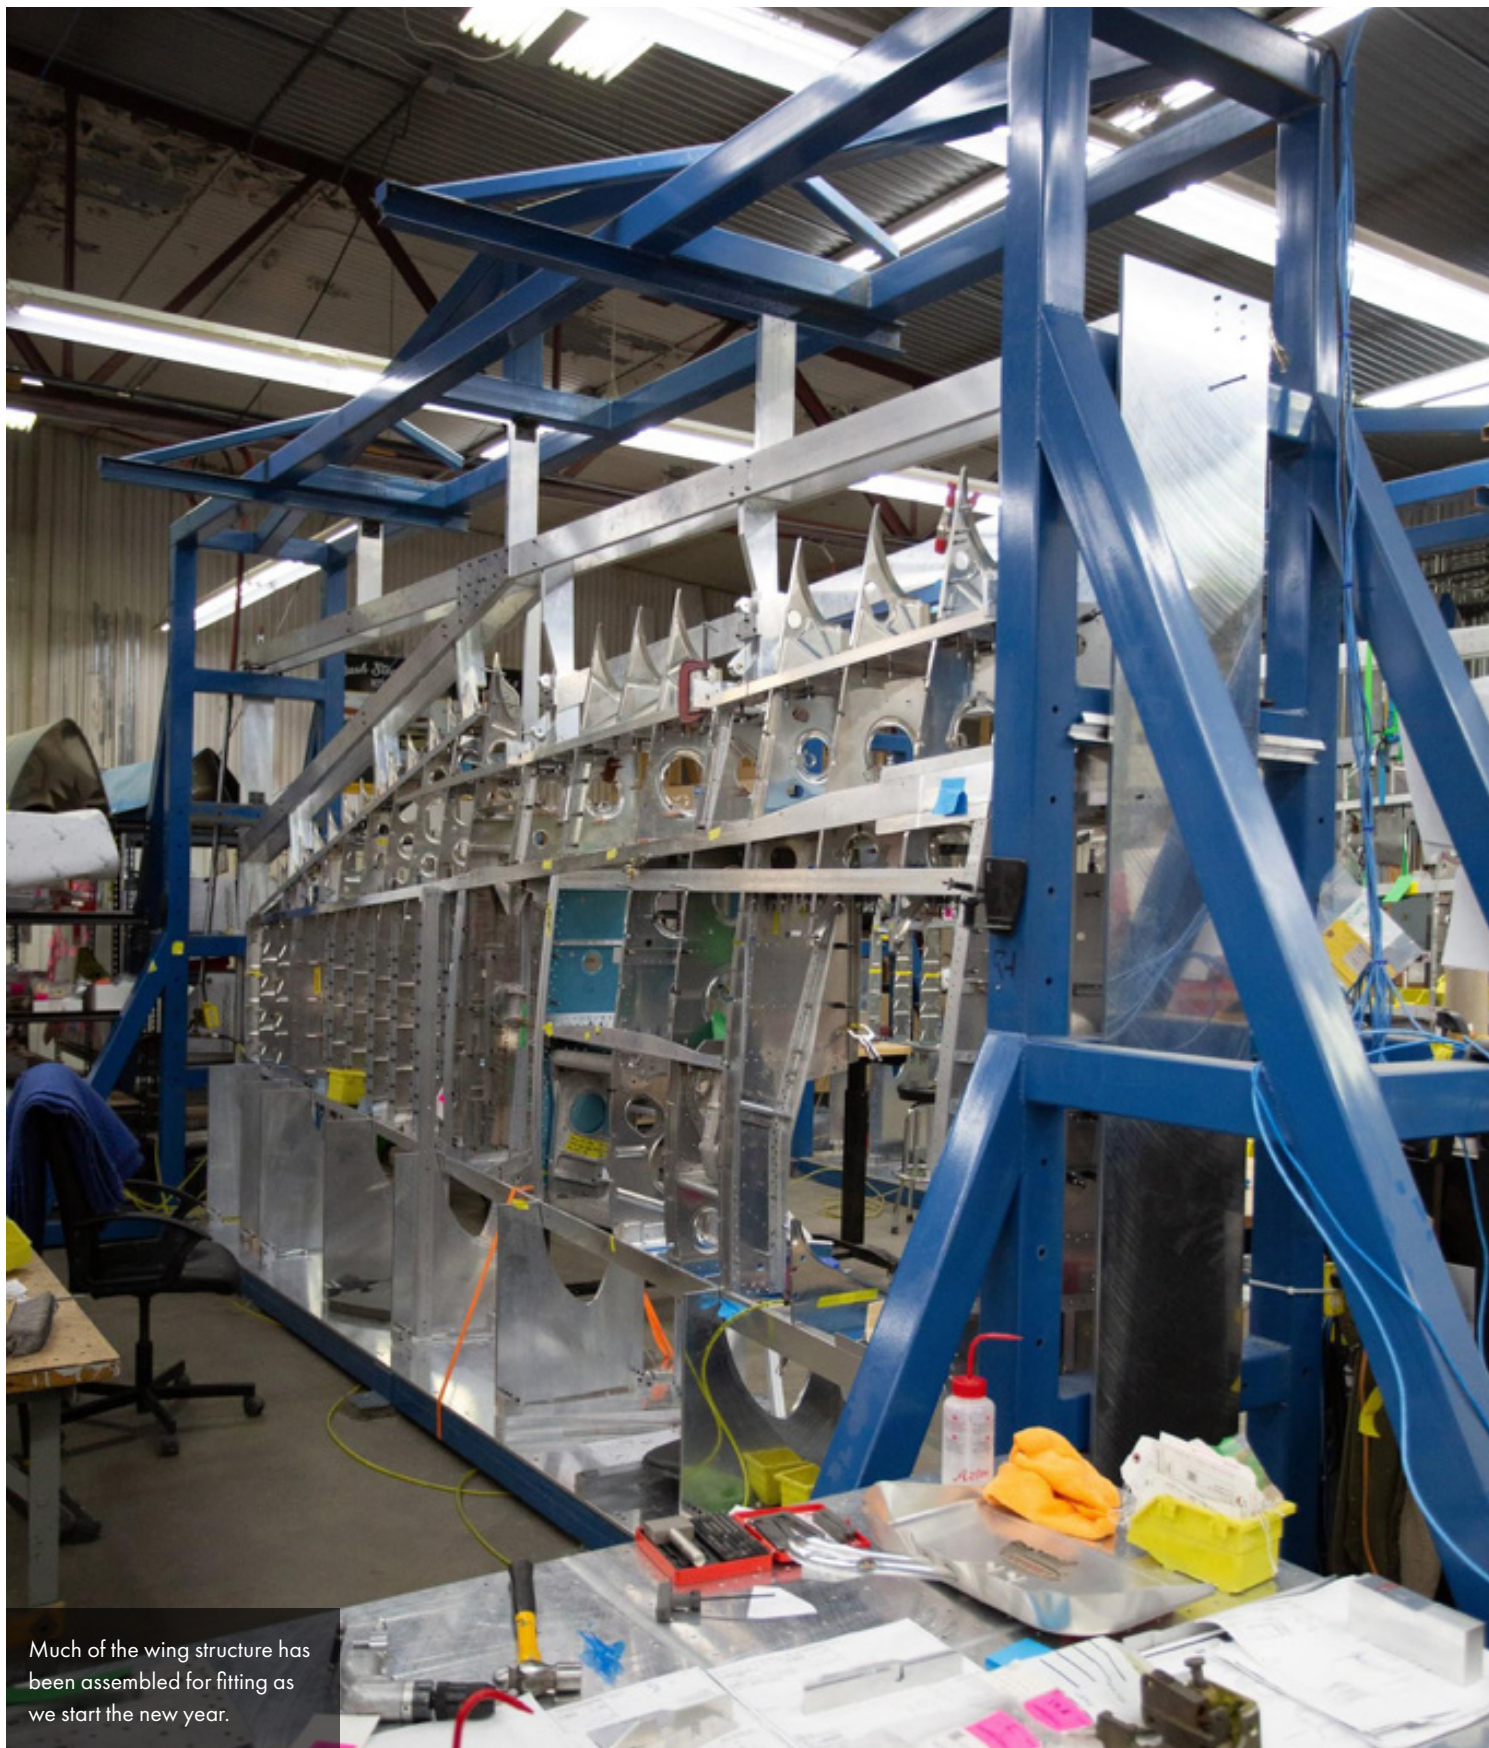
Much of the wing structure has been assembled for fitting as we start the new year.

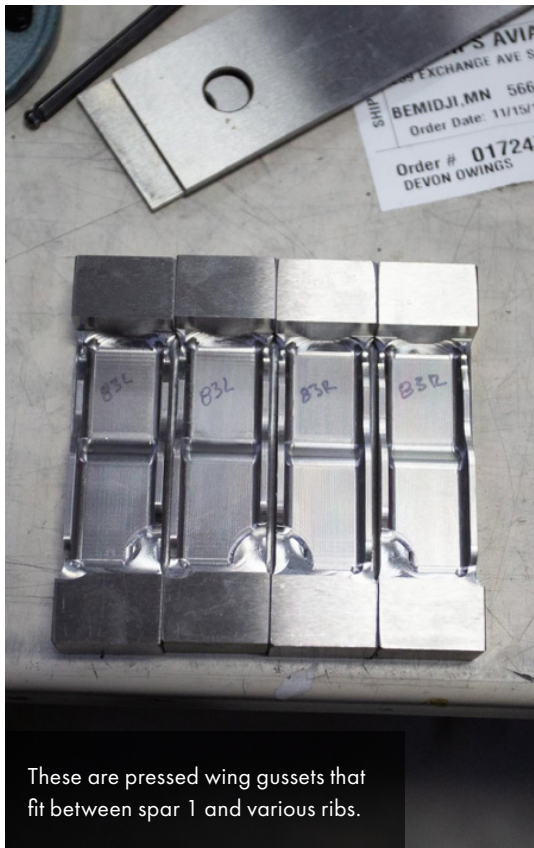
These are pressed wing gussets that fit between spar 1 and various ribs.

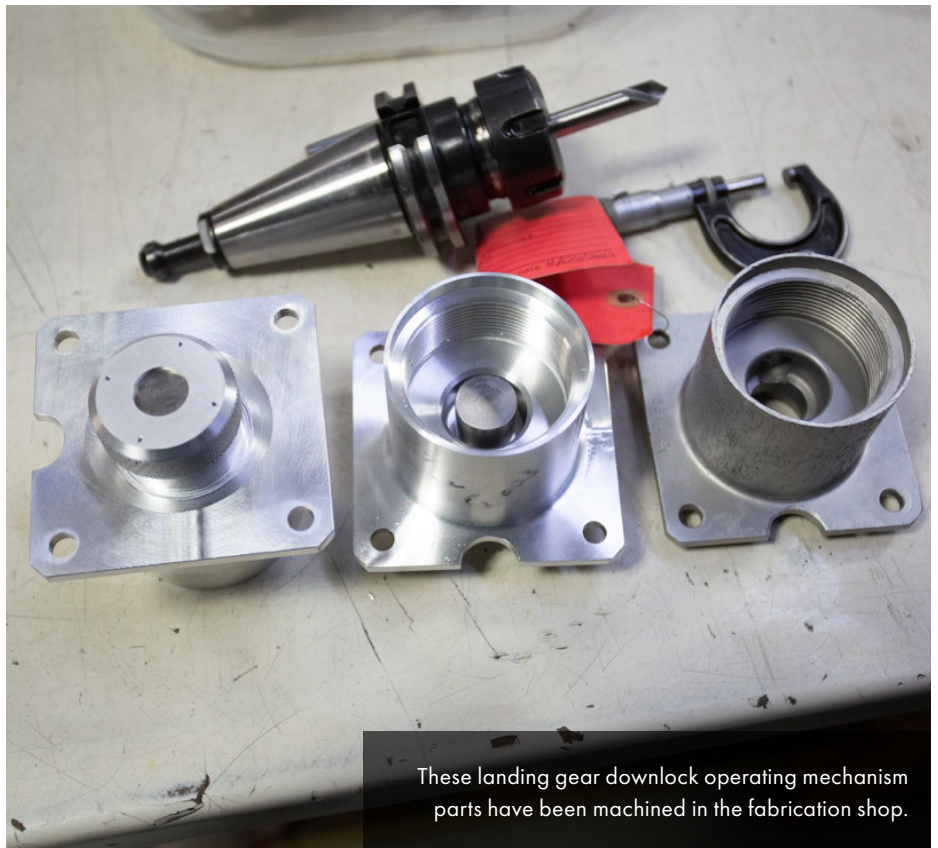
These landing gear downlock operating mechanism parts have been machined in the fabrication shop.

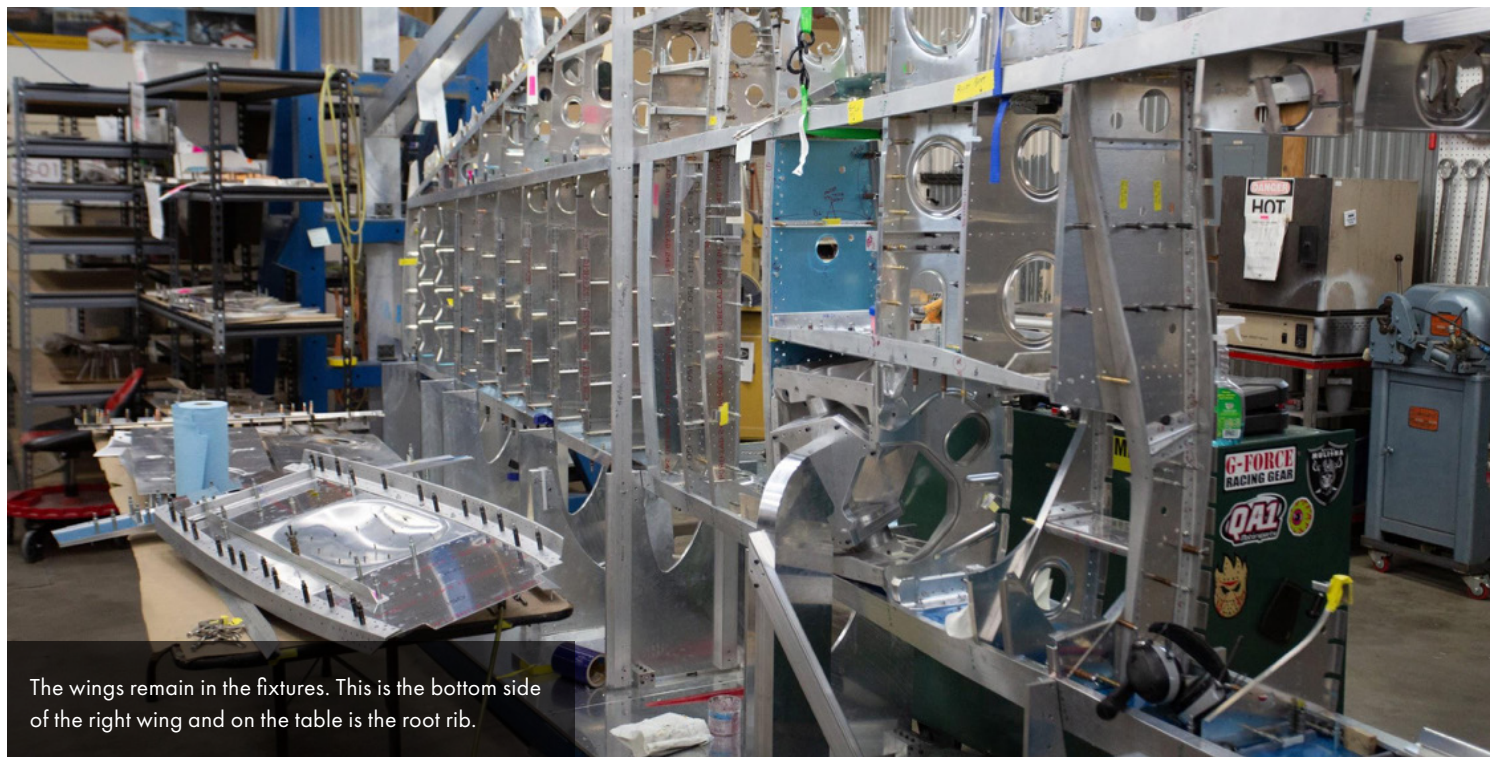
The wings remain in the fixtures. This is the bottom side of the right wing and on the table is the root rib.

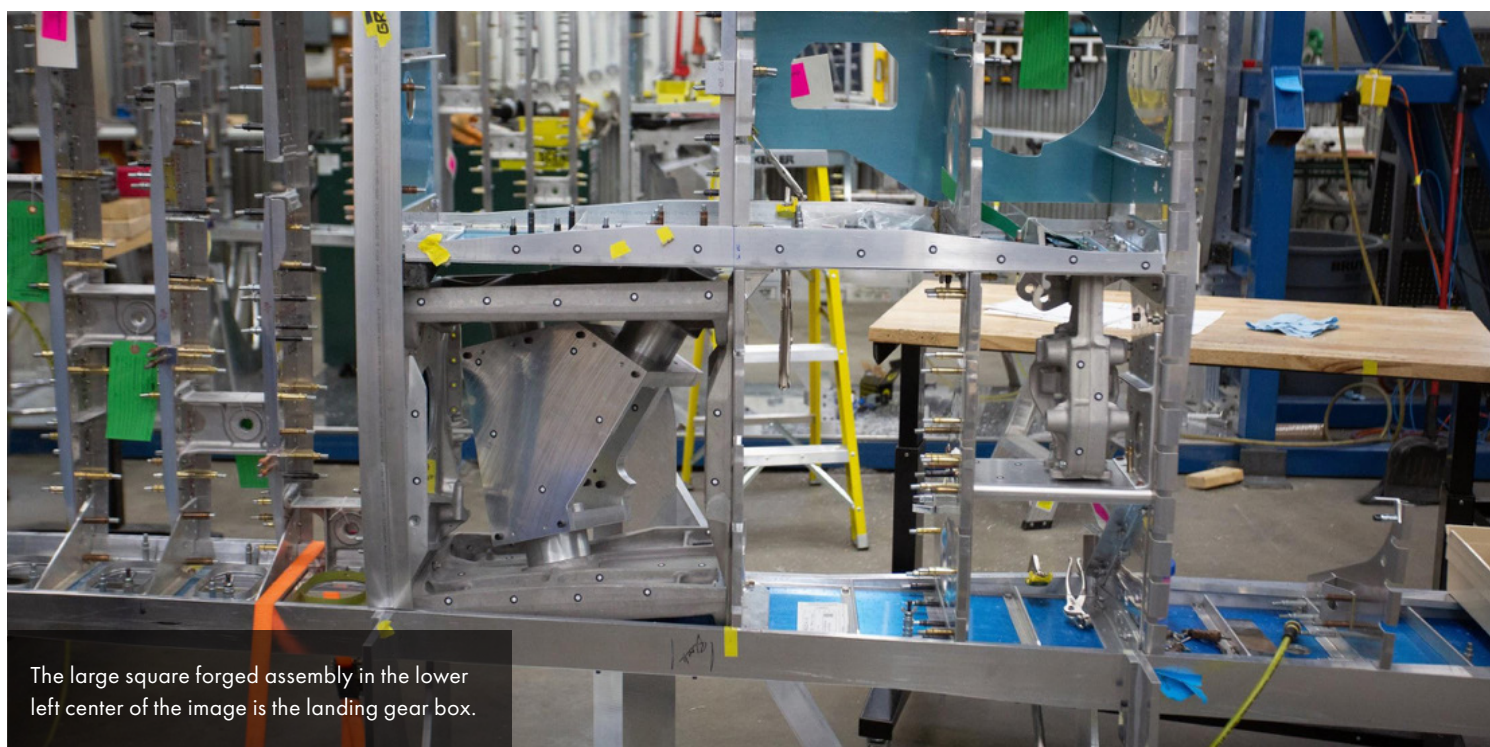
The large square forged assembly in the lower left center of the image is the landing gear box.

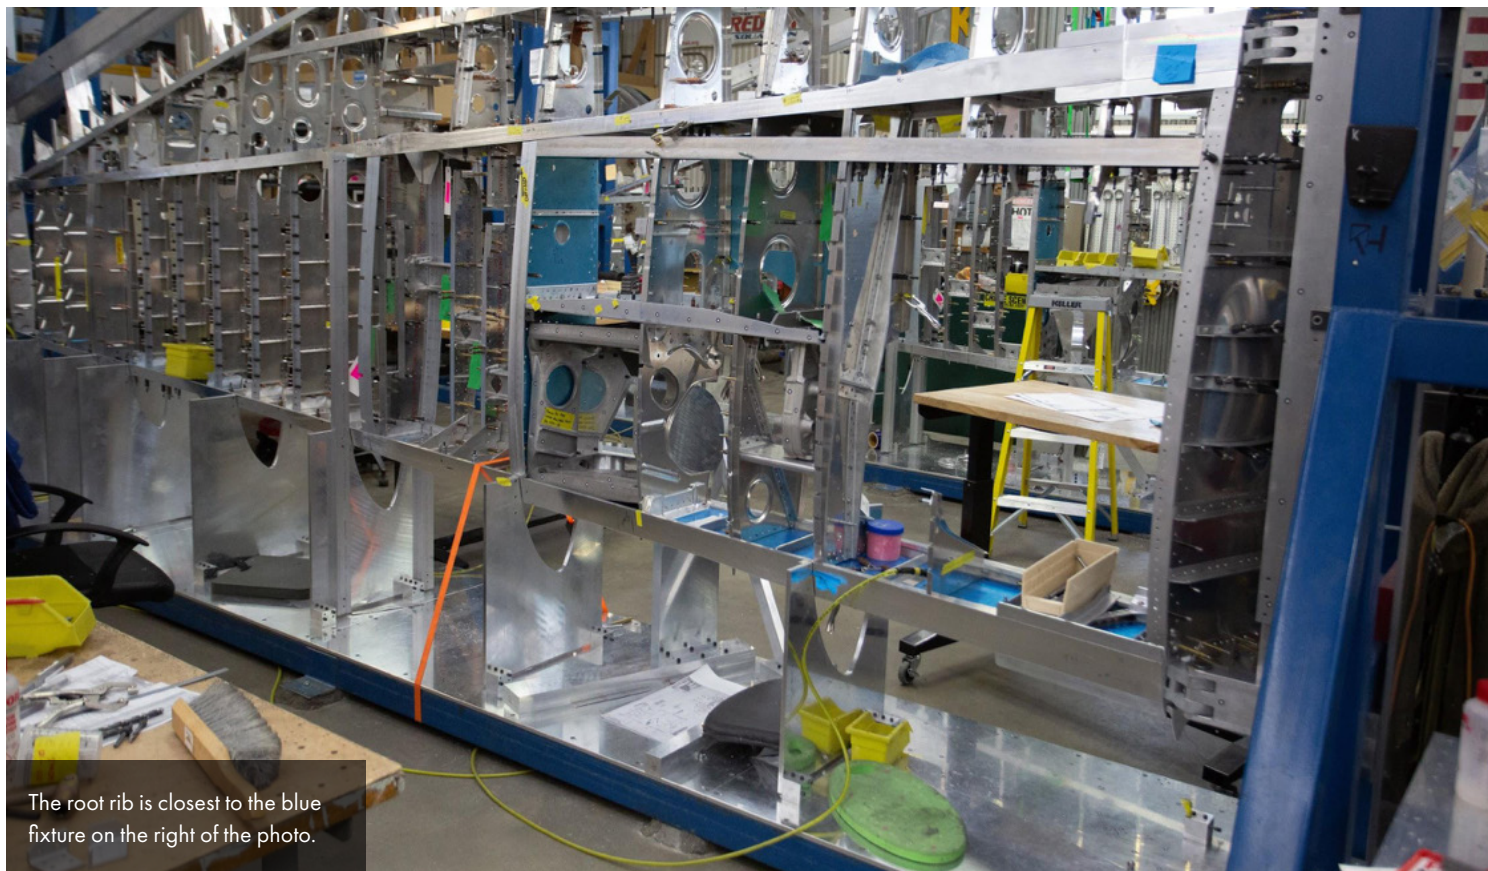
The root rib is closest to the blue fixture on the right of the photo.

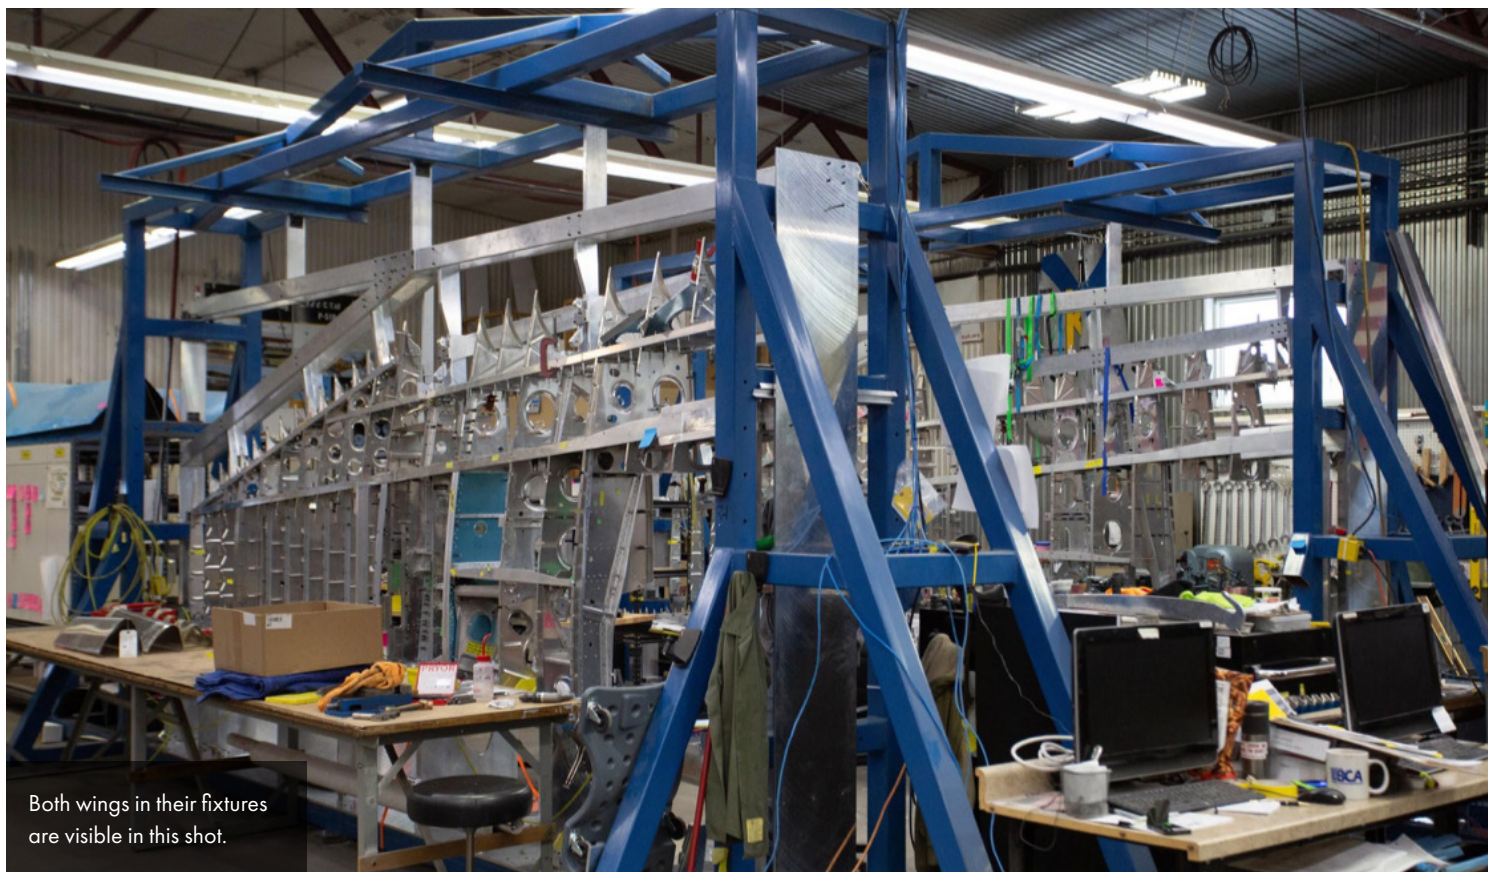
Both wings in their fixtures are visible in this shot.

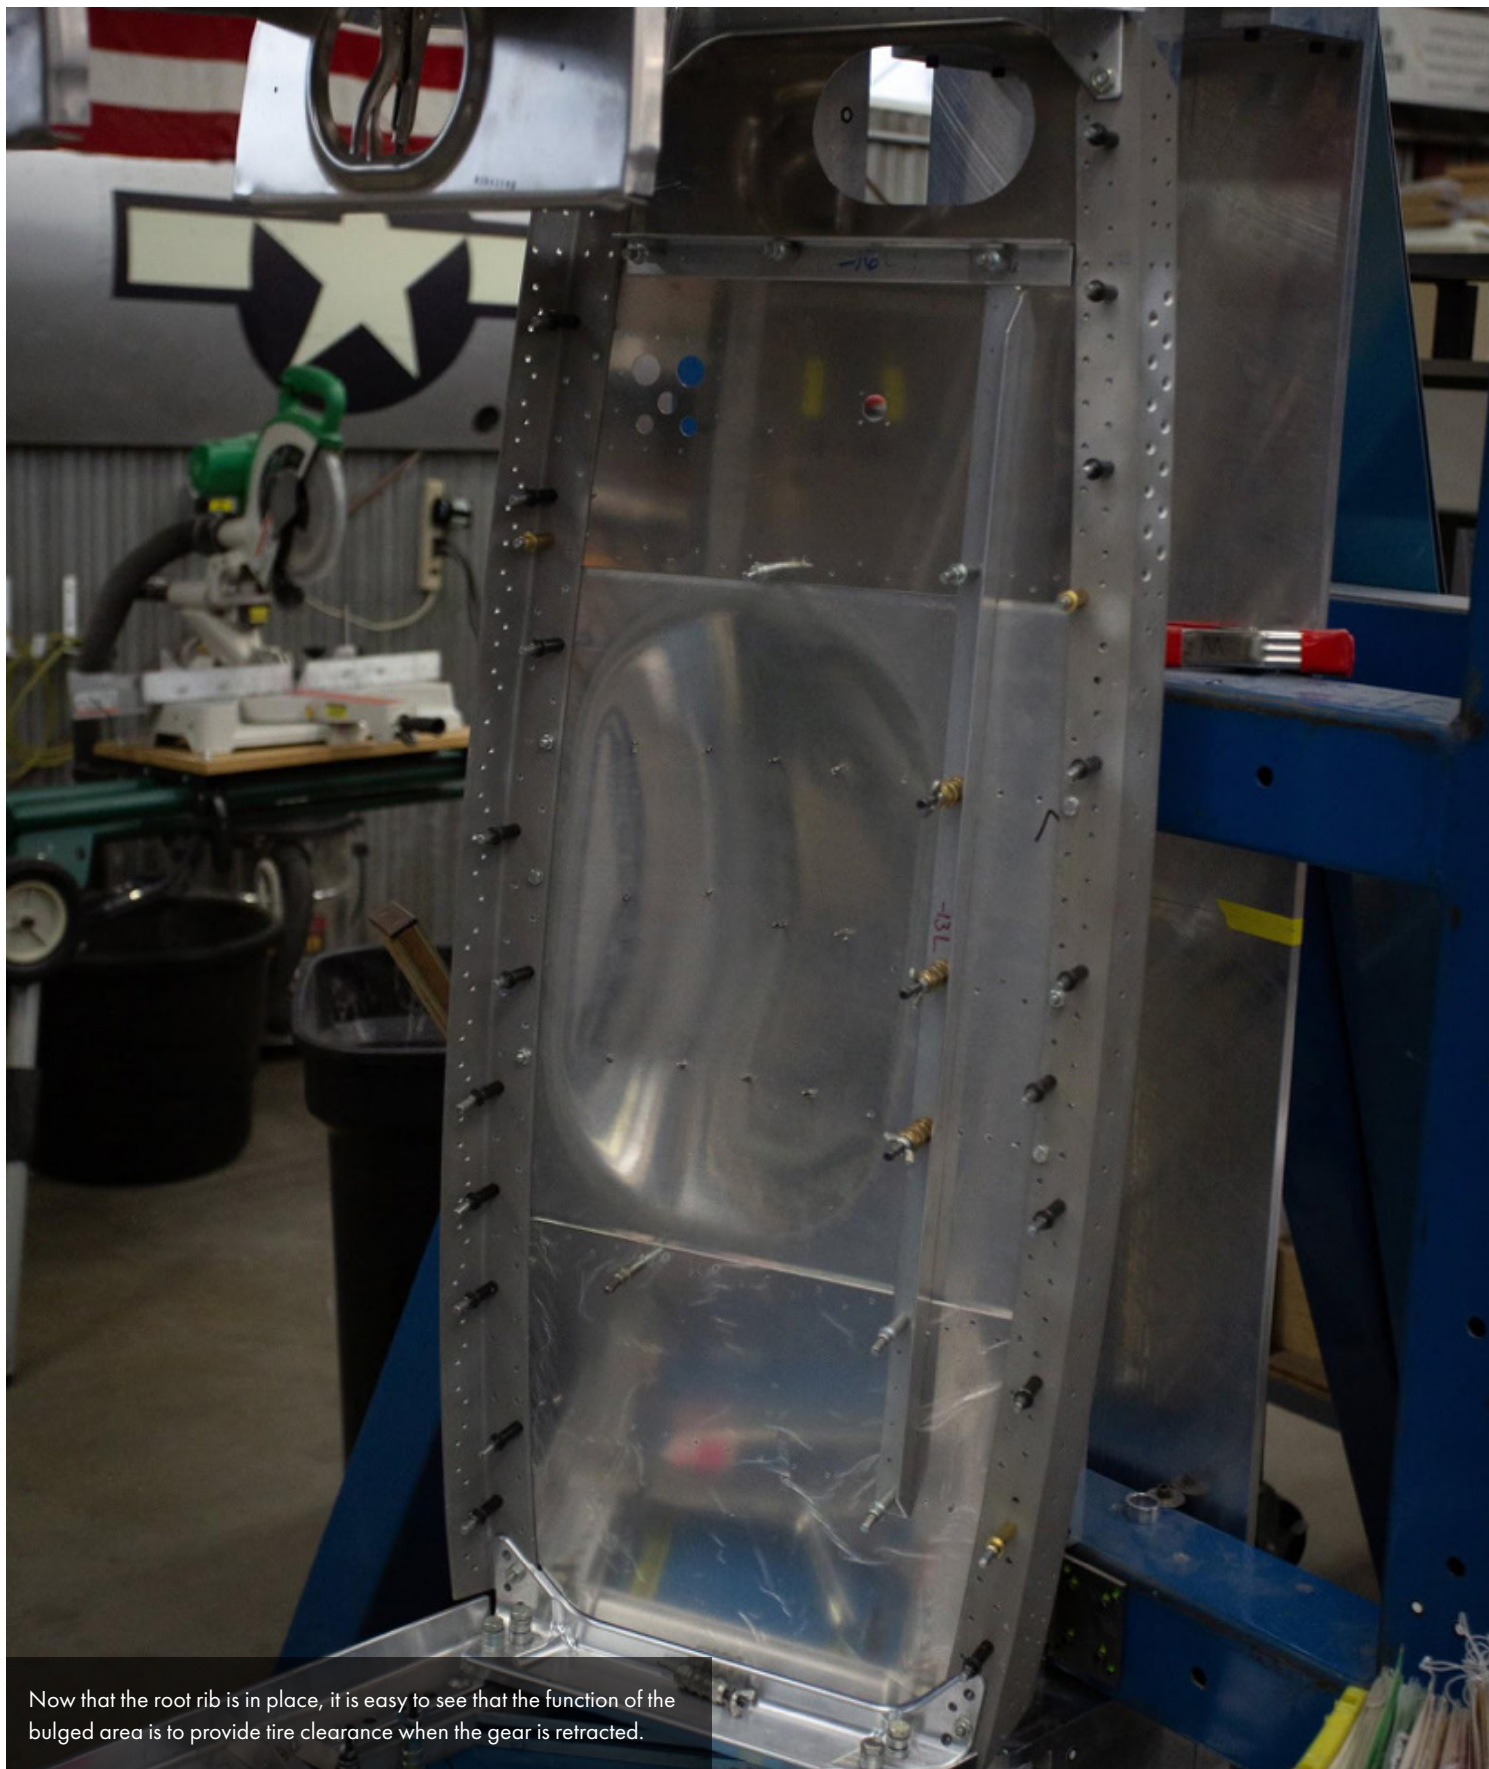
Now that the root rib is in place, it is easy to see that the function of the bulged area is to provide tire clearance when the gear is retracted.

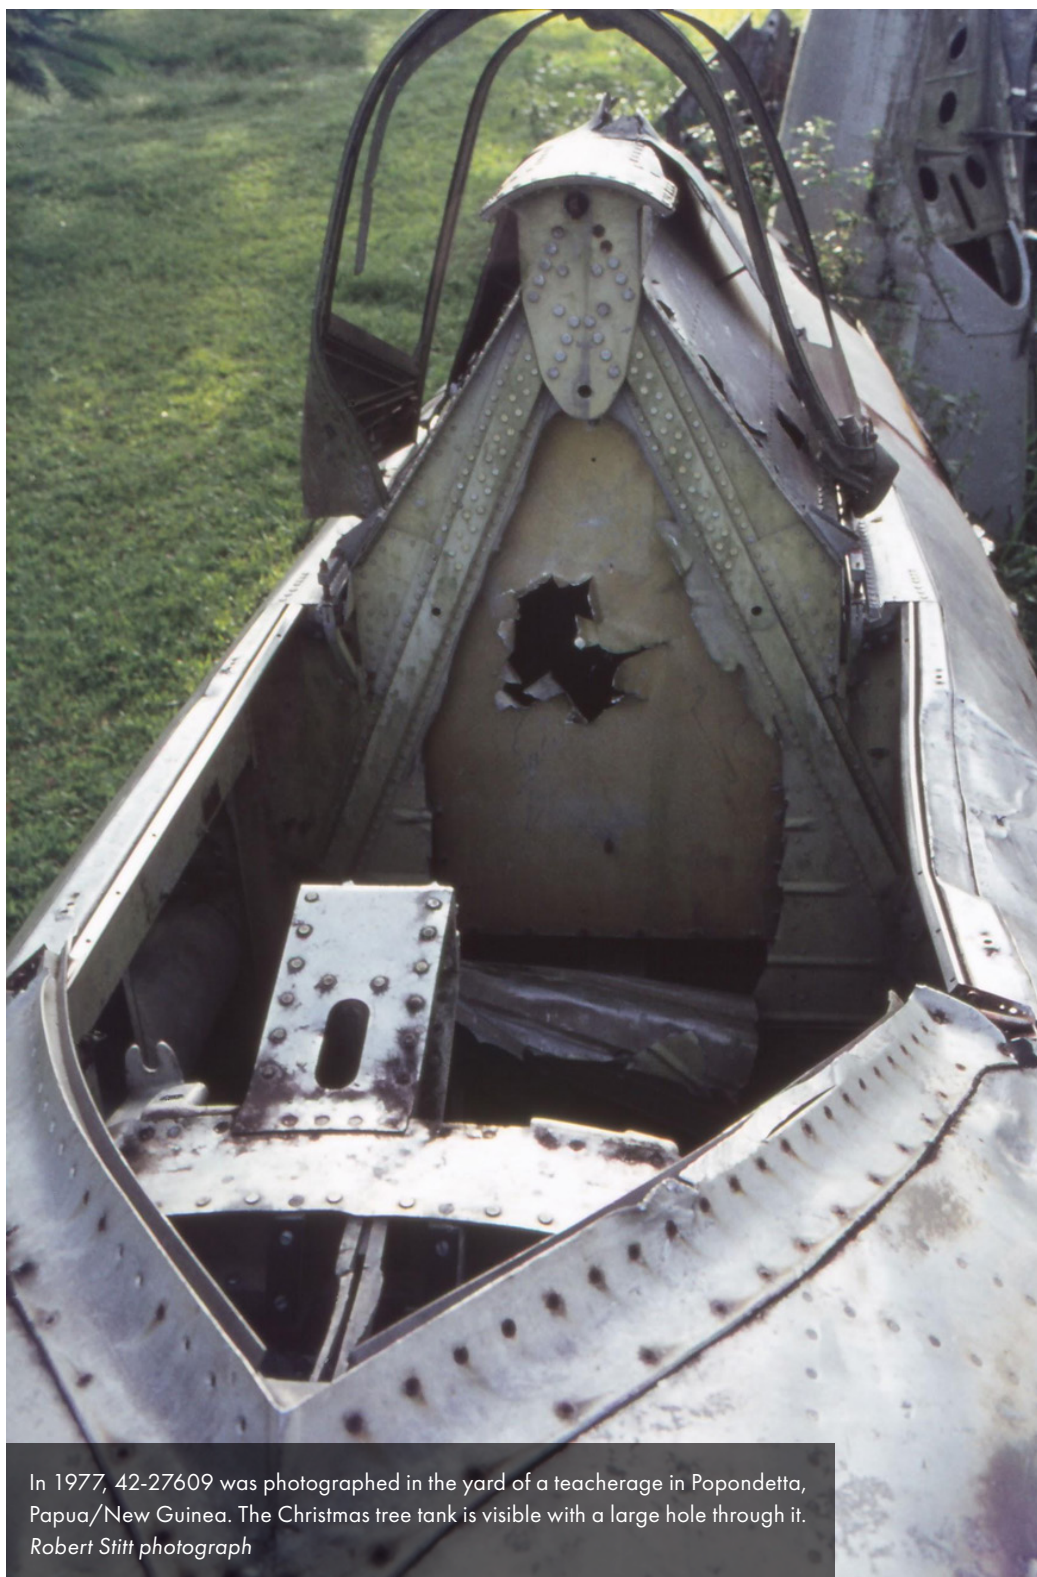
In 1977, 42-27609 was photographed in the yard of a teacherage in Popondetta, Papua/New Guinea. The Christmas tree tank is visible with a large hole through it. Robert Stitt photograph

The fire hazard resulted in orders to remove these tanks, issued in July of 1944. 42-27609 arrived at Townsville, Australia on May 8, 1944. Since this P-47D-23 still retains the tank, it had to have been readied for combat before July of 1944.
