Dakota Territory Air Museum's P-47 Update

by Chuck Cravens

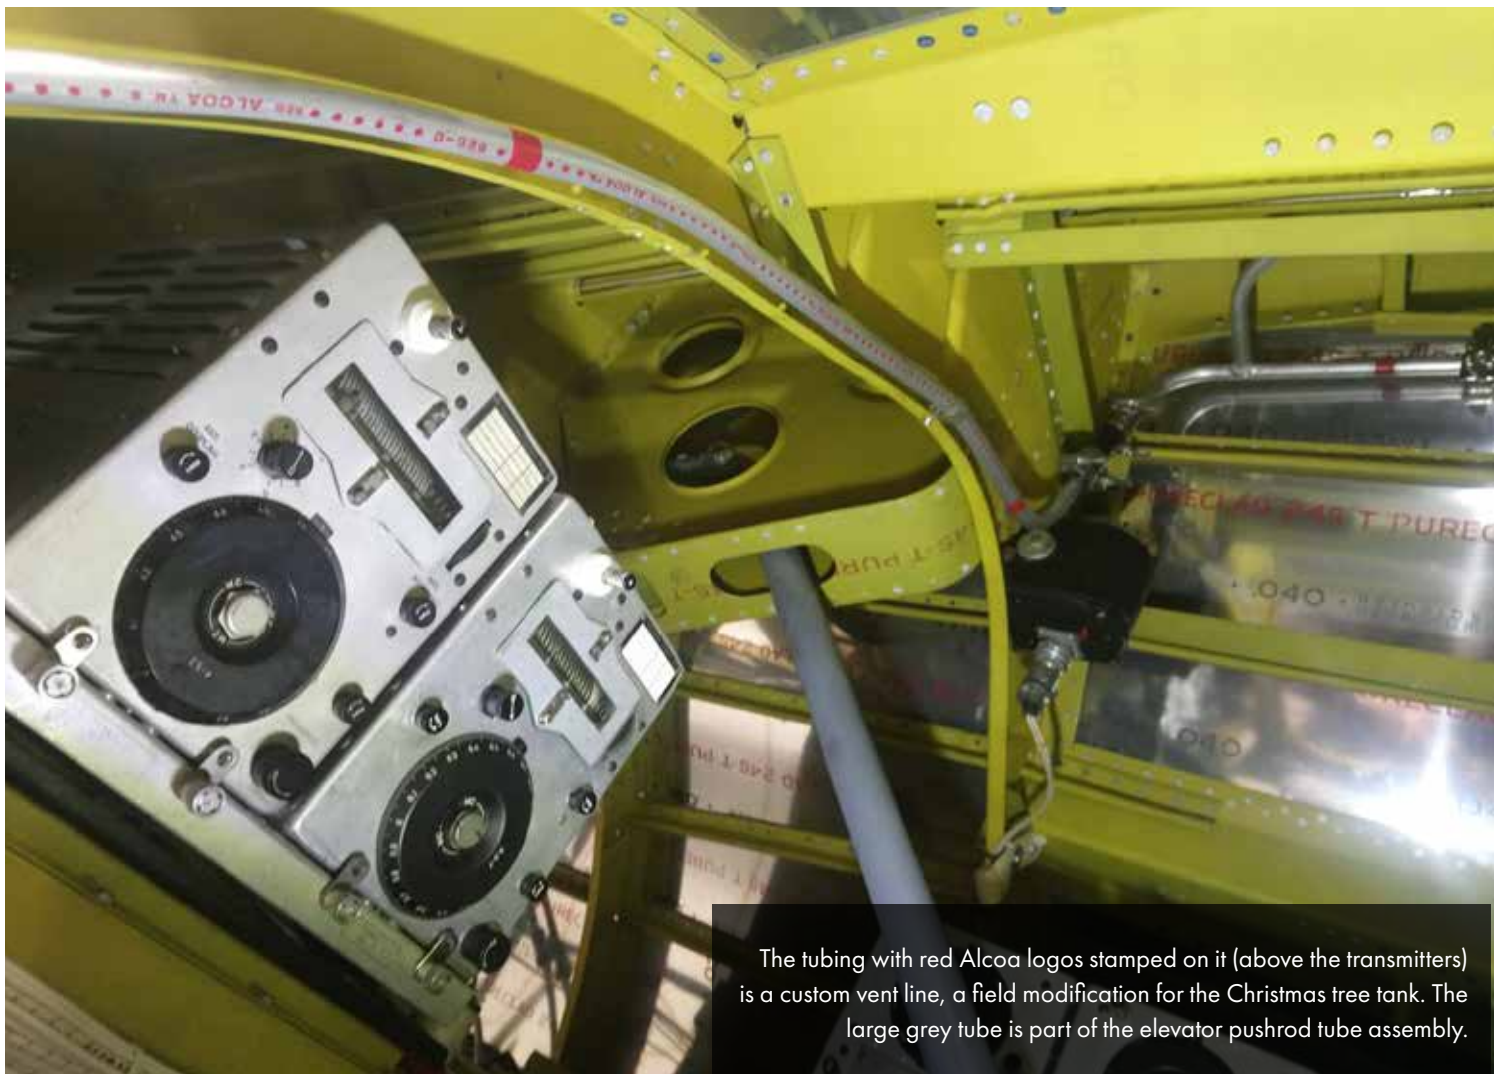
The tubing with red Alcoa logos stamped on it (above the transmitters) is a custom vent line, a field modification for the Christmas tree tank. The large grey tube is part of the elevator pushrod tube assembly.

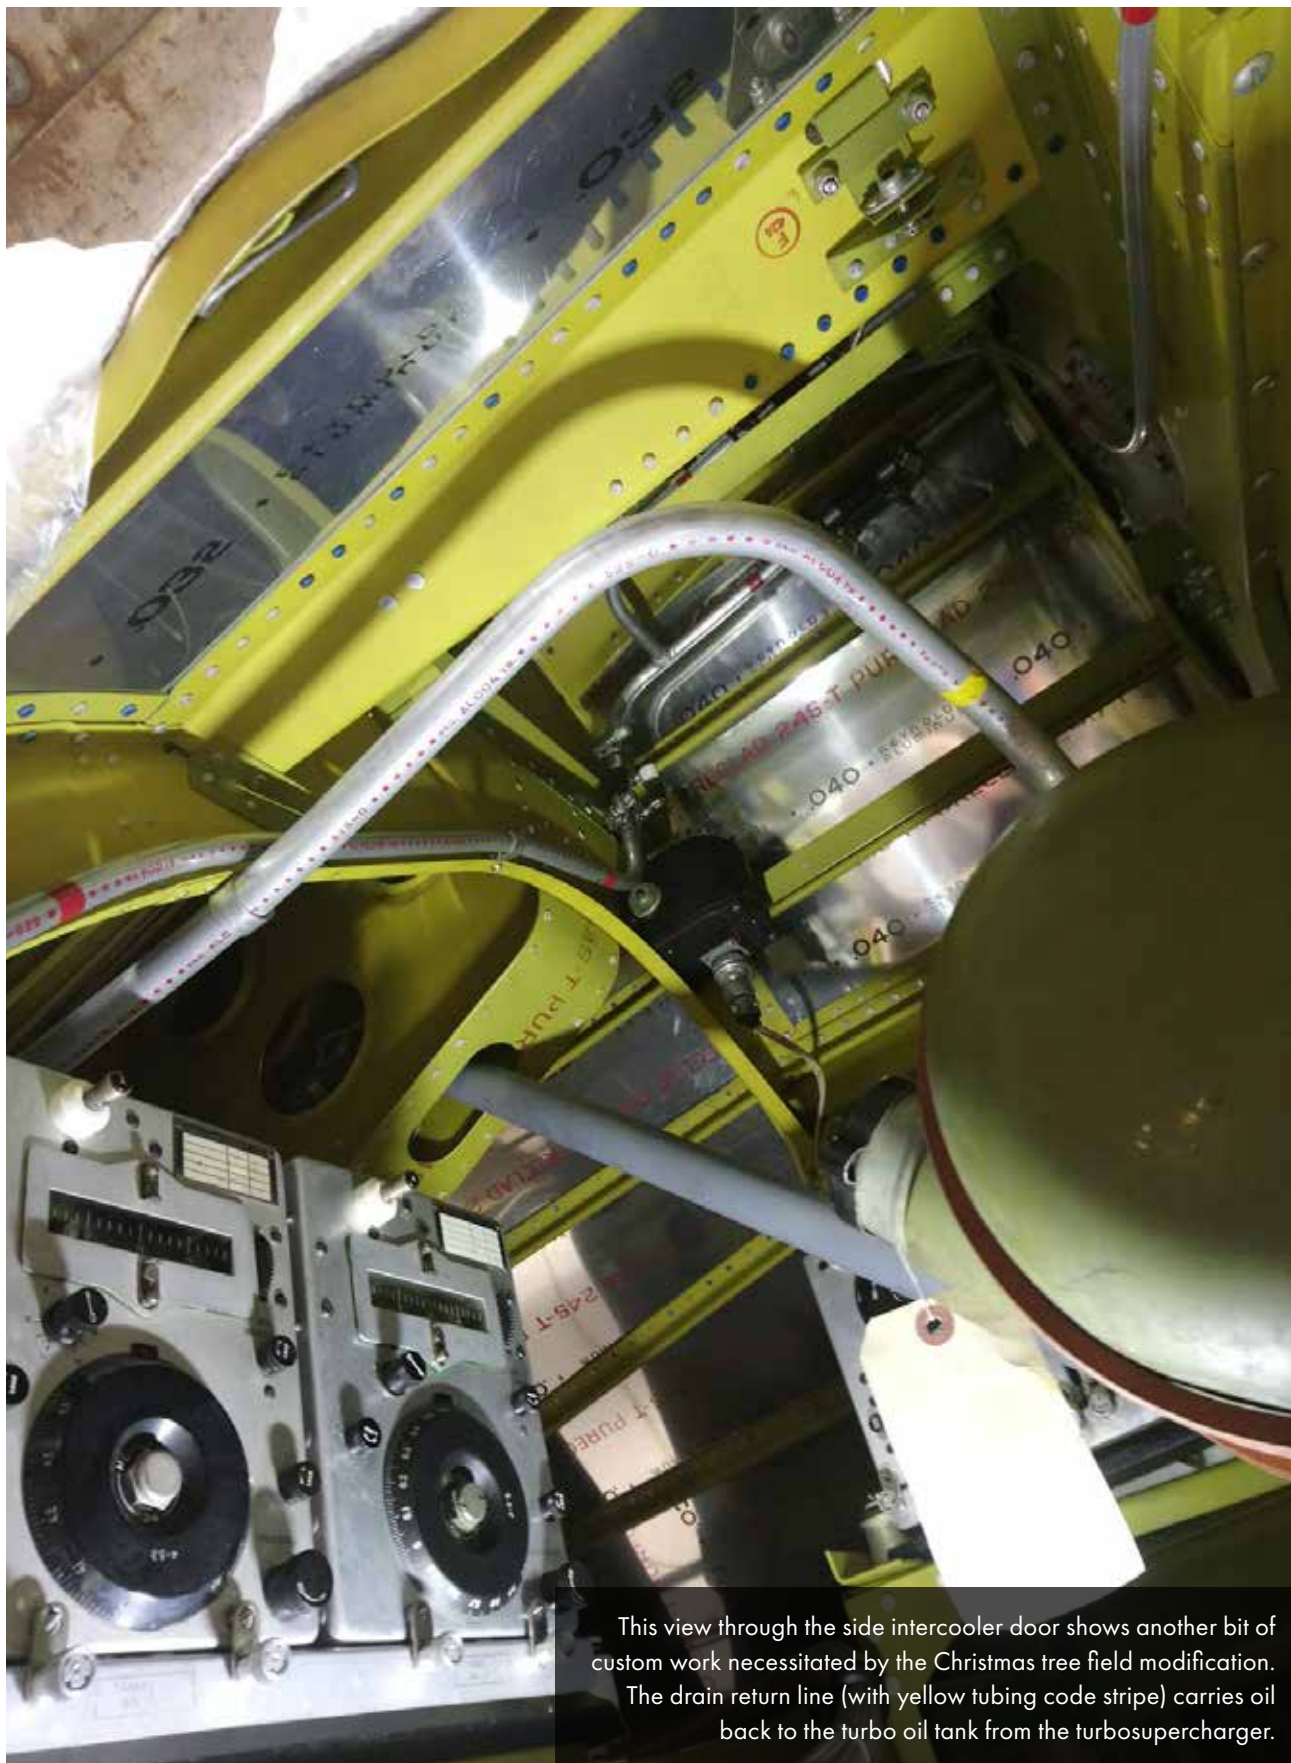
This view through the side intercooler door shows another bit of custom work necessitated by the Christmas tree field modification. The drain return line (with yellow tubing code stripe) carries oil back to the turbo oil tank from the turbosupercharger.

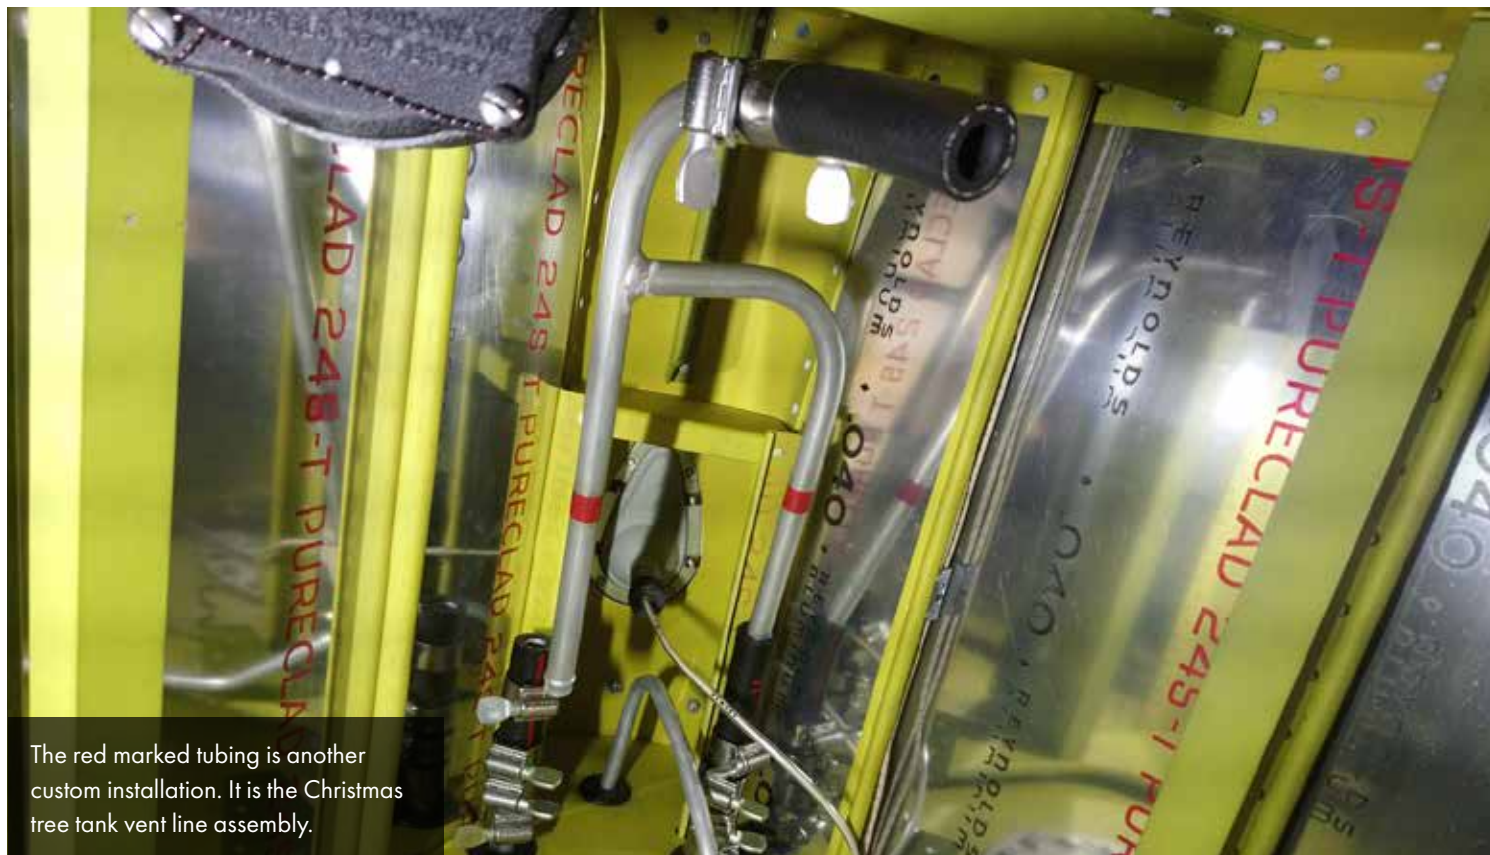
The red marked tubing is another custom installation. It is the Christmas tree tank vent line assembly.

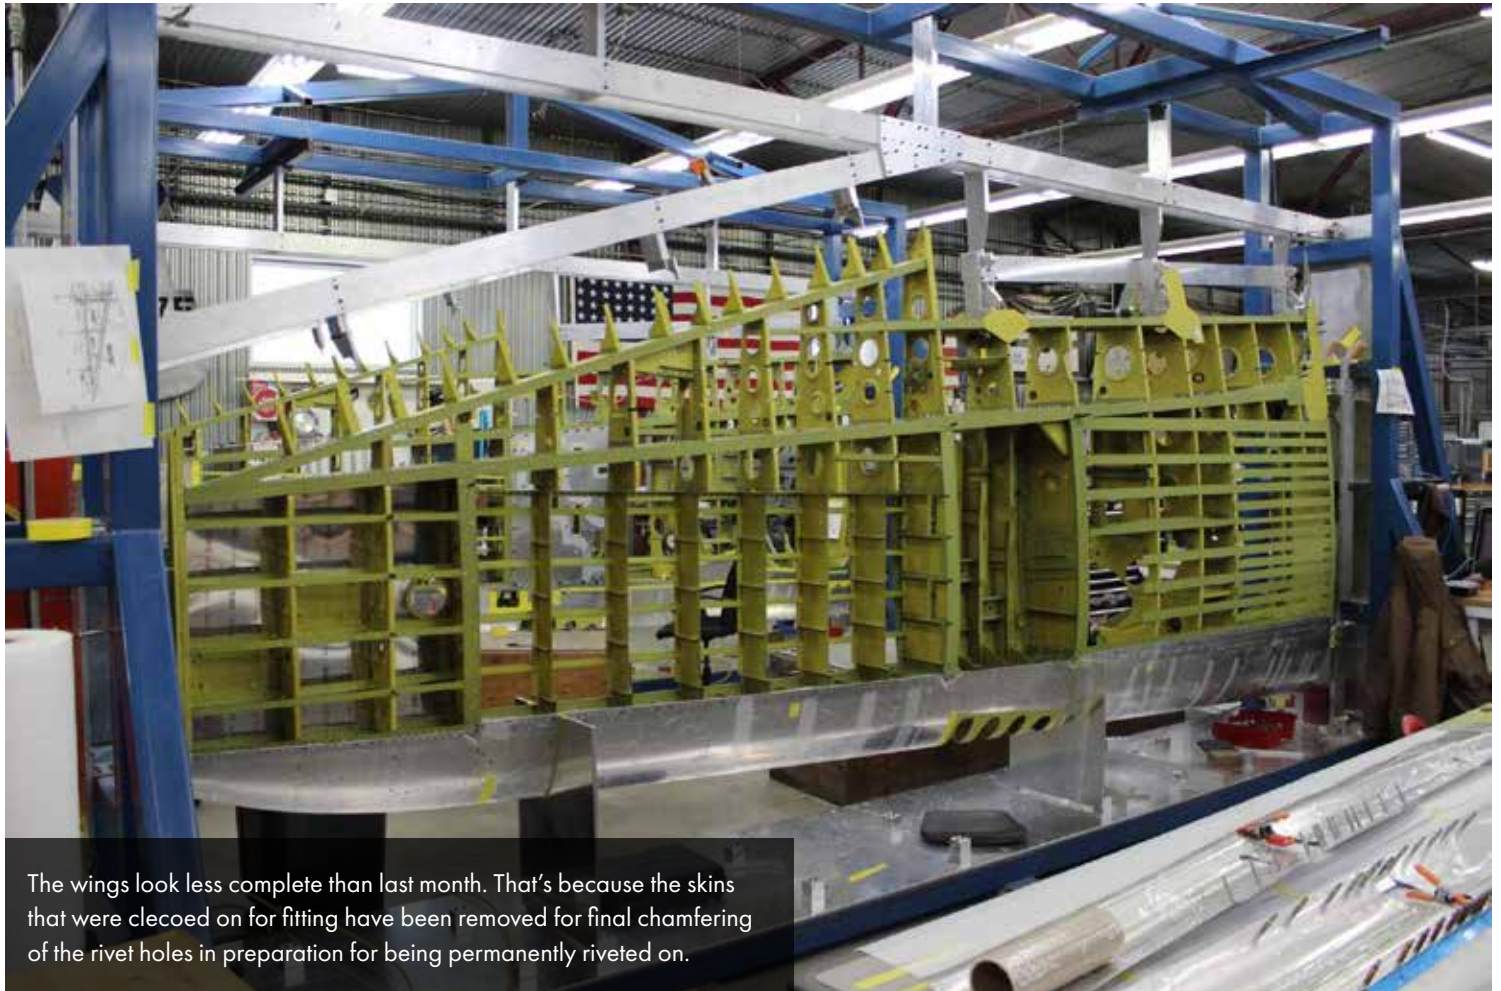
The wings look less complete than last month. That's because the skins that were clecoed on for fitting have been removed for final chamfering of the rivet holes in preparation for being permanently riveted on.

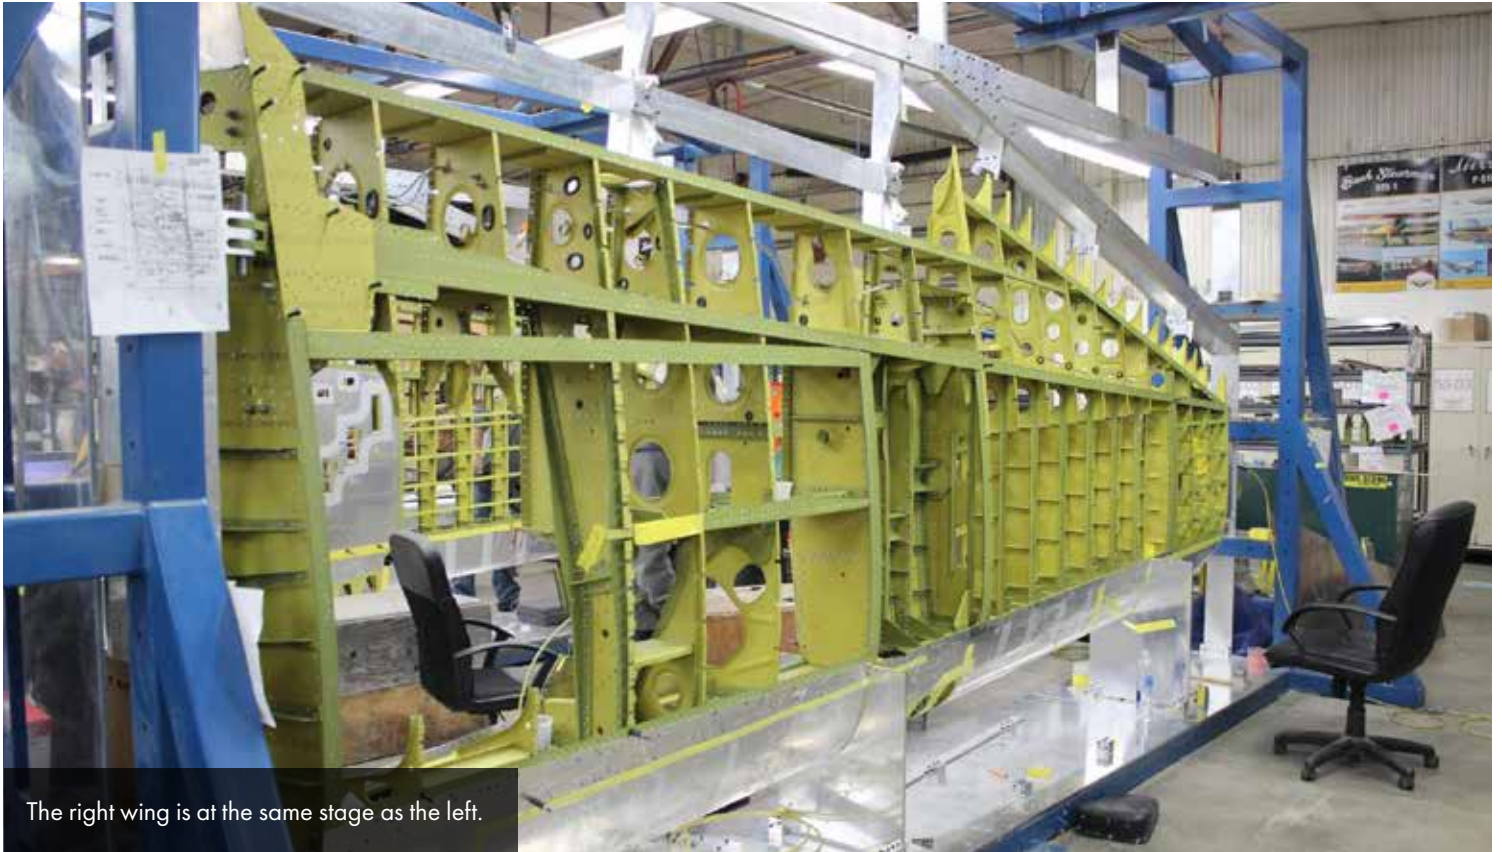
The right wing is at the same stage as the left.

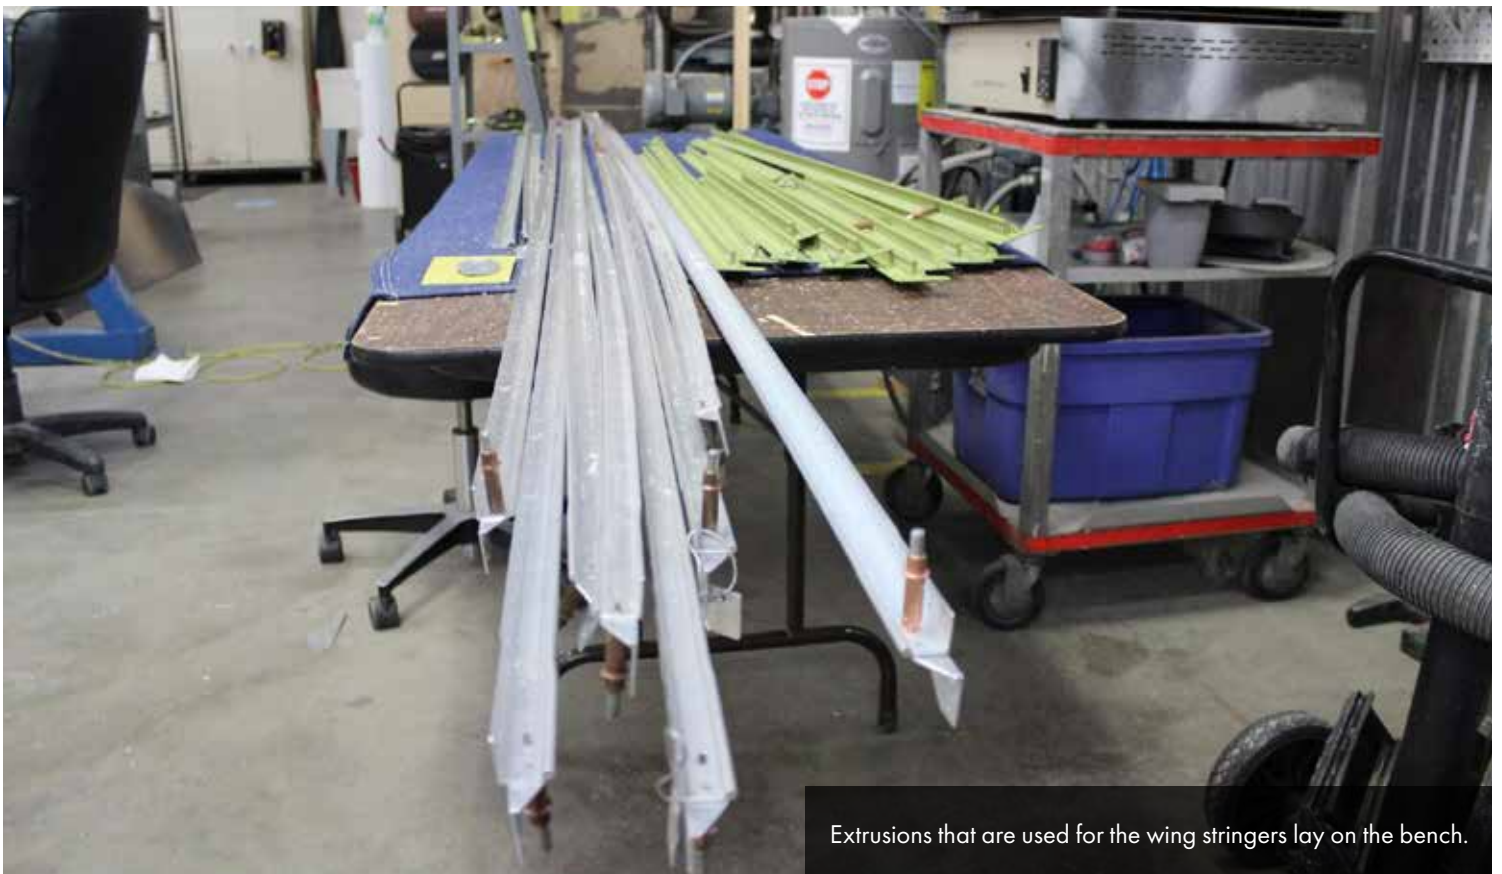
Extrusions that are used for the wing stringers lay on the bench.

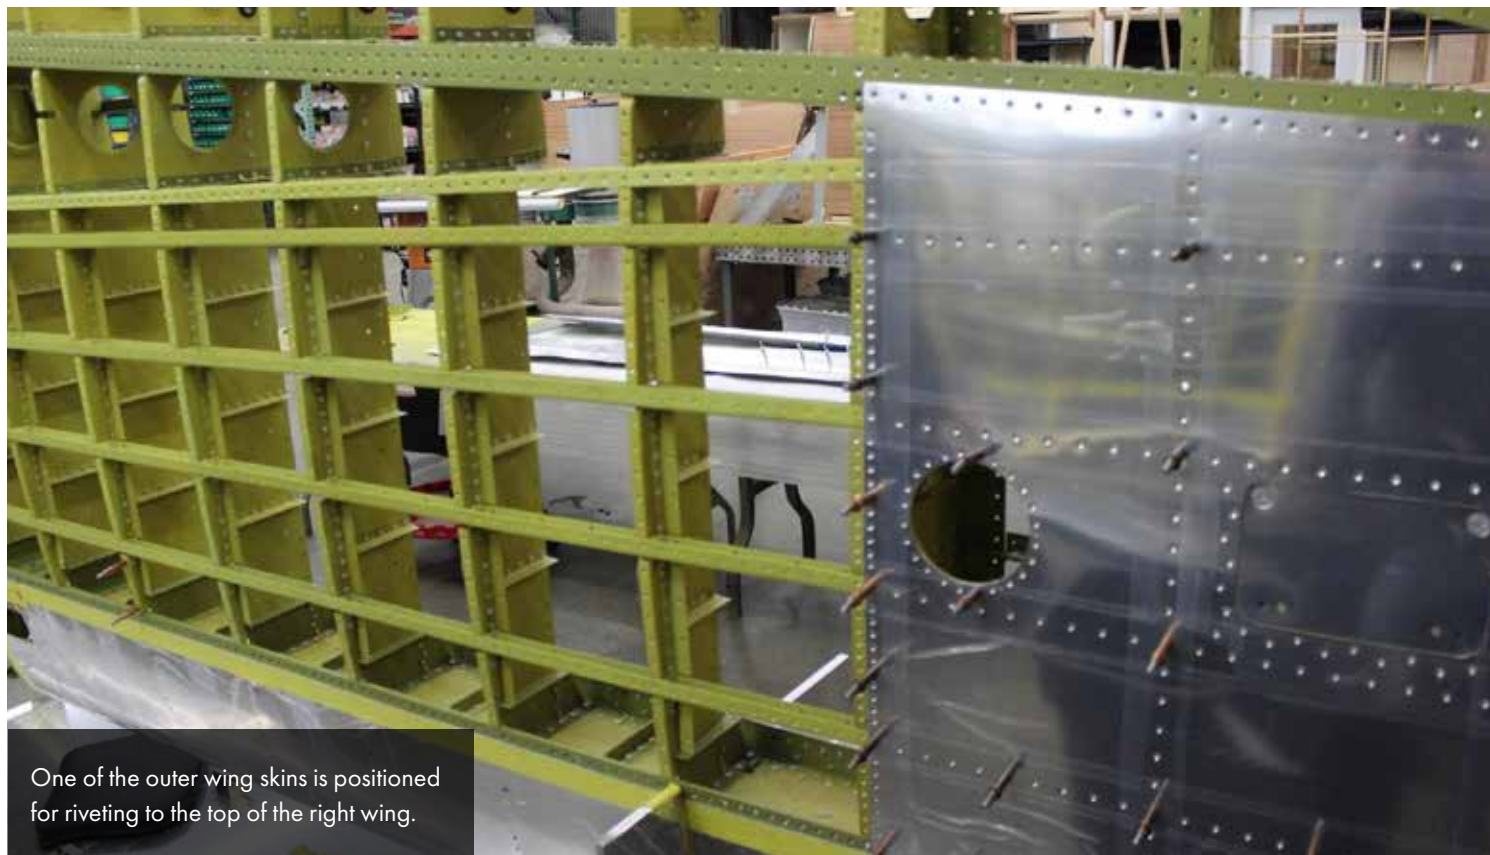
One of the outer wing skins is positioned for riveting to the top of the right wing.

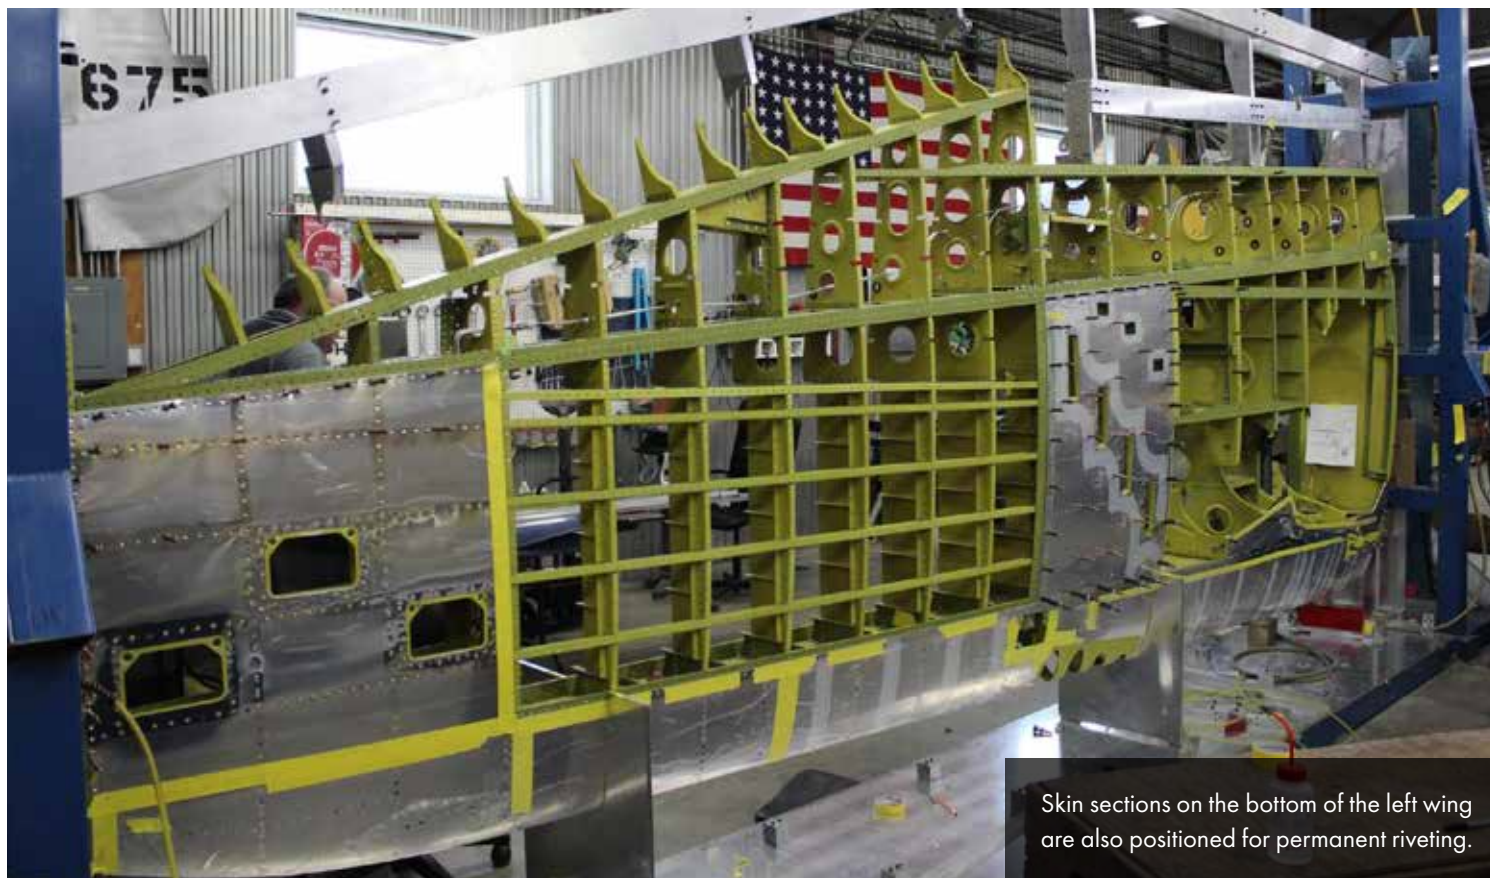
Skin sections on the bottom of the left wing are also positioned for permanent riveting.

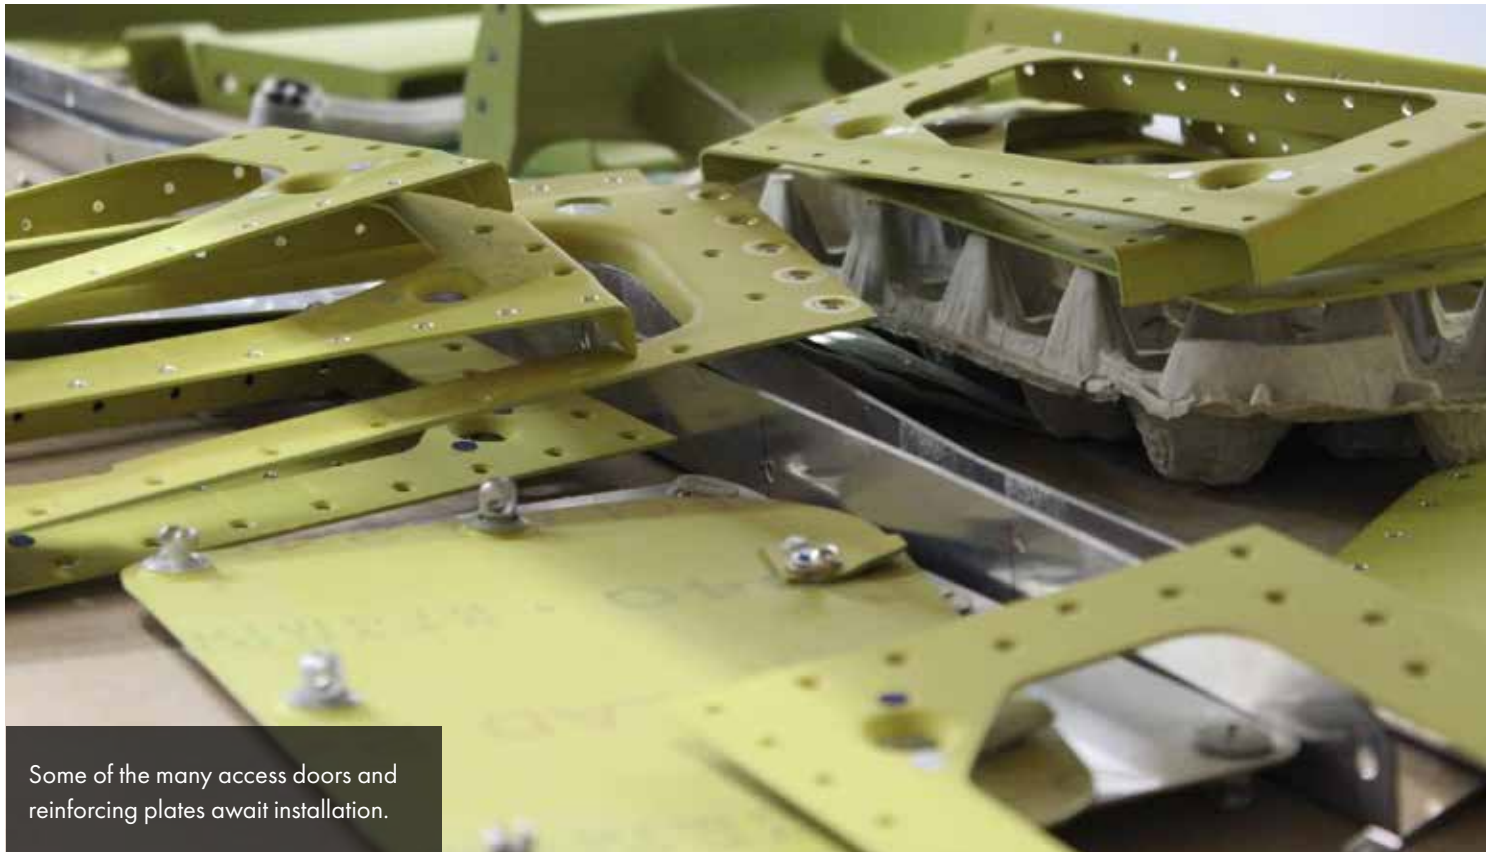
Some of the many access doors and reinforcing plates await installation.

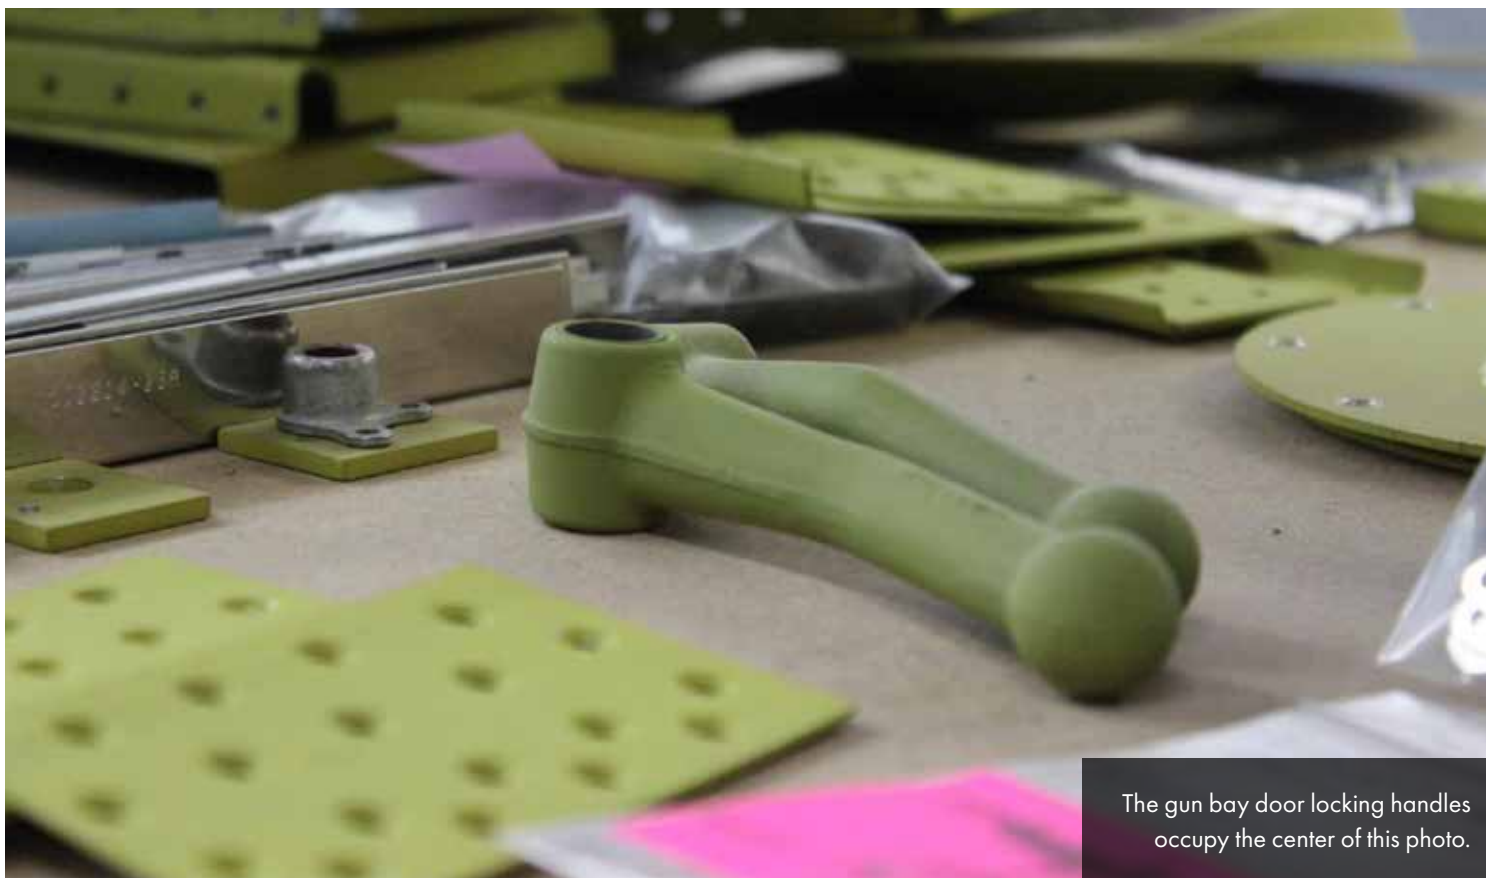
The gun bay door locking handles occupy the center of this photo.

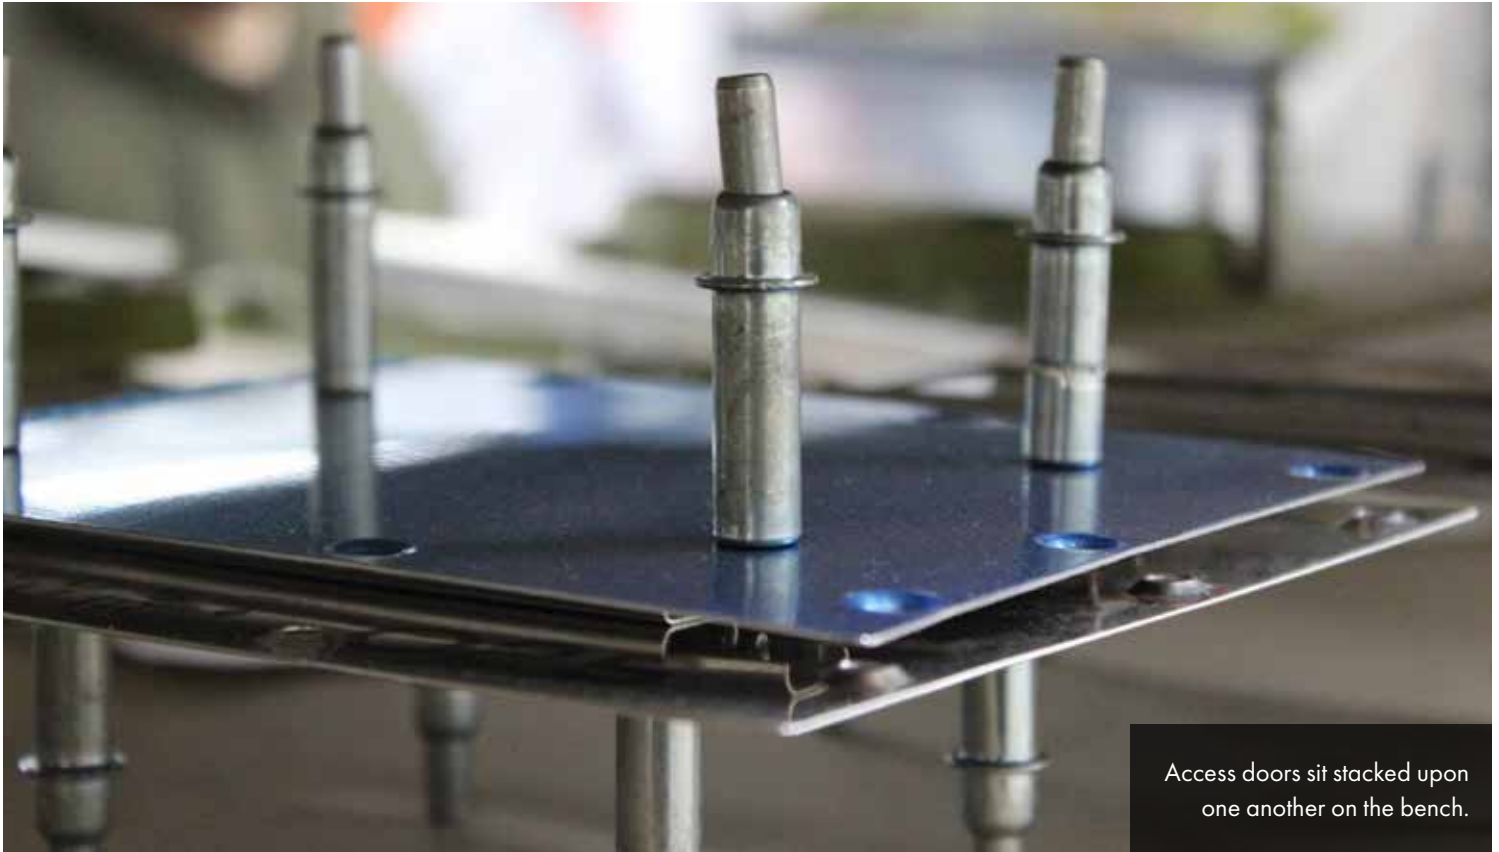
Access doors sit stacked upon one another on the bench.

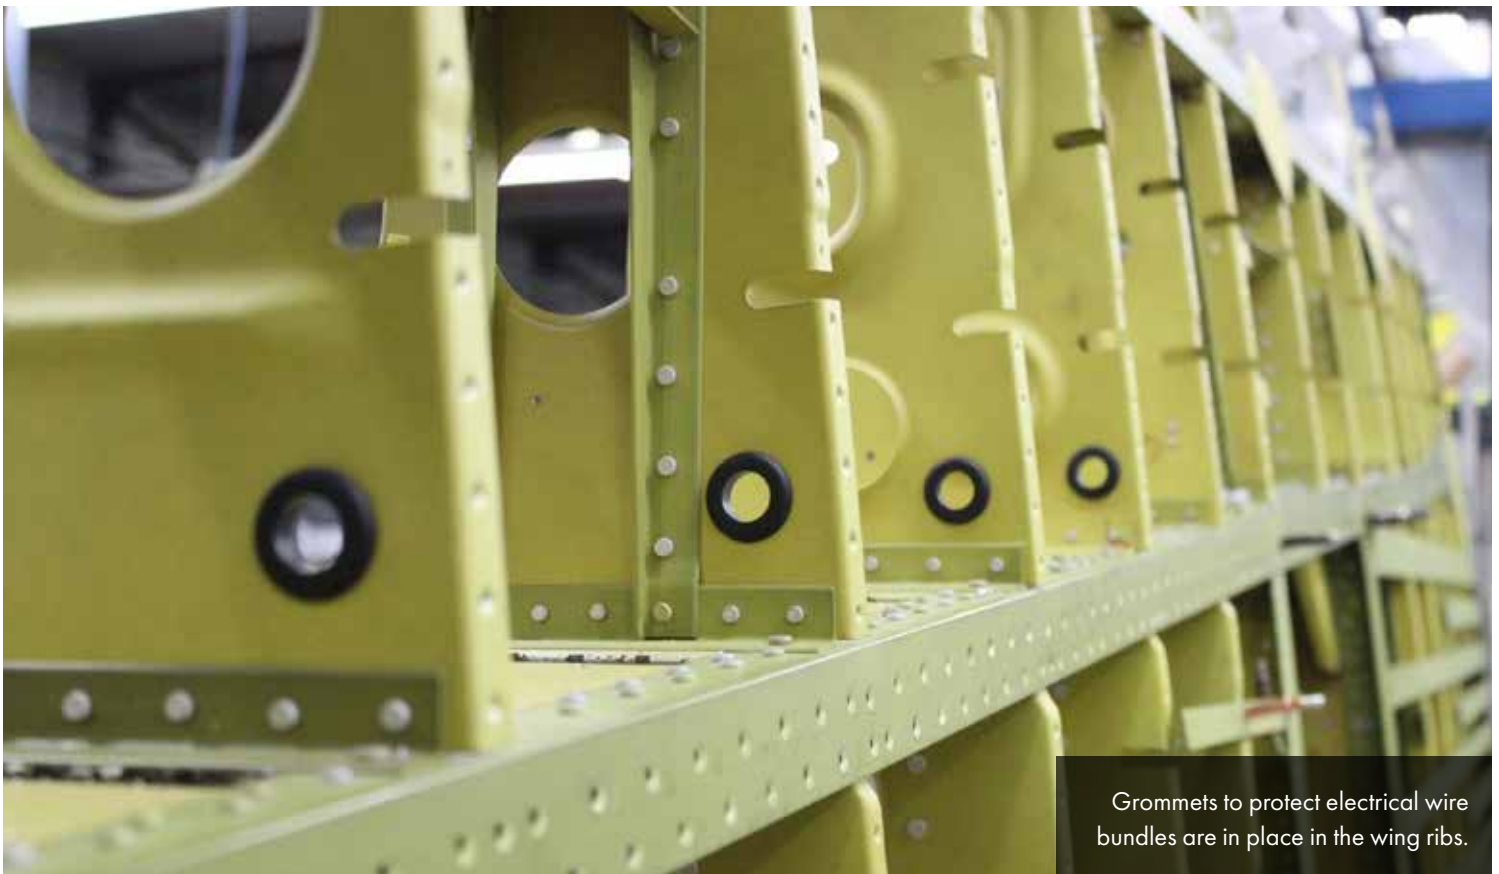
Grommets to protect electrical wire bundles are in place in the wing ribs.

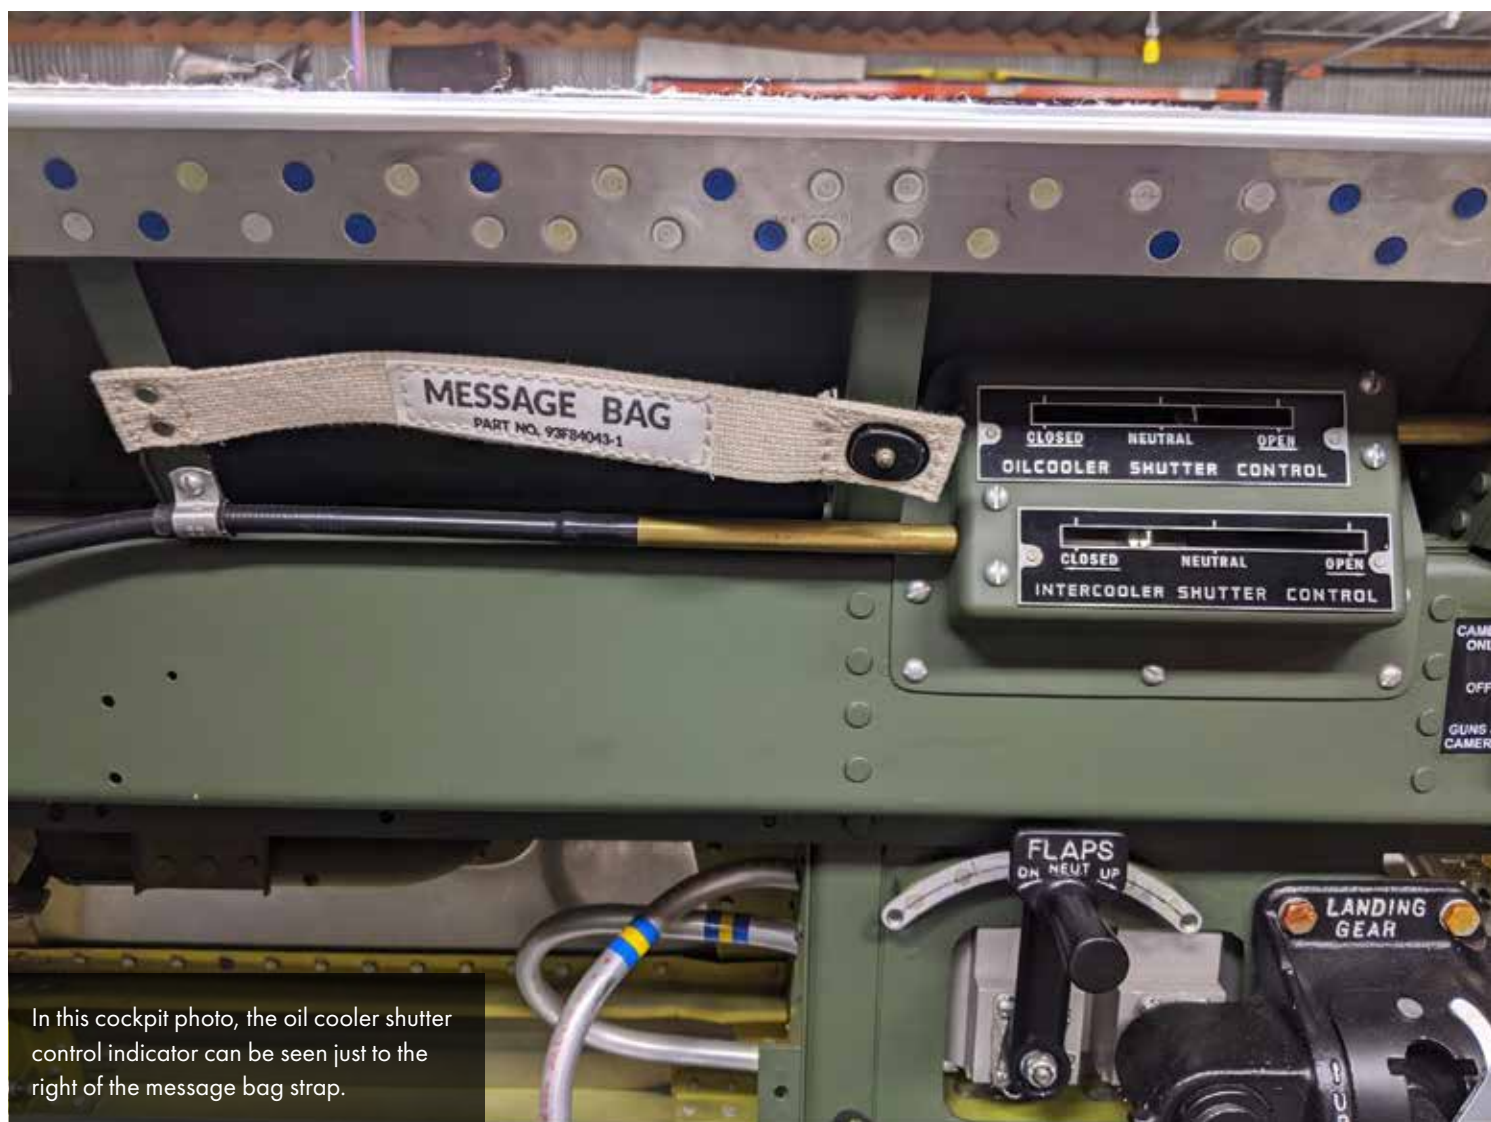
In this cockpit photo, the oil cooler shutter control indicator can be seen just to the right of the message bag strap.

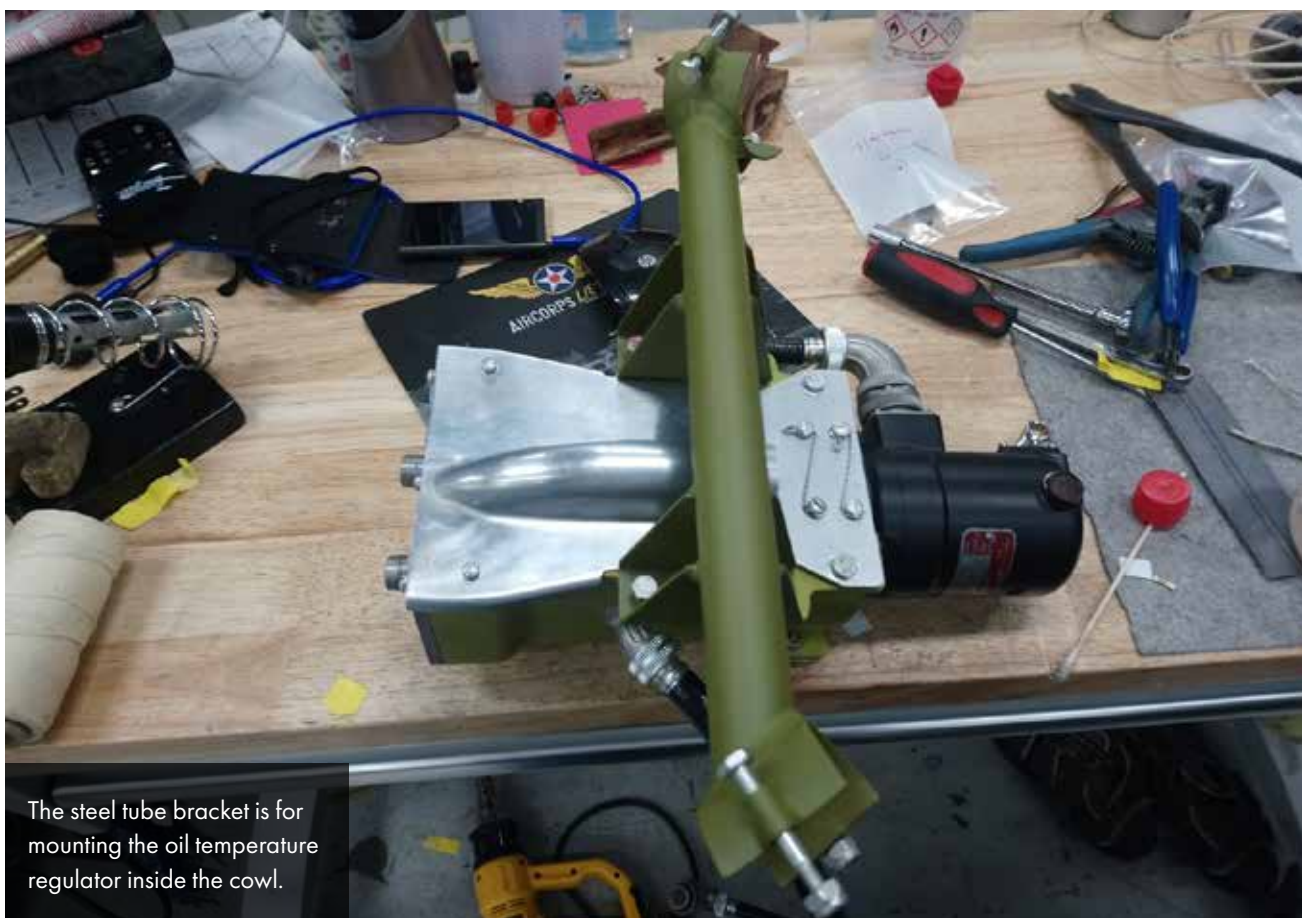
The steel tube bracket is for mounting the oil temperature regulator inside the cowl.

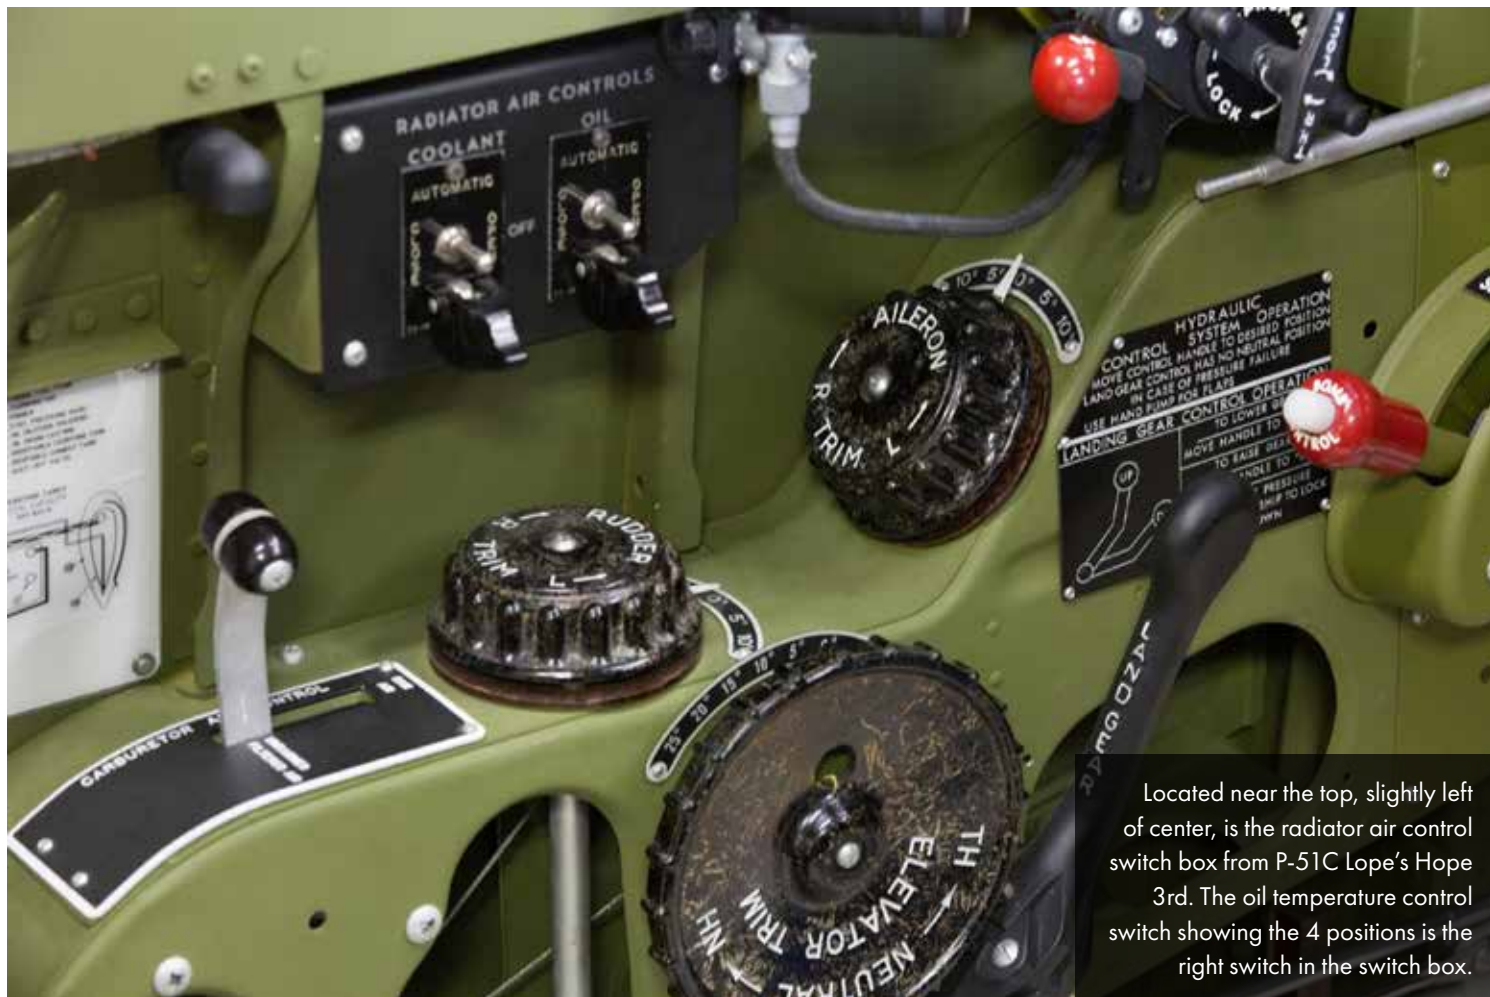
Located near the top, slightly left of center, is the radiator air control switch box from P-51C Lope's Hope 3rd. The oil temperature control switch showing the 4 positions is the right switch in the switch box.

Oil temperature on a P-51 was controlled automatically by an electric actuator for the oil radiator air outlet flap. The control is on the radiator control panel and has 4 positions OFF, CLOSE, AUTOMATIC, and OPEN. In normal operation, the switch was left in AUTOMATIC and a thermostat automatically starts and stops the actuator to move the oil radiator air outlet flaps. Only if the automatic feature fails and an abnormal temperature is indicated is it necessary to control the flap manually by changing switch positions between OPEN and CLOSED.
