Dakota Territory Air Museum's P-47 Update

by Chuck Cravens

Five years ago, in April of 2016, I began writing updates on the P-47D-23-RA AAF serial number 42-27609, though much fabrication and other preparation work preceded the first update.

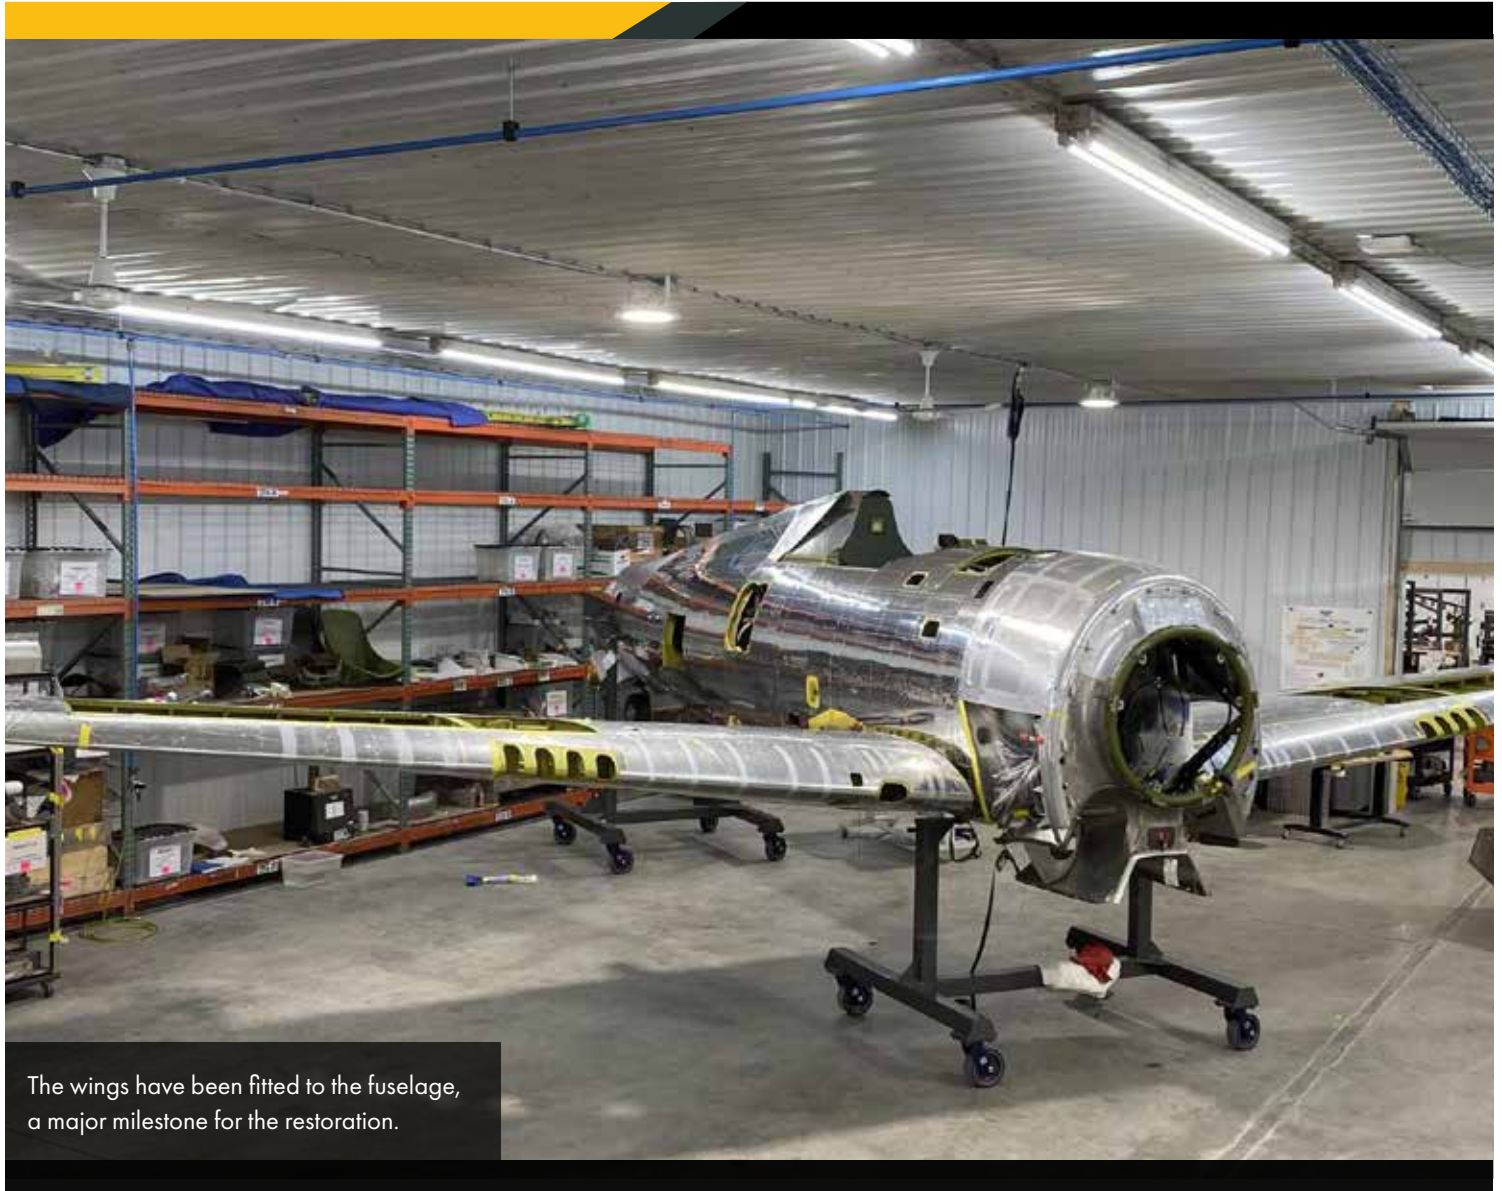
The wings have been fitted to the fuselage, a major milestone for the restoration.

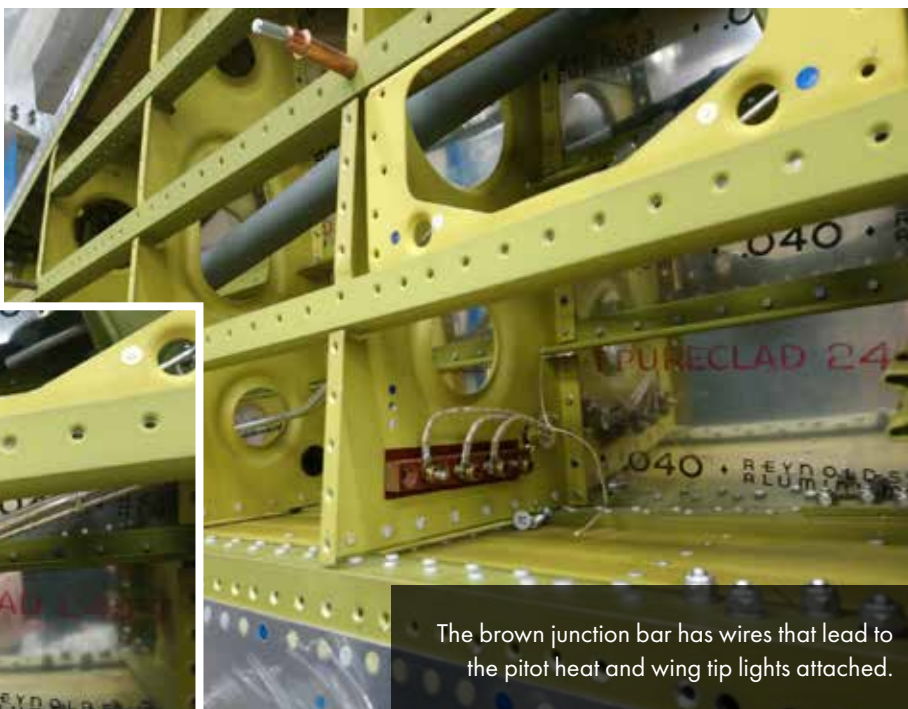
The brown junction bar has wires that lead to the pitot heat and wing tip lights attached.

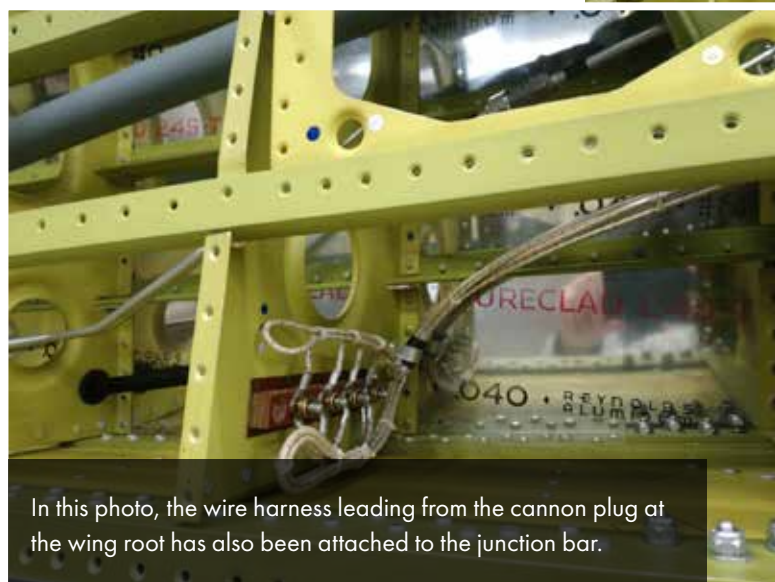
In this photo, the wire harness leading from the cannon plug at the wing root has also been attached to the junction bar.

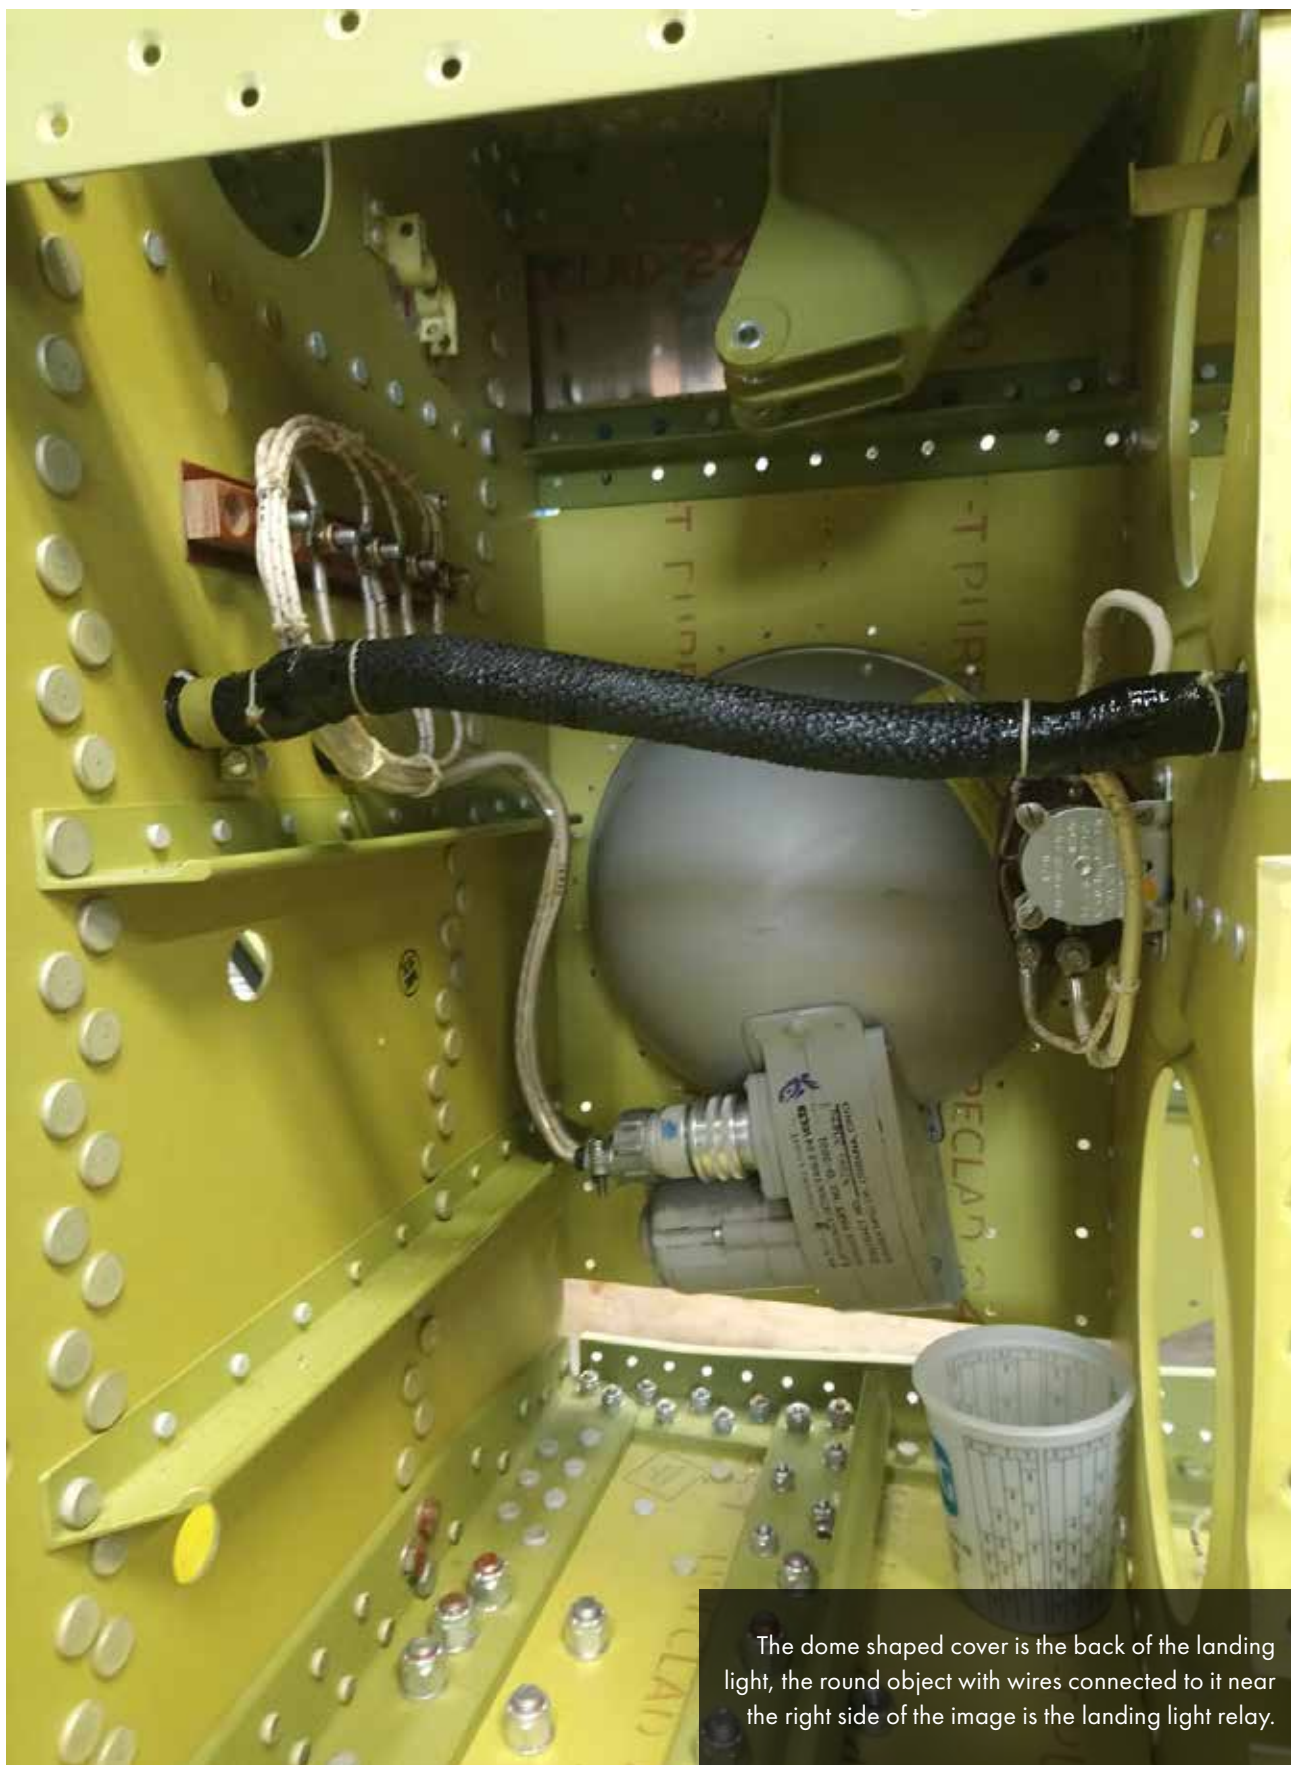
The dome shaped cover is the back of the landing light, the round object with wires connected to it near the right side of the image is the landing light relay.

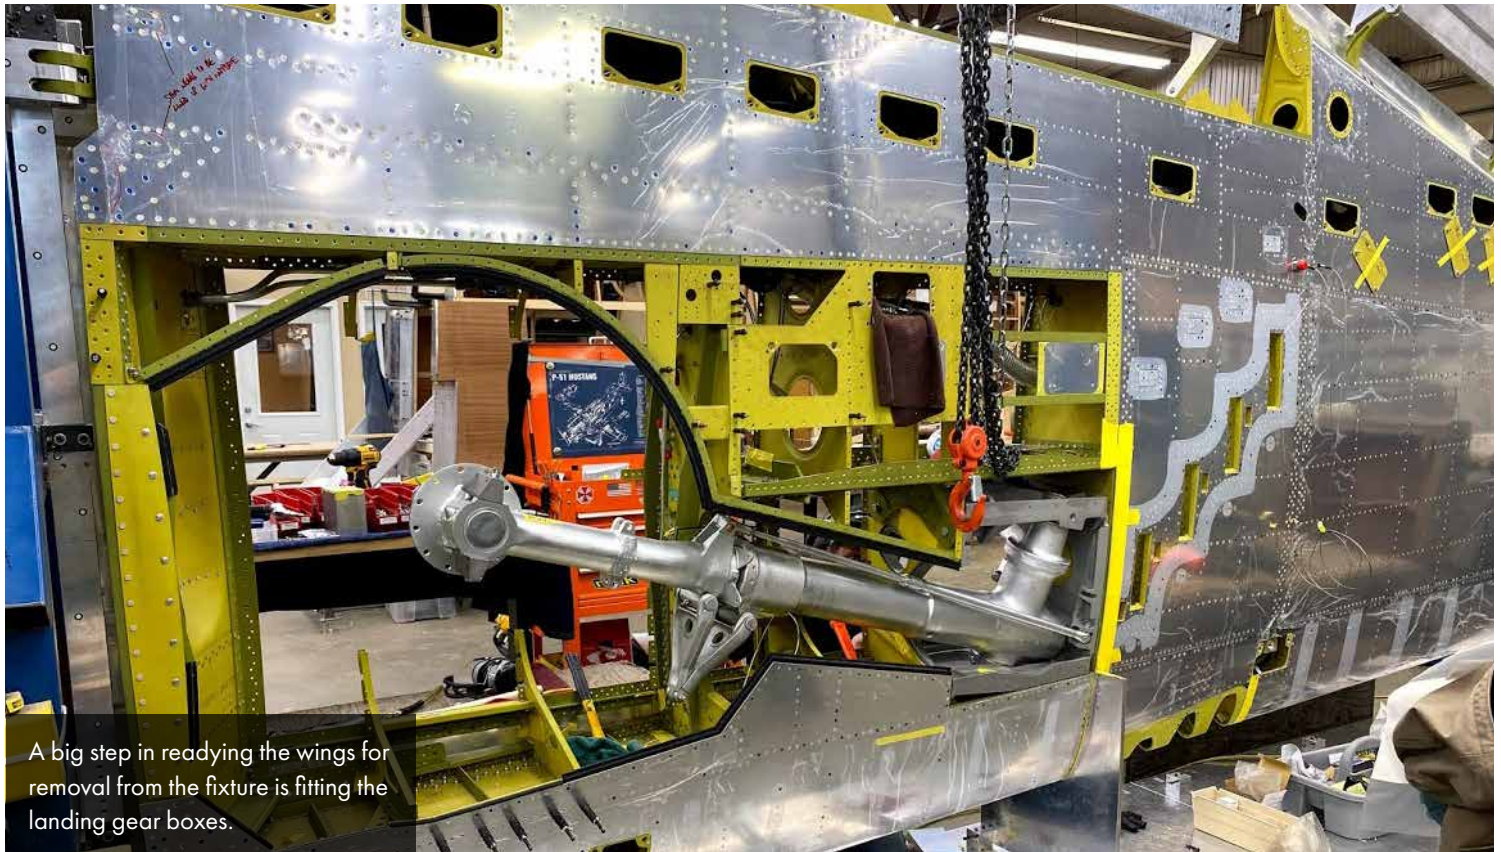
A big step in readying the wings for removal from the fixture is fitting the landing gear boxes.

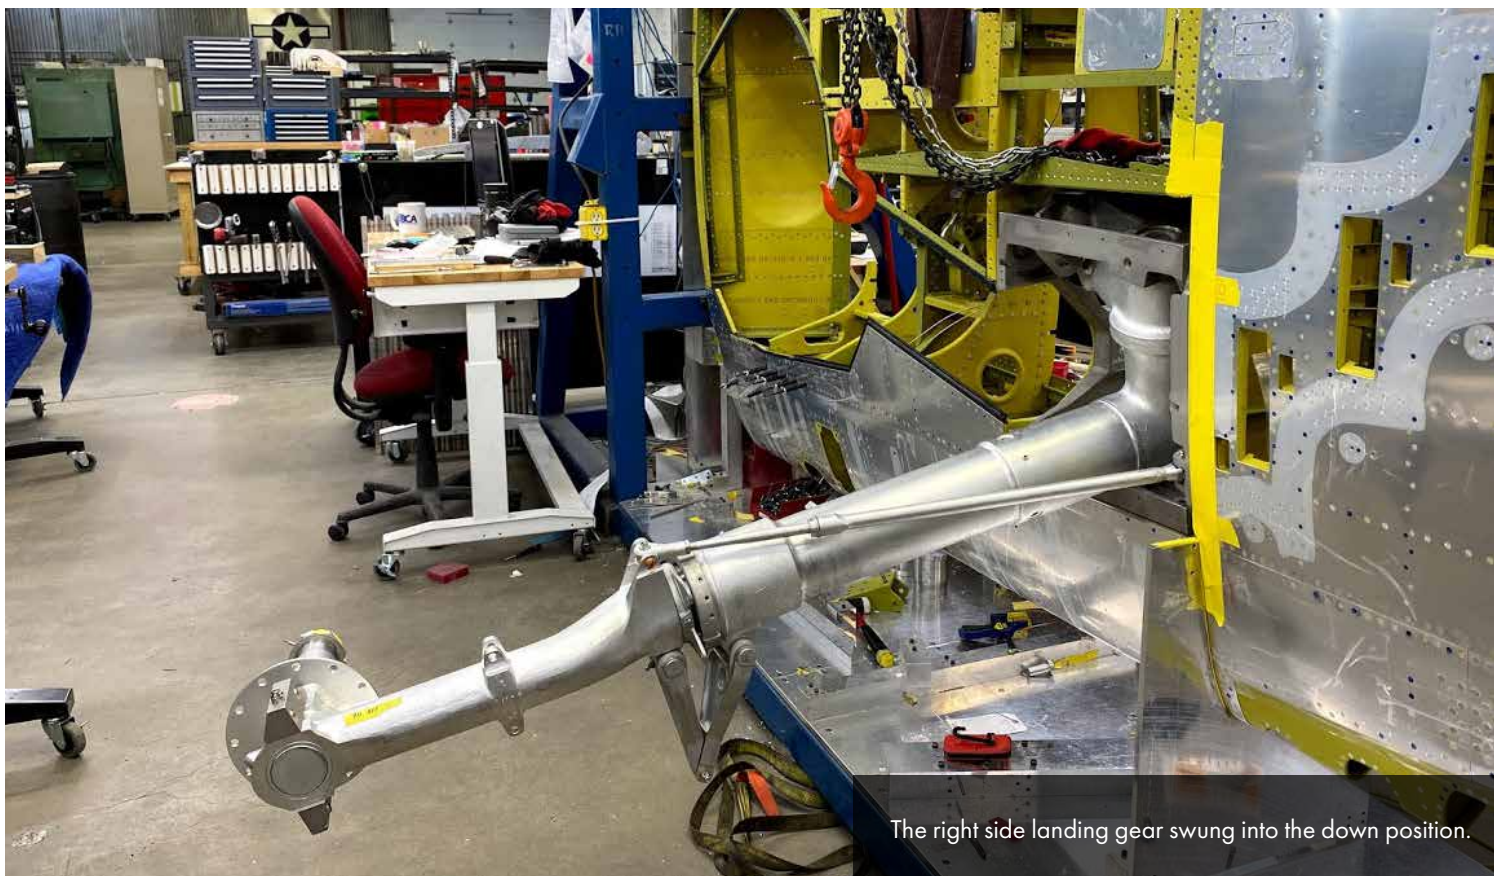
The right side landing gear swung into the down position.

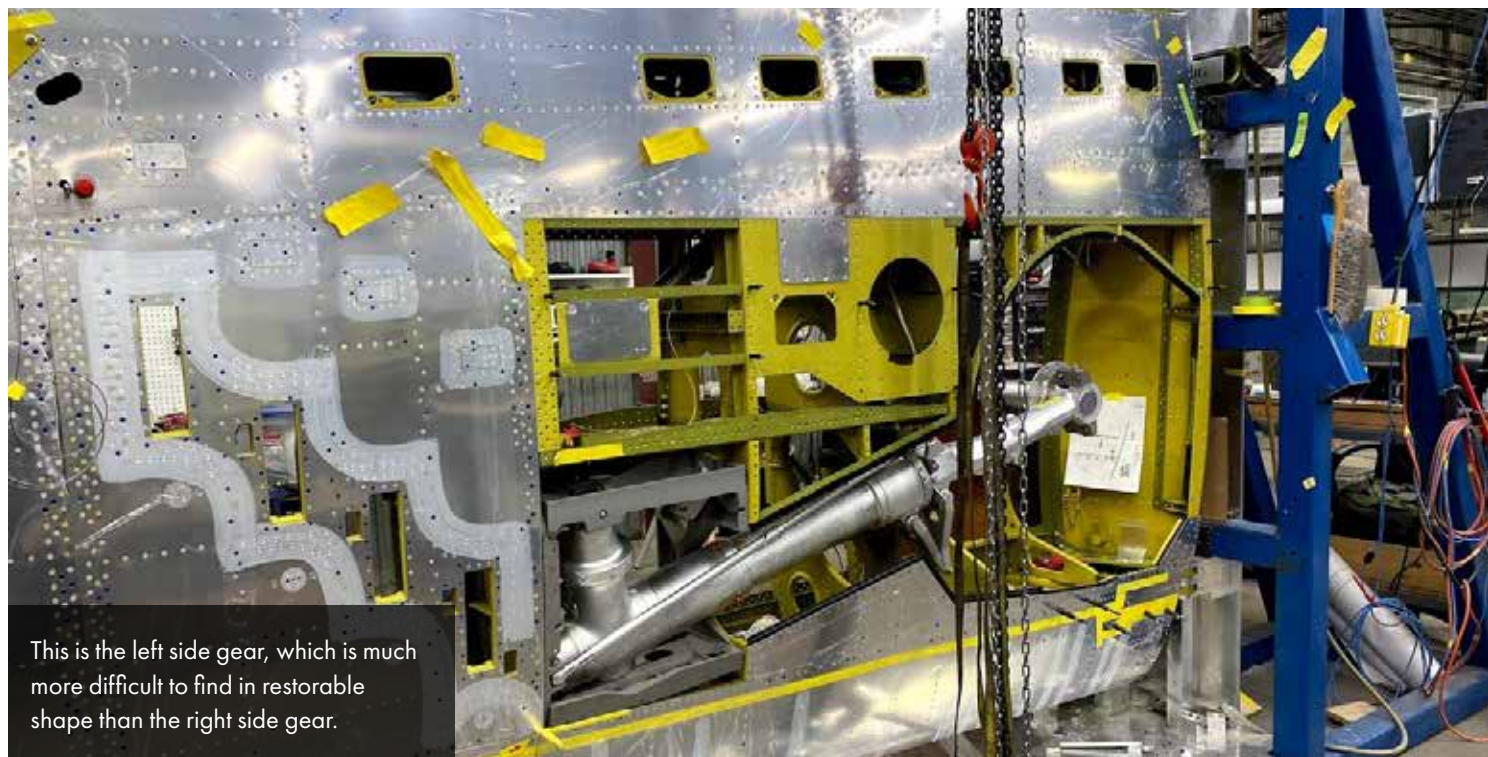
This is the left side gear, which is much more difficult to find in restorable shape than the right side gear.

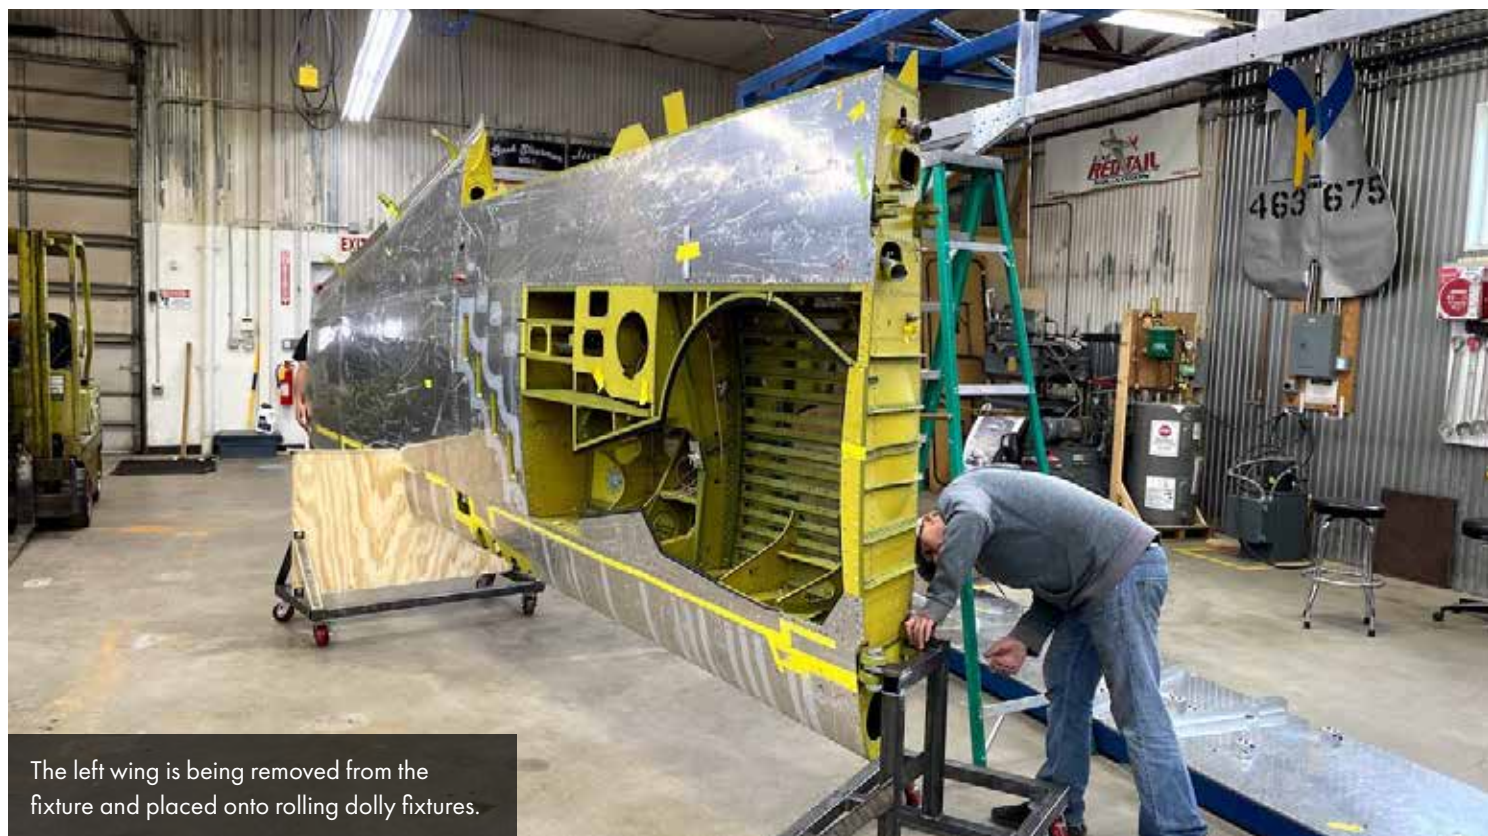
The left wing is being removed from the fixture and placed onto rolling dolly fixtures.

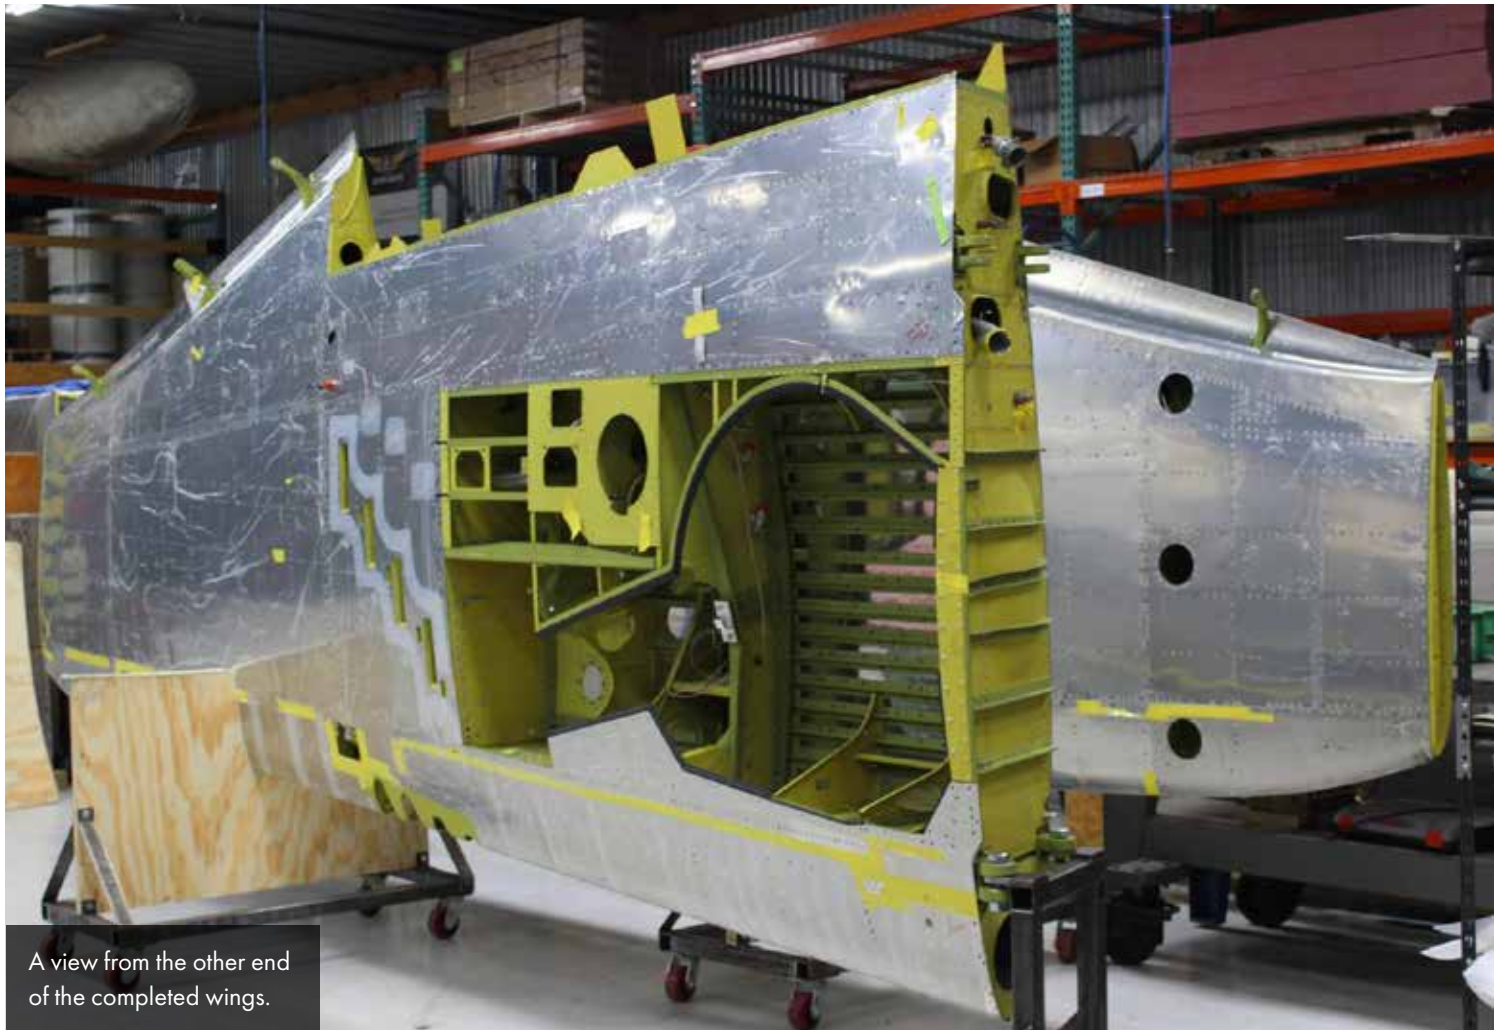
A view from the other end of the completed wings.

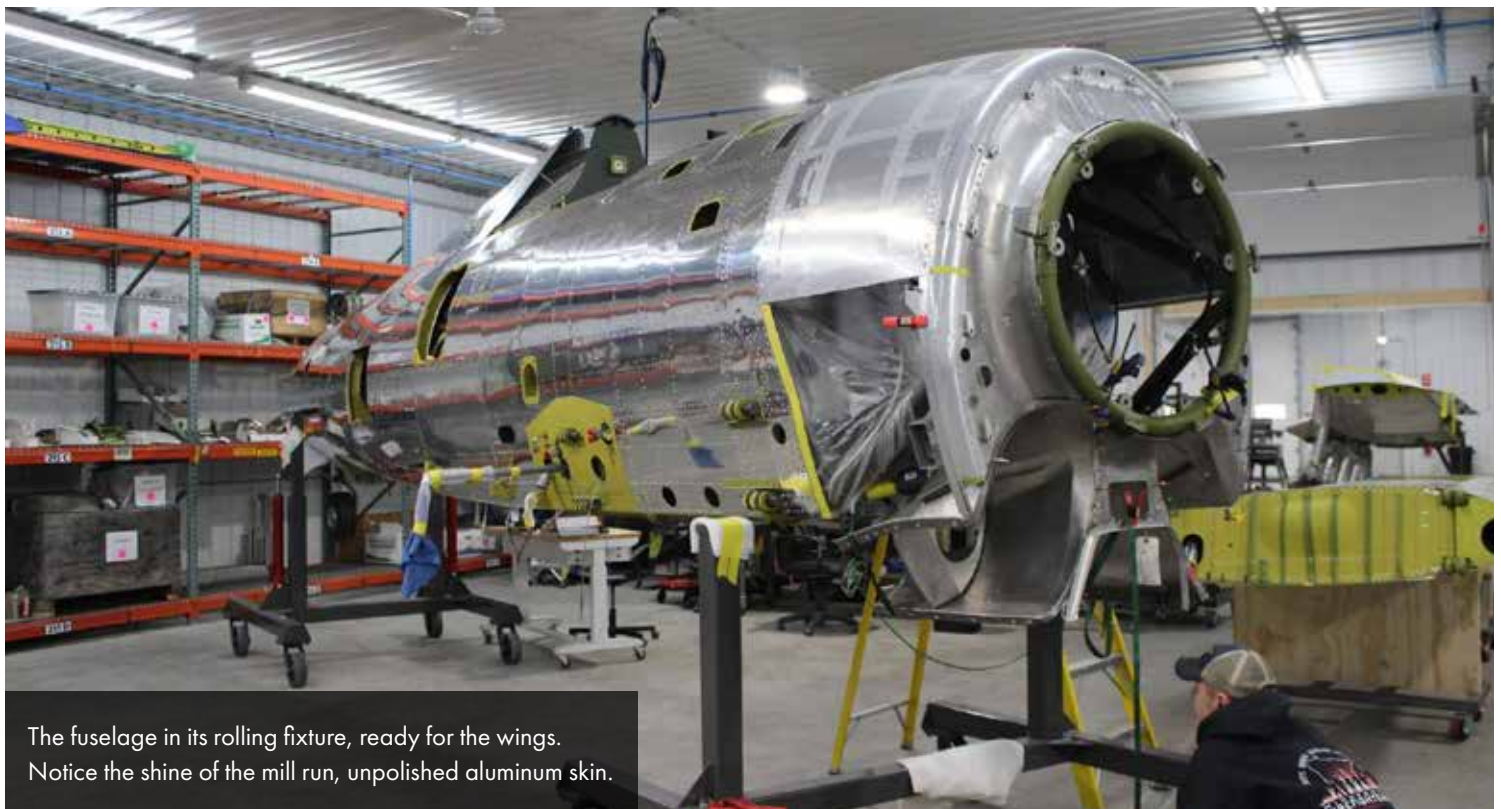
The fuselage in its rolling fixture, ready for the wings. Notice the shine of the mill run, unpolished aluminum skin.

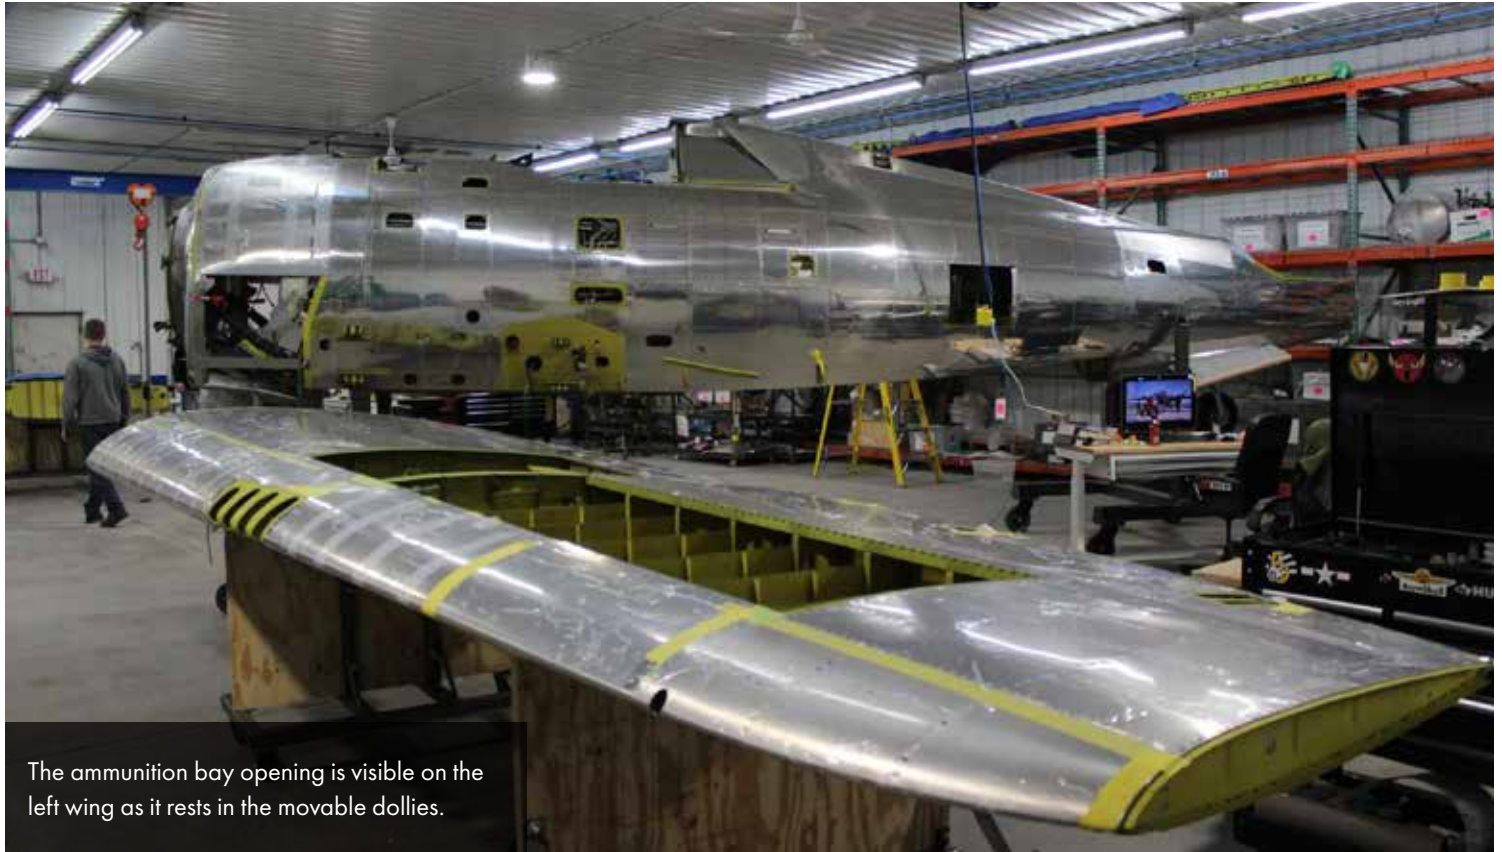
The ammunition bay opening is visible on the left wing as it rests in the movable dollies.

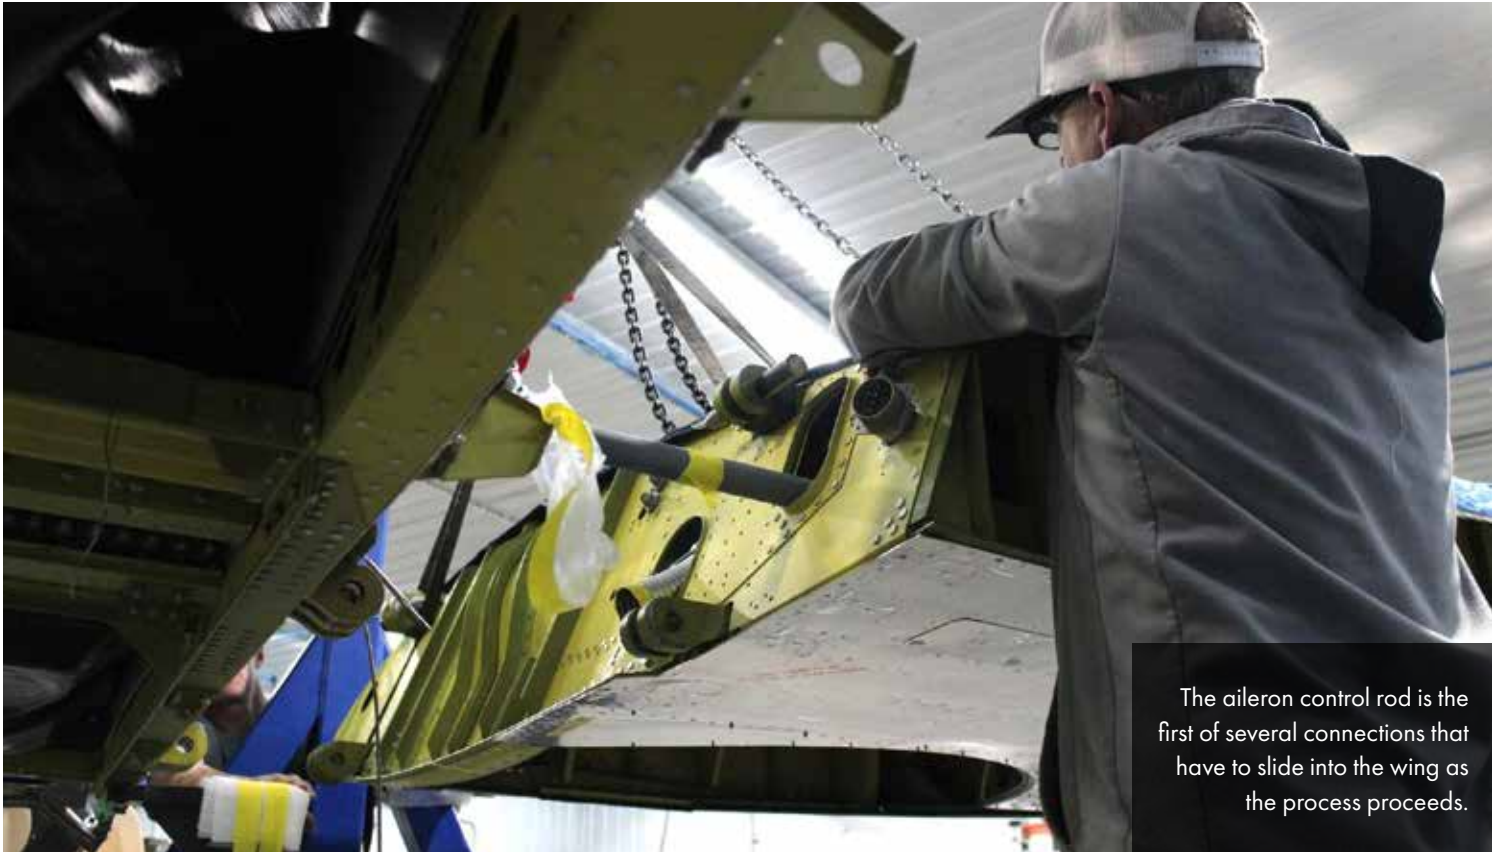
The aileron control rod is the first of several connections that have to slide into the wing as the process proceeds.

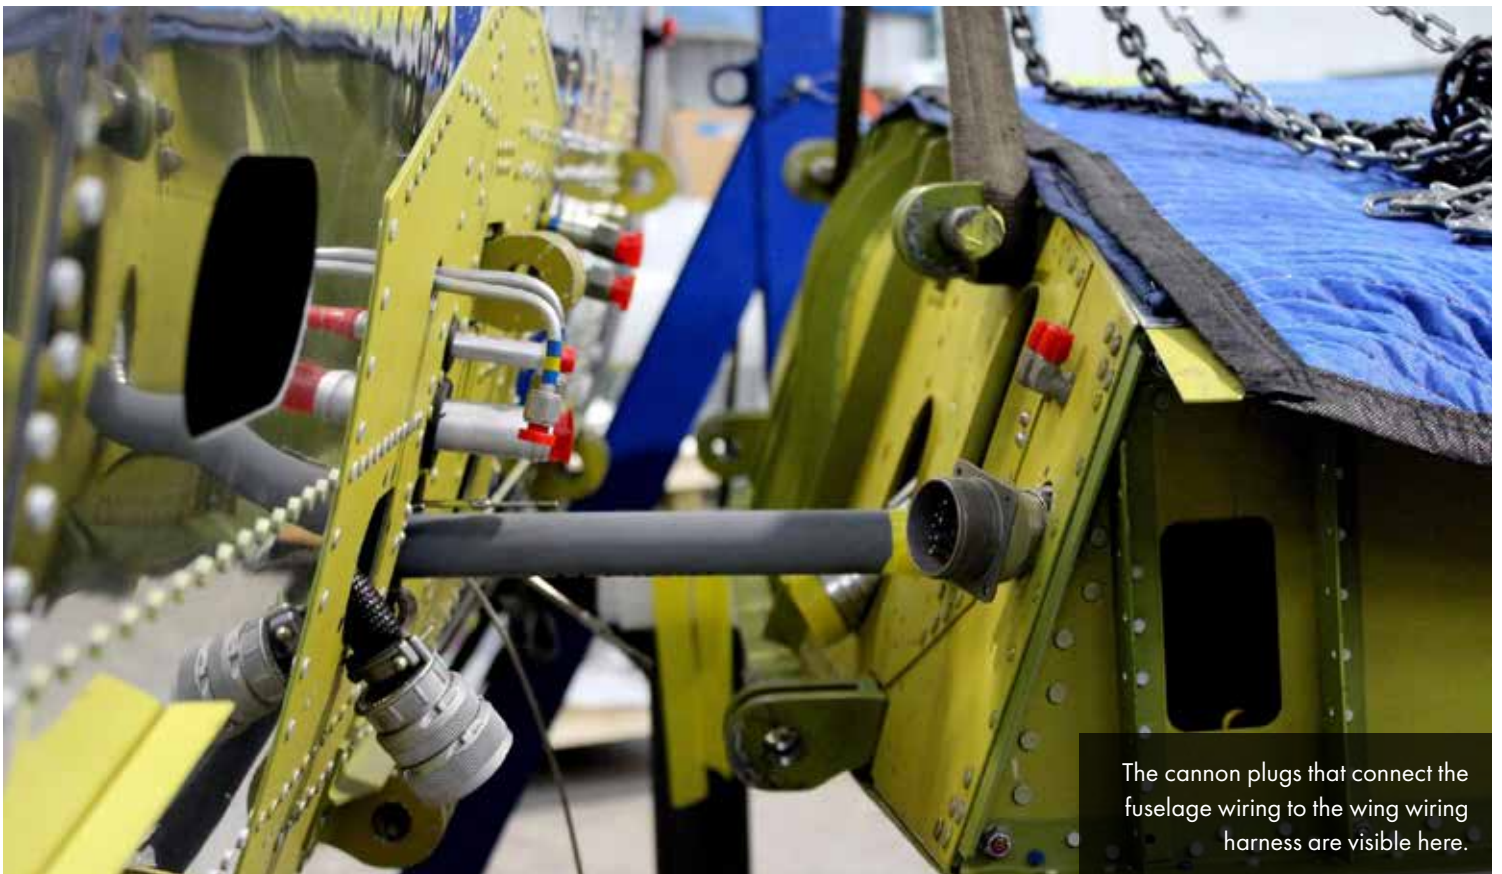
The cannon plugs that connect the fuselage wiring to the wing wiring harness are visible here.

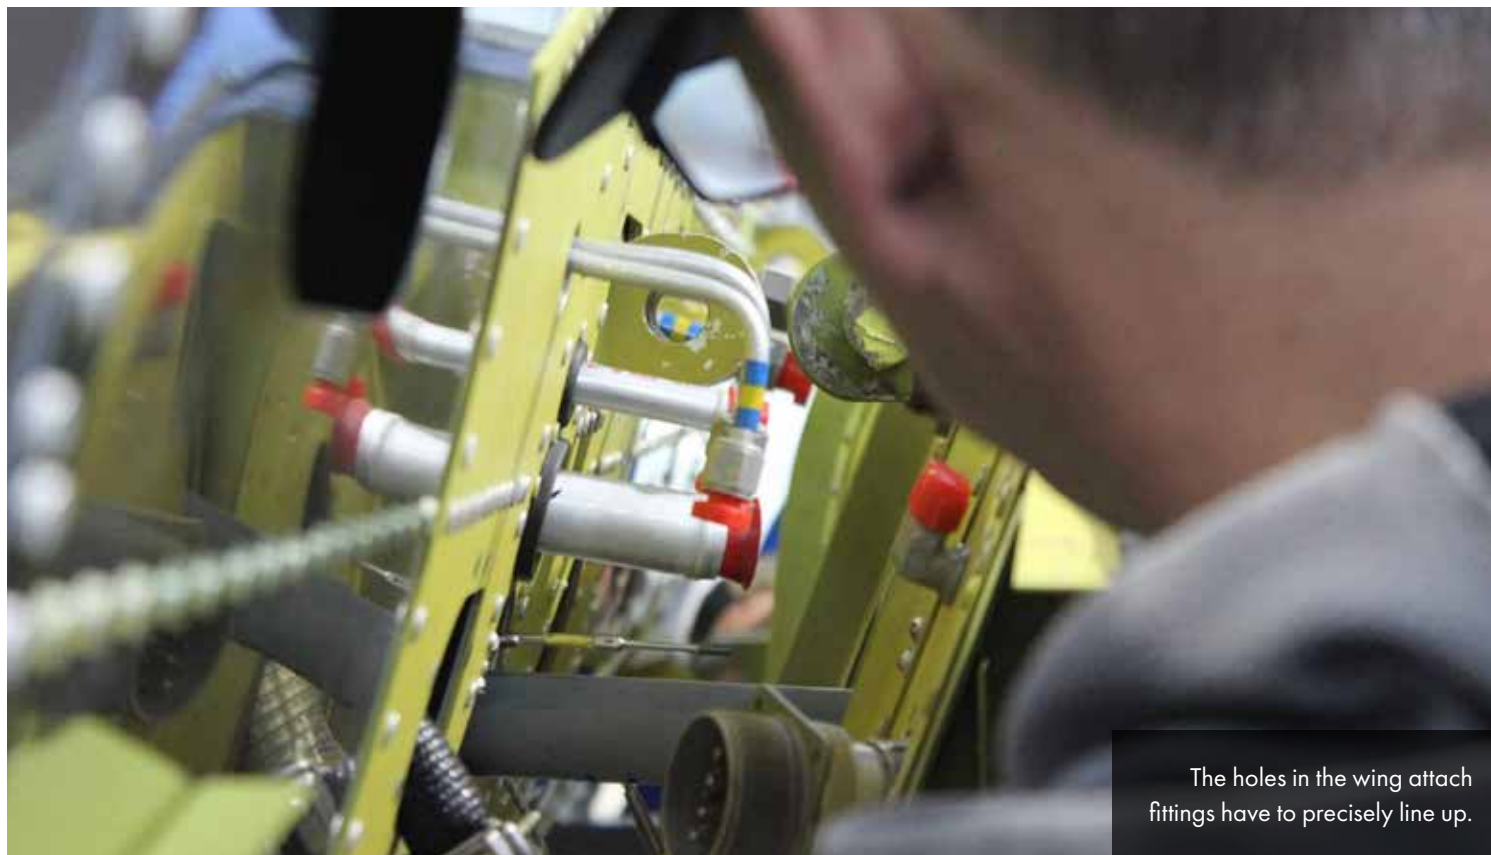
The holes in the wing attach fittings have to precisely line up.

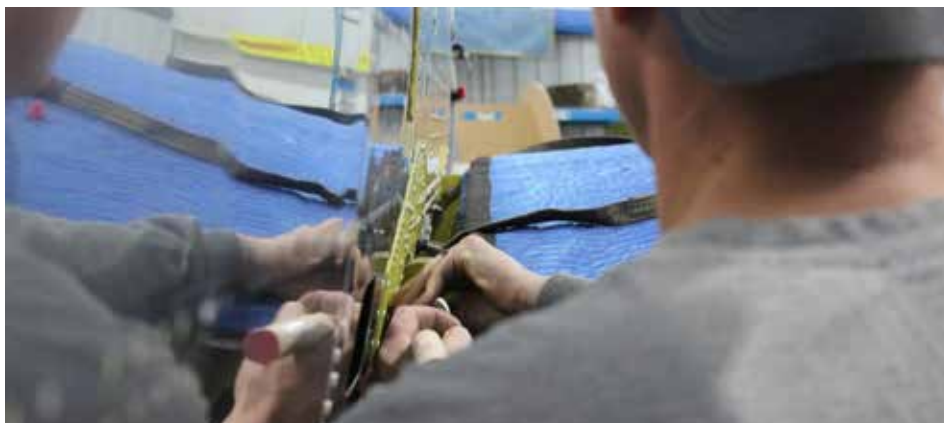
Chad lines up the large, machined, temporary wing retaining pin. Even though these are just temporary for the fitting, they had to be made with close tolerances.

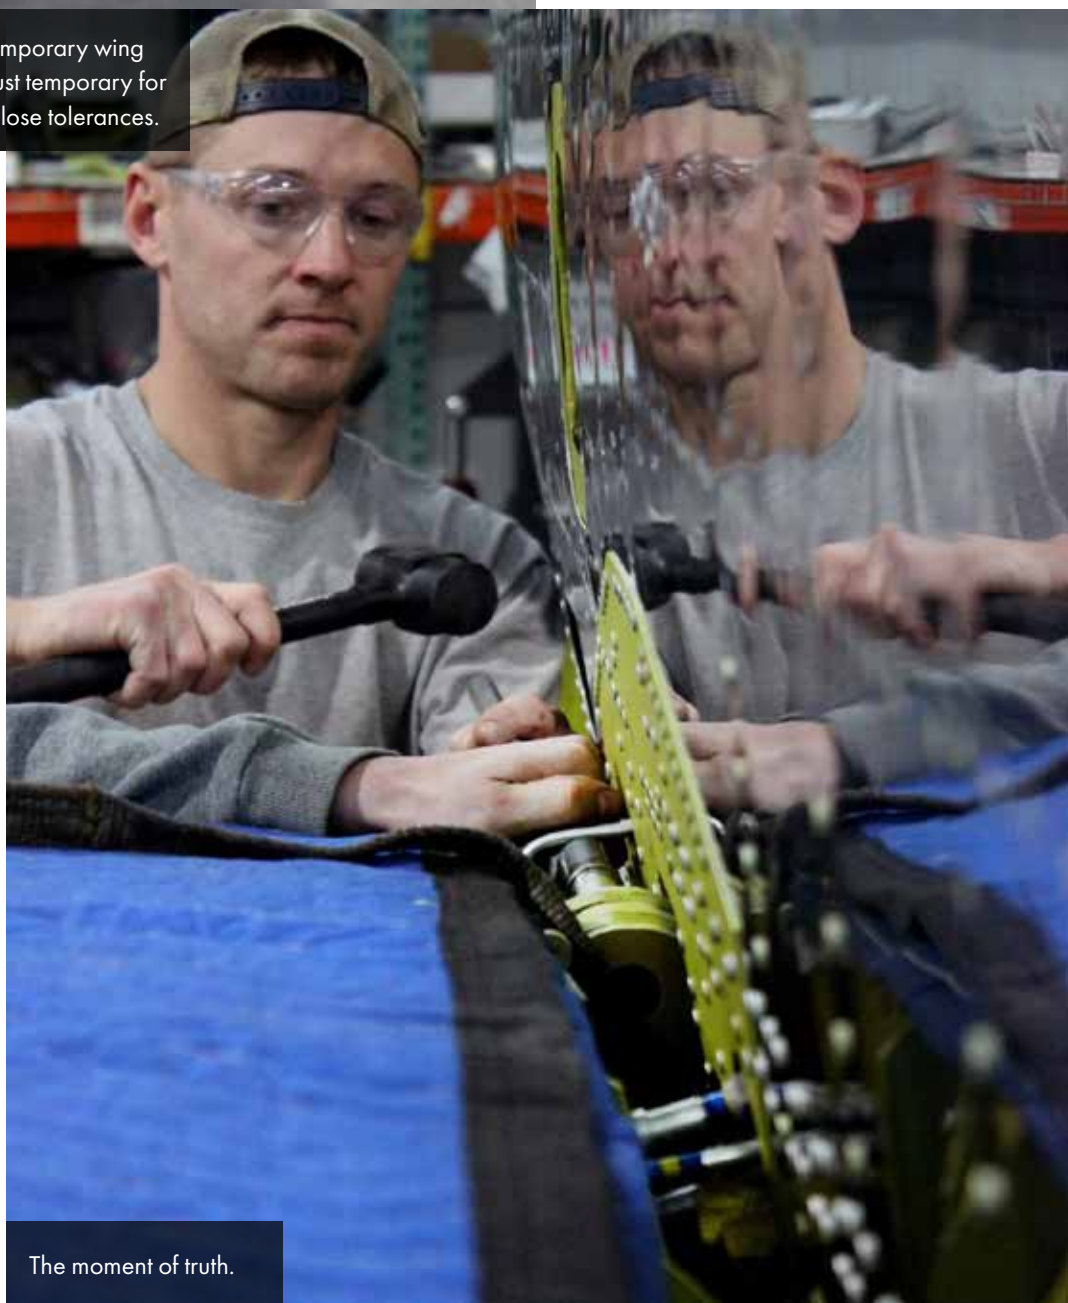
The moment of truth.

Because each wing has four attachment points and the precision required to line up the four temporary retaining pins; everyone feels a little pressure, even though they know they'll fit. These pins will be replaced by the permanent wing bolts at final assembly.

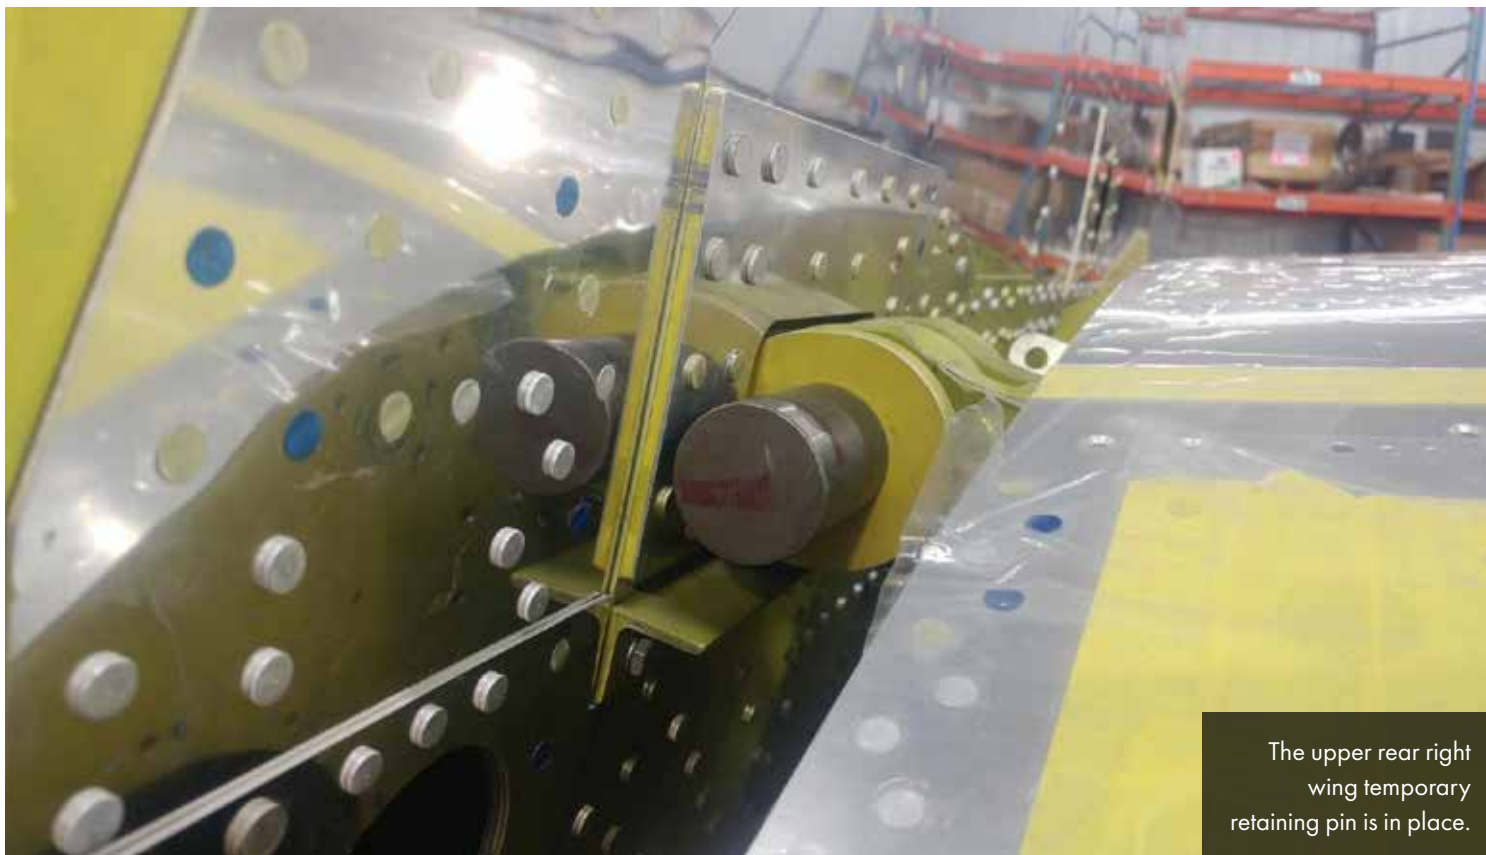
The upper rear right wing temporary retaining pin is in place.

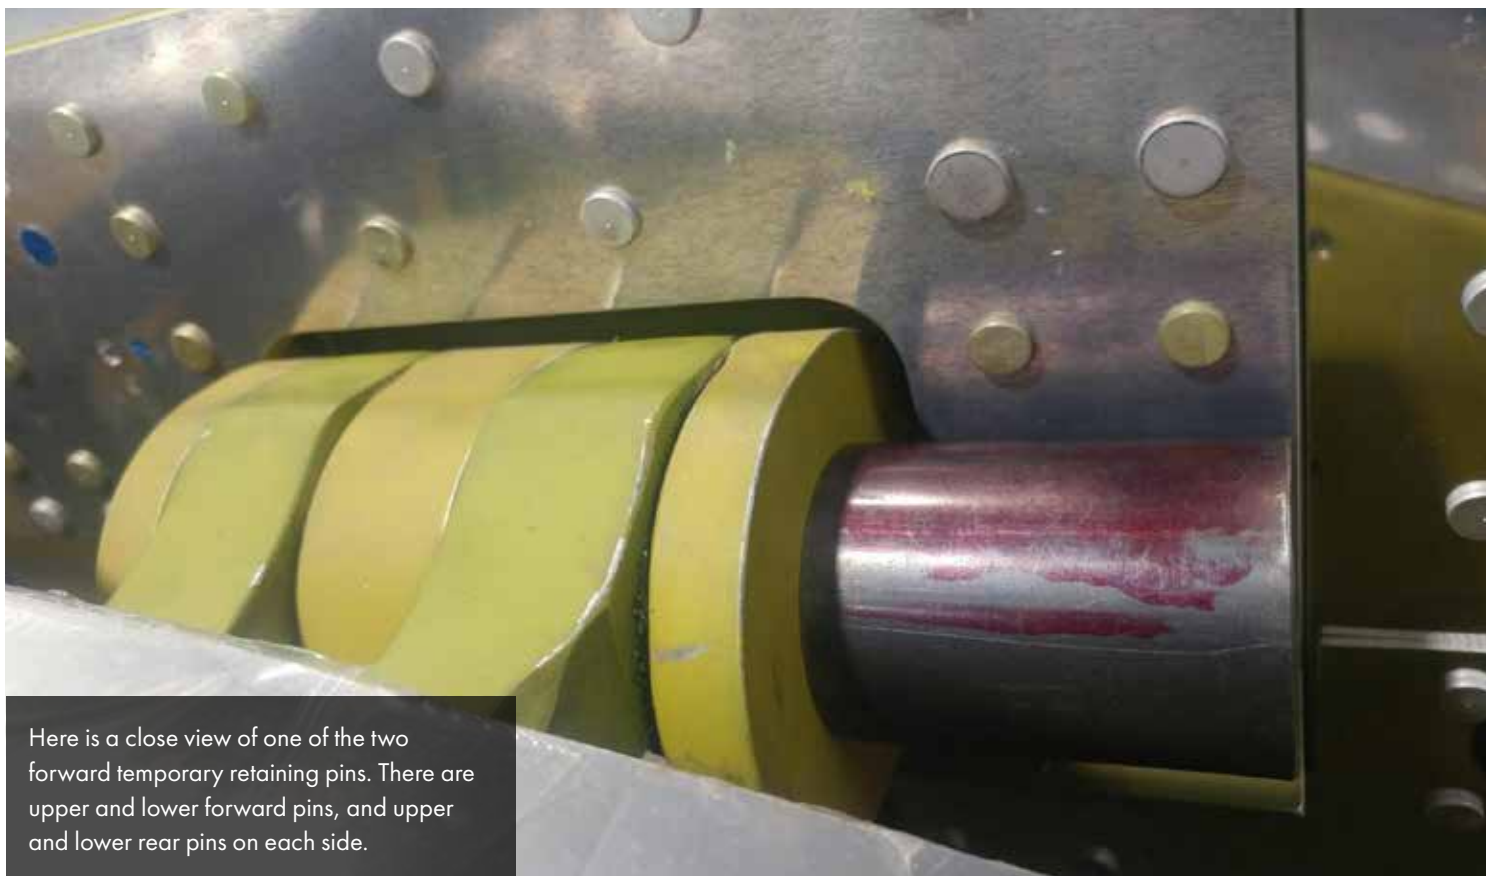
Here is a close view of one of the two forward temporary retaining pins. There are upper and lower forward pins, and upper and lower rear pins on each side.
