Dakota Territory Air Museum's P-47 Update

by Chuck Cravens

Five years ago, in April of 2016, I began writing updates on the P-47D-23-RA AAF serial number 42-27609, though much fabrication and other preparation work preceded the first update.

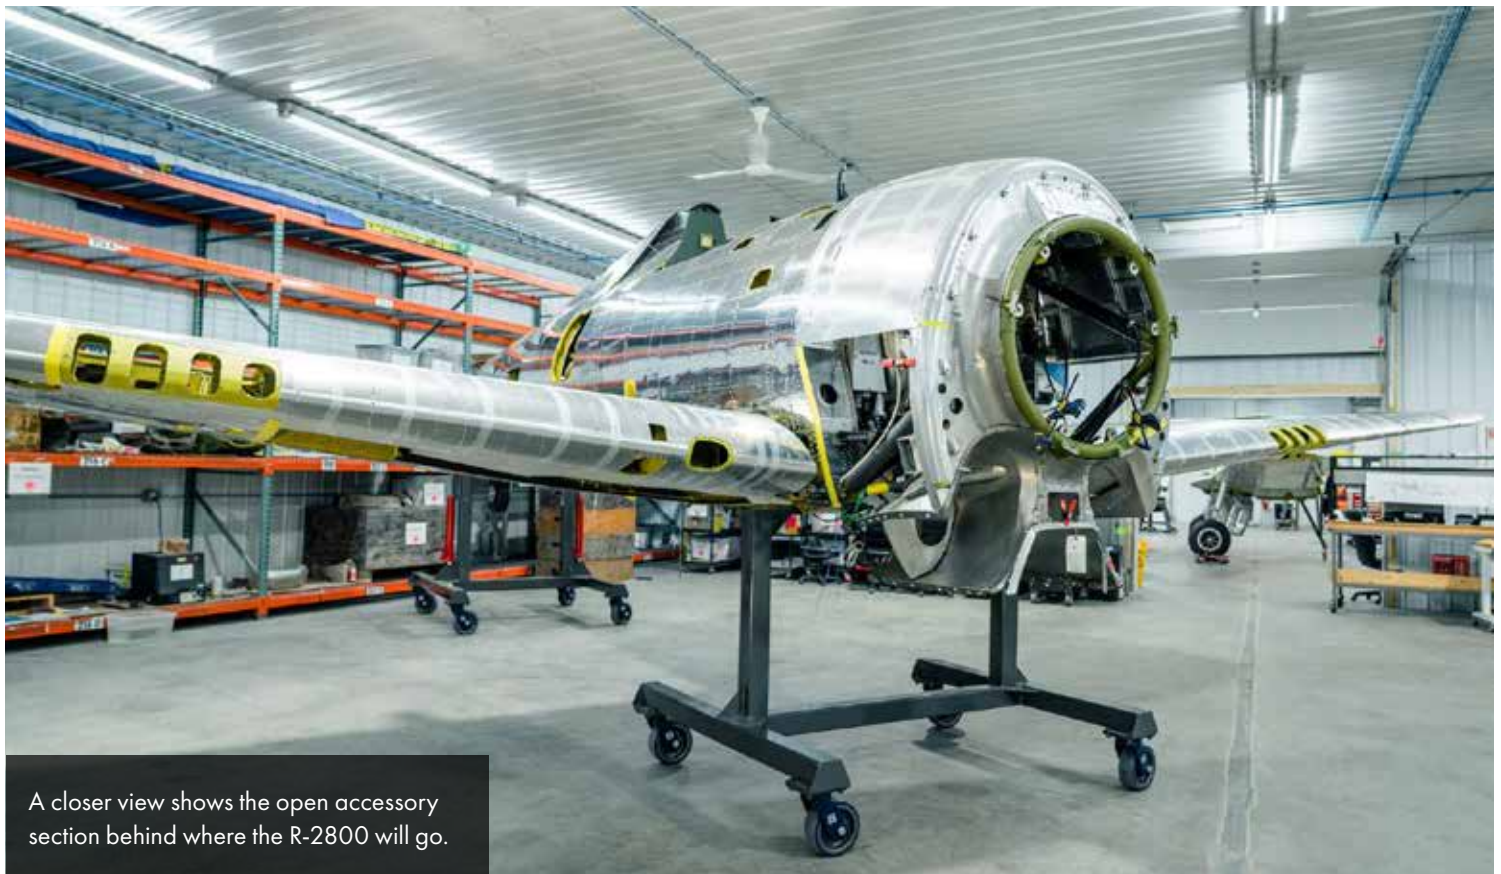
A closer view shows the open accessory section behind where the R-2800 will go.

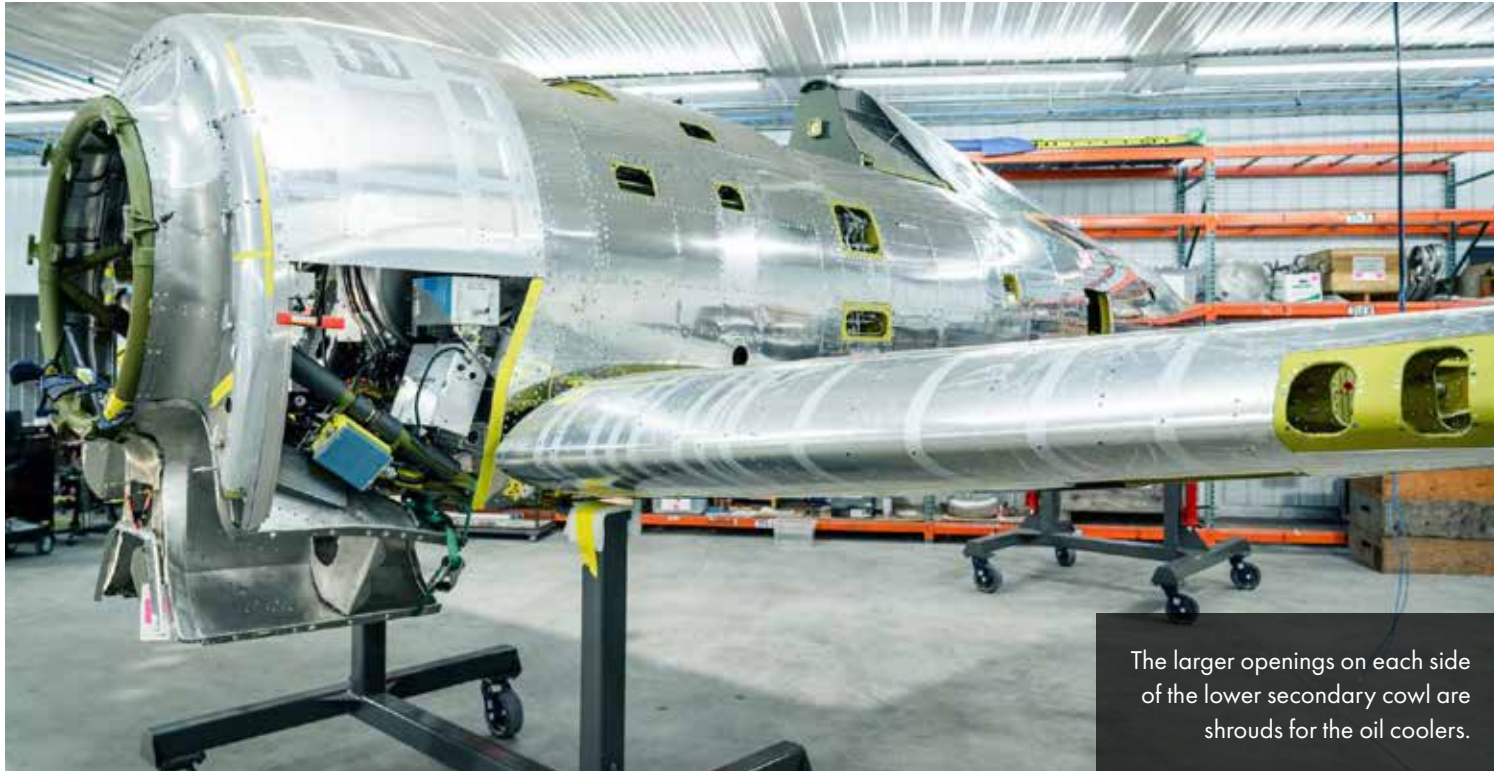
The larger openings on each side of the lower secondary cowl are shrouds for the oil coolers.

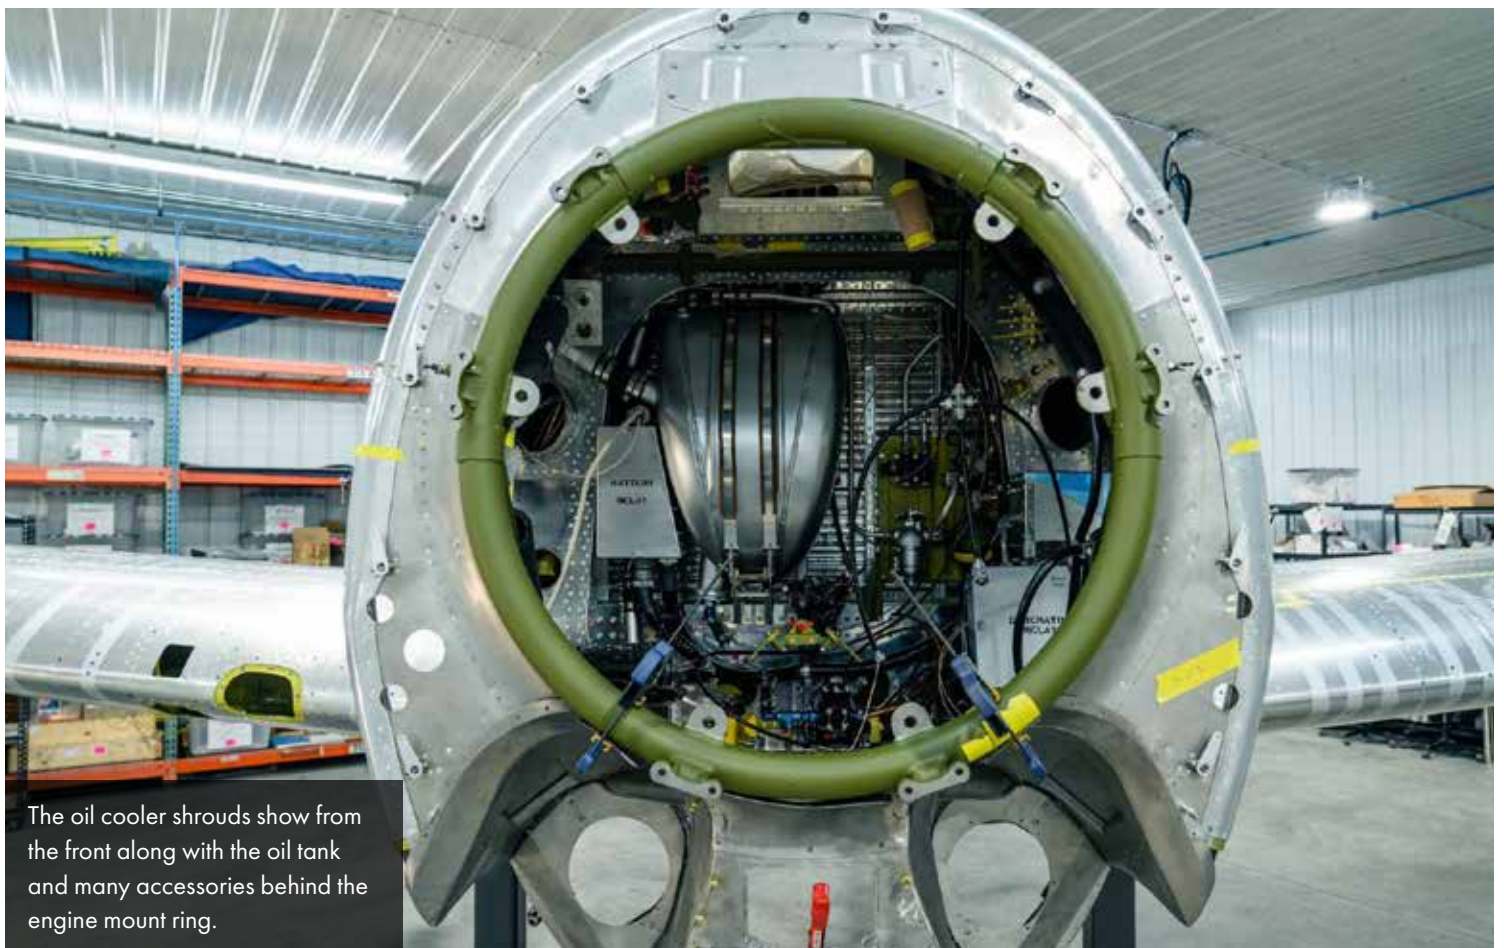
The oil cooler shrouds show from the front along with the oil tank and many accessories behind the engine mount ring.

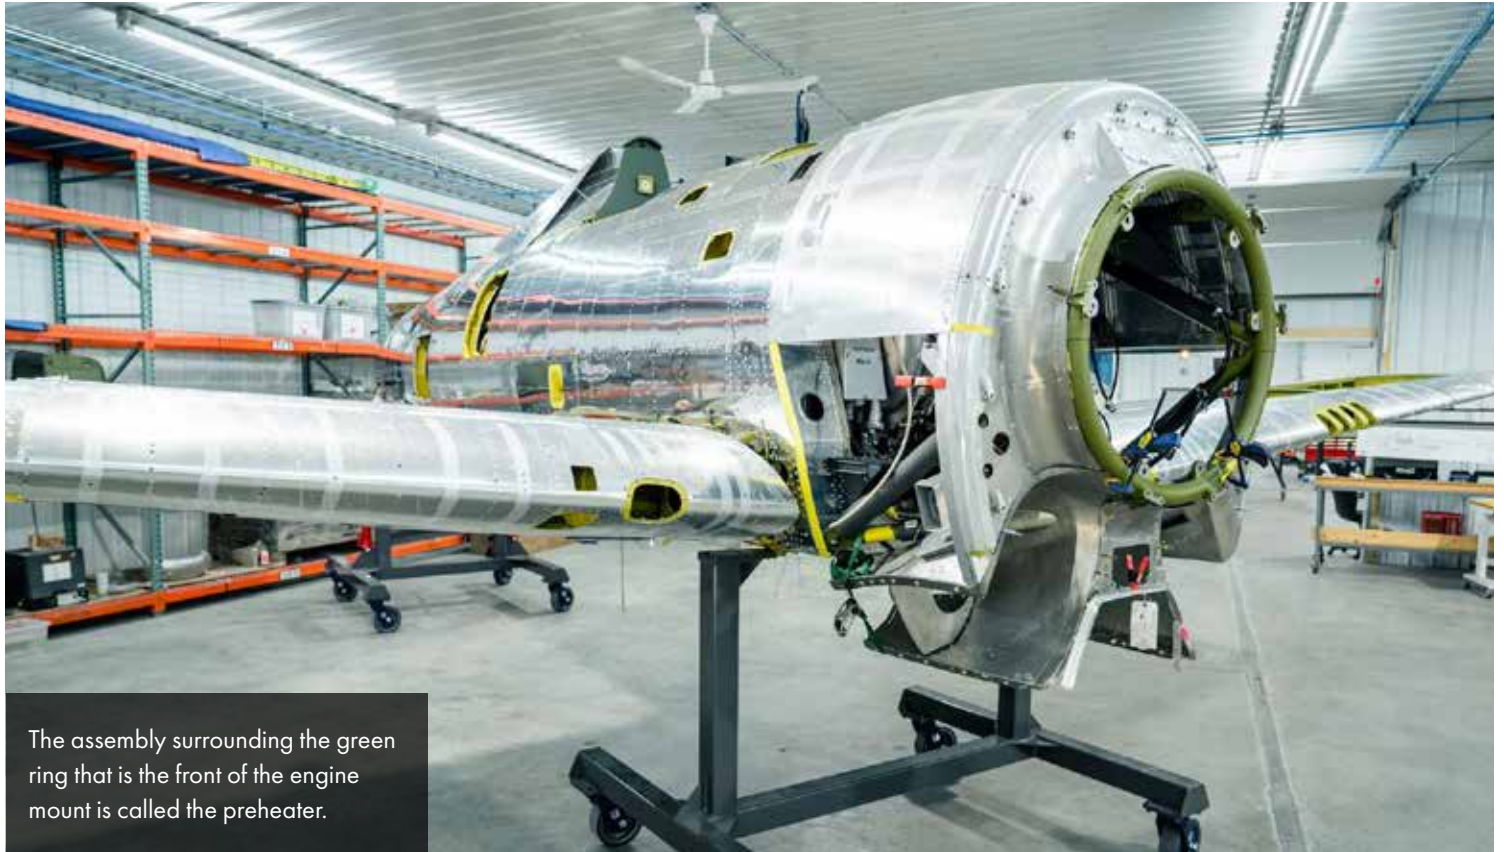
The assembly surrounding the green ring that is the front of the engine mount is called the preheater.

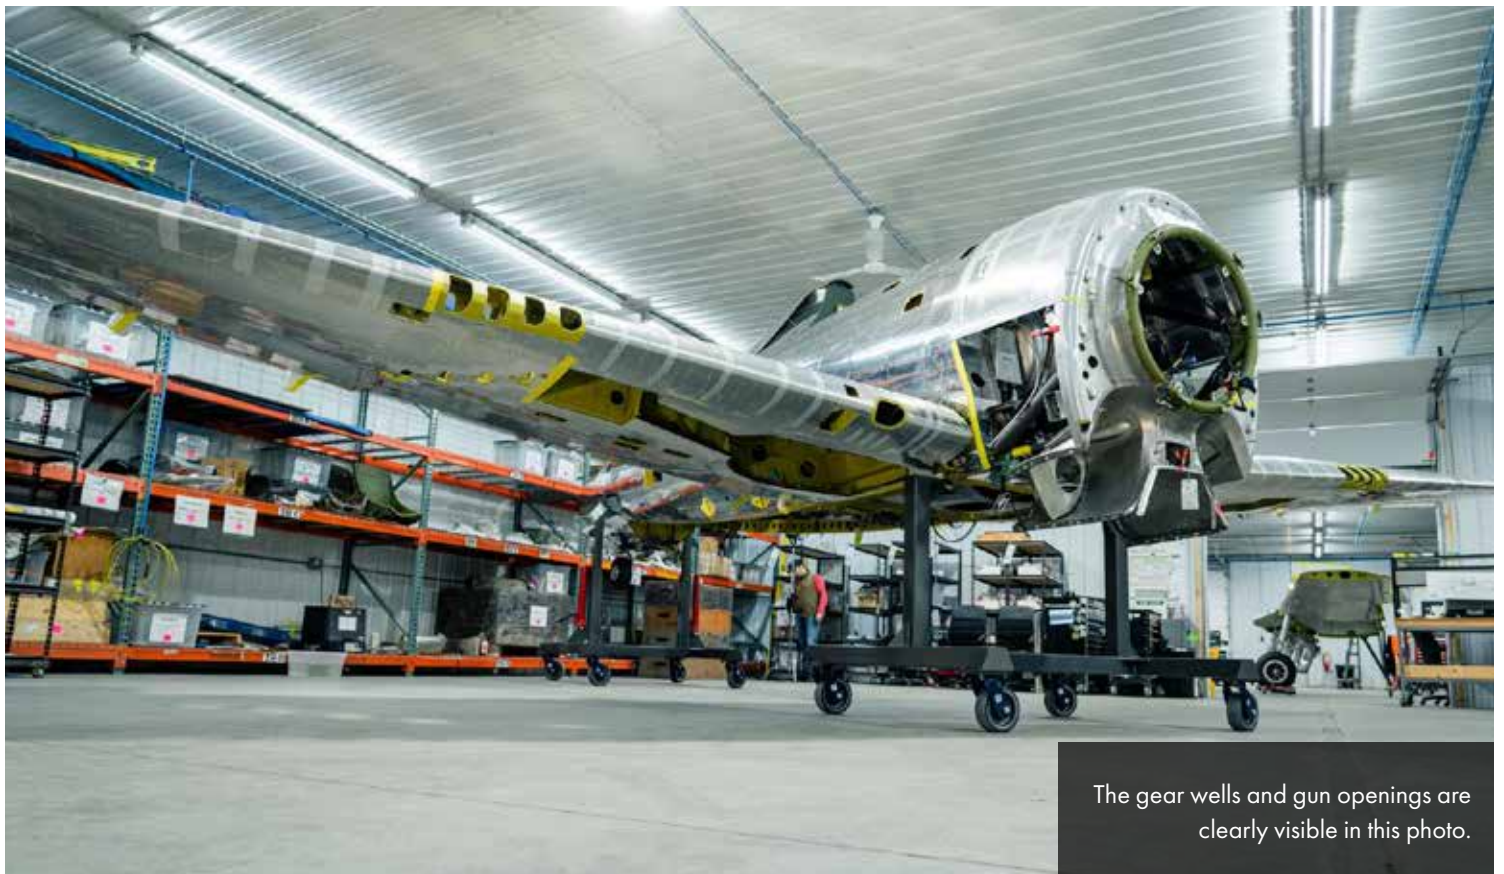
The gear wells and gun openings are clearly visible in this photo.

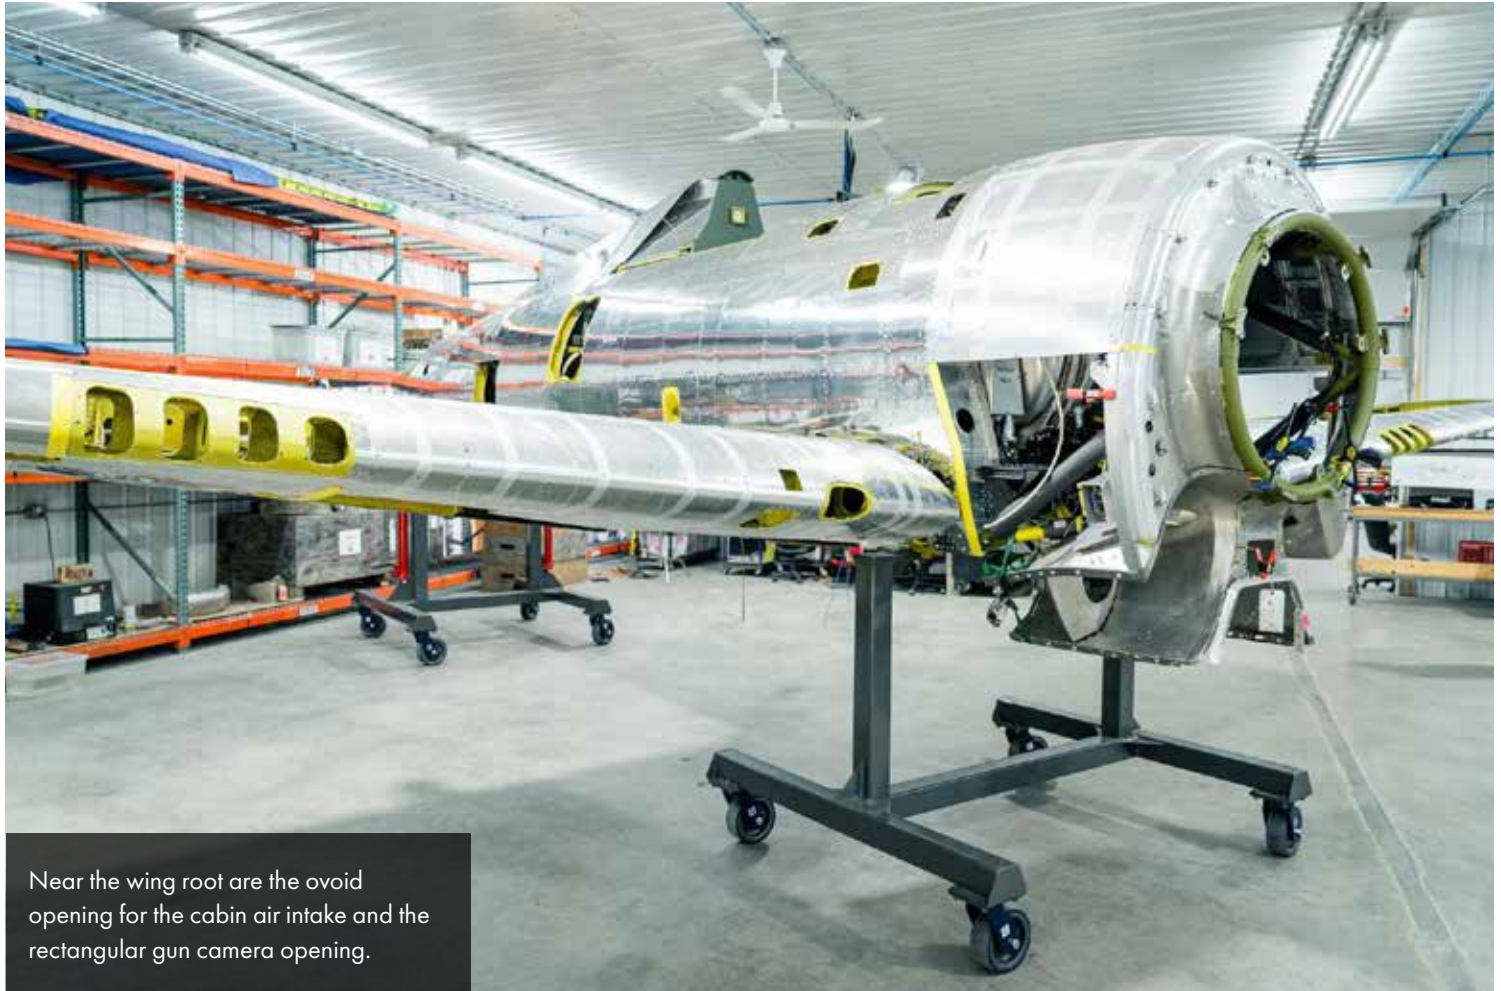
Near the wing root are the ovoid opening for the cabin air intake and the rectangular gun camera opening.
