Texas Flying Legends' P-47 Update
by Chuck Cravens

Update

Last month we looked into the fabrication and assembly of the horizontal and vertical stabilizers. This month the restoration technicians moved on to skinning the tail cone where those stabilizers will eventually mount.

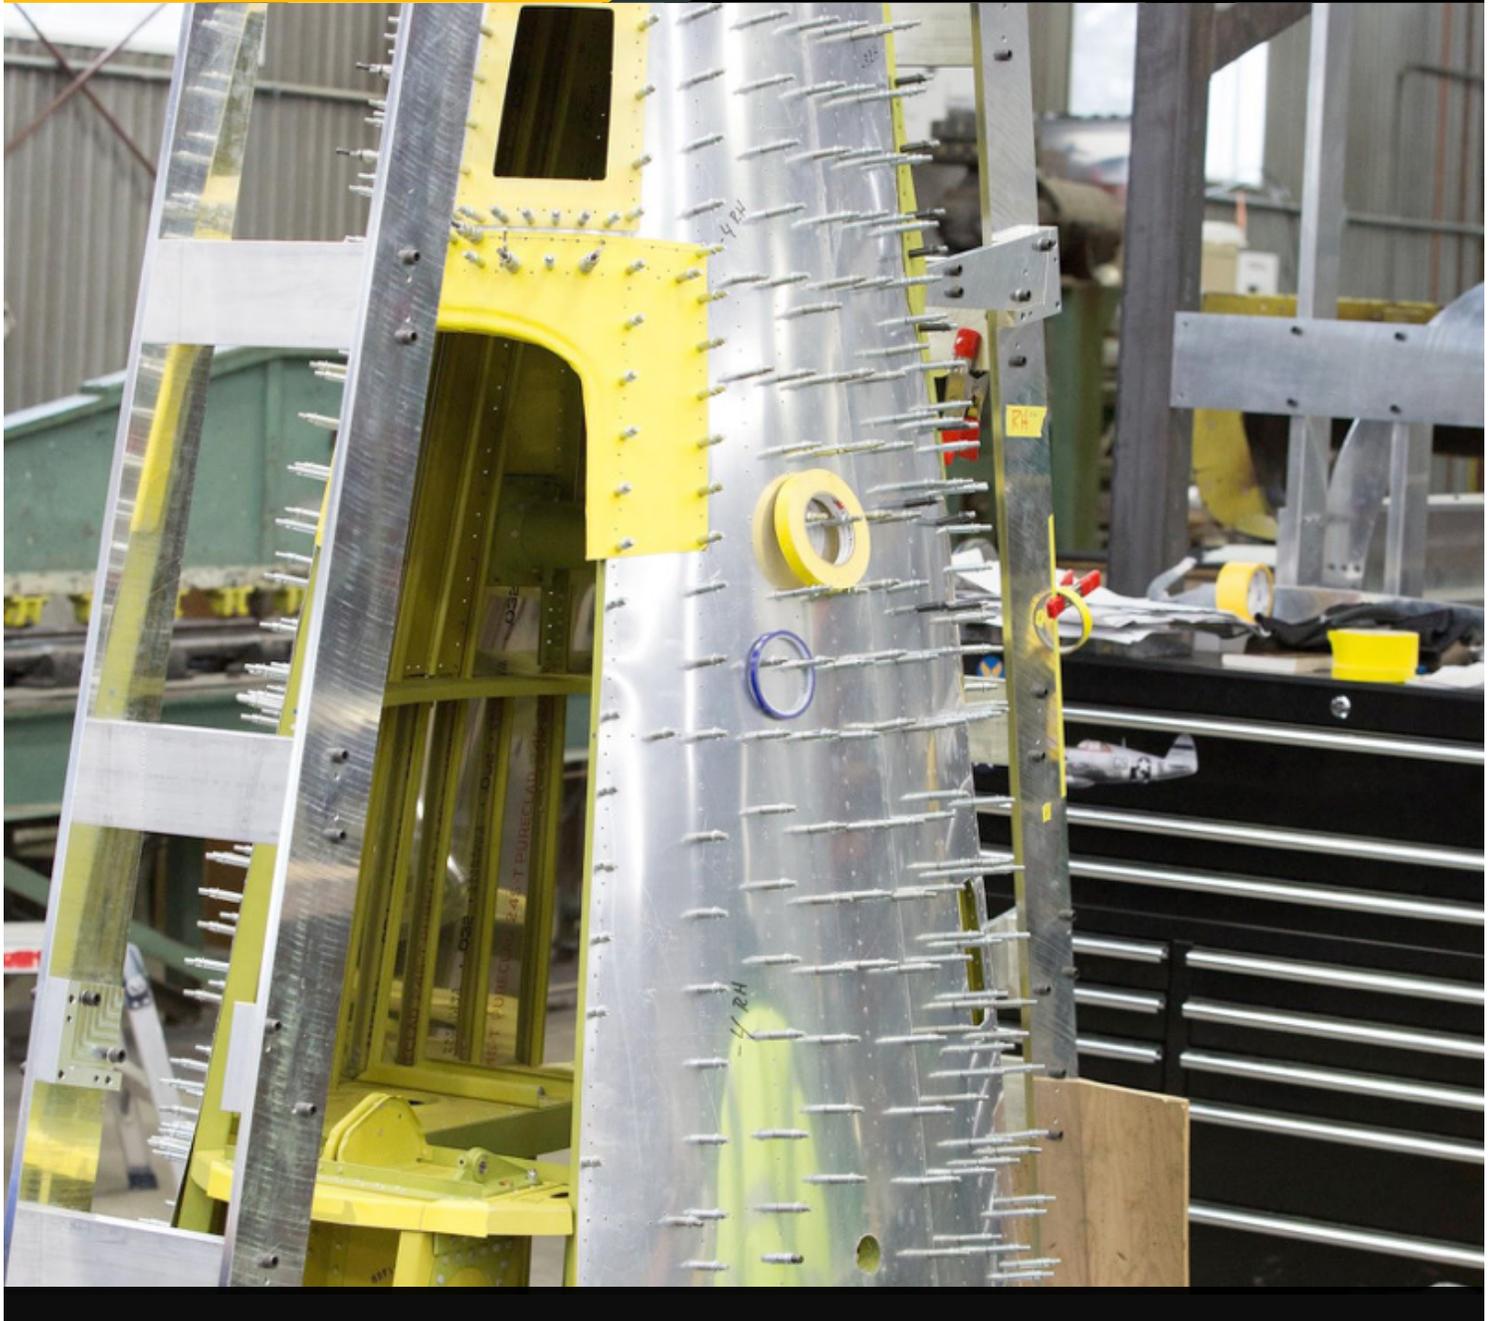
Most of the skin has been fitted to the tail cone.

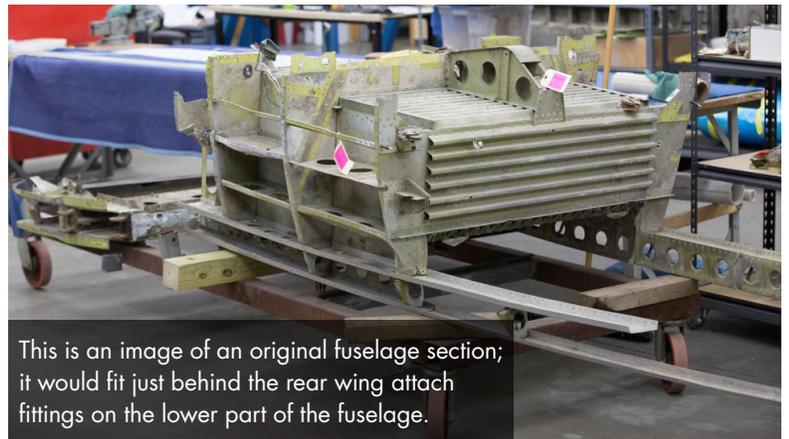
This is an image of an original fuselage section; it would fit just behind the rear wing attach fittings on the lower part of the fuselage.

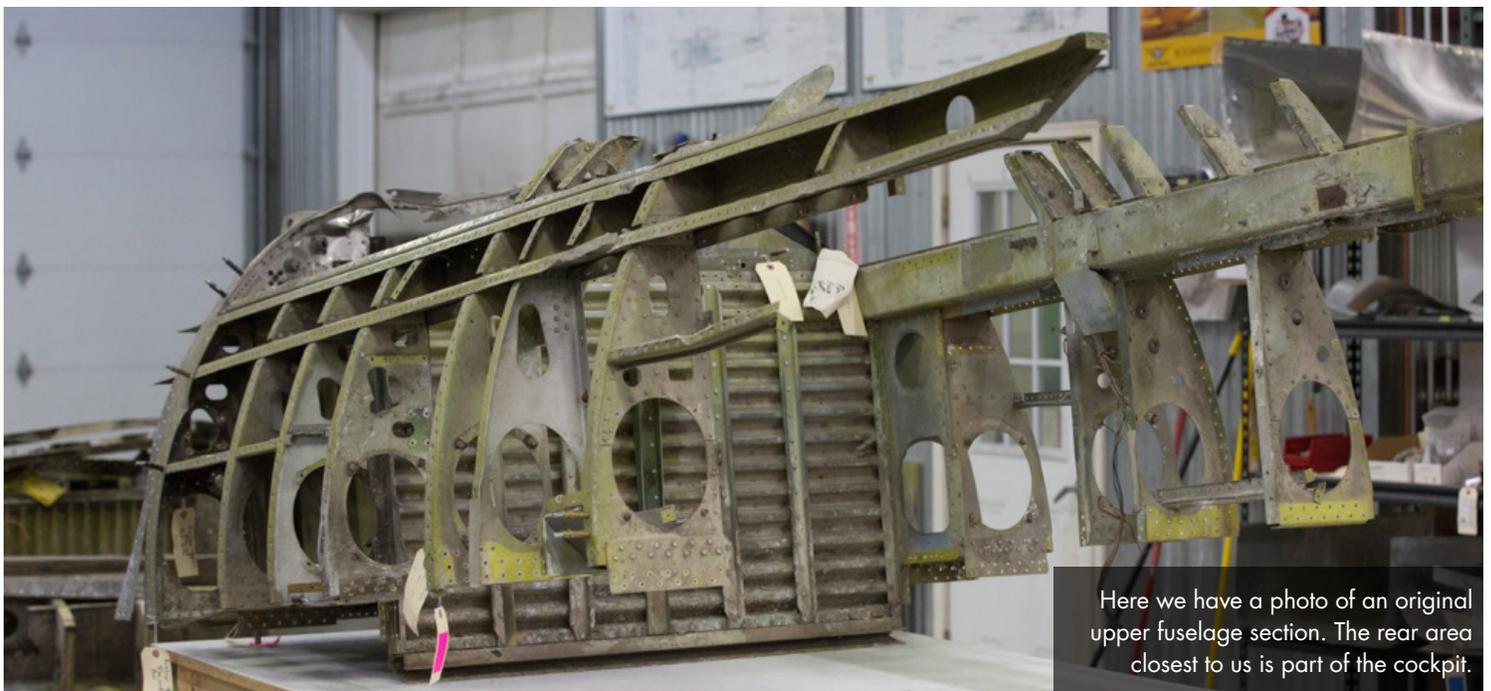
Here we have a photo of an original upper fuselage section. The rear area closest to us is part of the cockpit.

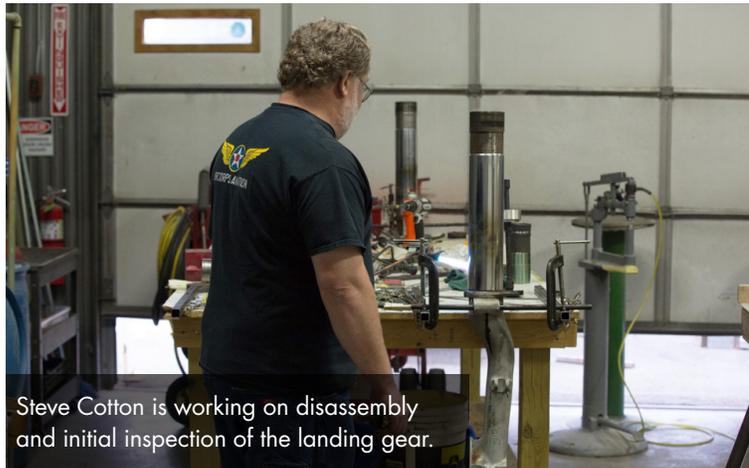
Steve Cotton is working on disassembly and initial inspection of the landing gear.

Reforging new landing gear parts unique to P-47s would be extremely costly so the initial inspection of the original parts acquired for the restoration was done carefully. Many more inspections and testing procedures will follow before we can determine whether or not the parts can be reused in the restored airframe.

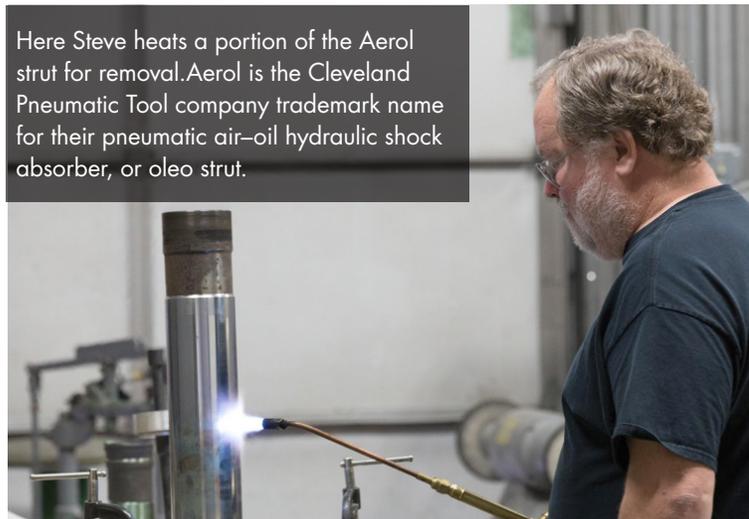
Here Steve heats a portion of the Aerol strut for removal. Aerol is the Cleveland Pneumatic Tool company trademark name for their pneumatic air-oil hydraulic shock absorber, or oleo strut.

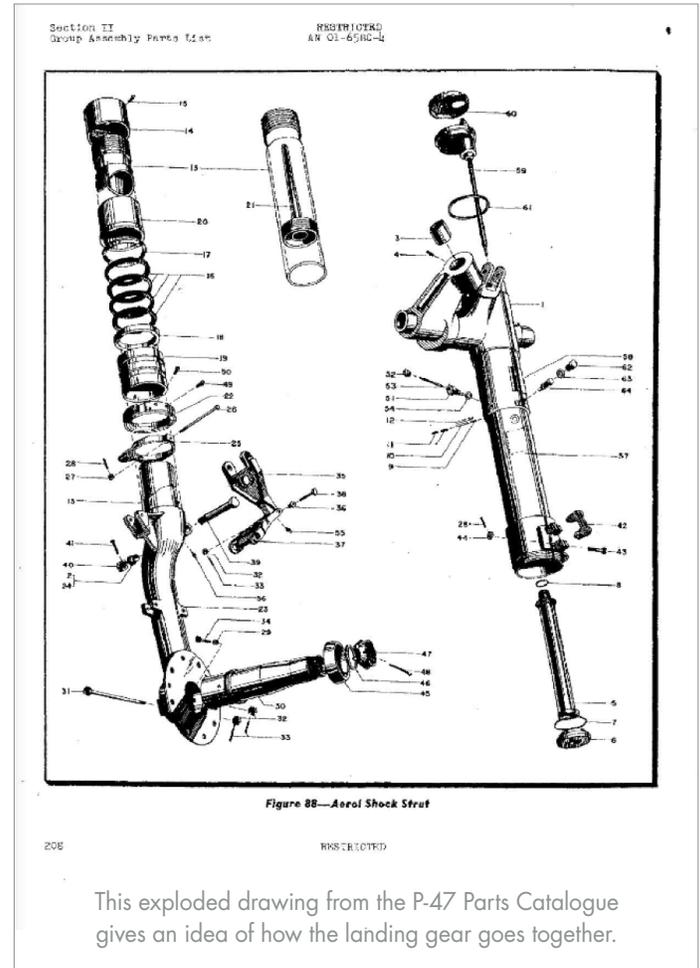
This exploded drawing from the P-47 Parts Catalogue gives an idea of how the landing gear goes together.

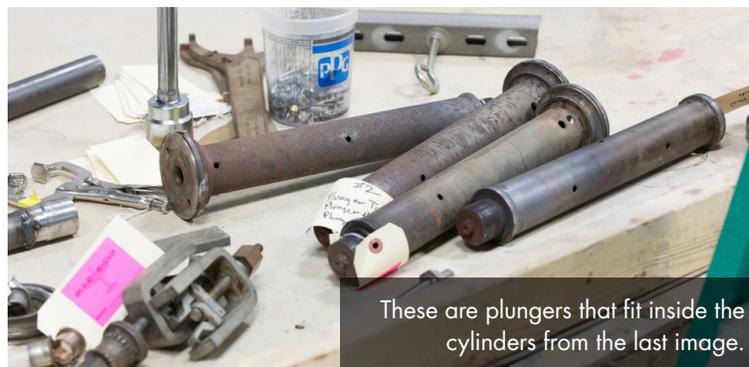
These are plungers that fit inside the cylinders from the last image.

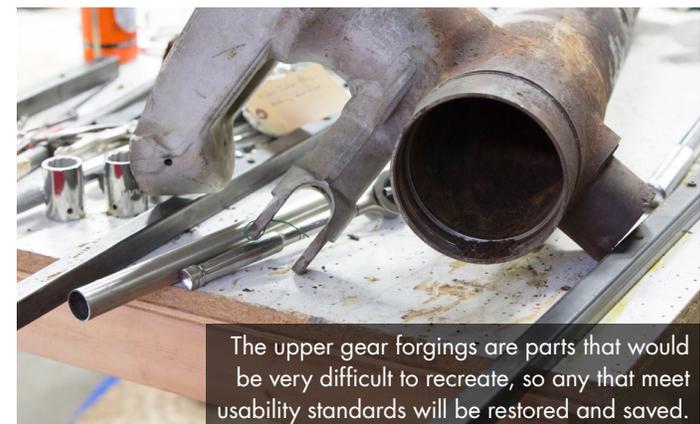
The upper gear forgings are parts that would be very difficult to recreate, so any that meet usability standards will be restored and saved.

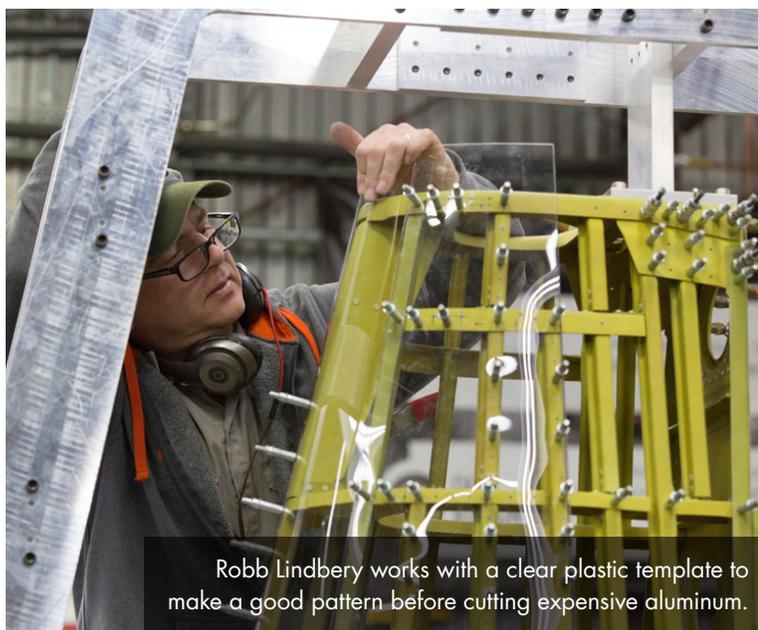
Robb Lindbery works with a clear plastic template to make a good pattern before cutting expensive aluminum.

The process of making and fitting skins on a P-47 comes with the challenge of compound curves on nearly every skin piece. A template is made of clear plastic, trimmed and fitted until it lays smoothly on its intended location. Then the plastic template is used to mark a piece of Alclad or PureClad skin for cutting. Holes are drilled, deburred, and the skin is clecoed on to trial fit. Once the guys are happy with the fit, the skin section gets a coat of zinc chromate on what will be the interior surface. Only then can the skin be permanently riveted on.

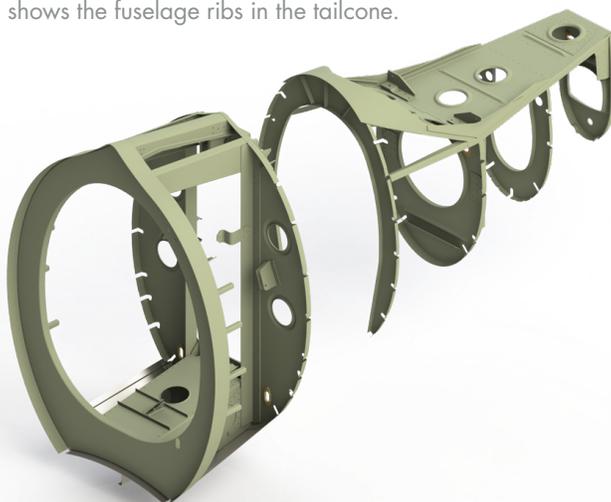
Here is one of Rob McCune's fine CAD renderings of the framework. This image shows the fuselage ribs in the tailcone.

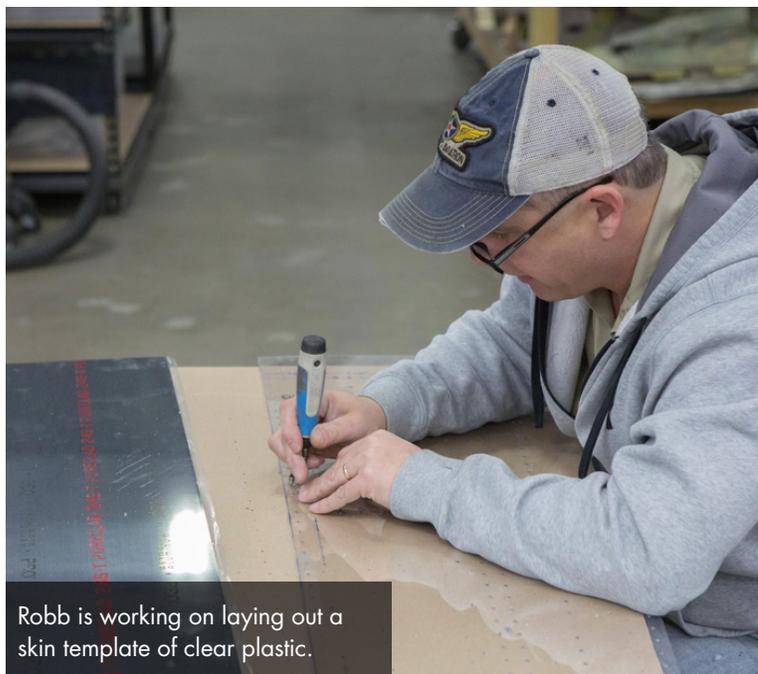
Robb is working on laying out a skin template of clear plastic.

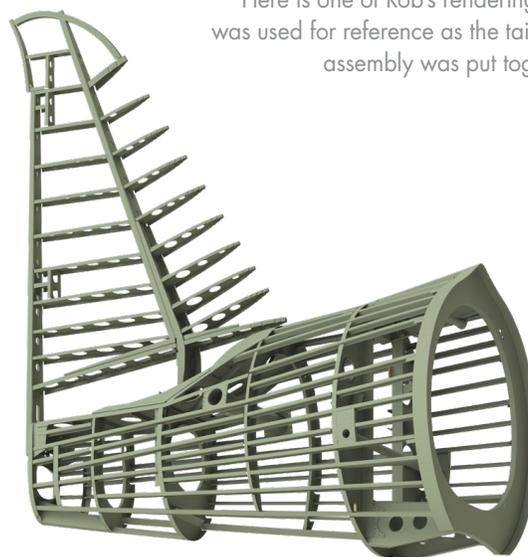
Here is one of Rob's renderings that was used for reference as the tail cone assembly was put together.

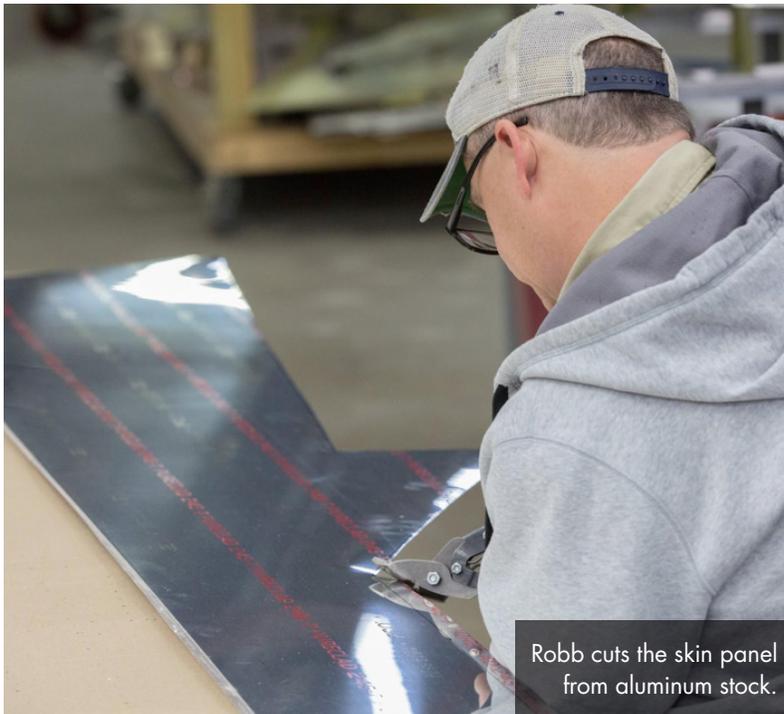
Robb cuts the skin panel from aluminum stock.

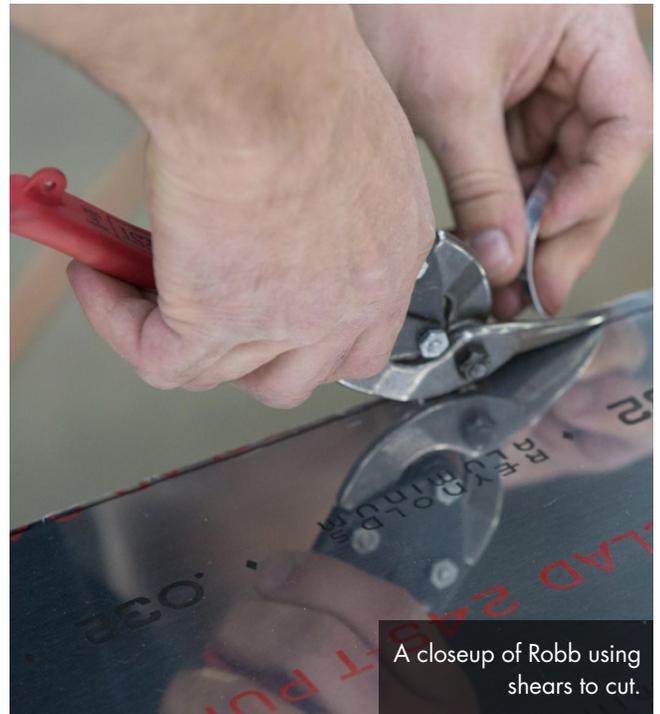
A closeup of Robb using shears to cut.

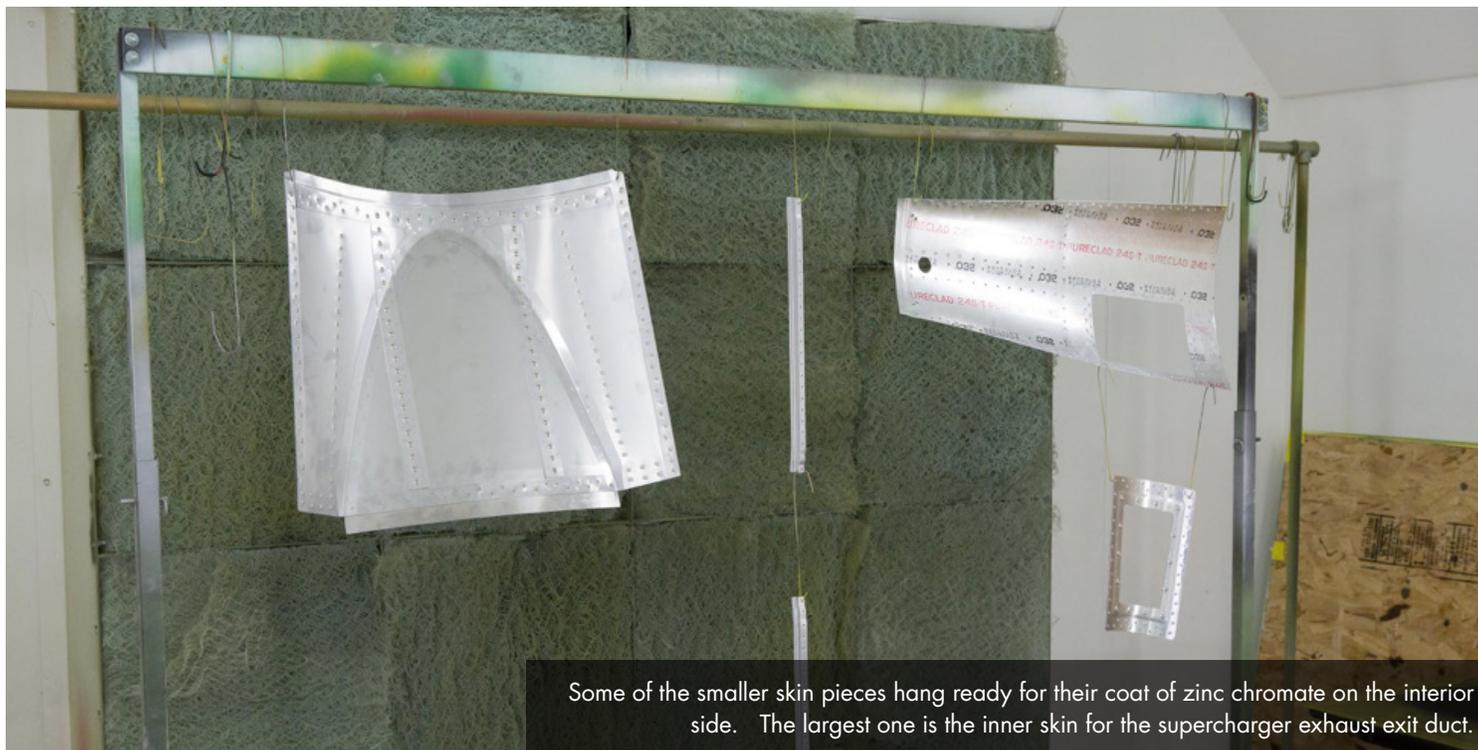
Some of the smaller skin pieces hang ready for their coat of zinc chromate on the interior side. The largest one is the inner skin for the supercharger exhaust exit duct.

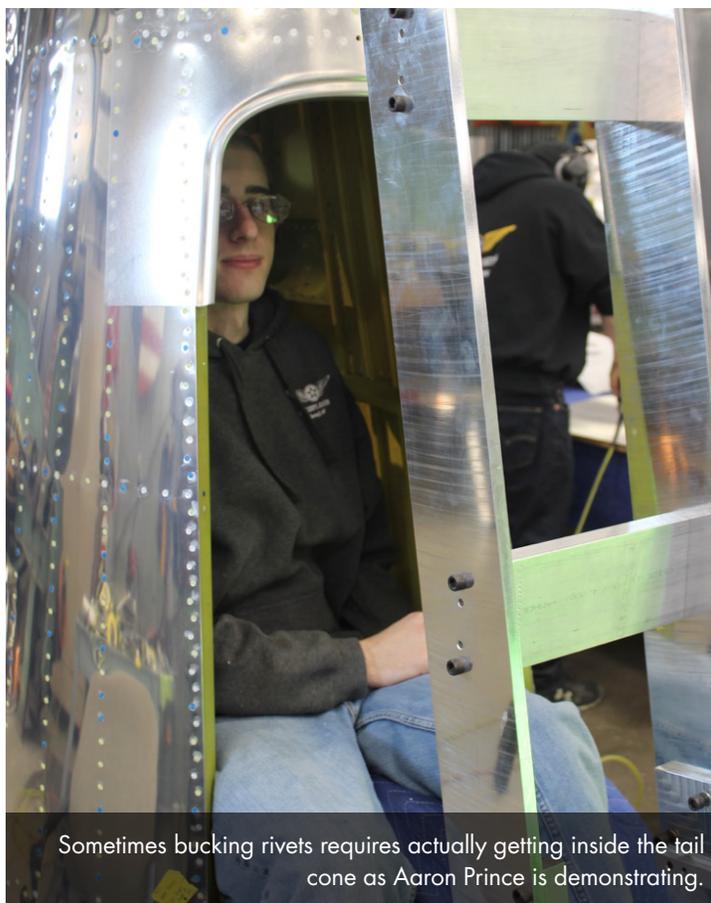
Sometimes bucking rivets requires actually getting inside the tail cone as Aaron Prince is demonstrating.

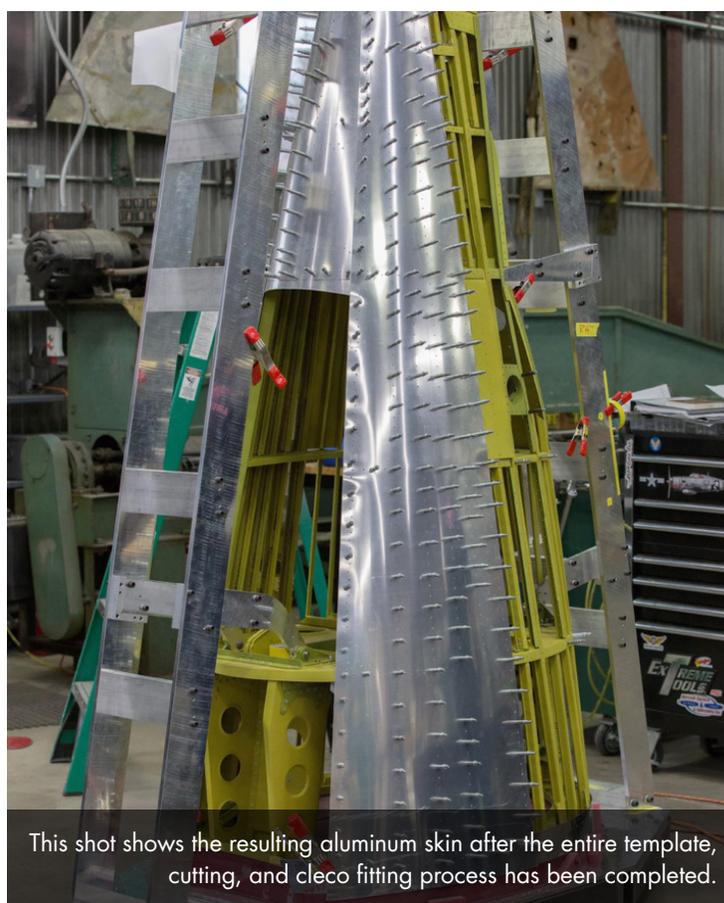
This shot shows the resulting aluminum skin after the entire template, cutting, and cleco fitting process has been completed.

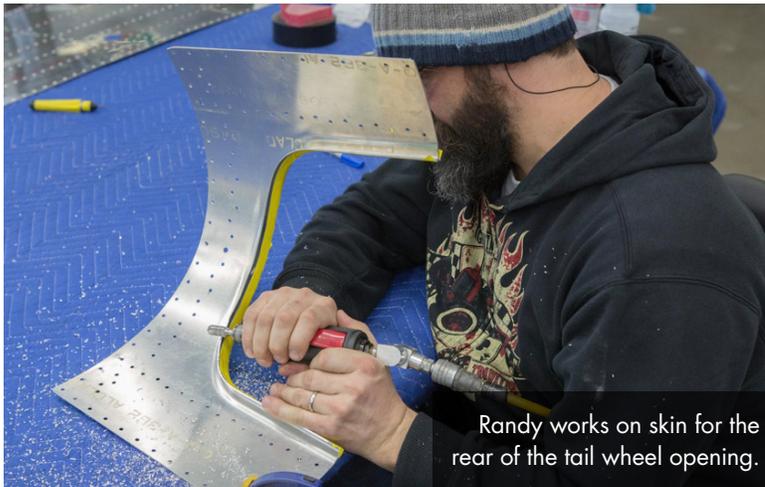
Randy works on skin for the rear of the tail wheel opening.

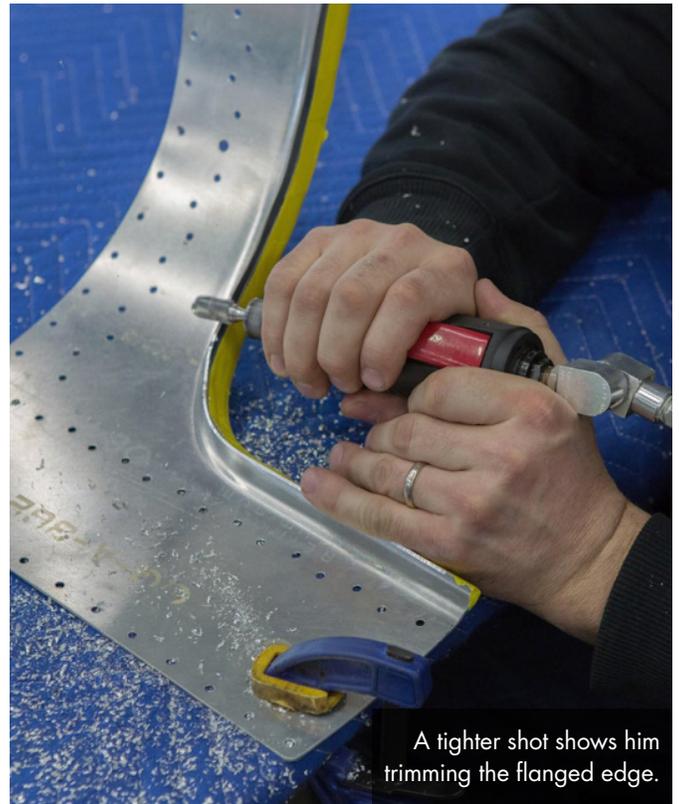
A tighter shot shows him trimming the flanged edge.

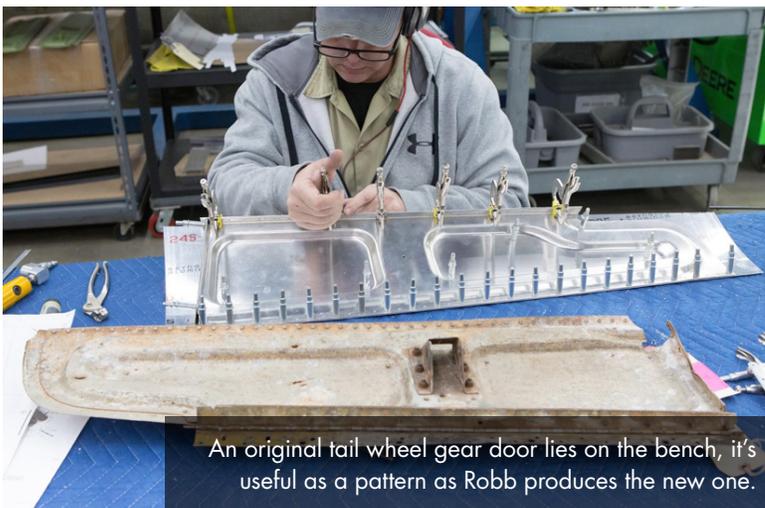
An original tail wheel gear door lies on the bench, it's useful as a pattern as Robb produces the new one.

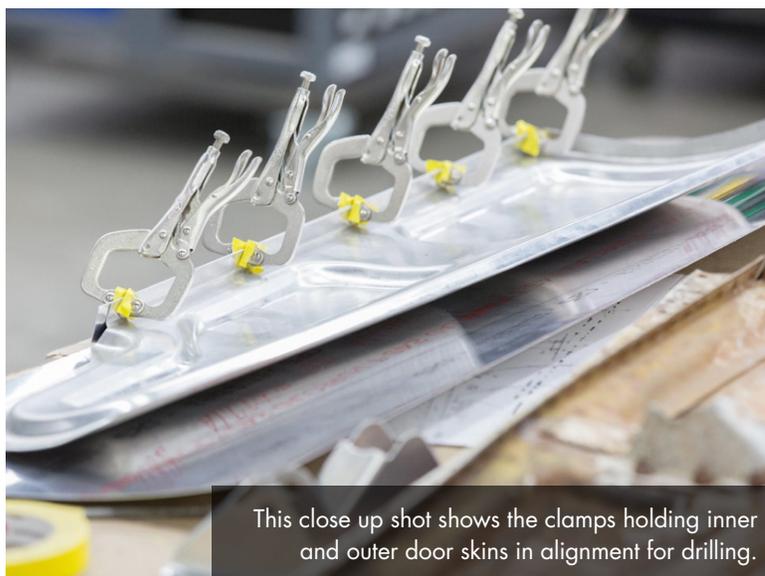
This close up shot shows the clamps holding inner and outer door skins in alignment for drilling.

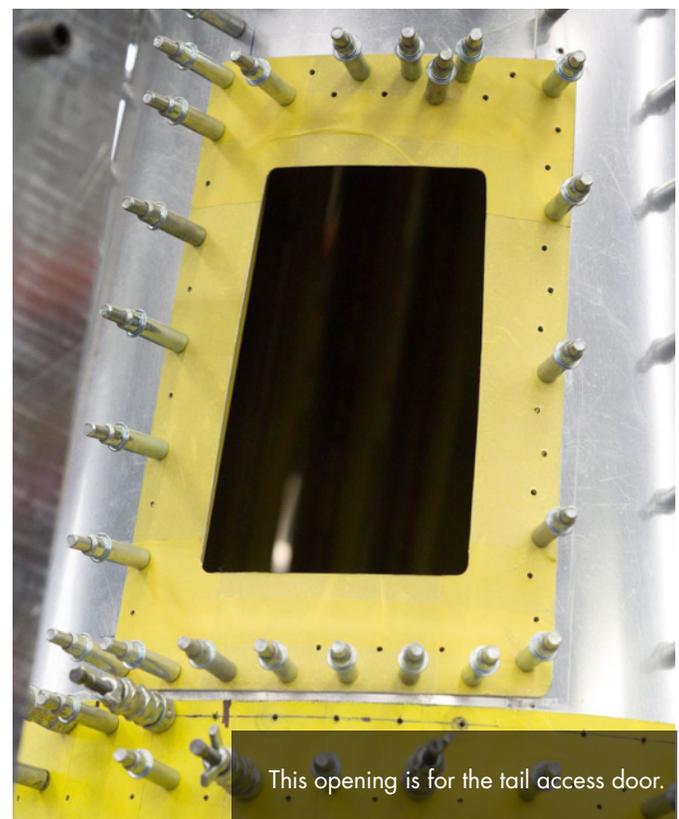
This opening is for the tail access door.

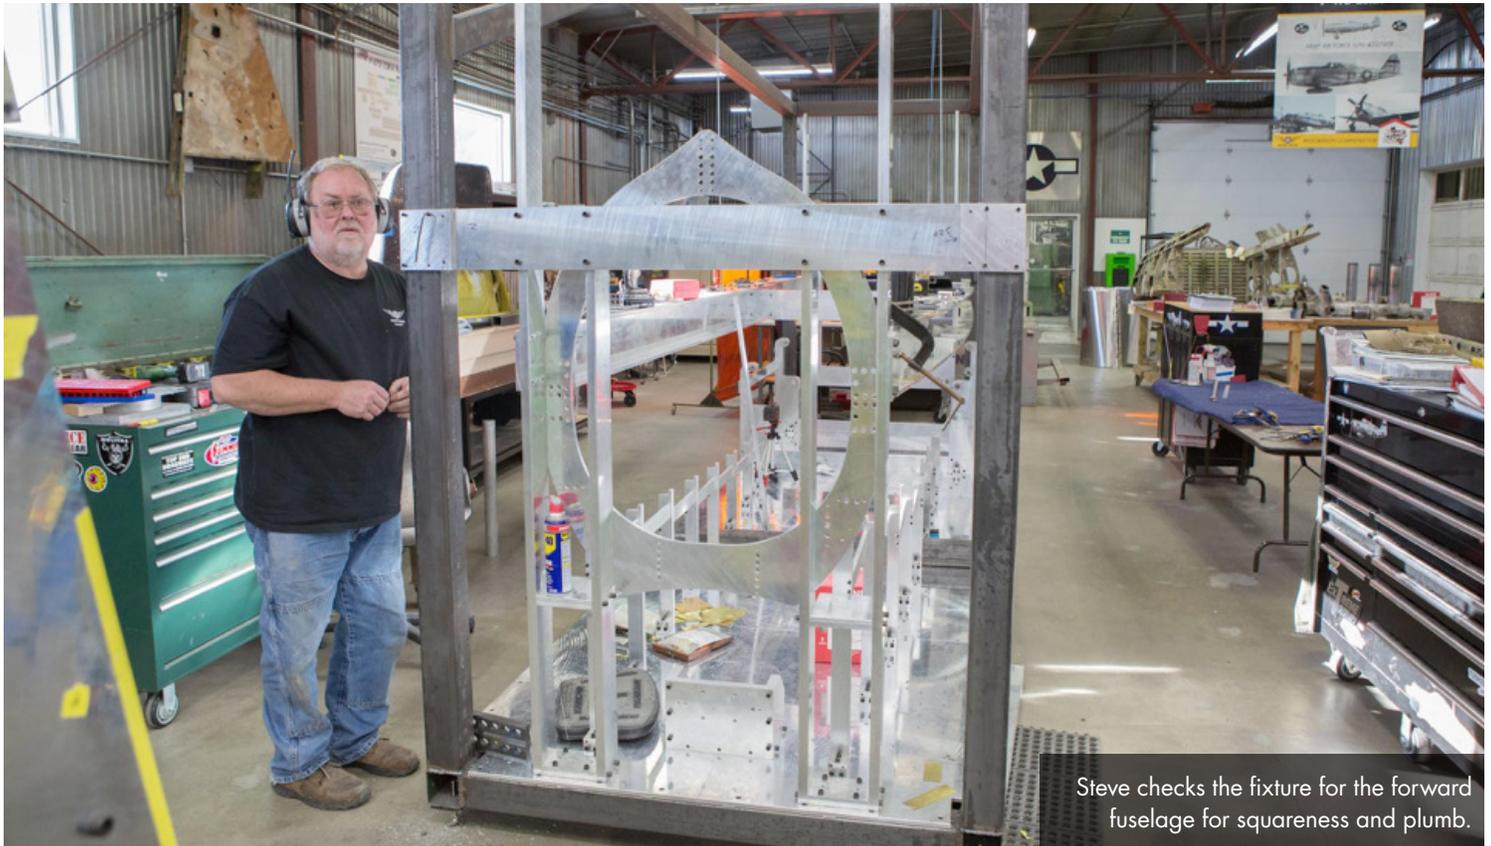
Steve checks the fixture for the forward fuselage for squareness and plumb.

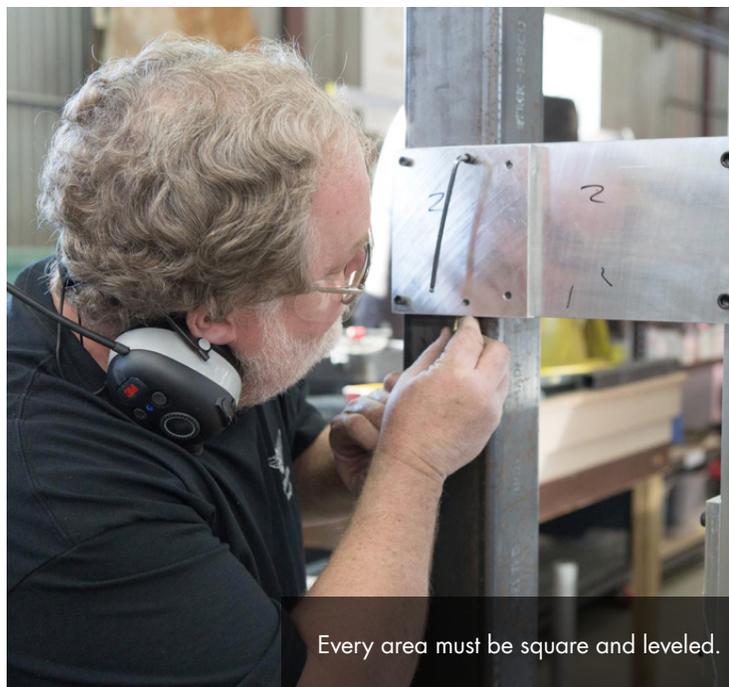
Every area must be square and leveled.

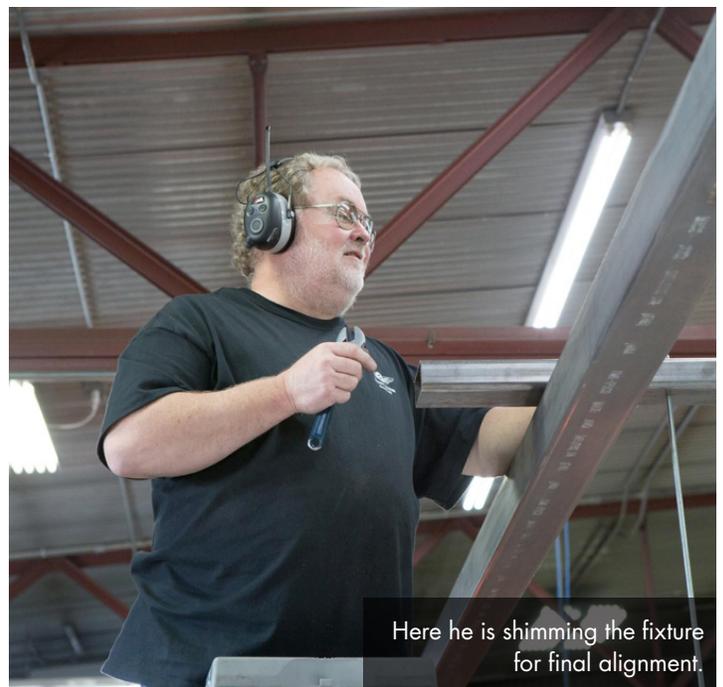
Here he is shimming the fixture for final alignment.
