Dakota Territory Air Museum's P-47 Update  
by Chuck Cravens

AIRCORPS AVIATION

## Ducts, Turbos and Intercooler

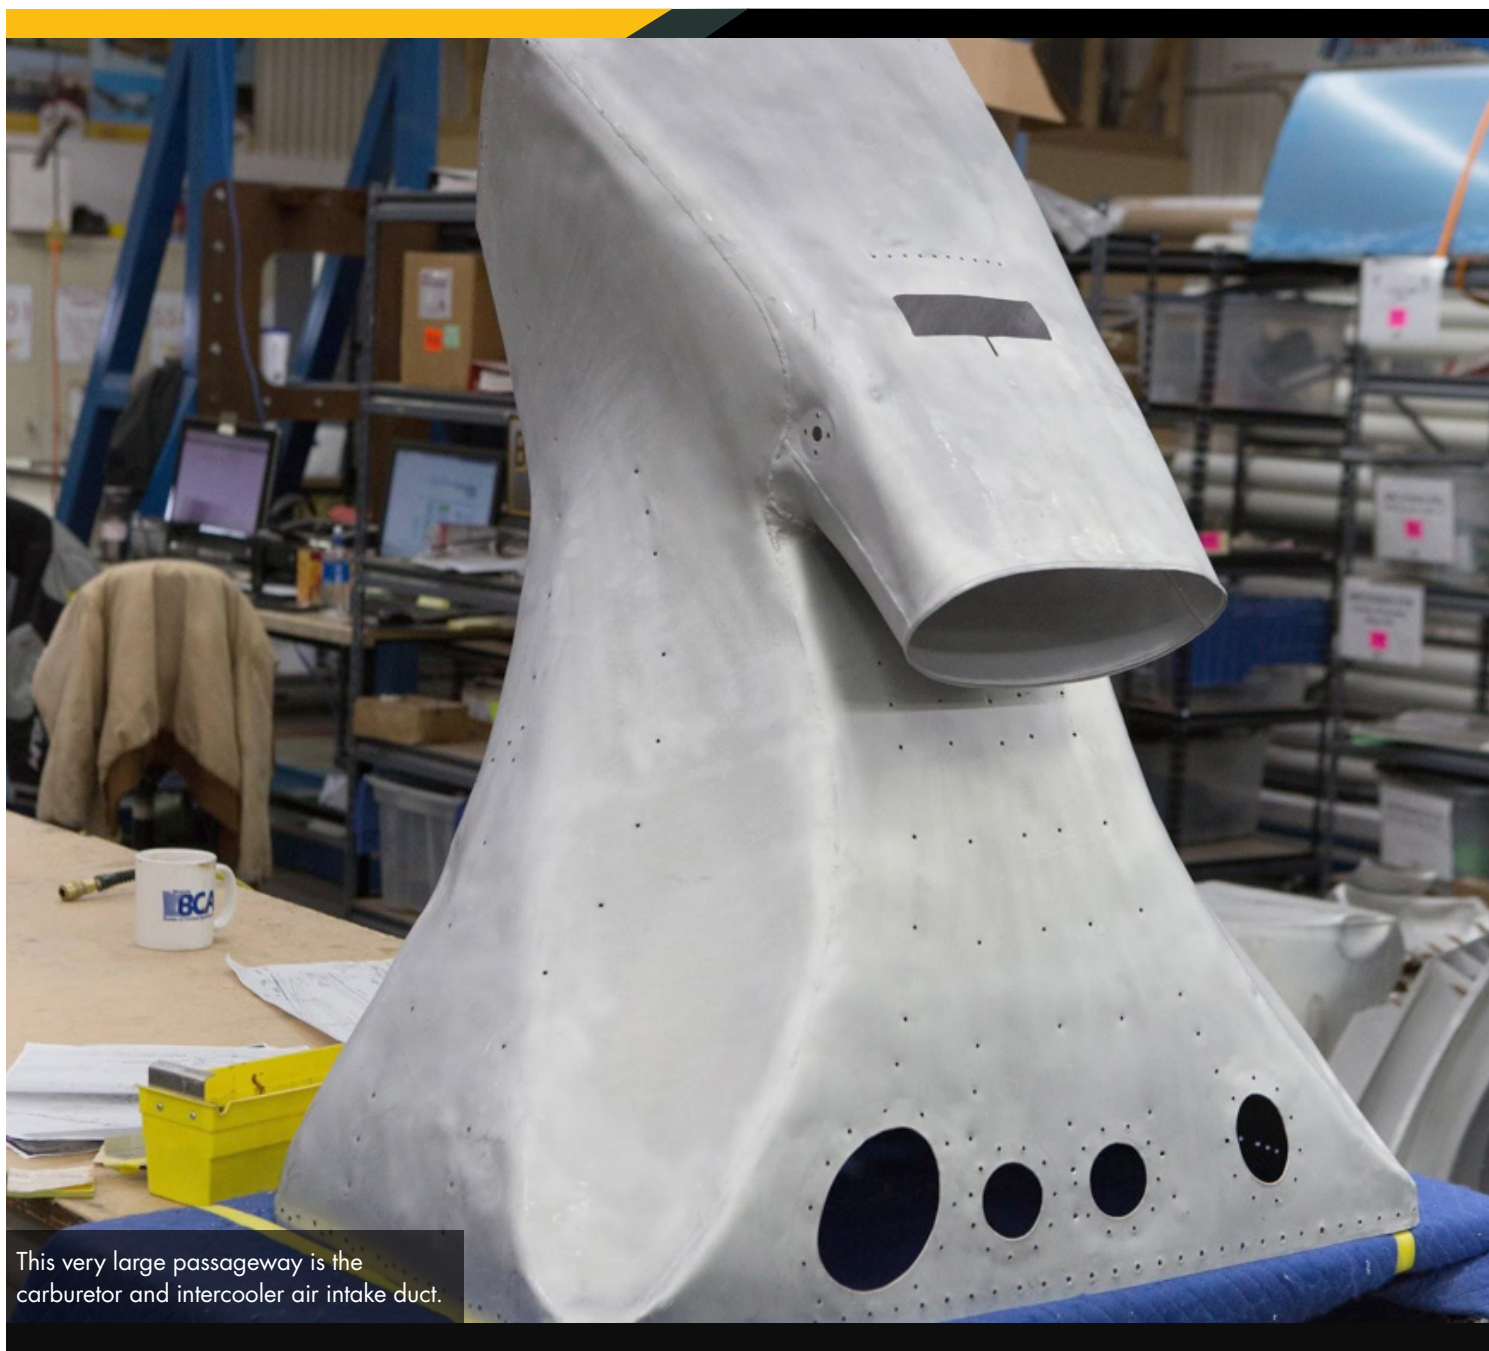
This very large passageway is the carburetor and intercooler air intake duct.

The strangely shaped structure is the main cool air intake to the intercooler. The upper end in this image leads forward to the air intake at the bottom of the cowl. The smaller opening on the right leads back to the air cleaner just ahead of the turbine. The large opening face down on the table is where the duct attaches to the intercooler.

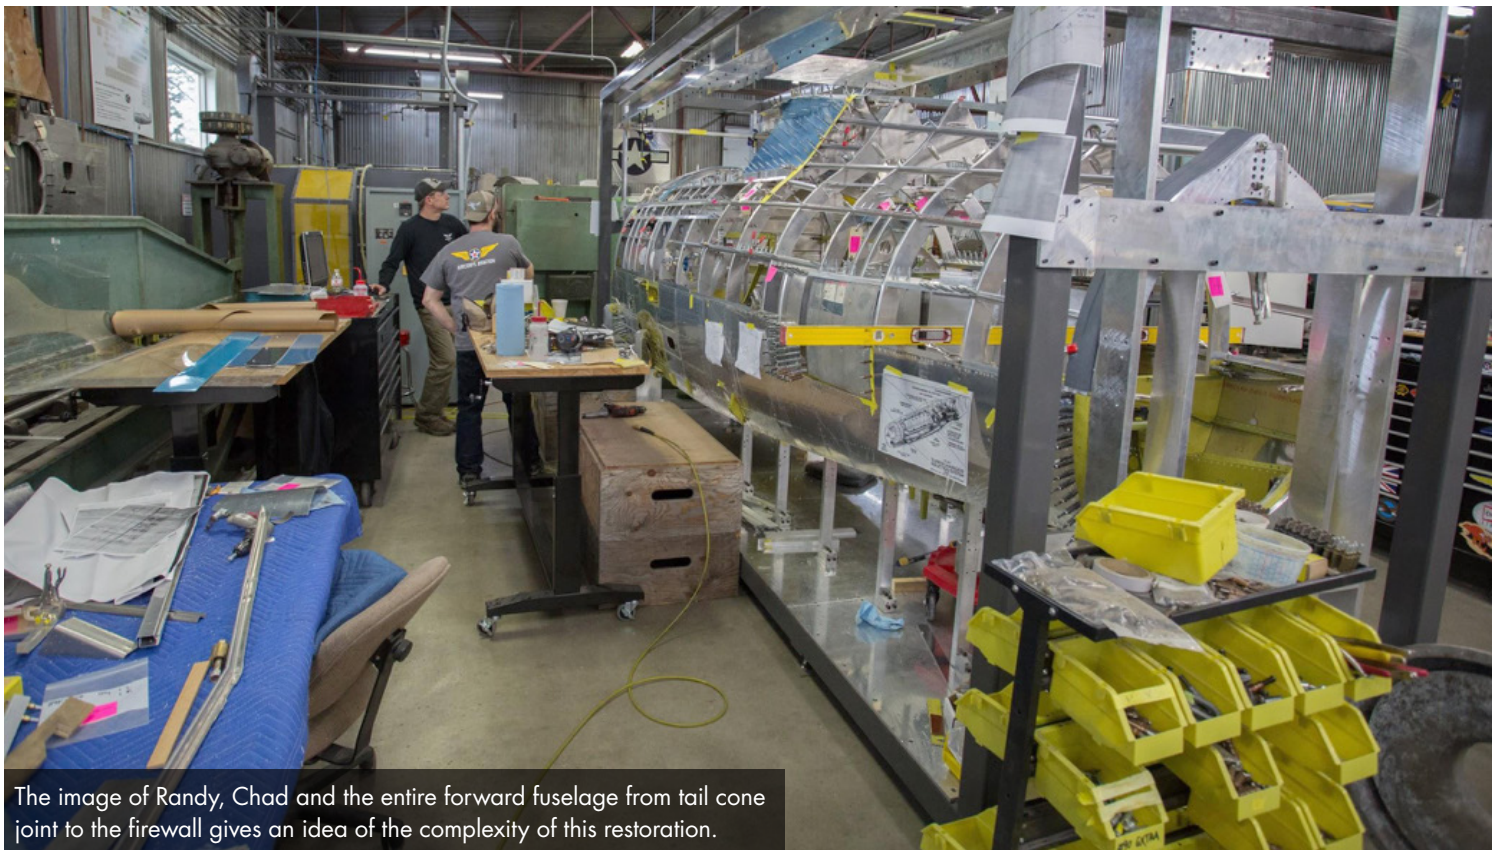
The image of Randy, Chad and the entire forward fuselage from tail cone joint to the firewall gives an idea of the complexity of this restoration.

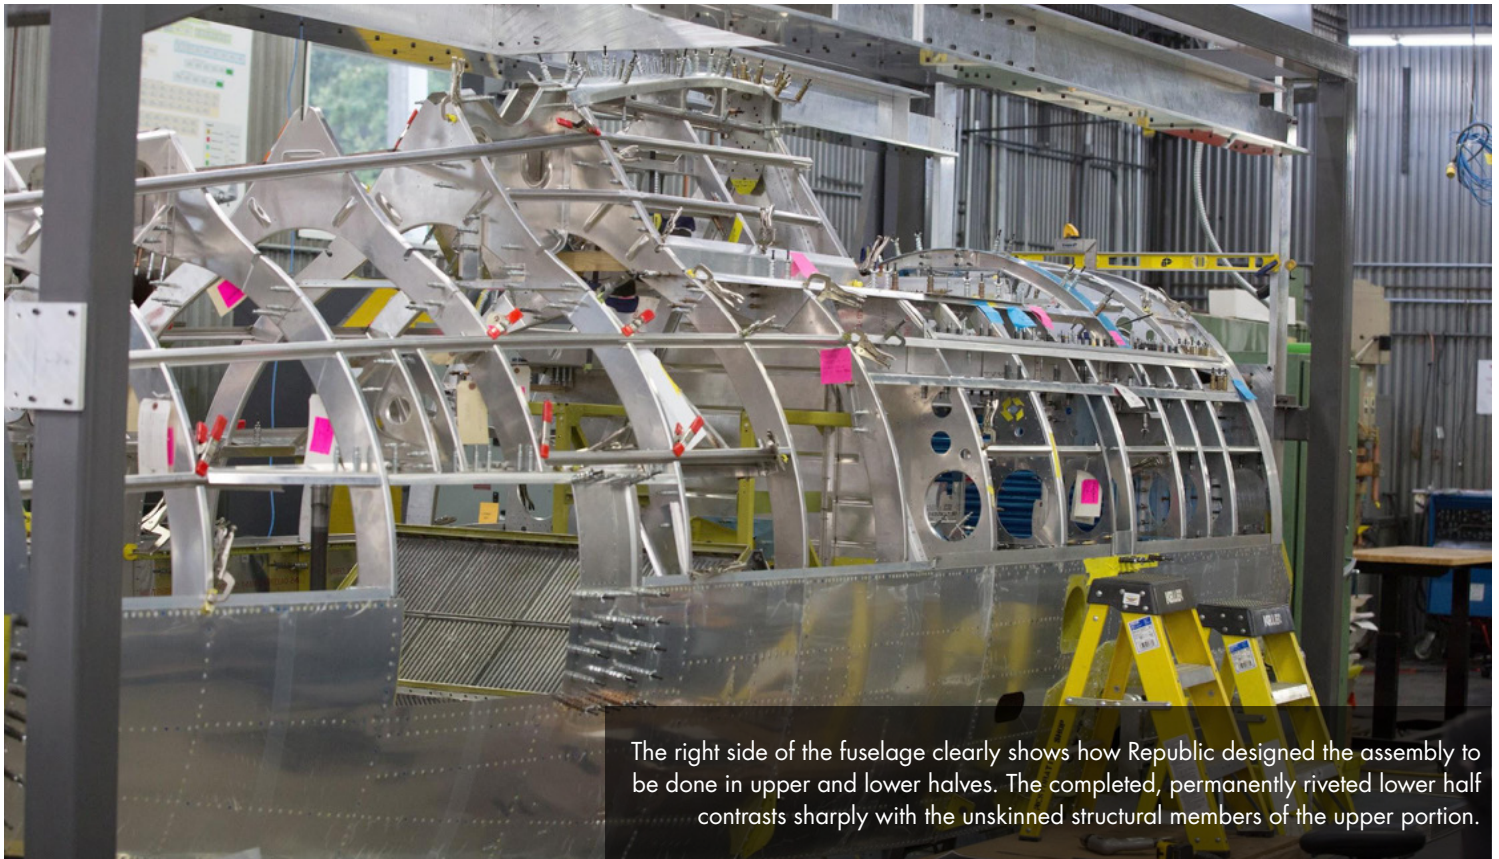
The right side of the fuselage clearly shows how Republic designed the assembly to be done in upper and lower halves. The completed, permanently riveted lower half contrasts sharply with the unskinned structural members of the upper portion.

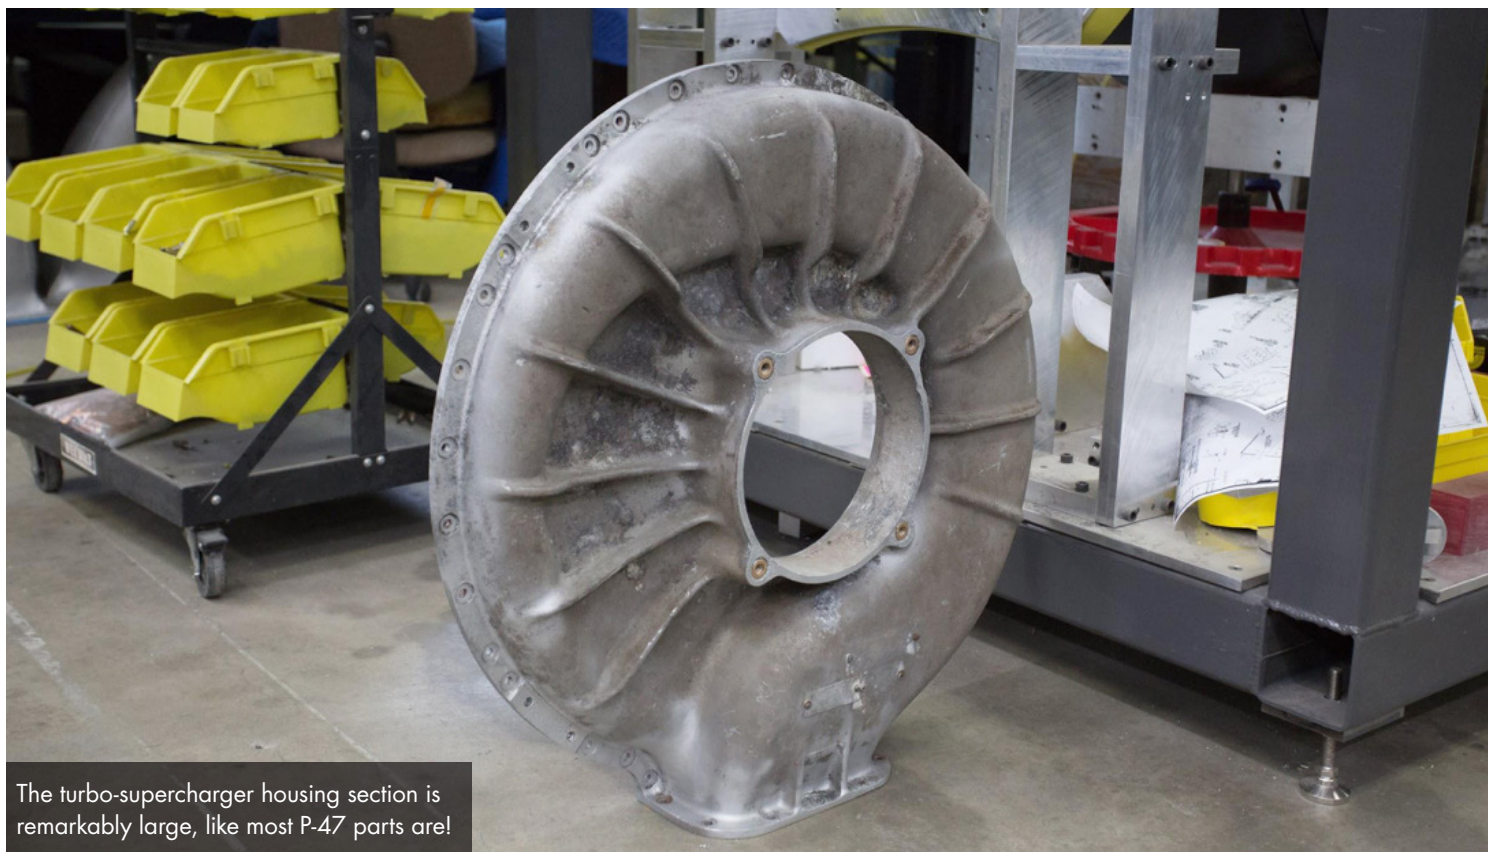
The turbo-supercharger housing section is remarkably large, like most P-47 parts are!

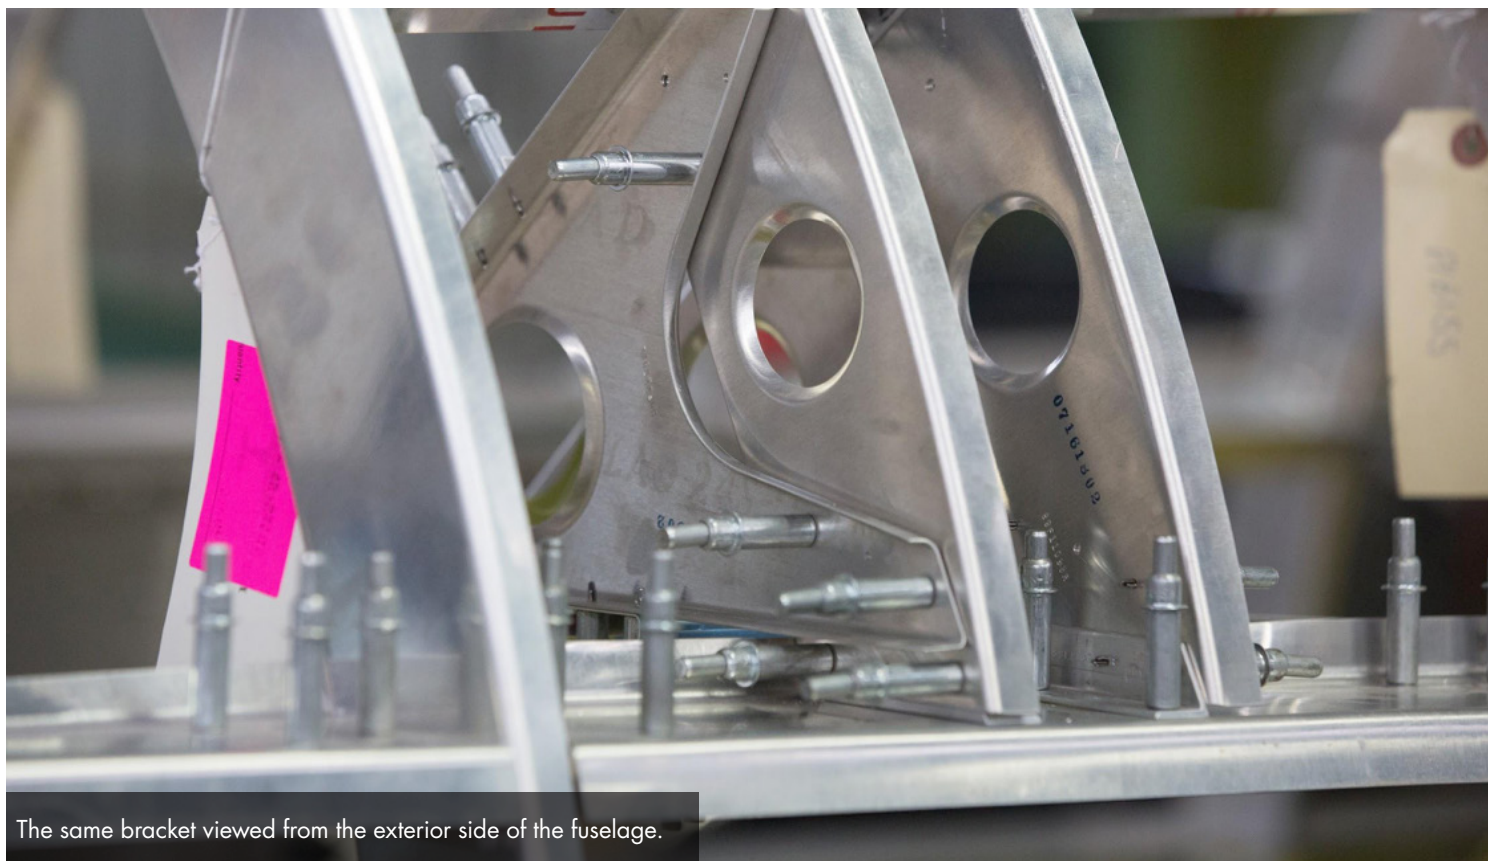
The same bracket viewed from the exterior side of the fuselage.

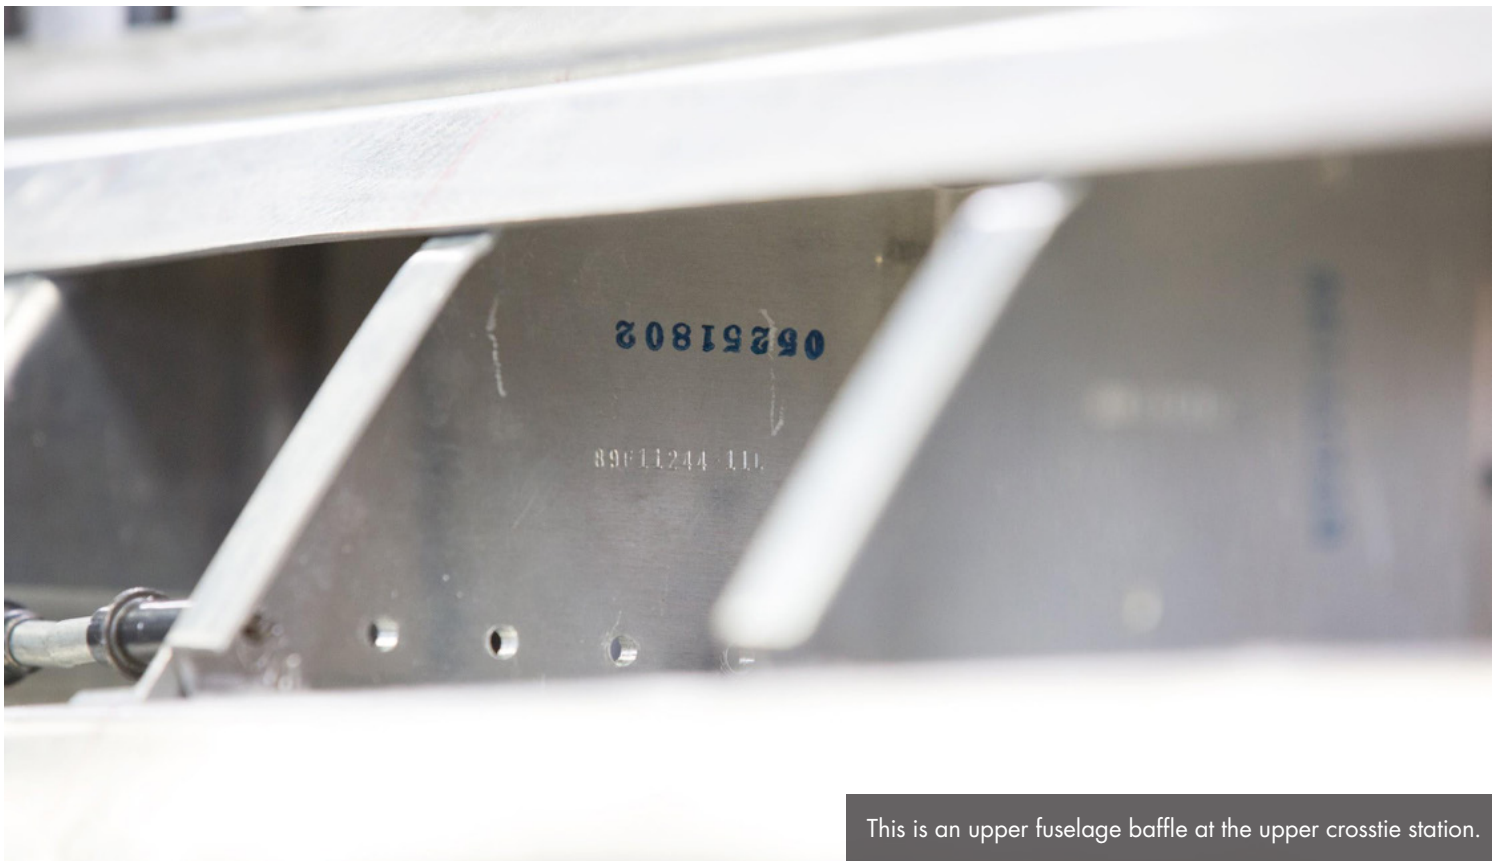
This is an upper fuselage baffle at the upper cross-tie station.

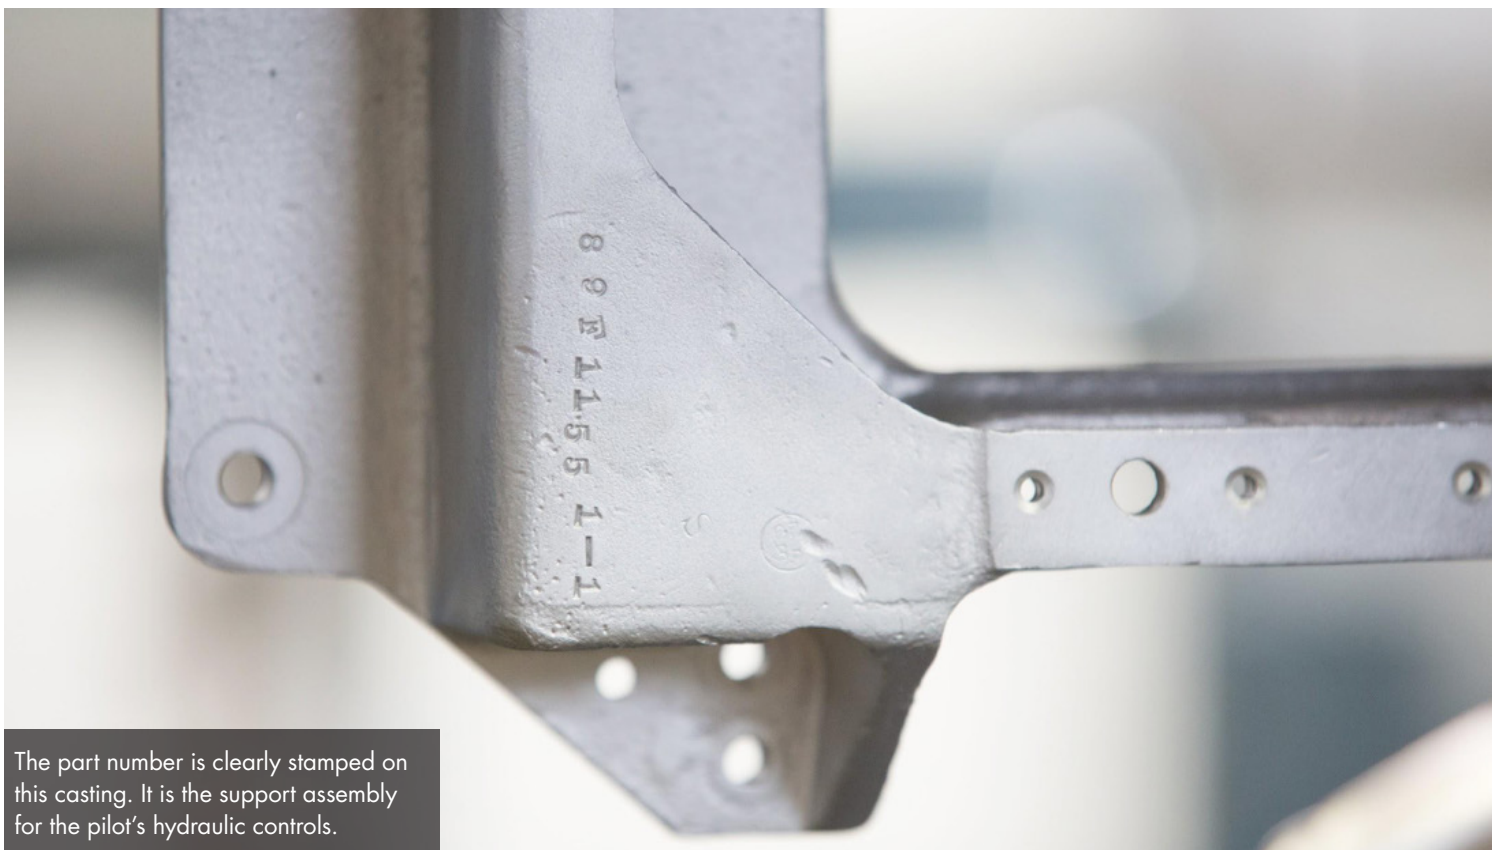
The part number is clearly stamped on this casting. It is the support assembly for the pilot's hydraulic controls.

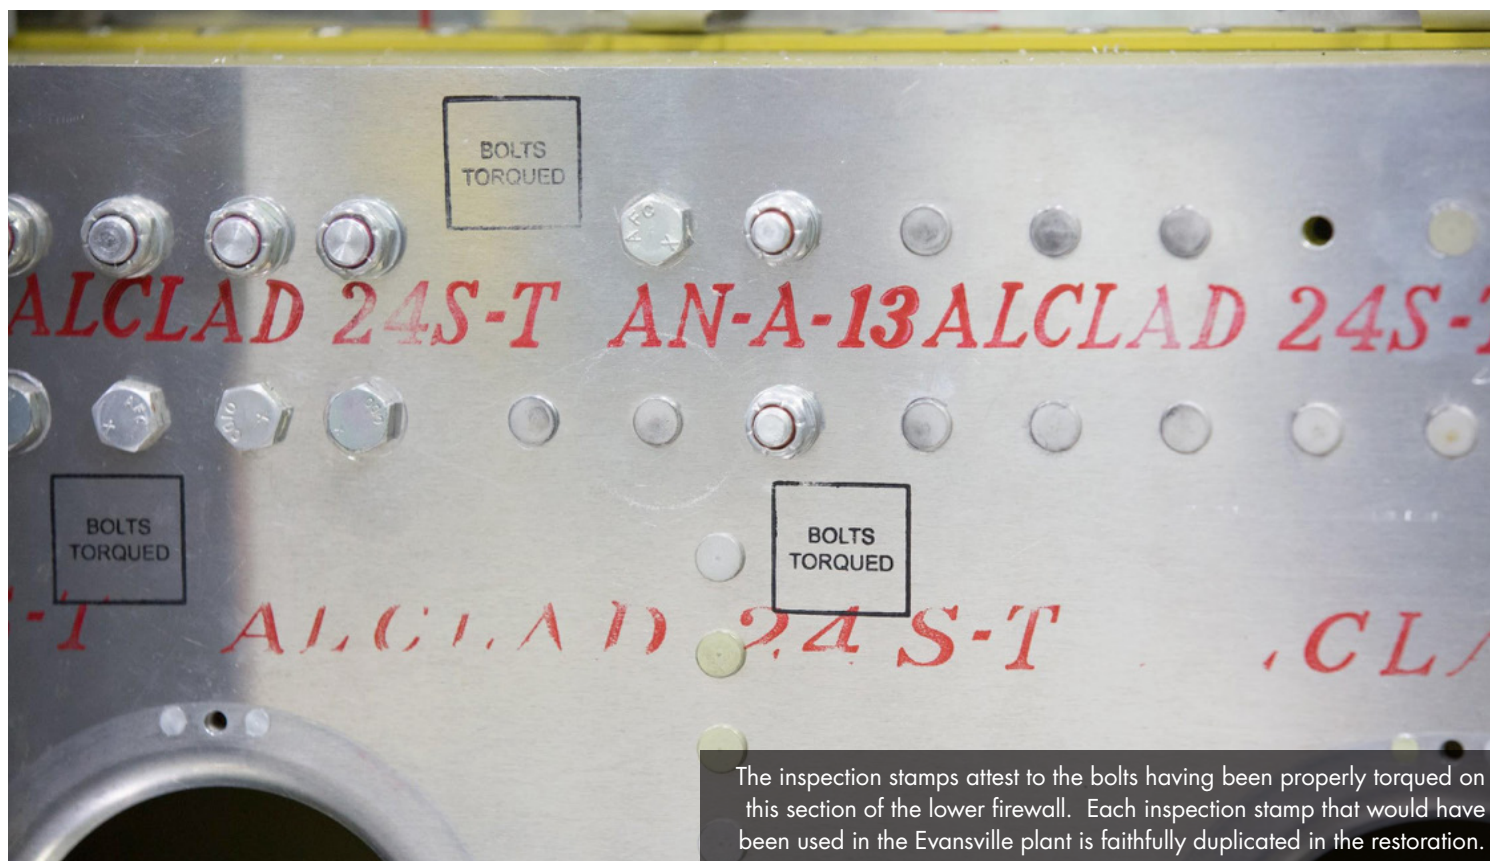
The inspection stamps attest to the bolts having been properly torqued on this section of the lower firewall. Each inspection stamp that would have been used in the Evansville plant is faithfully duplicated in the restoration.

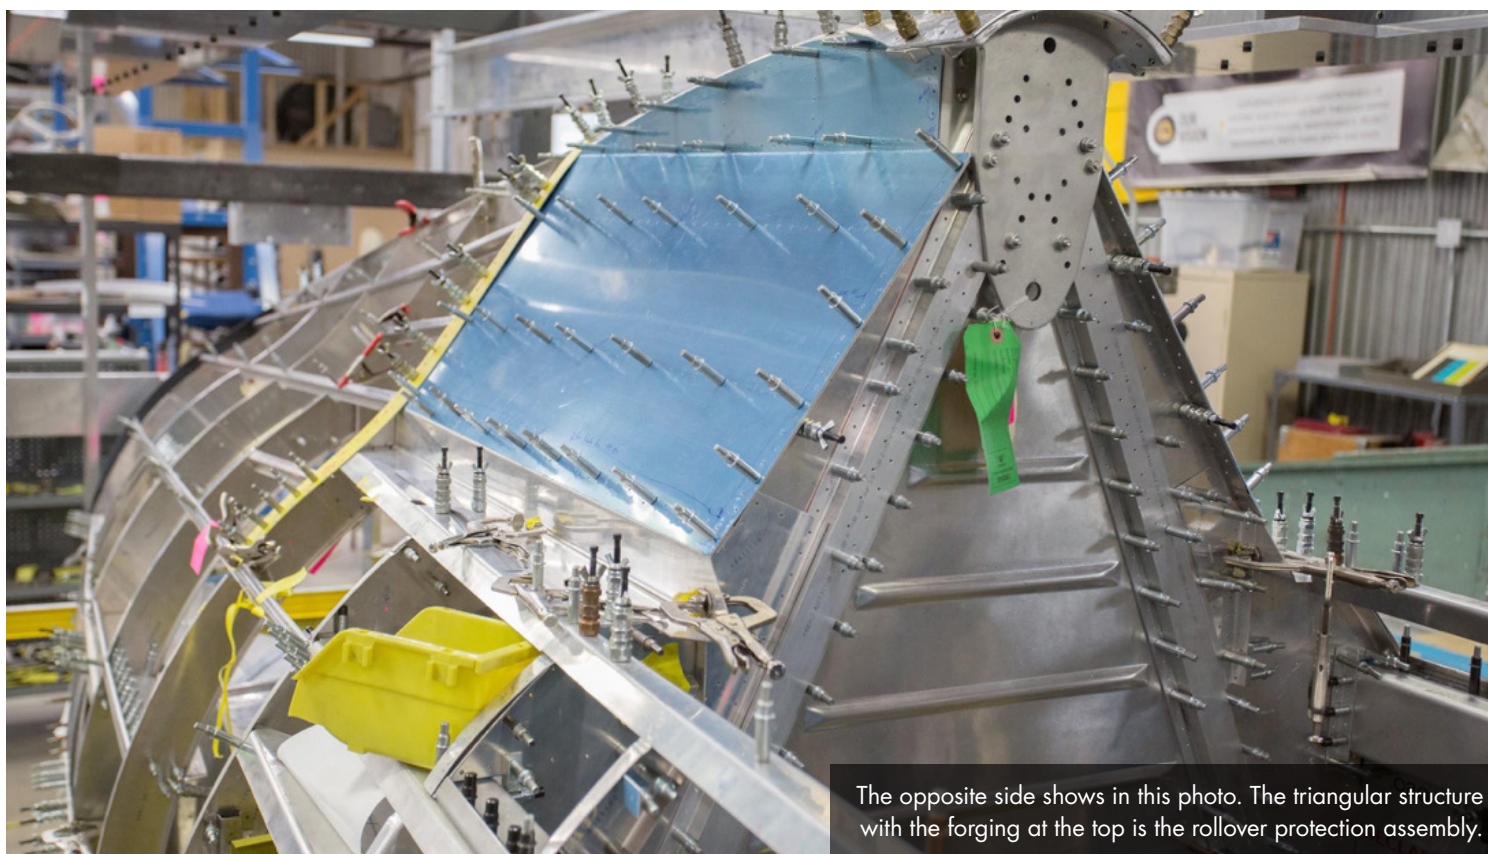
The opposite side shows in this photo. The triangular structure with the forging at the top is the rollover protection assembly.

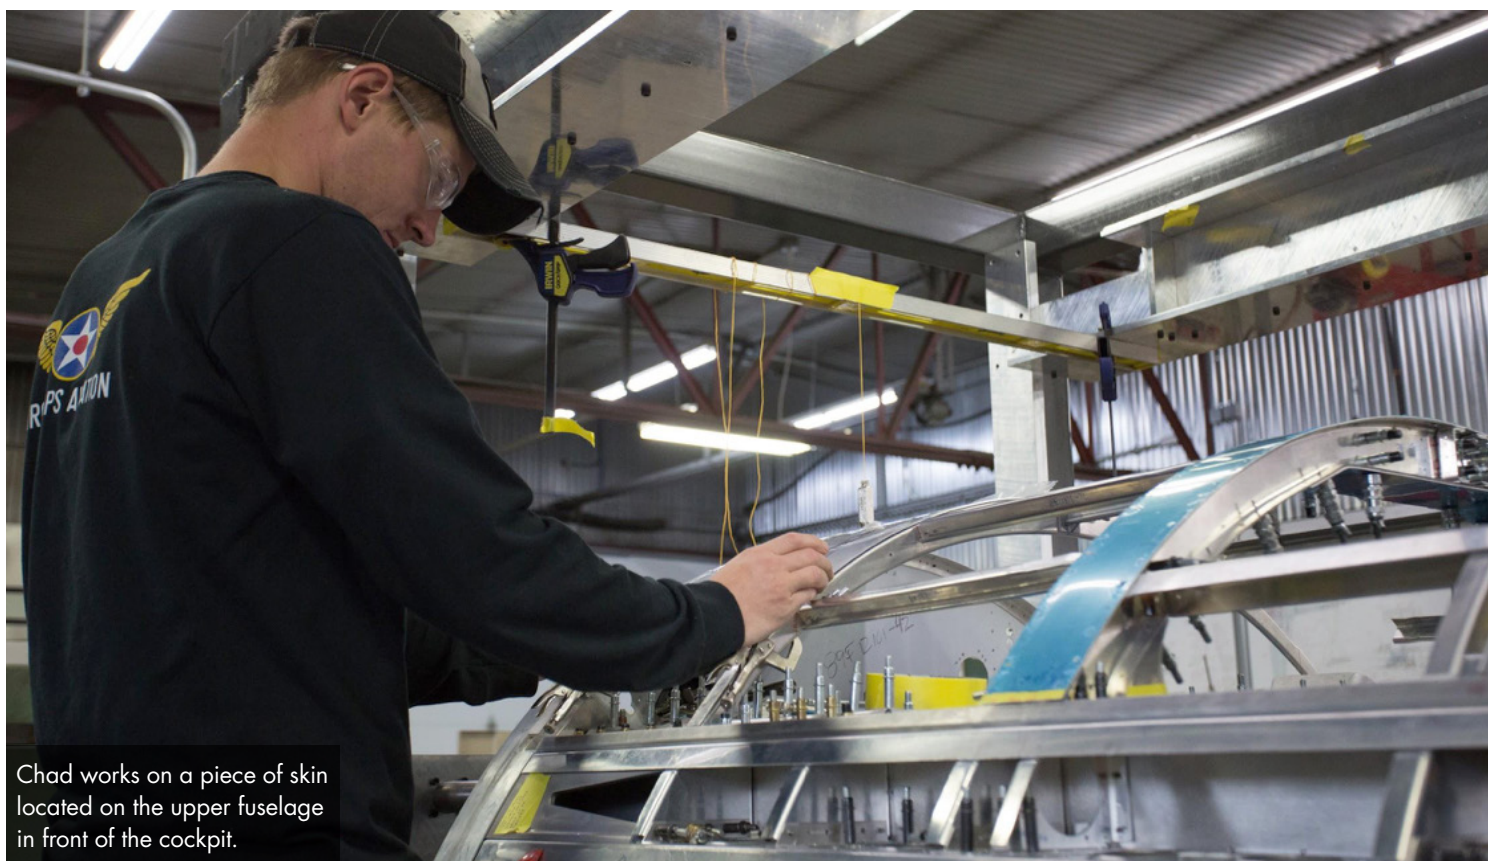
Chad works on a piece of skin located on the upper fuselage in front of the cockpit.

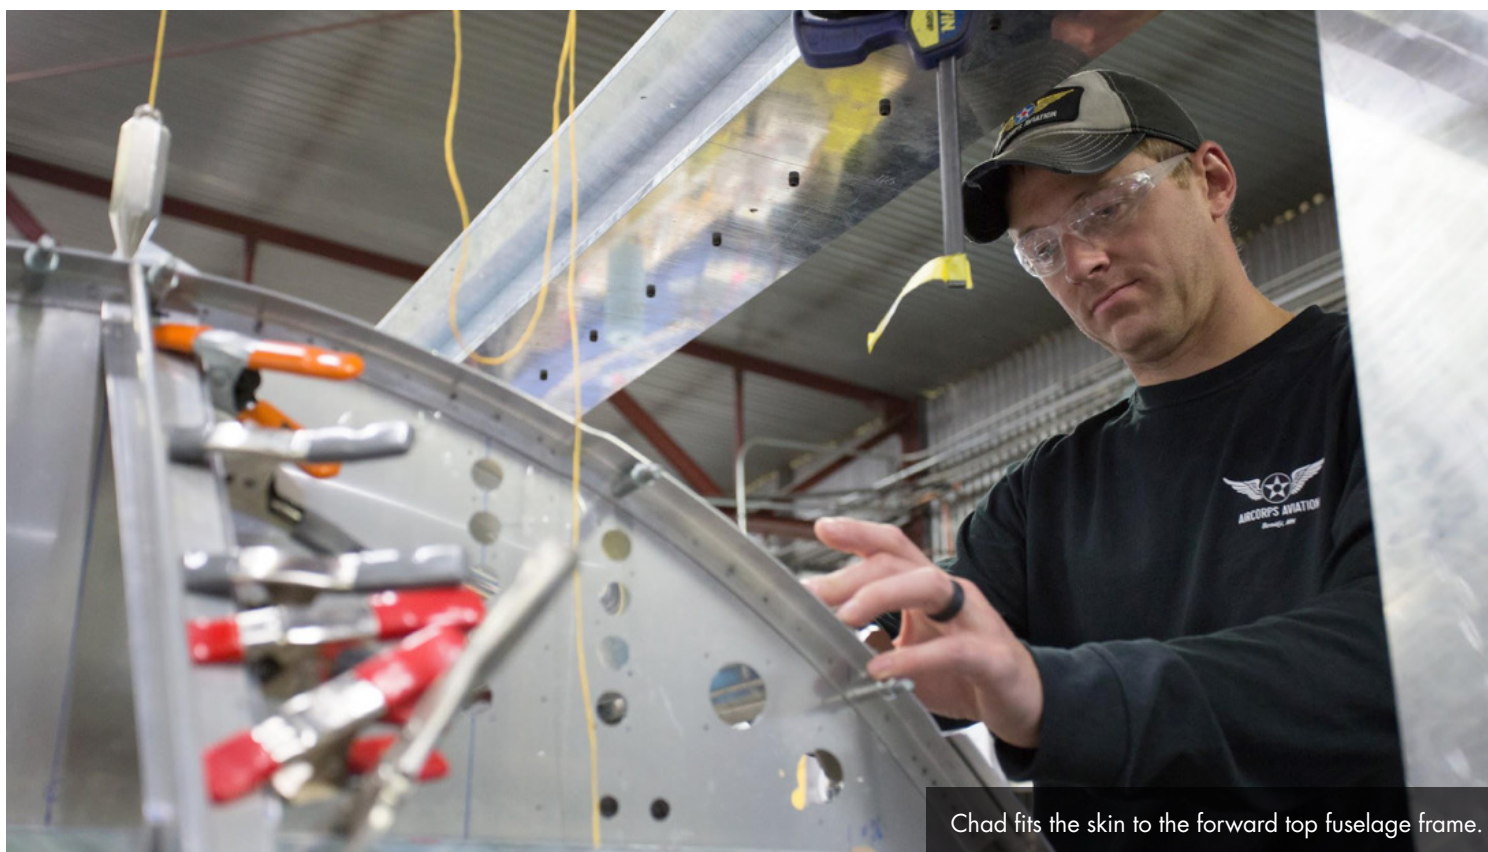
Chad fits the skin to the forward top fuselage frame.
