P-51B SHILLELAUGH WINTER UPDATE

Dakota Territory Air Museum's P-51B Mustang

by Chuck Cravens

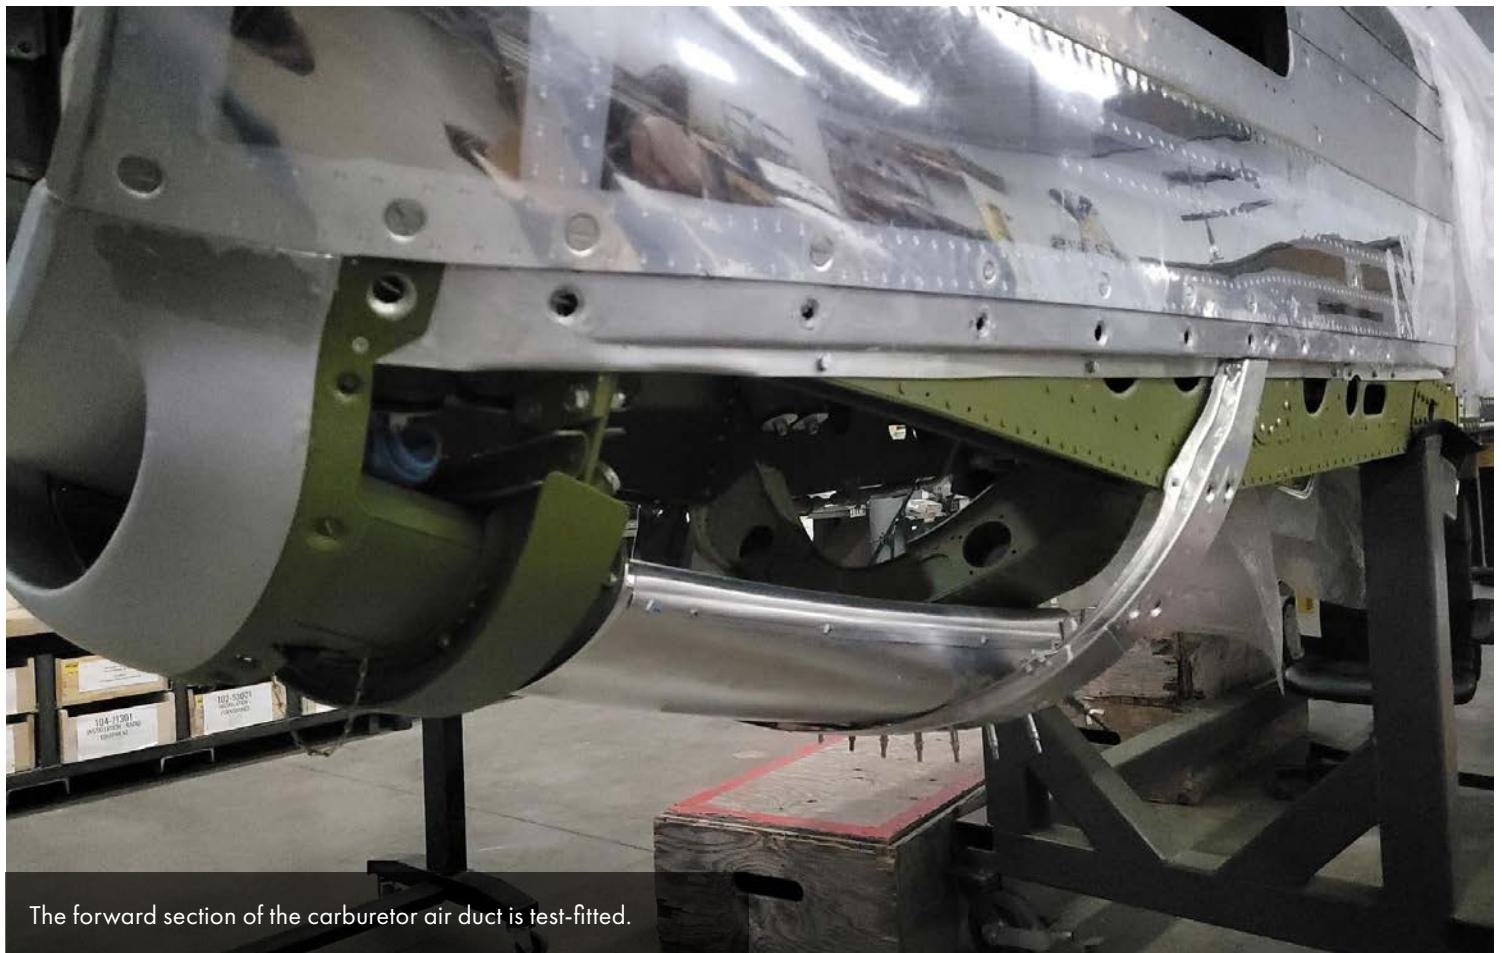
The forward section of the carburetor air duct is test-fitted.

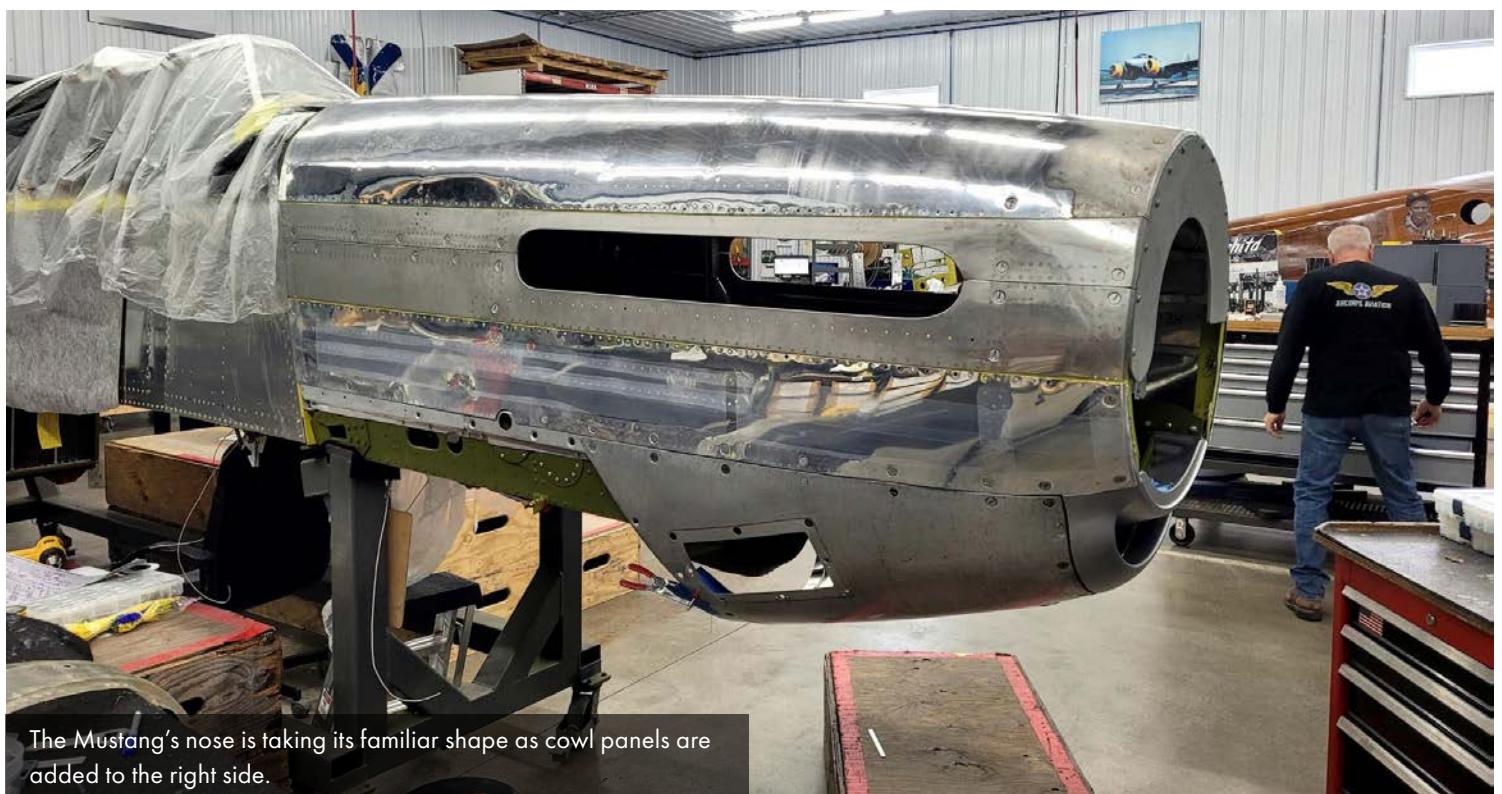
The Mustang's nose is taking its familiar shape as cowl panels are added to the right side.

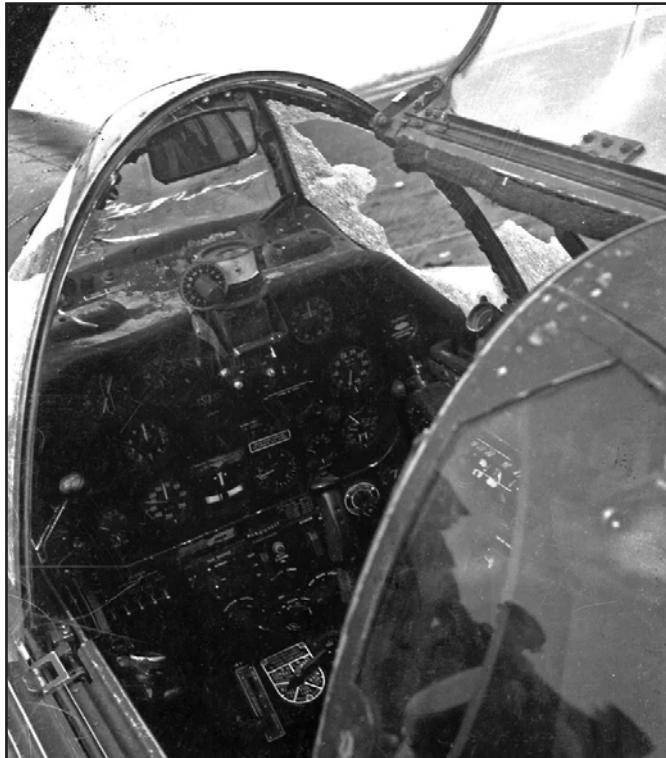
This wartime photo of a P-51B cockpit is in the same configuration as Shillelaugh's was.

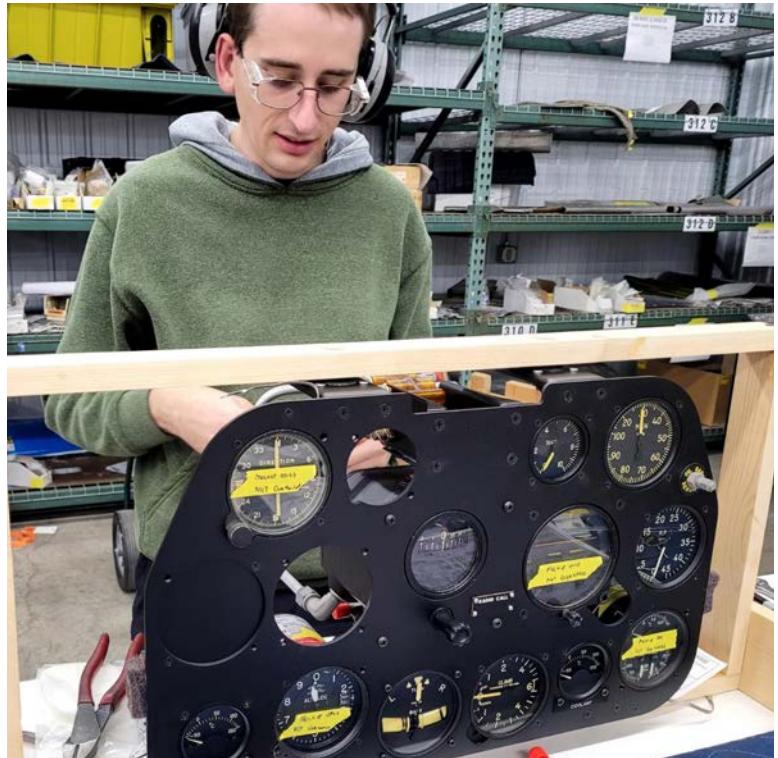
Aaron works on fitting instruments to the panel.

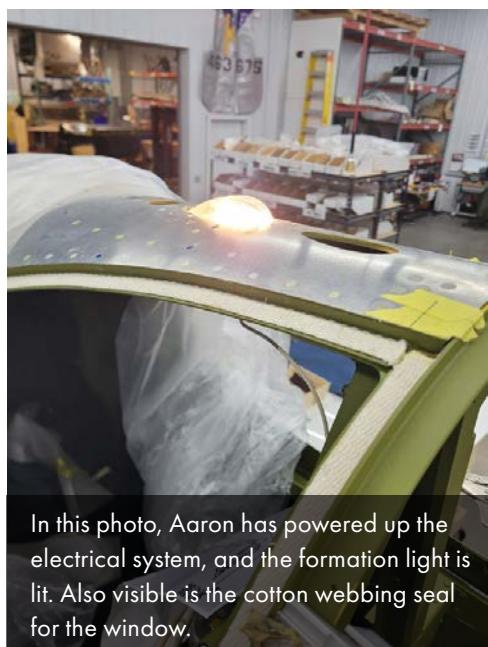
In this photo, Aaron has powered up the electrical system, and the formation light is lit. Also visible is the cotton webbing seal for the window.

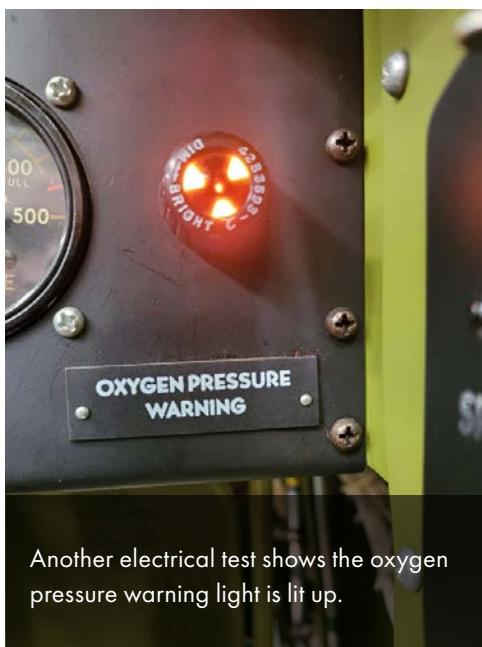
Another electrical test shows the oxygen pressure warning light is lit up.

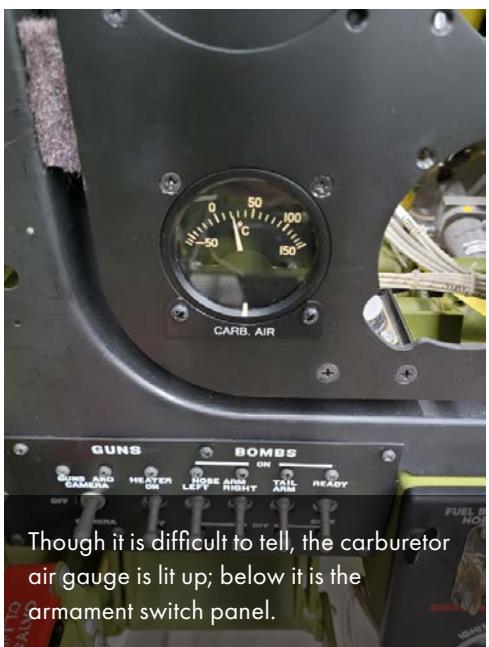
Though it is difficult to tell, the carburetor air gauge is lit up; below it is the armament switch panel.

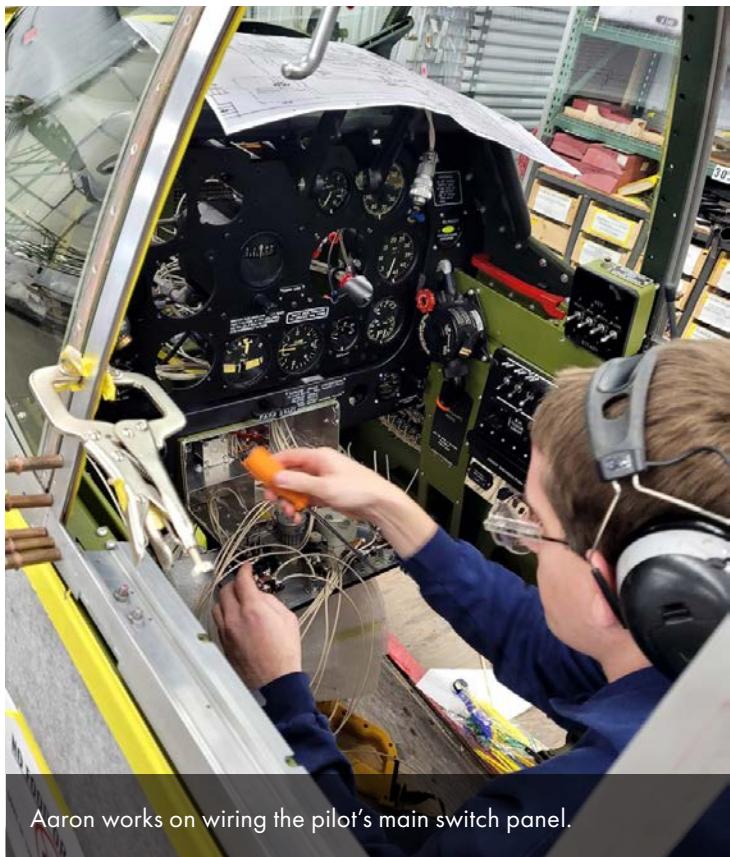
Aaron works on wiring the pilot's main switch panel.

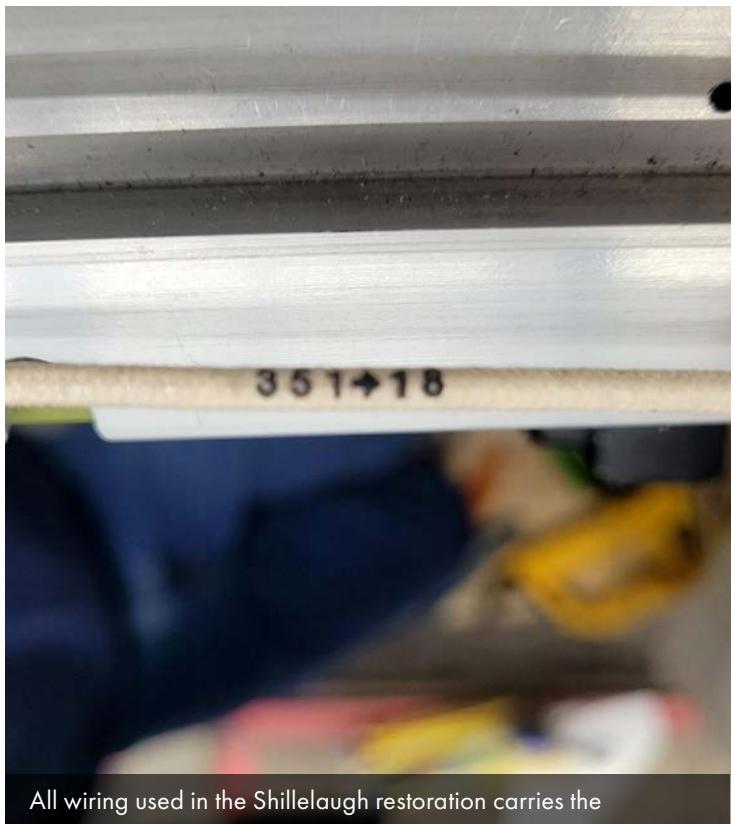
All wiring used in the Shillelaugh restoration carries the period-correct font markings WWII era wiring had.

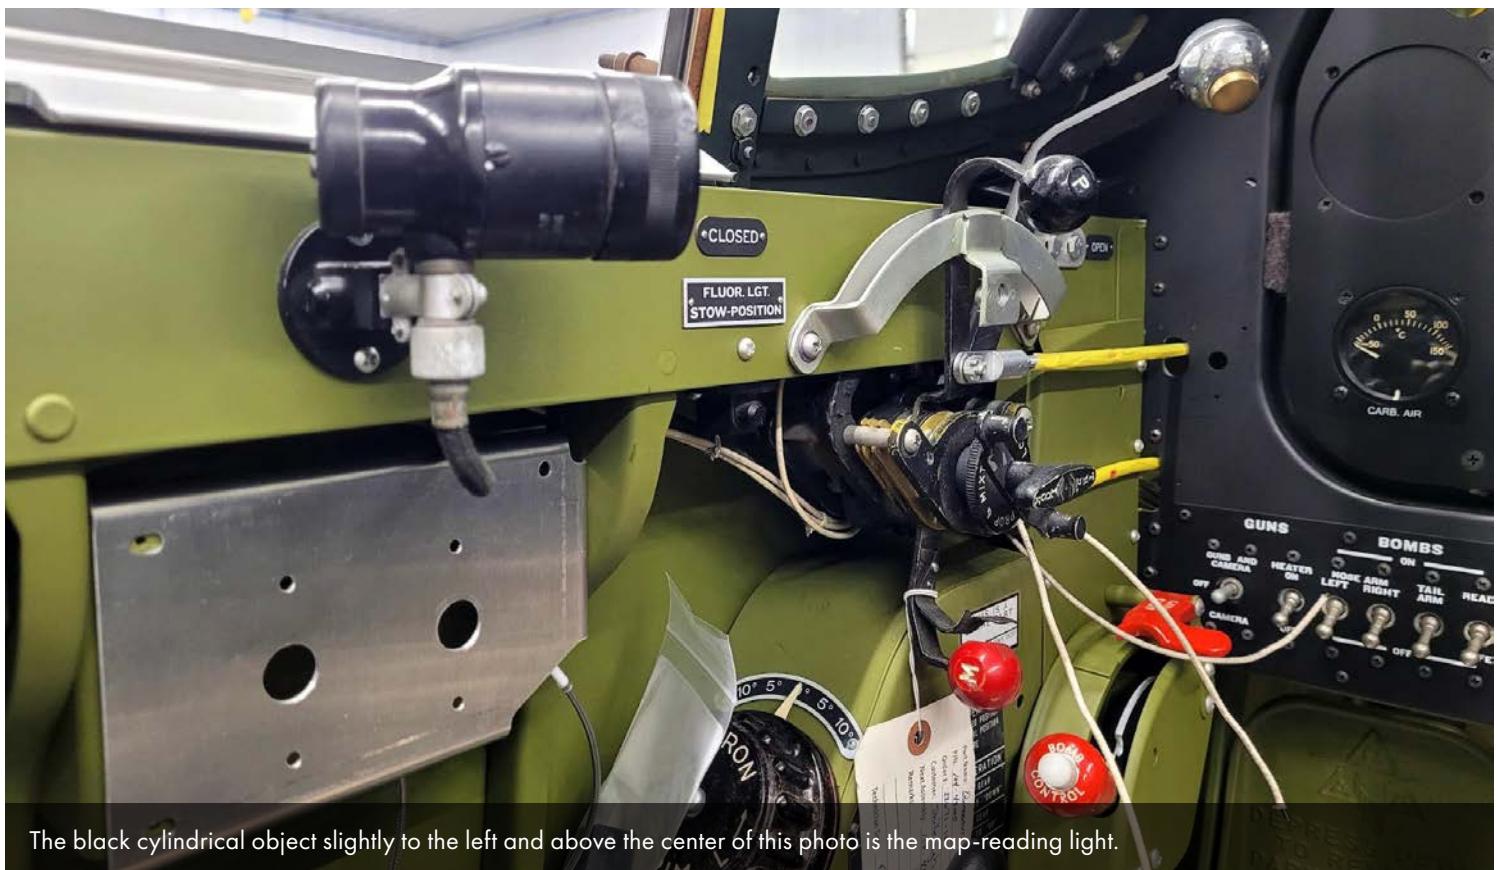
The black cylindrical object slightly to the left and above the center of this photo is the map-reading light.

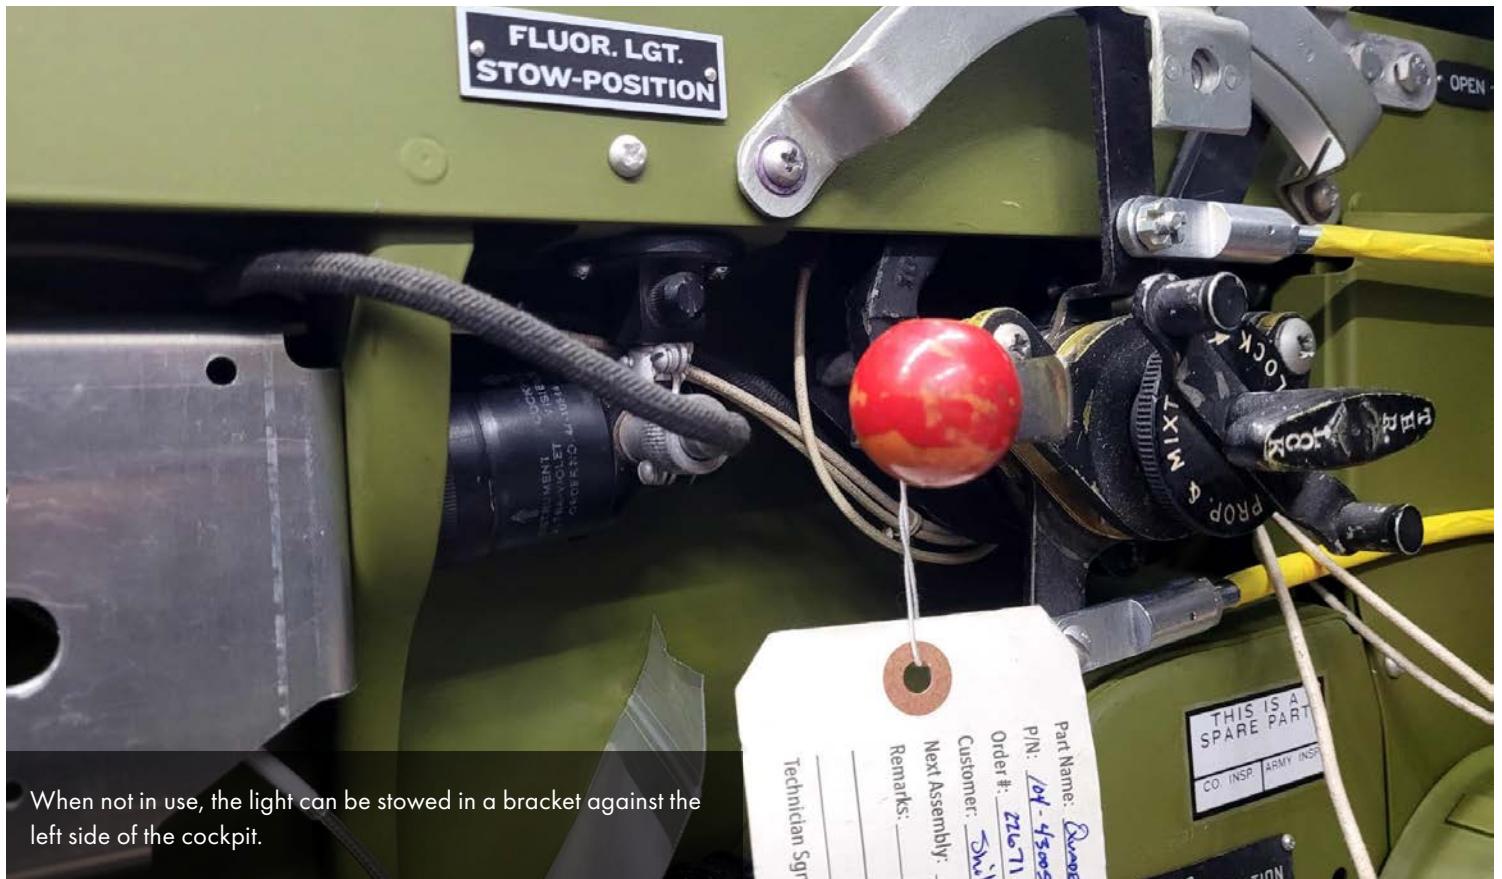
When not in use, the light can be stowed in a bracket against the left side of the cockpit.

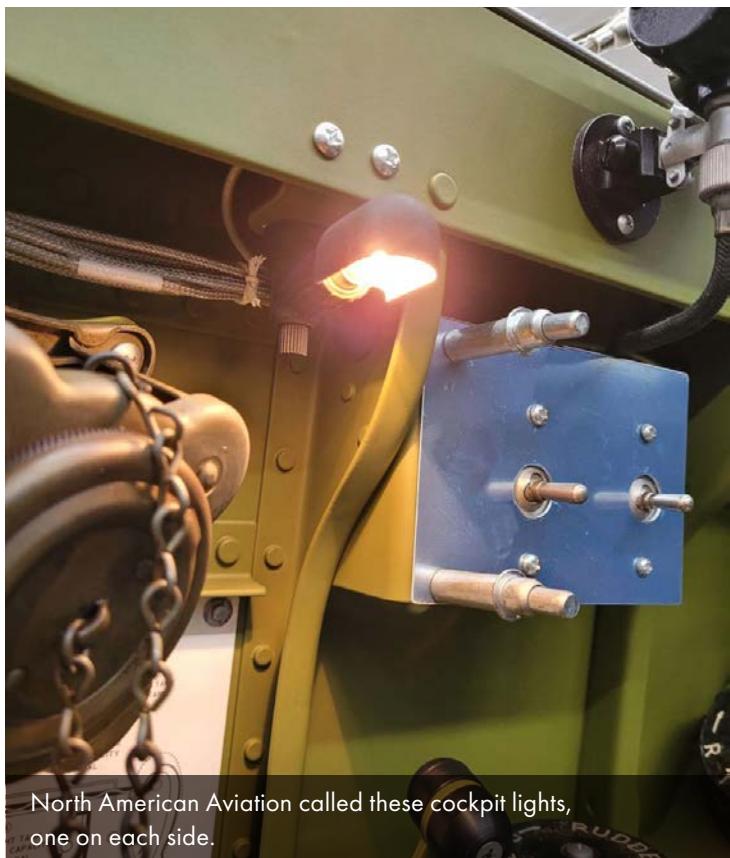
North American Aviation called these cockpit lights, one on each side.

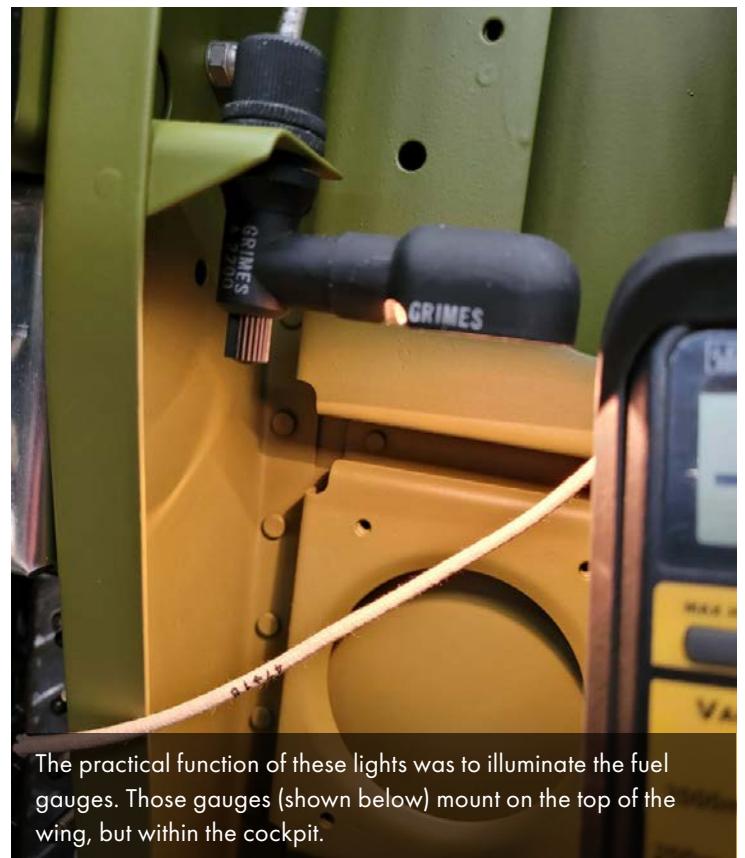
The practical function of these lights was to illuminate the fuel gauges. Those gauges (shown below) mount on the top of the wing, but within the cockpit.

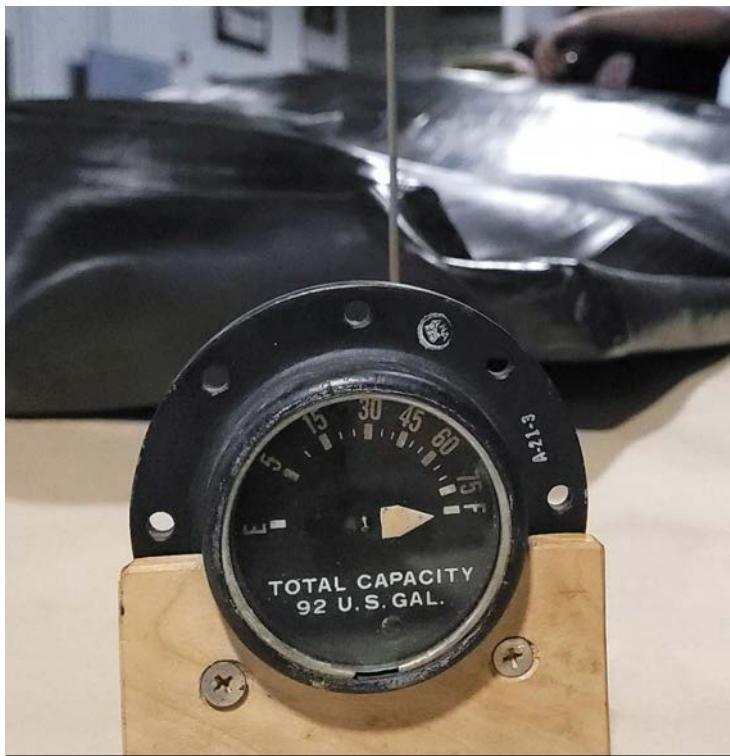
When installed, this wing tank fuel gauge face is oriented horizontally and is visible to the pilot on his lower right or left. When the float is positioned as shown, the gauge indicates a full tank.

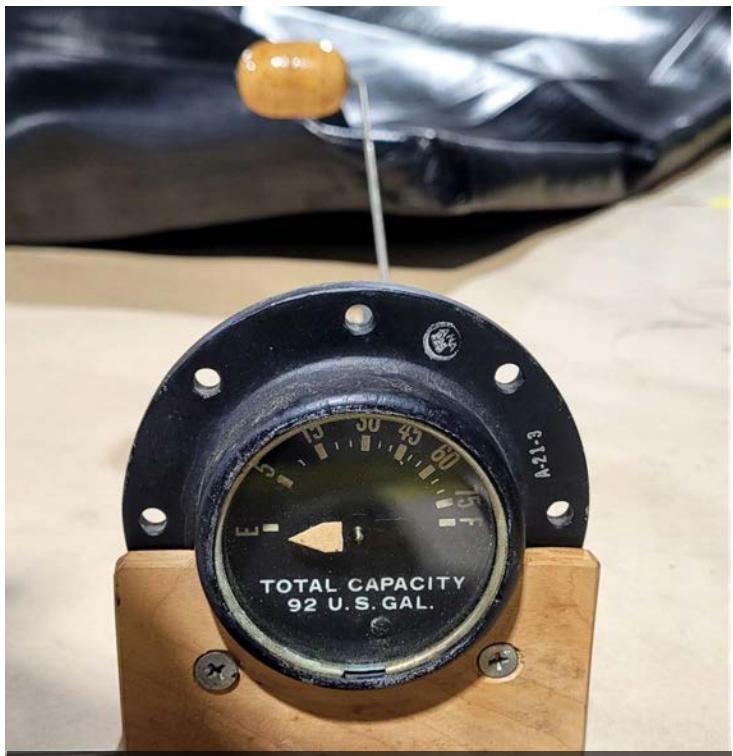
When the fuel in the tank is used up, the float drops to this position and the gauge indicates an empty wing tank.

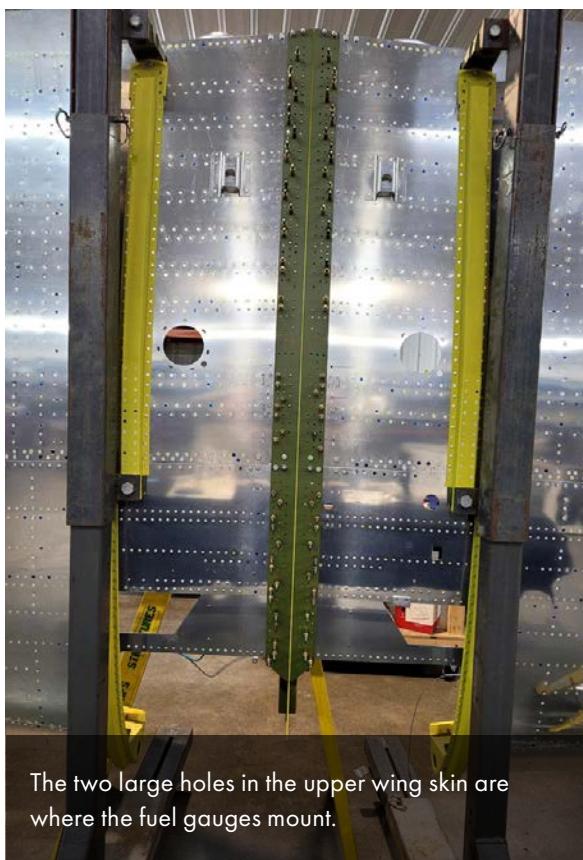
The two large holes in the upper wing skin are where the fuel gauges mount.

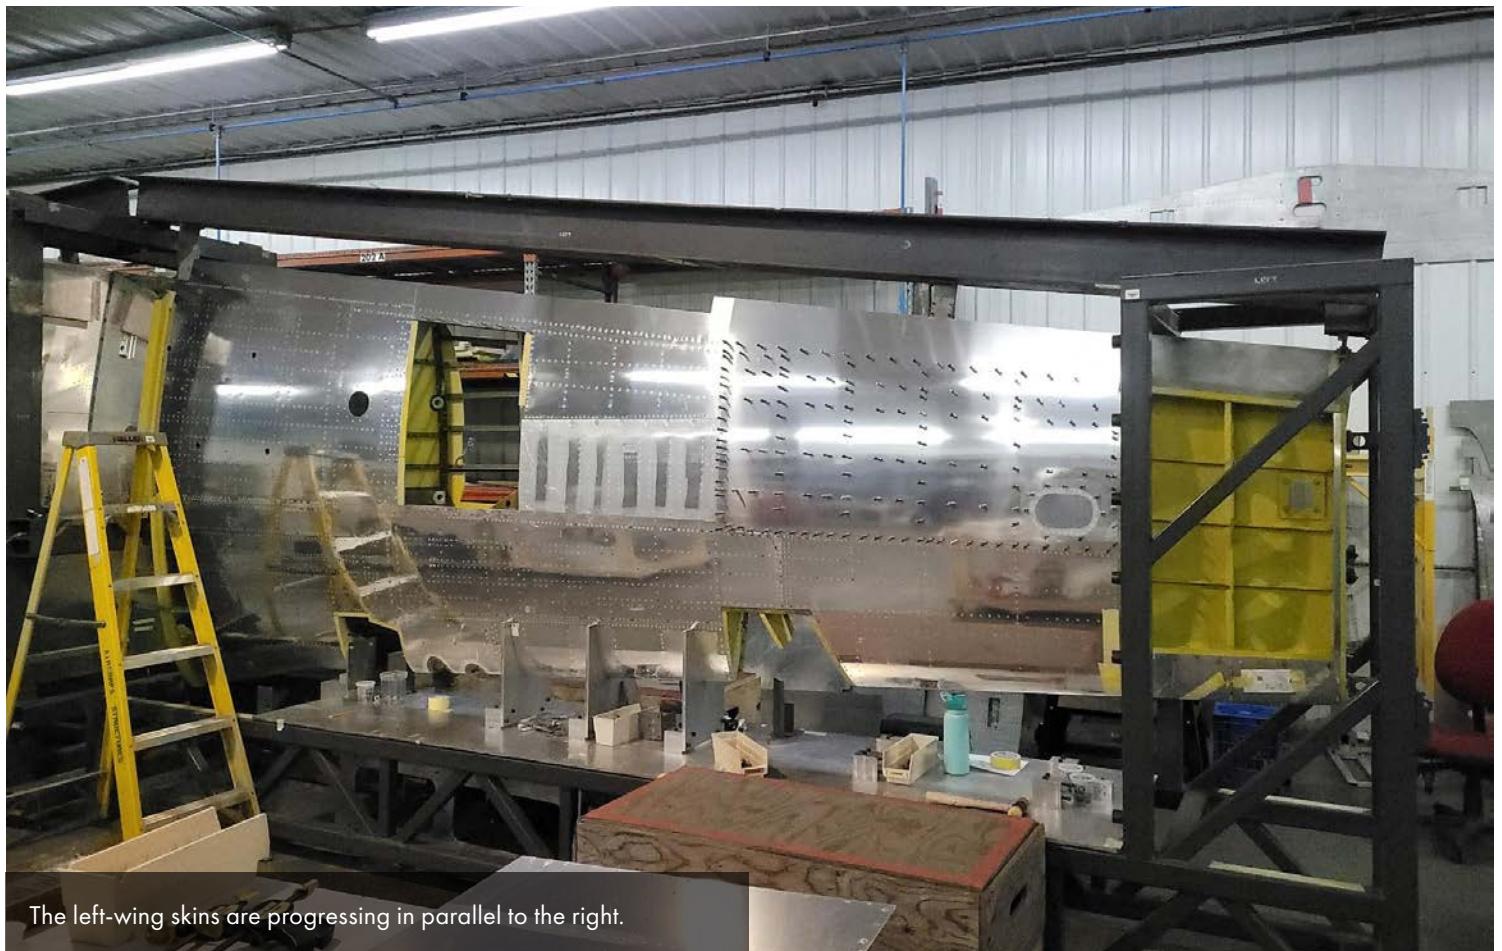
The left-wing skins are progressing in parallel to the right.

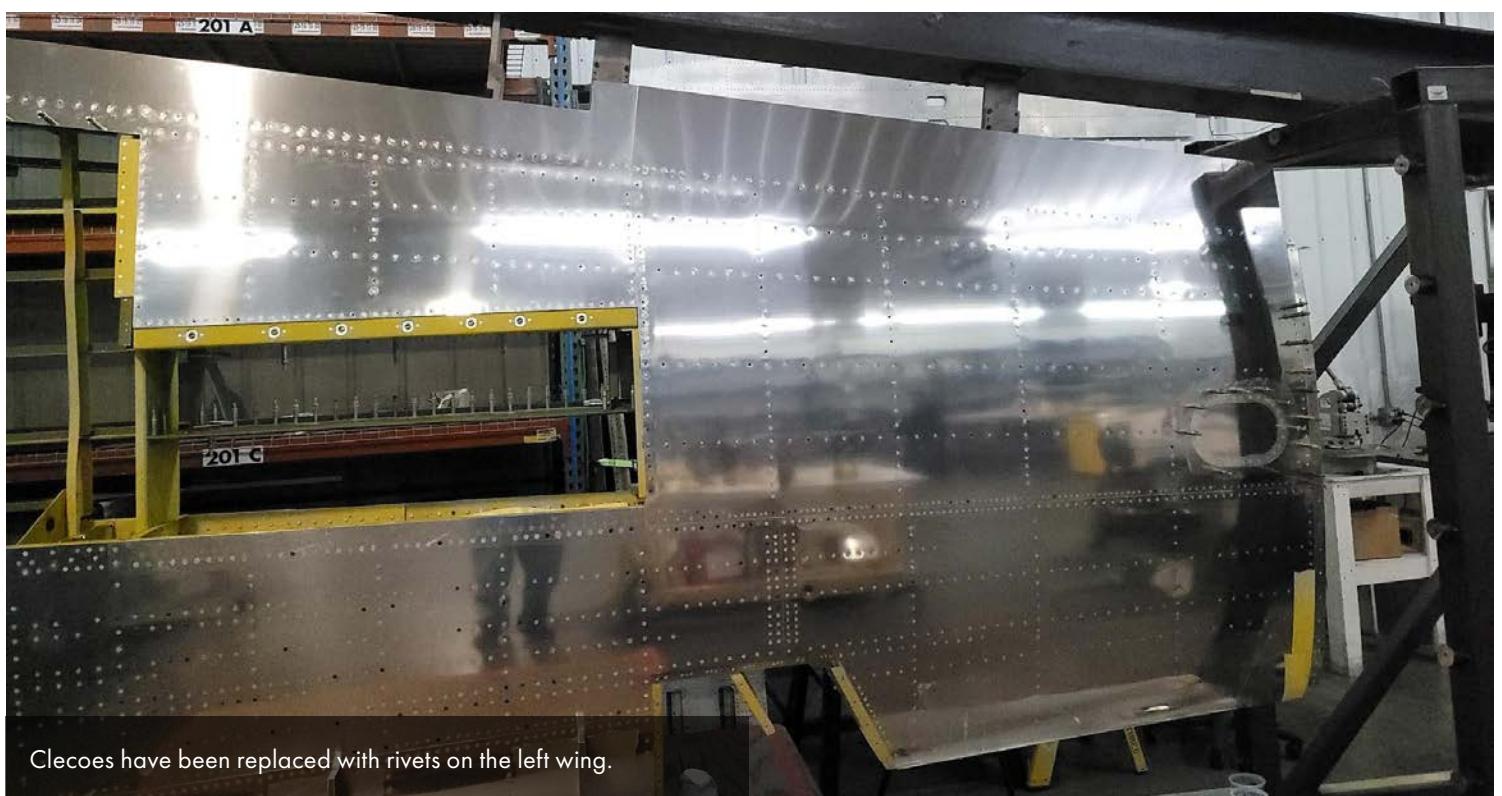
Clecoes have been replaced with rivets on the left wing.

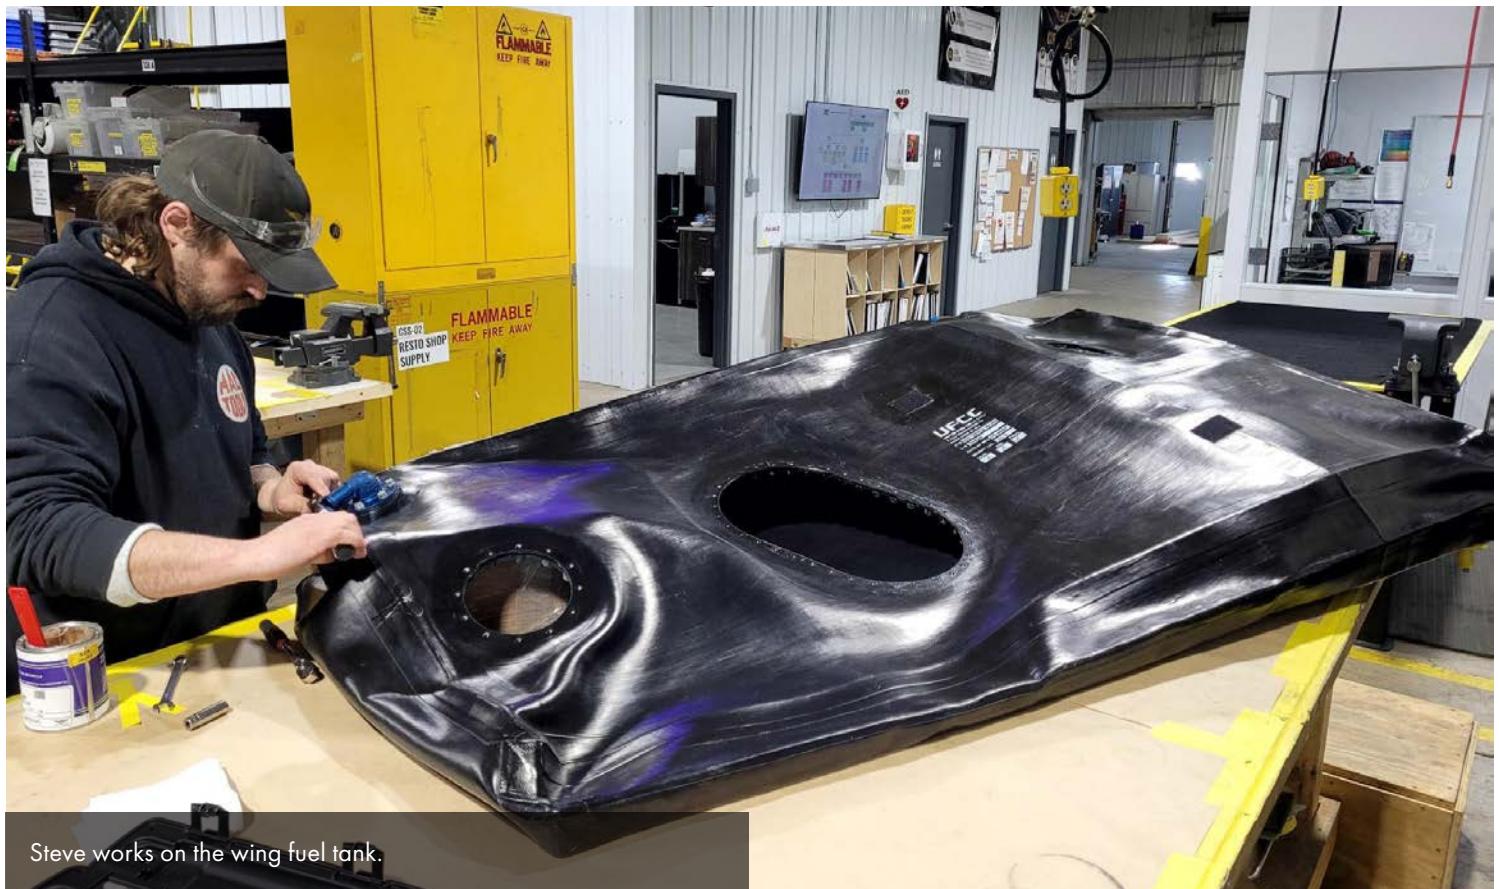
Steve works on the wing fuel tank.

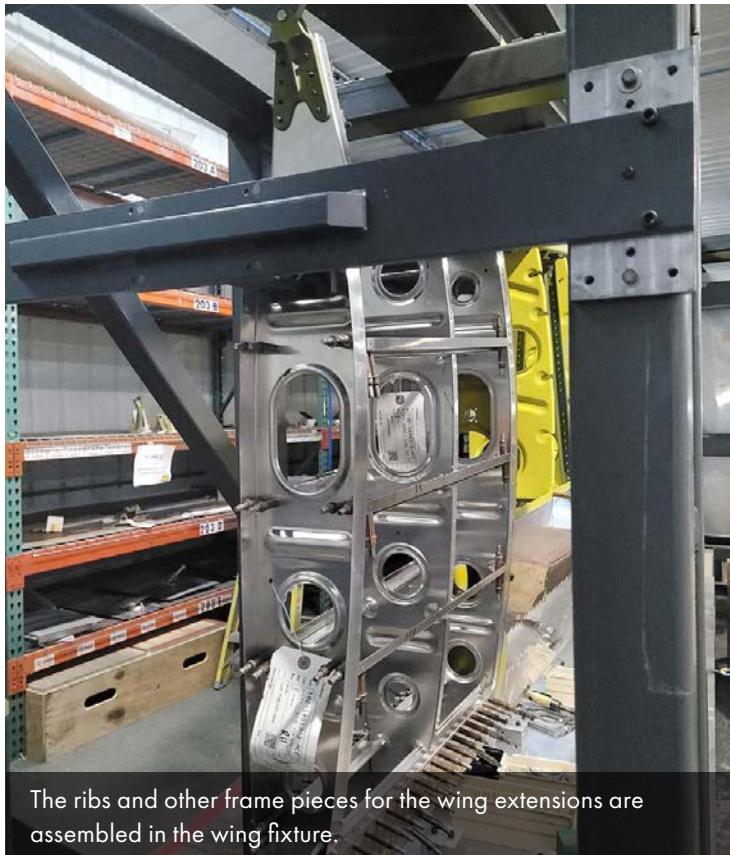
The ribs and other frame pieces for the wing extensions are assembled in the wing fixture.

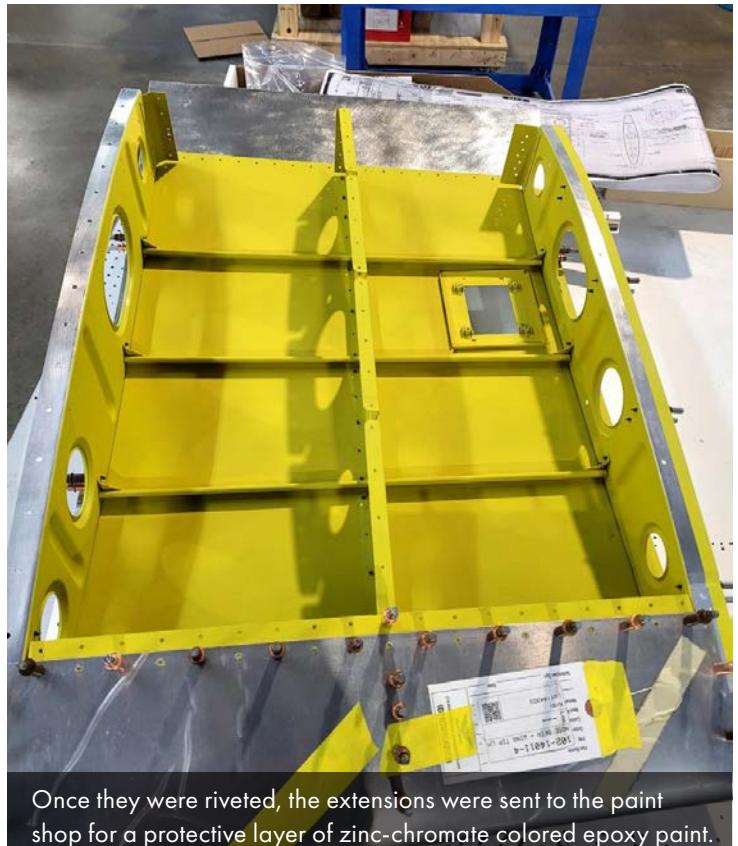
Once they were riveted, the extensions were sent to the paint shop for a protective layer of zinc-chromate colored epoxy paint.

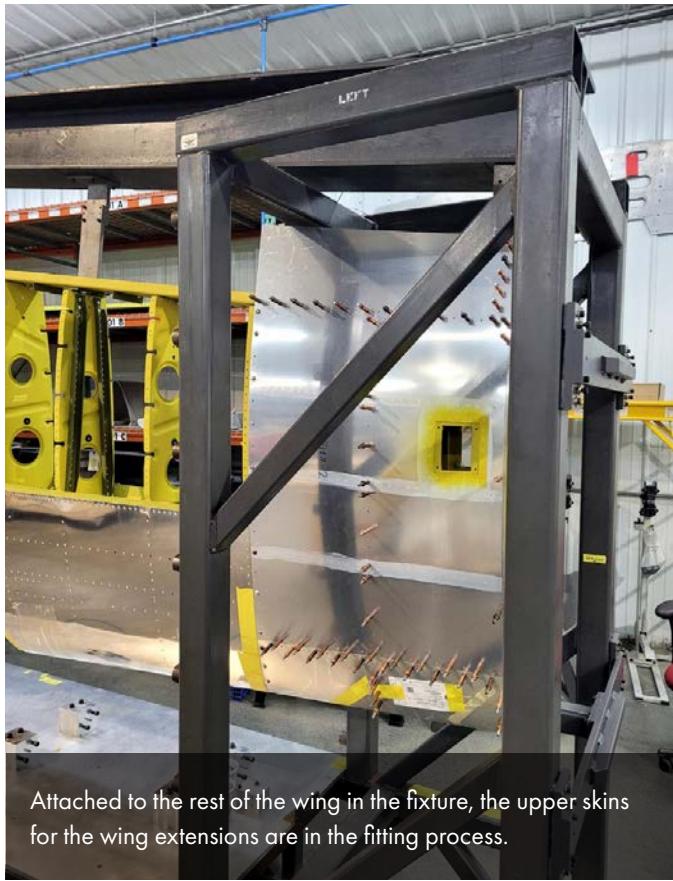
Attached to the rest of the wing in the fixture, the upper skins for the wing extensions are in the fitting process.

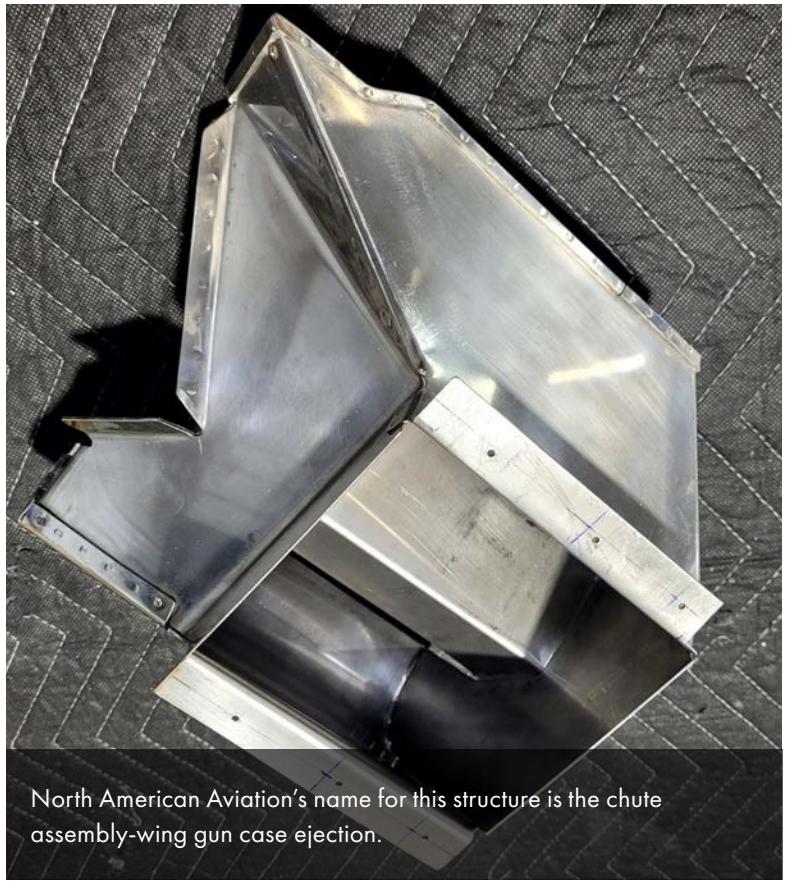
North American Aviation's name for this structure is the chute assembly-wing gun case ejection.

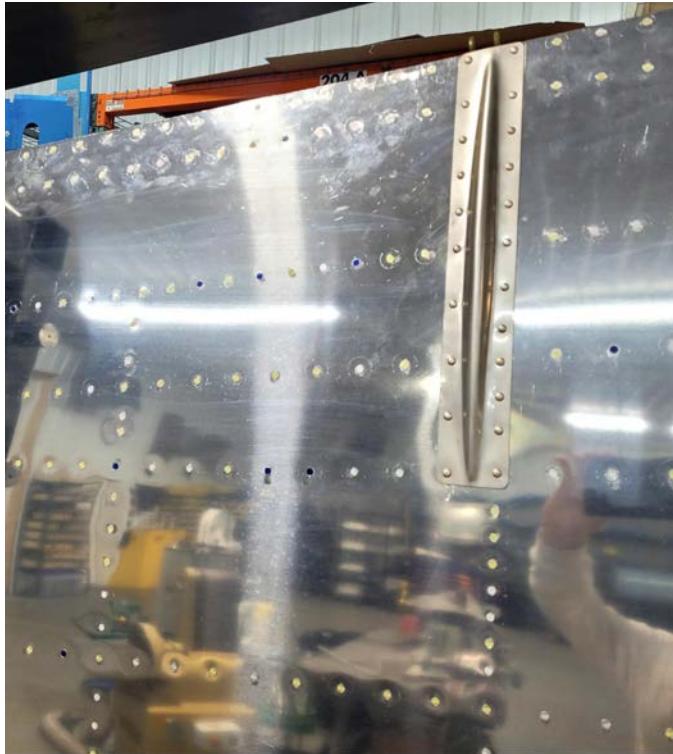
Stiffeners have been added to both wings, just inboard of the wing extensions.

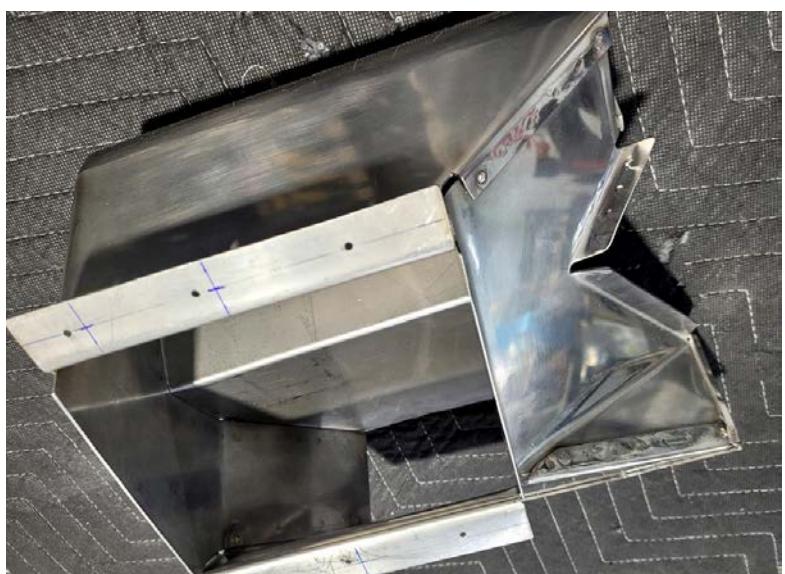
The part number for this one is 102-61111-1. The final dash 1 indicates that this assembly is for the right wing. The assembly that would go in the left wing would not have the dash 1 at the end, (102-61111)

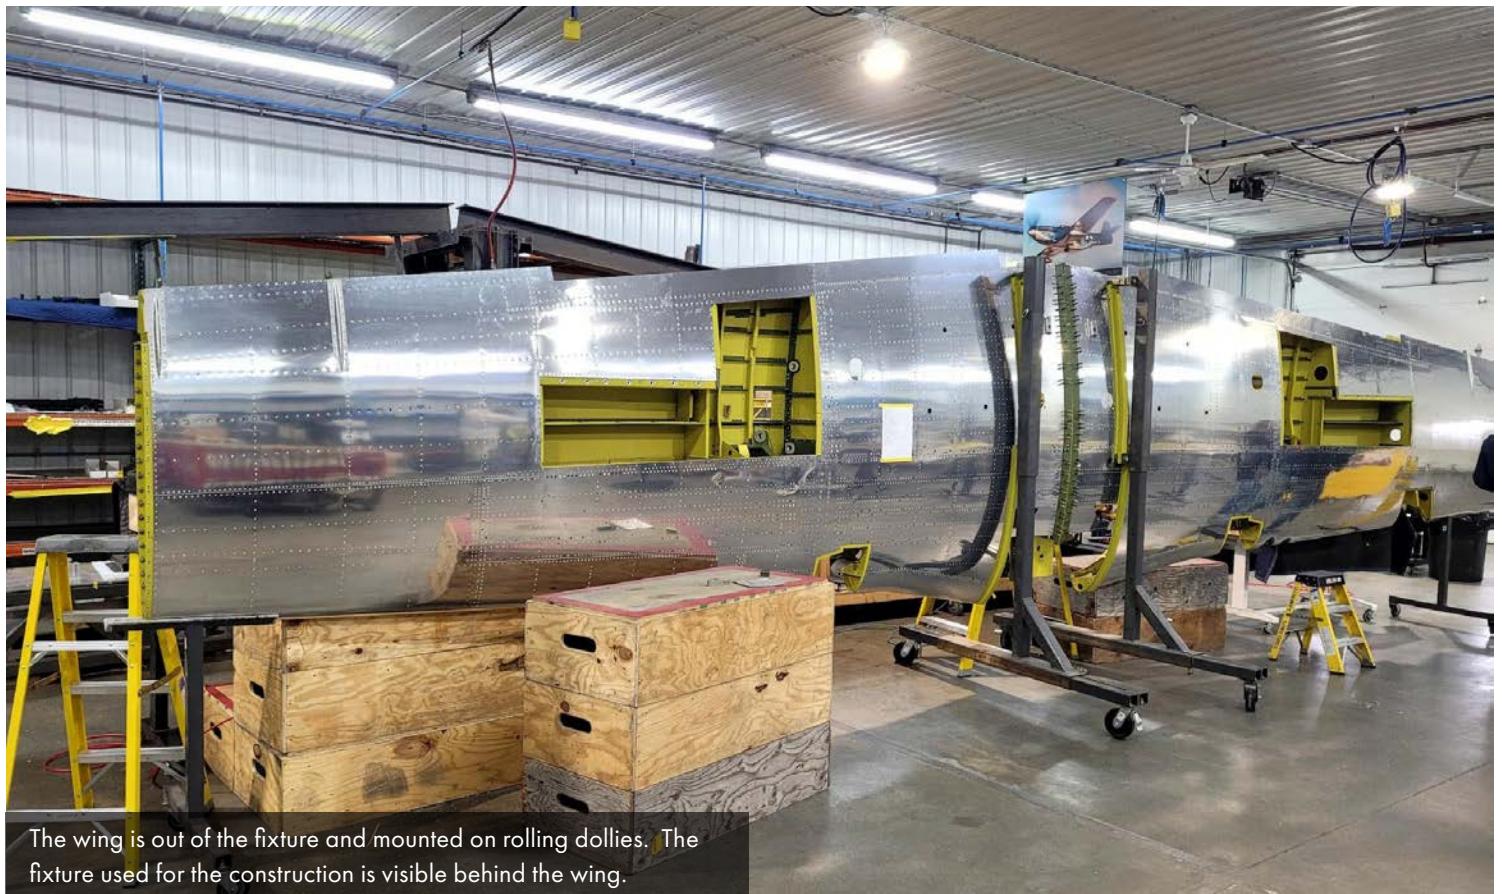
The wing is out of the fixture and mounted on rolling dollies. The fixture used for the construction is visible behind the wing.

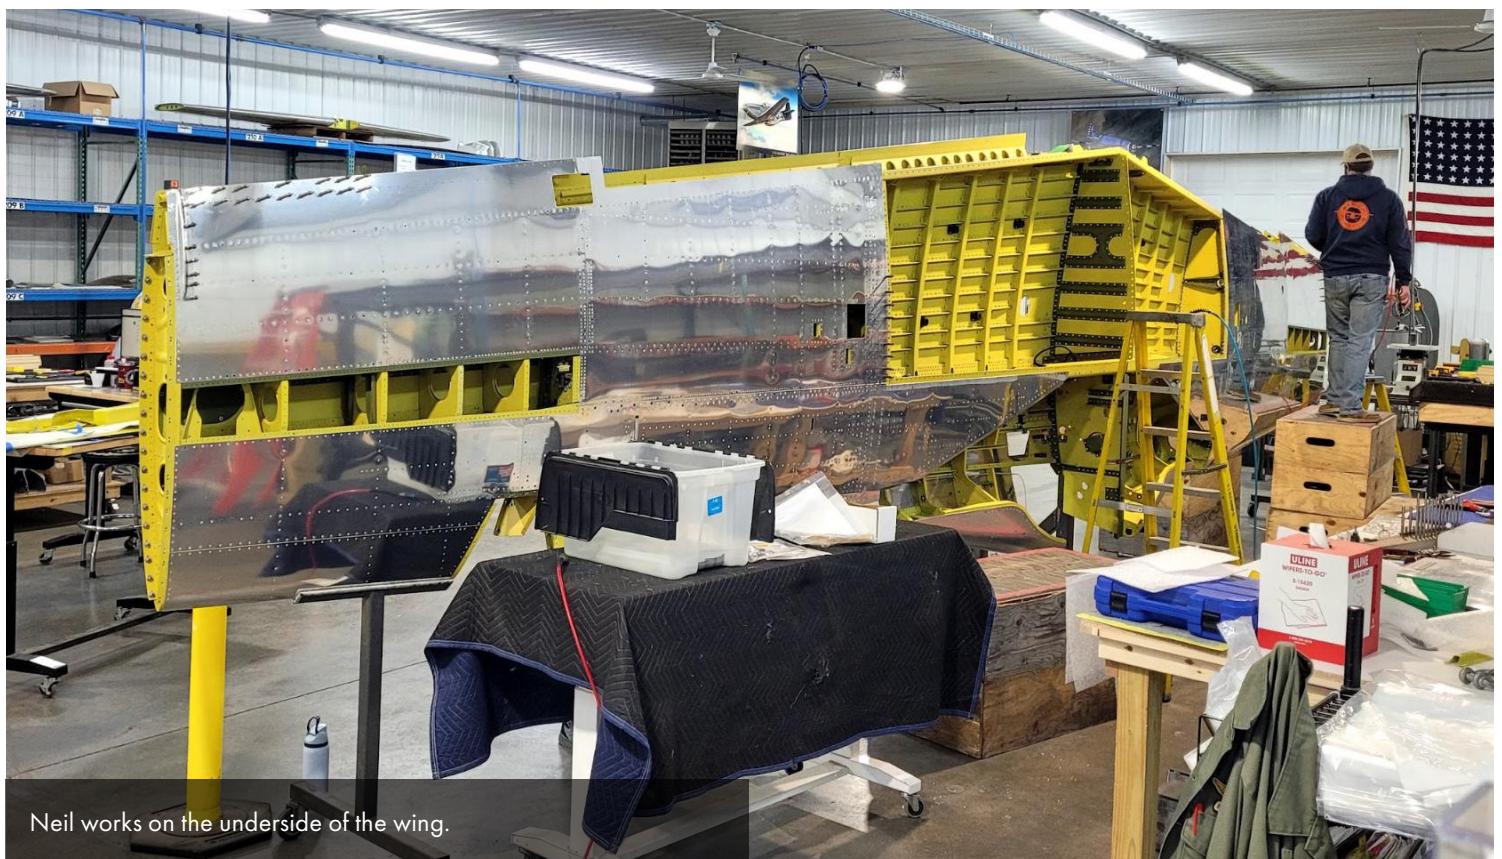
Neil works on the underside of the wing.

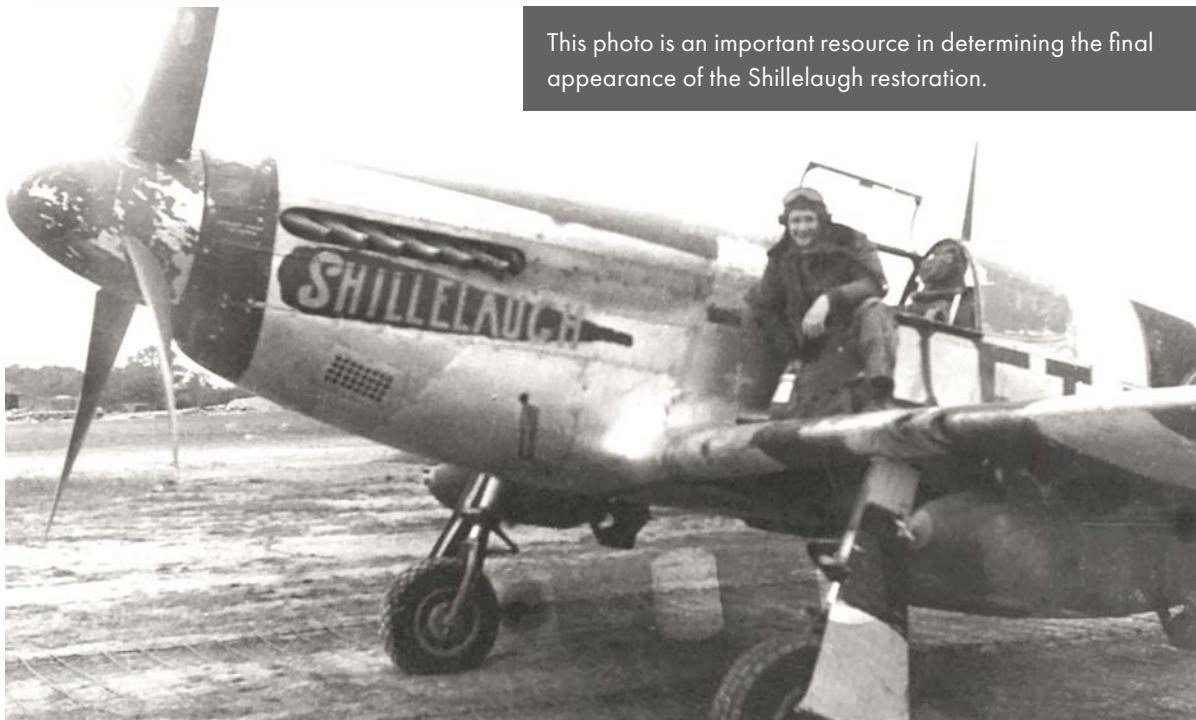
This photo is an important resource in determining the final appearance of the Shillelaugh restoration.
