# P-51B SHILLELAGH SUMMER UPDATE

Dakota Territory Air Museum's P-51 B Mustang by Chuck Cravens

Work on the fuselage systems was a focus this month. Cooling and induction, cockpit, and firewall forward systems all received attention as the restoration progressed. The wing construction also proceeded. Finally, a research mystery was solved when the family of Fred Osborne, Shillelagh's crew chief, was located.

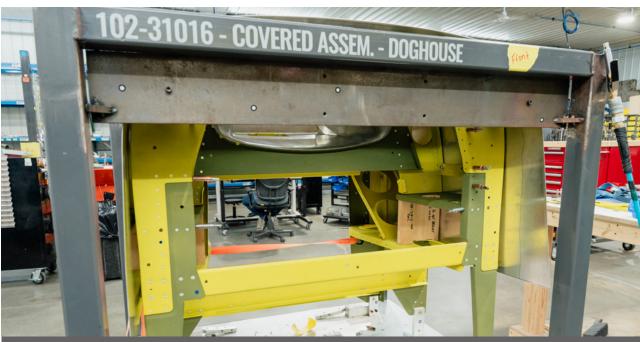
Despite being new old stock, the doghouse still had to be disassembled, inspected, and painted. Here it is shown in the fixture as it is reassembled.

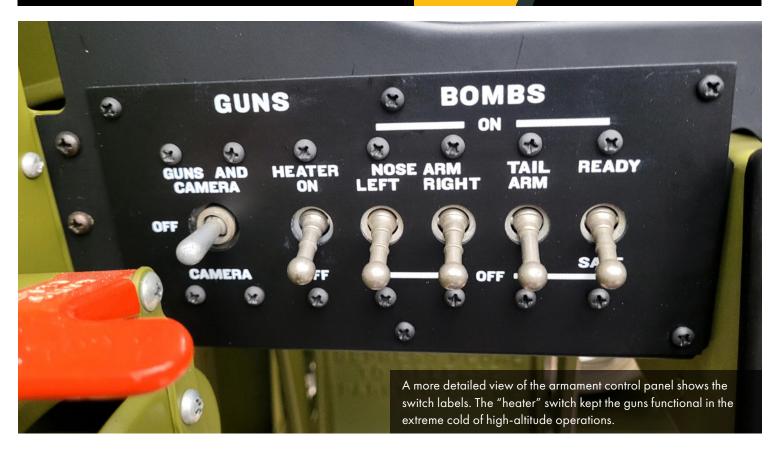
Cabin heat is a system that keeps the pilot functional at altitude, and is controlled by a handle mounted on the floor. Gun heat is provided electrically, while cabin heat uses warm air ducted from the radiator.

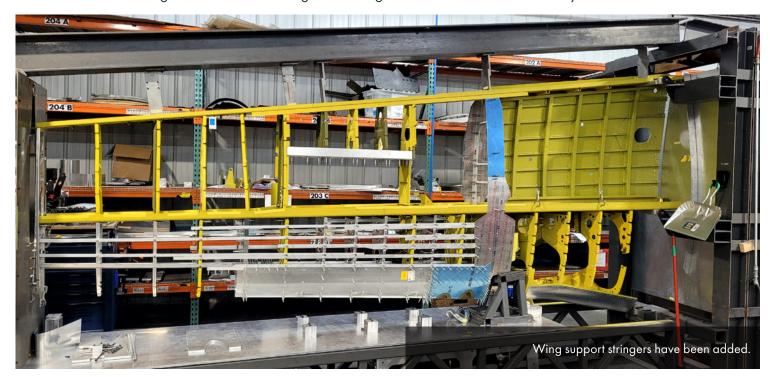
Construction of the wings is progressing nicely. The ribs, stringers, and spars have all been painted as necessary and assembled into the wing framework. The fitting of the wing skins to the frame is underway.

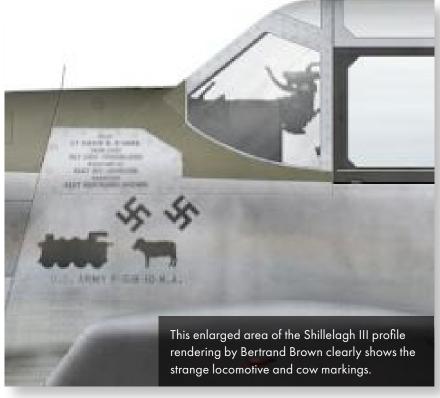
In photos of the original Shillelagh III, there are two rather strange markings in the area where victory markings are customarily painted on a P-51 - a cow and a locomotive. The reason for the cow and locomotive remained a mystery until the author was able to locate the family of Shillelagh's crew chief: Fred Osborne. Fred's daughter, Kathy (Osborne) Brookside, and her husband Steve were kind enough to explain the meaning during a phone interview.

Fred Osborne painted the cow and locomotive on Shillelagh III to commemorate the event. Most likely, they also enjoyed needling the poor guy who hit the cow and had it recorded for posterity on the gun camera film.
