Repair Station - P-51 Stock Brakes

Getting into Goodyears

Manufacturer	North American Aviation / Goodyear Aircraft Company
Aircraft	P-51 Mustang
Brake Manufacturer P/N	511124M (Goodyear)
Proper Description	BRAKE ASSEMBLY - 7.6 x .100/.125 x 9 HIGH PRESSURE
Location	Mounted to the torque flange of each lower landing gear axle
Nickname	Mustang Stock Brakes / 7" Mustang Brakes

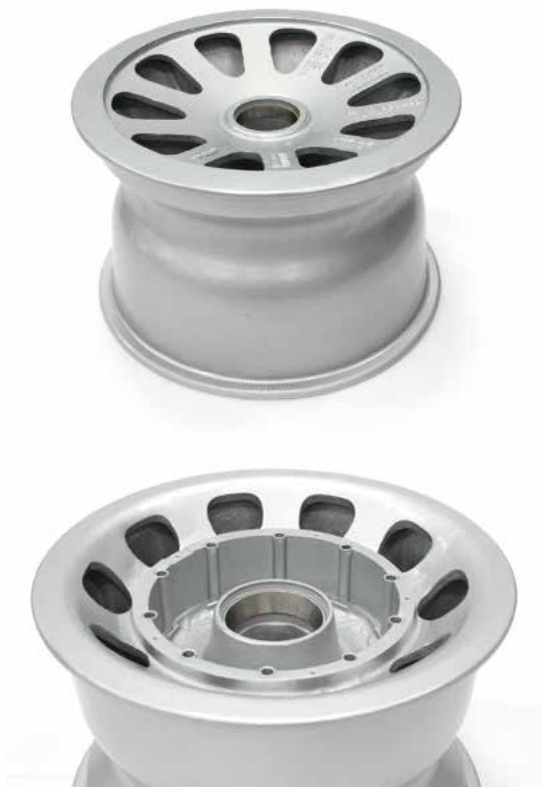
530441 27" SC LANDING WHEEL P-51 MUSTANG

The 511124 Goodyear brake assembly for the P-51 was likely designed and engineered by Goodyear in the same date range (August 1940) as that of the P-51 Landing Gear assembly. The brake design never changed considerably as evidenced by the usage of that brake assembly on the prototype P-51 drawing 73-33001.¹ The 511124 brake assembly was used on all models through the P-51D model mustangs. The 511124 Brake Assembly was designed to be solely used with the [530441M 27" SMOOTH CONTOUR LANDING WHEEL ASSEMBLY](#).

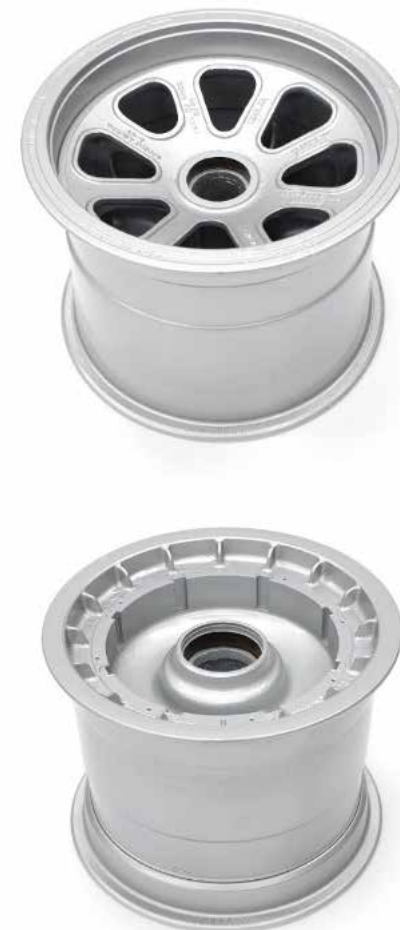
530761 27" SC LANDING WHEEL P-63 Kingcobra

The P-63 Kingcobra built by Bell Aircraft is a fighter that emanated from its predecessor the P-39 Airacobra. The P-63 Kingcobra used a similar sized 530761 27" SMOOTH CONTOUR LANDING WHEEL and tire. The wheel uses the same races and bearings and fits on the P-51 axle assembly without any changes to the landing gear strut. A number of mustang owner operators use the P-63 brake [511638 - BRAKE ASSEMBLY - HIGH PRESSURE - 10.0 W x 100/125 x 7](#) on their aircraft. The change only requires some slight modifications to the striker and plunger. Both the design and dimensions of the P-63 wheel and brake combo are quite different from the stock mustang brake. We will write a blog specifically on the P-63 wheel and brake, until then, here are a couple of differences.

- The P-63 Brake 511638 is a 10" Brake
- The P-63 brake used 8 Stationary Discs and 7 Rotating Discs
- The P-63 wheel used a split rim design, the wheel has a separate flange on the outboard side which is held in place by a locking. The split rim design for changing tires is a nice convenience

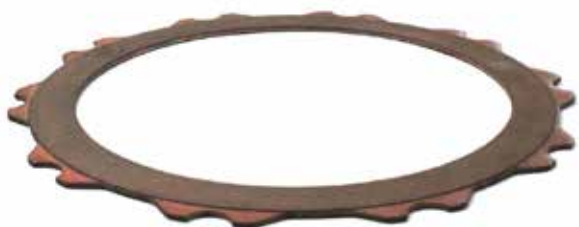
Failure Location # 1

The most common failure occurs in the wear of the rotating disc (PN 530597-1). The disc should be inspected for flatness and that the thickness is no less than .090". The friction coating should not be flaking off, and should not have been blasted with sand like coarse abrasives which compromise the friction coating.

The P-51 Mustang [T.O. 01-60J-52](#) from 1945 specified that .020" wear was allowed. However [T.O. No. 4B1-2-3 \(Formerly AN 03-25GAC-1\)](#) brake overhaul manual dated 1960, revised the earlier TO to allow only .010" in wear.

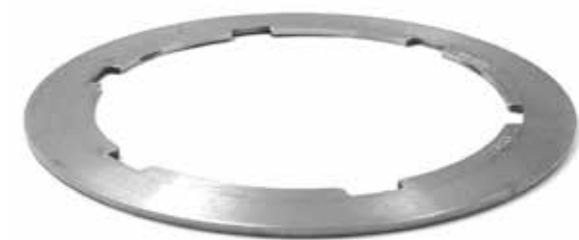
Failure Location # 2

Another common failure occurs in the 530596-1 Stationary Disc. This steel disc that is ground and chromed can also show wear. This disc should be checked for flatness and there should be no pitting or flaking of the chrome or accumulation of foreign matter fused to the disc. Cracks emanating from the anchor key slot corner is a common problem to watch out for.

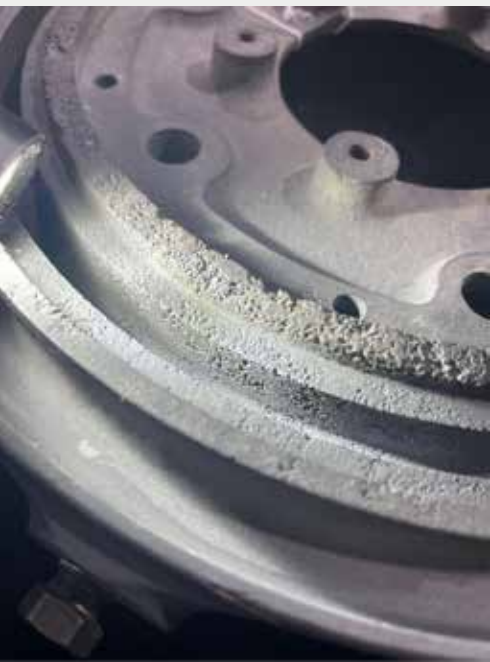
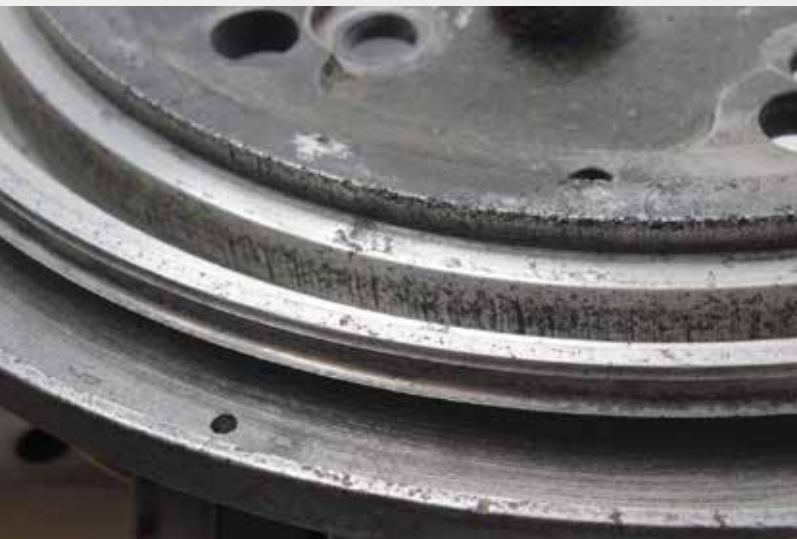
With 70 year old BRACKET - BRAKE MOUNTING AND PISTON CAVITY (P/N 530467) we are seeing a prevalence of pitted magnesium cavities for the PISTON SEAL GASKET. brake mounting and piston cavity (P/N 530467) often referred to as the backing plate.

Option 1 - Replacement of 530467 BRACKET - BRAKE MOUNTING AND PISTON CAVITY

Option 2 - Repair by machining of the piston cavity on 530467 BRACKET to accept an oversized 510664 Piston Seal Gasket

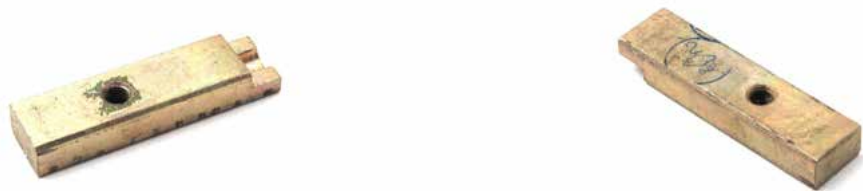
FAILURE MODE #4 – Excessive wear on the anchor key retainer blocks.

How to recognize - grooving or wear from moving discs

Tolerance of damage or wear : [T.O. No. 4B1-2-3 \(Formerly AN 03-25GAC-1\)](#) brake overhaul manual specifies to replace any keys grooved or notched greater than .002

Solutions offered: Replacement of anchor keys

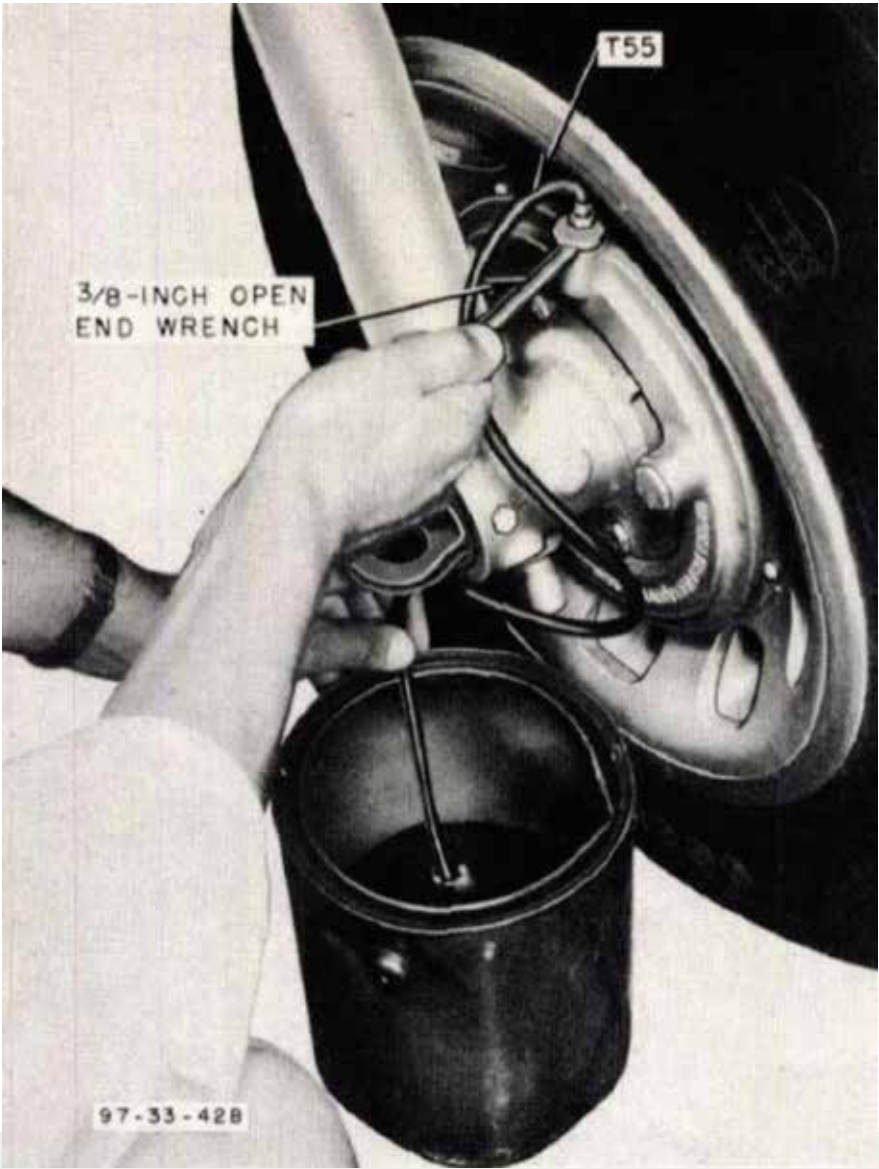
BLEEDING P-51 DISC BRAKES

Note: Air in the brake system causes the pedals to have a springy, rubbery action, or a lack of resistance to foot pressure. The air must be eliminated by forcing fluid through the brake lines until there are no more air bubbles in the fluid

- STEP 1** See that the hydraulic fluid reservoir is full.
- STEP 2** Remove cap screw and washer from brake bleeder plug and insert T55 bleeder hose.
- STEP 3** Place the free end of the bleeder hose in a clean receptacle containing a little hydraulic fluid, and then loosen the bleeder plug. This will allow fluid to flow by gravity and fill the brake system.
- STEP 4** When fluid begins to flow out of the bleeder hose, hold the free end of hose under the fluid level in the receptacle, push the brake pedal forward, and then allow the pedal to come back slowly. Repeat this operation until no more air bubbles come from the bleeder hose.
- STEP 5** Tighten the bleeder plug, remove bleeder hose, and install bleeder plug cap screw and washer.
- STEP 6** Follow the same procedure at the opposite brake and at the parking brake compensator bleeder lug just aft of the hydraulic system reservoir.
