Landing Gear Retraction Rod End Failures & Safety Spring Installation

All P-51 Mustang Variants

Manufacturer	North American Aviation
Aircraft	P-51 Mustang
NAA Part Number	<u>73-33578-3</u>
Rod End Manufacturer	ATE-6N (Schafer)
P/N	
Proper Description	ROD ASSEM - LANDING GEAR RETRACTING STRUT CONNECTING
Location	One assembly is located in each main landing gear wheel well
Nickname	Gear Links / Landing Gear Rod Ends

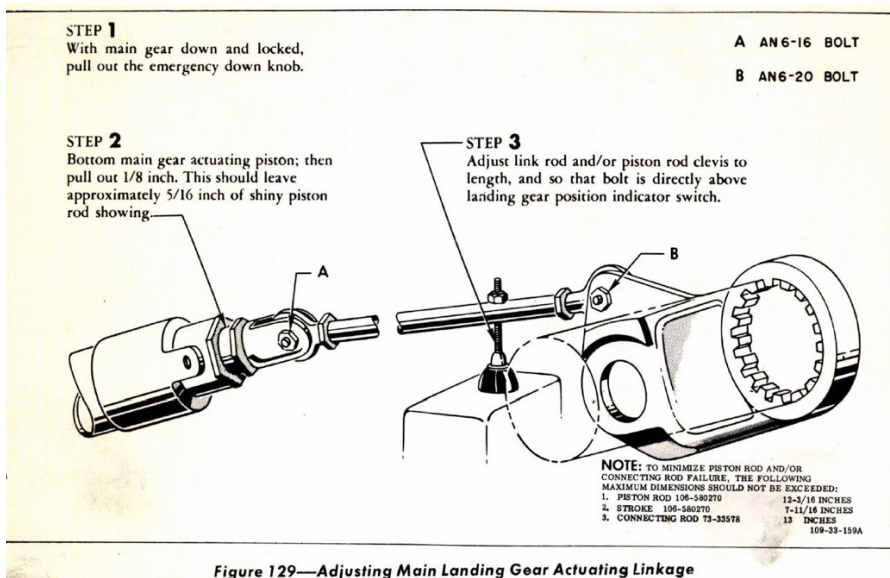
Figure 129—Adjusting Main Landing Gear Actuating Linkage

Because the hydraulic strut never fully bottoms in either direction, the rod assembly is constantly under pressure or tension at both ends of travel. Because of the hinge-like motion of the cycle, misalignment of the bearings will cause additional pressure and tension, and potentially failure of the rod ends.
