Landing Gear Retraction Rod End Failures & Safety Spring Installation

All P-51 Mustang Variants

Manufacturer	North American Aviation
Aircraft	P-51 Mustang
NAA Part Number	<u>73-33578-3</u>
Rod End Manufacturer	ATE-6N (Schafer)
P/N	
Proper Description	ROD ASSEM - LANDING GEAR RETRACTING STRUT CONNECTING
Location	One assembly is located in each main landing gear wheel well
Nickname	Gear Links / Landing Gear Rod Ends

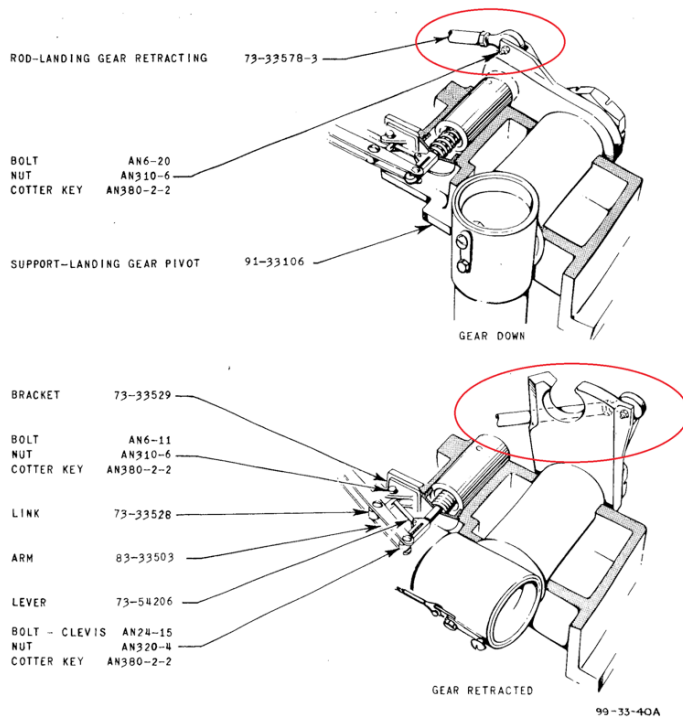
Figure 113—Main Gear Down-position Lock

- Provides the connection between the main landing gear strut and main landing gear, along with transferring hydraulic pressure to extend and retract the landing gear.
- Special bolt 73-54221 contacts the landing gear position indicator switch when in the down position (P/Ns 109-54206 or 109-54226).
