## P-51 Landing Gear Pivot Shafts

### All P-51 Mustang Variants

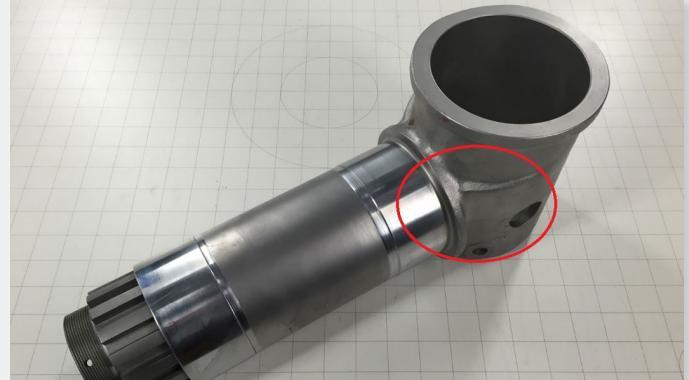
Light pivot shaft - Notice lack of additional material in the cheeks area of the shaft. Only 3 of the 16 light pivot shafts inspected and tested by AirCorps have passed.

Therefore, AirCorps recommends, Following guidance given Military T.O. 01-60JE-47 to replace "light weight" shafts 73-33112 & 66584 as soon as possible or at next inspection. If "light weight" shafts are operated, we recommend immediate magnaflux inspection if not previously inspected by removal and magnaflux.

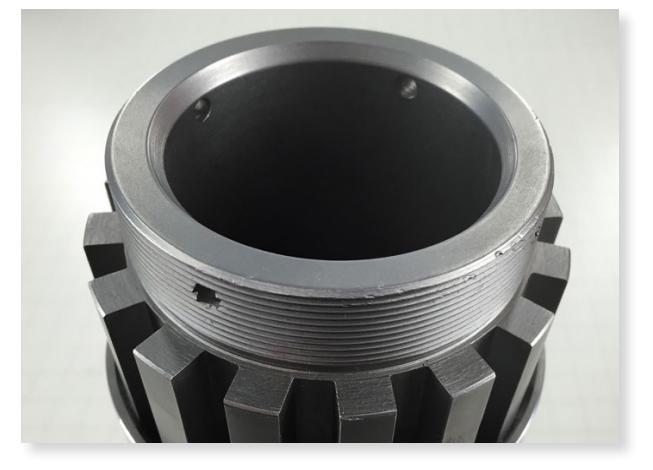
Twist of spline shafts is an often overlooked element of inspection that can affect the landing gear not properly engaging and uplocking when retracted. Splines will twist under 73-33116 bushing which is not visible without careful inspection.

Heavy pivot shaft - Notice additional material through cheeks of shaft to strengthen area prone to cracking. Also the chamfered / symmetrical sloping edge is visible within the highlighted area where the upright portion makes the transition to the shaft
