Dakota Territory Air Museum's P-47 Update

by Chuck Cravens

The flaps, elevators, cowling, and wingtips were areas of restoration progress this month. The fuselage work was concentrated on the cockpit, where the pilot's seat has been installed, and on finishing the turbosupercharger ducting. The wings were attached near the end of the month. We will also examine some of the 'teething problems' the early P-47s experienced as they were introduced to combat.

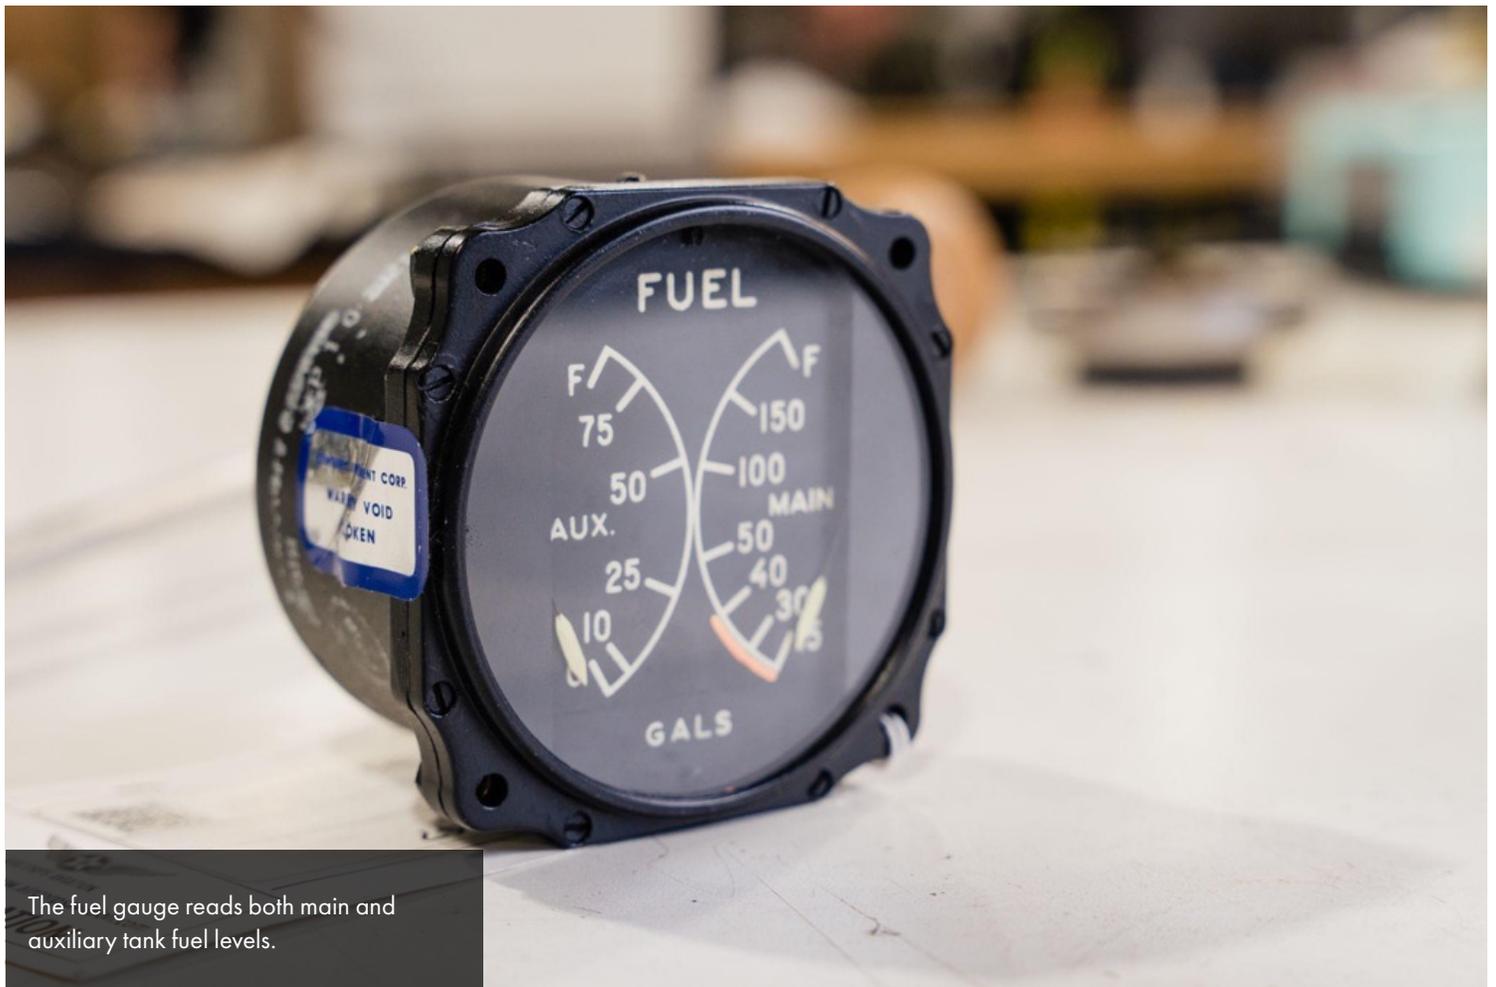
The fuel gauge reads both main and auxiliary tank fuel levels.

Work continues on the fuel level sender and fuel gauge.

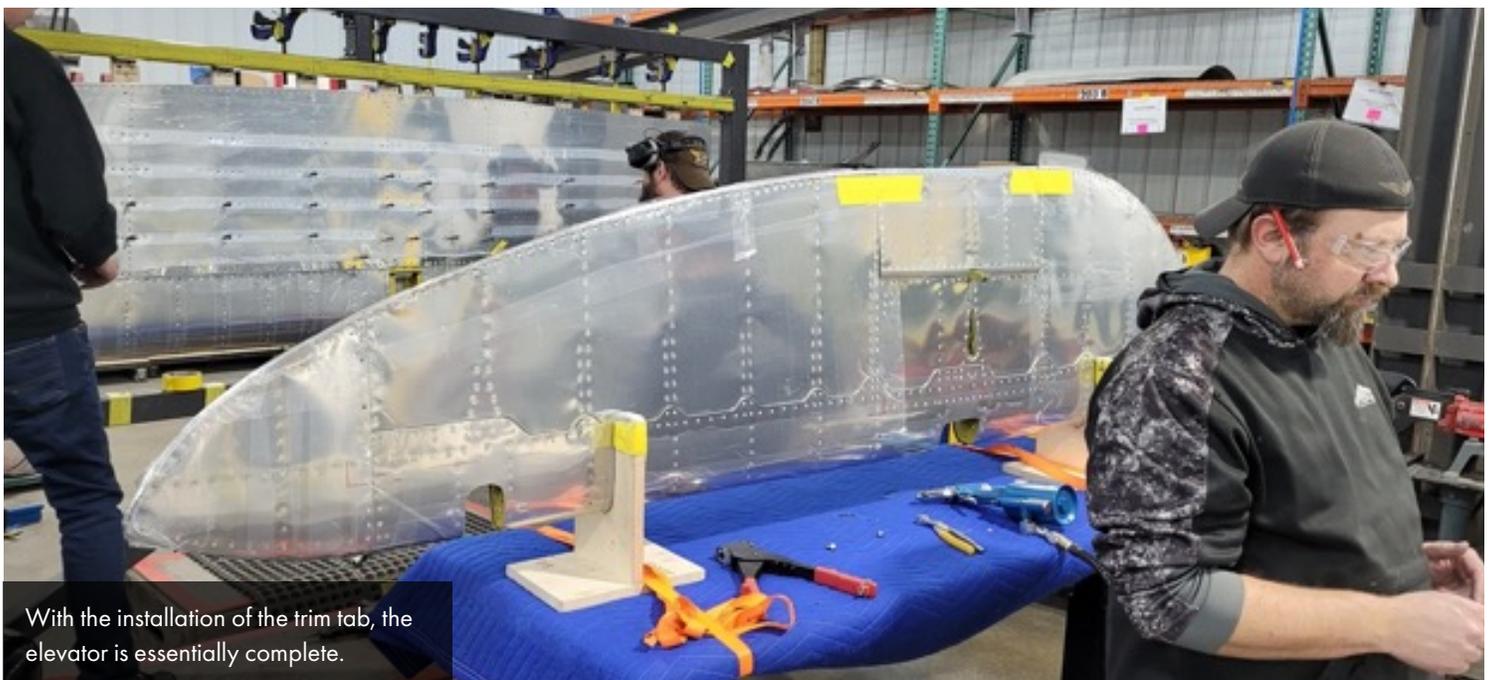
With the installation of the trim tab, the elevator is essentially complete.

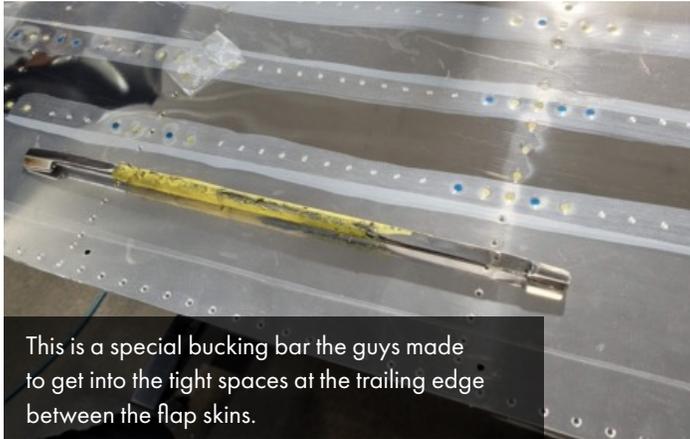
This is a special bucking bar the guys made to get into the tight spaces at the trailing edge between the flap skins.

Driving rivets in tight places, like the trailing edges of control surfaces, requires some ingenuity and special tooling.

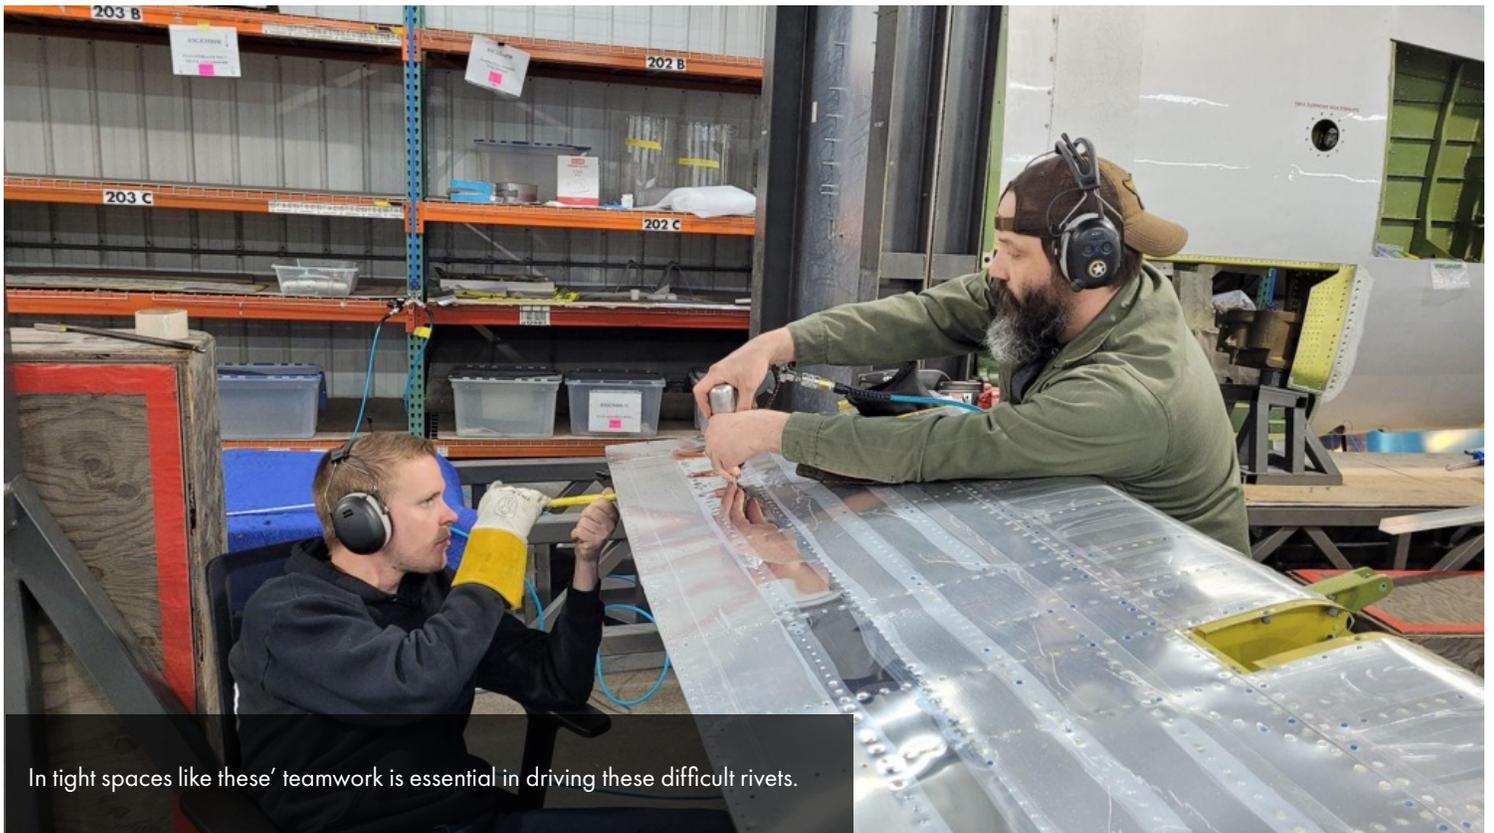
In tight spaces like these' teamwork is essential in driving these difficult rivets.

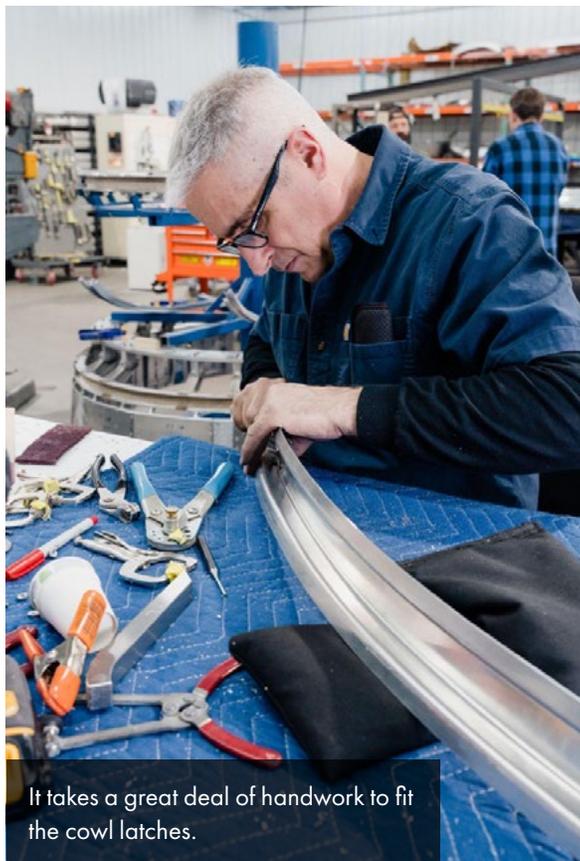
It takes a great deal of handwork to fit the cowl latches.

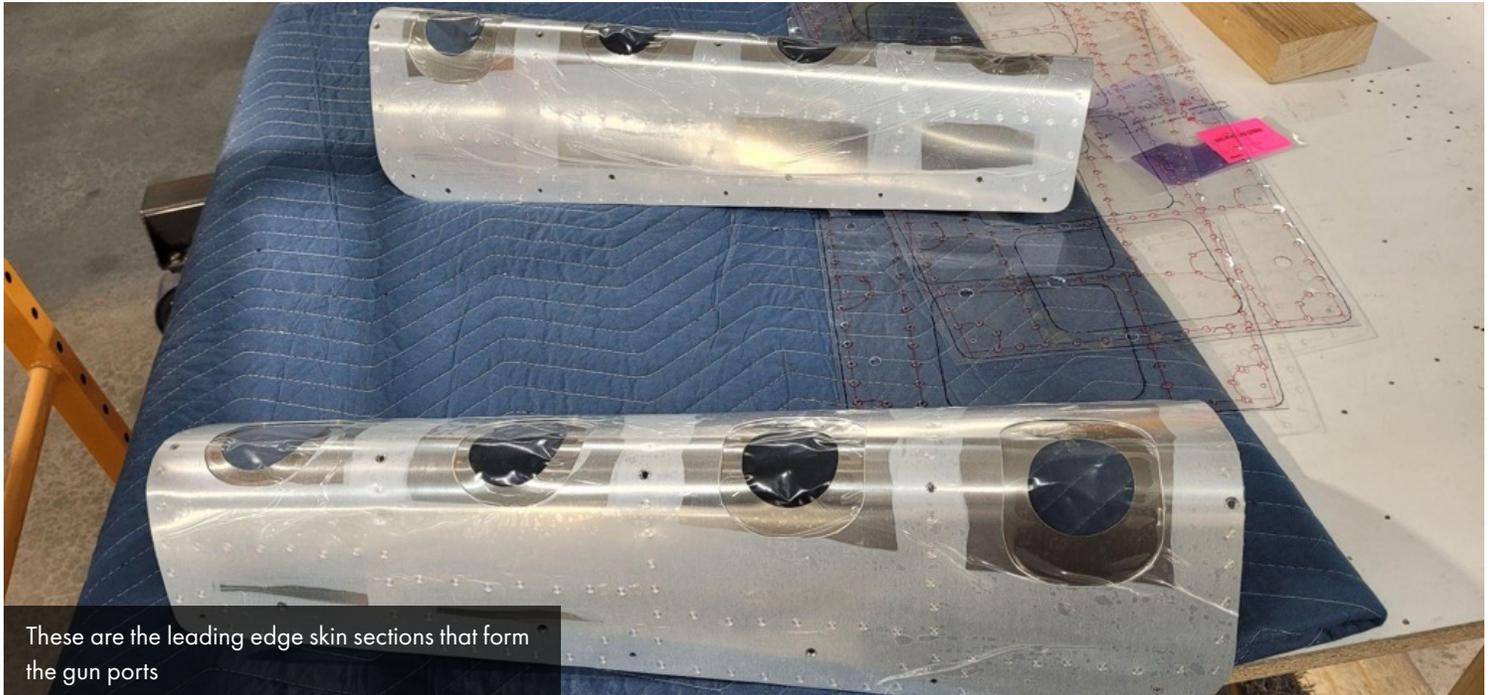
These are the leading edge skin sections that form the gun ports

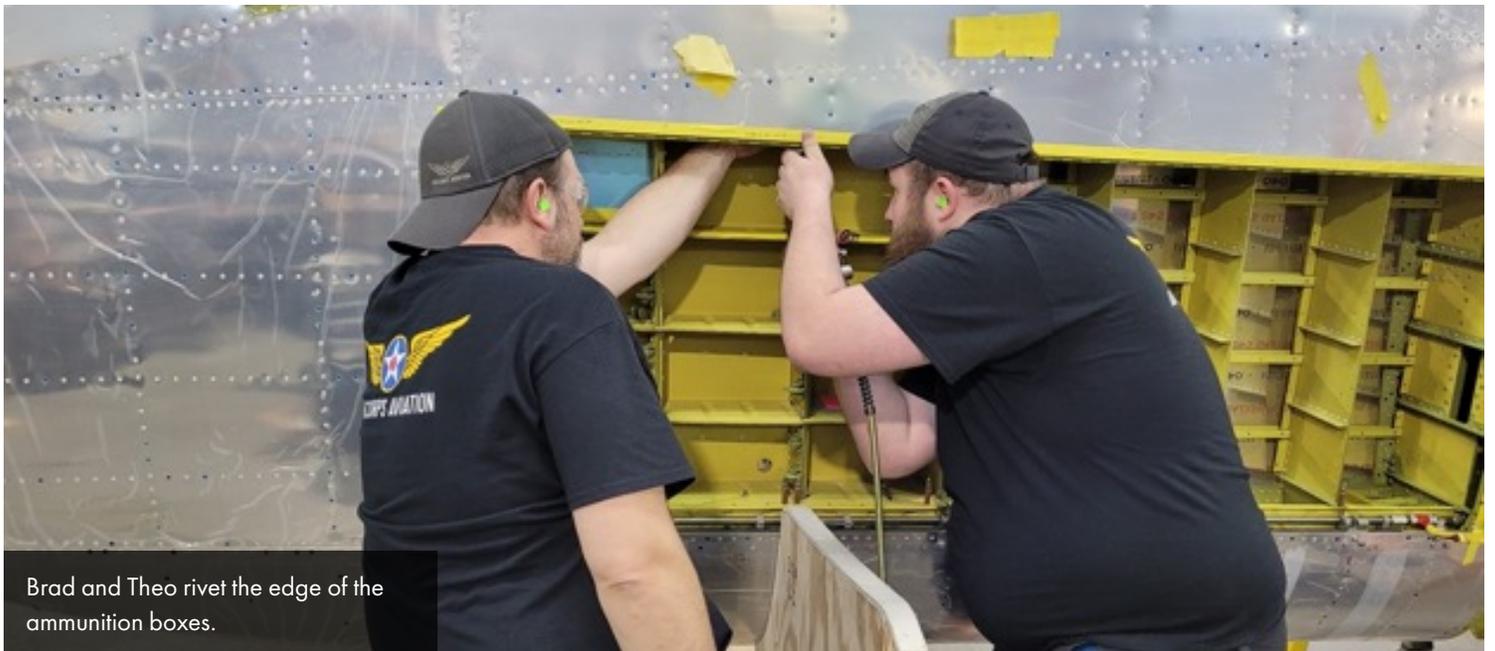
Brad and Theo rivet the edge of the ammunition boxes.

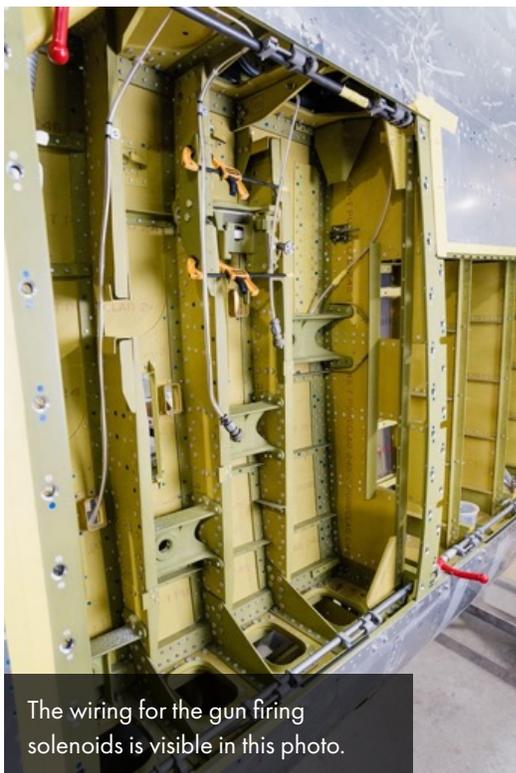
The wiring for the gun firing solenoids is visible in this photo.

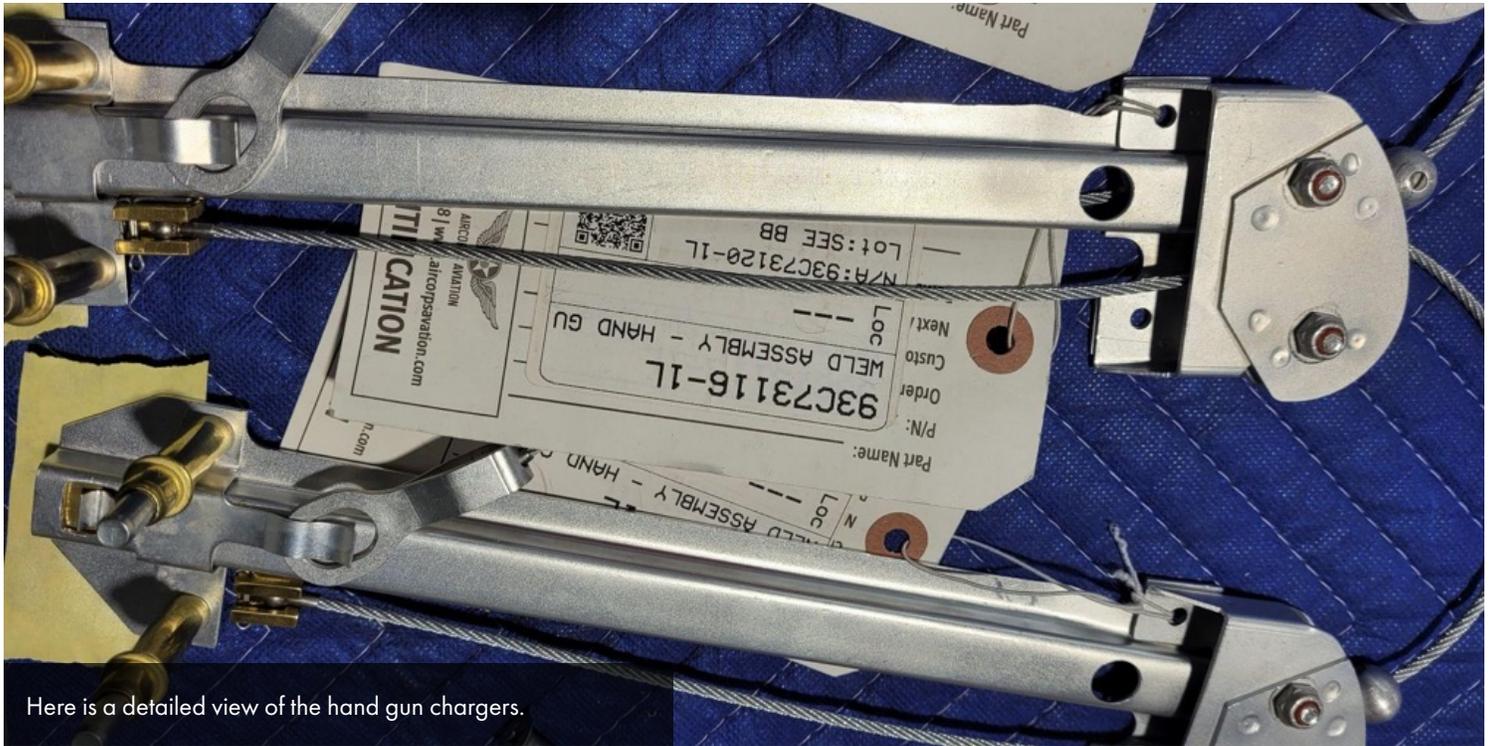
Here is a detailed view of the hand gun chargers.

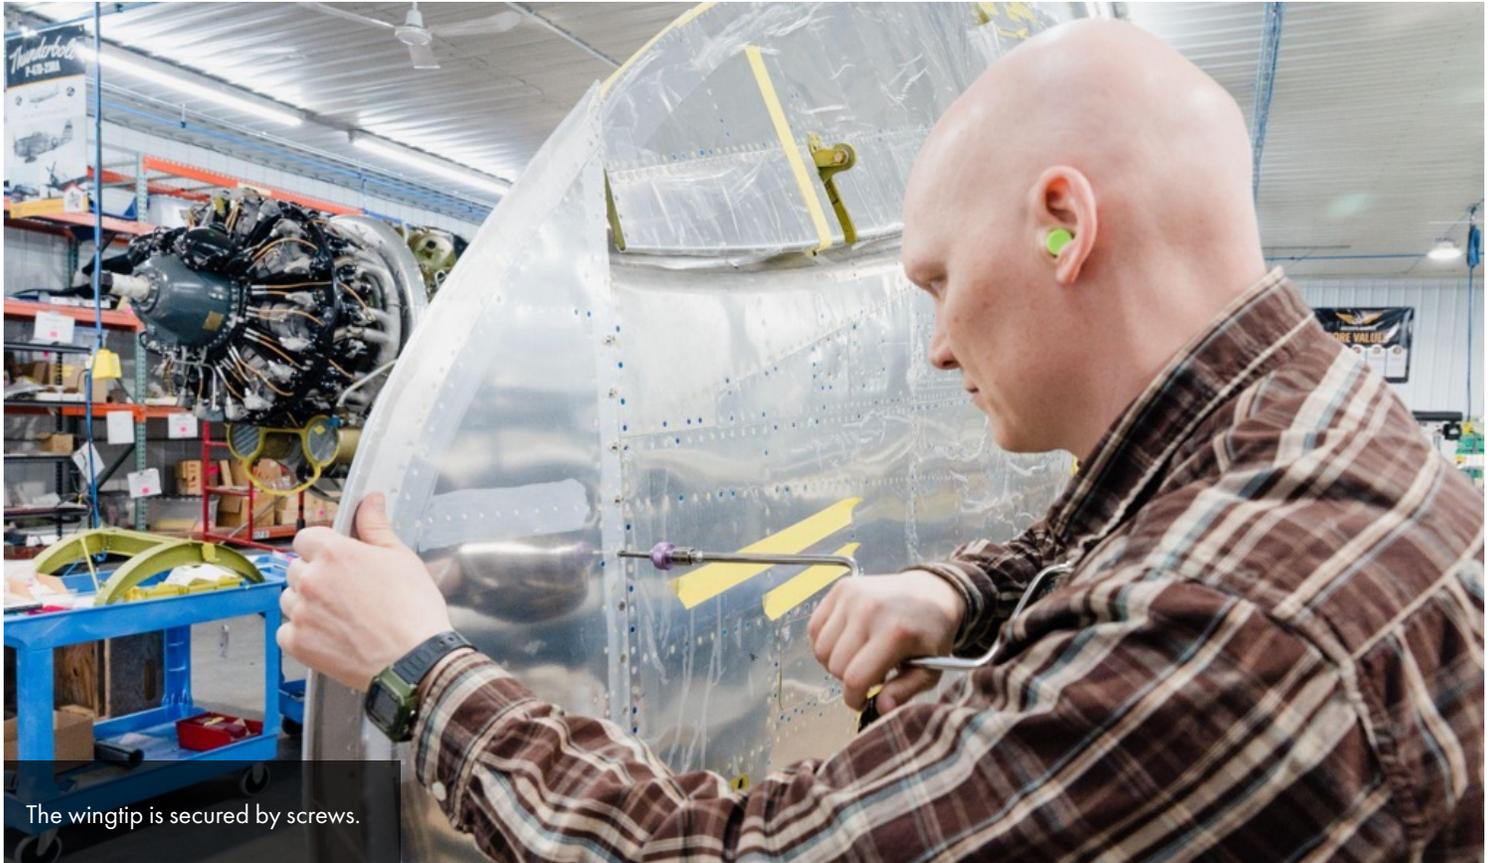
The wingtip is secured by screws.

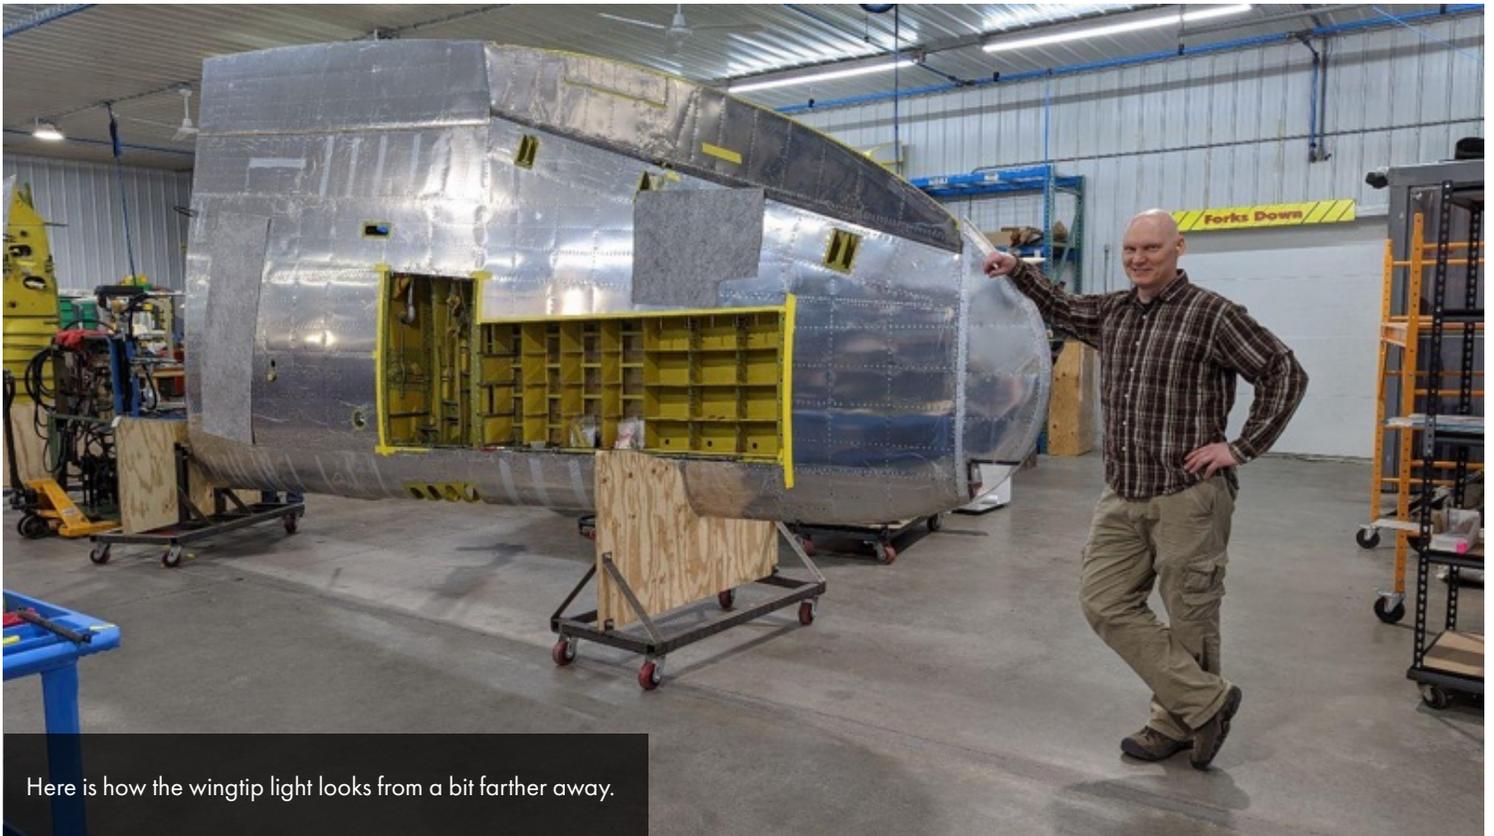
Here is how the wingtip light looks from a bit farther away.

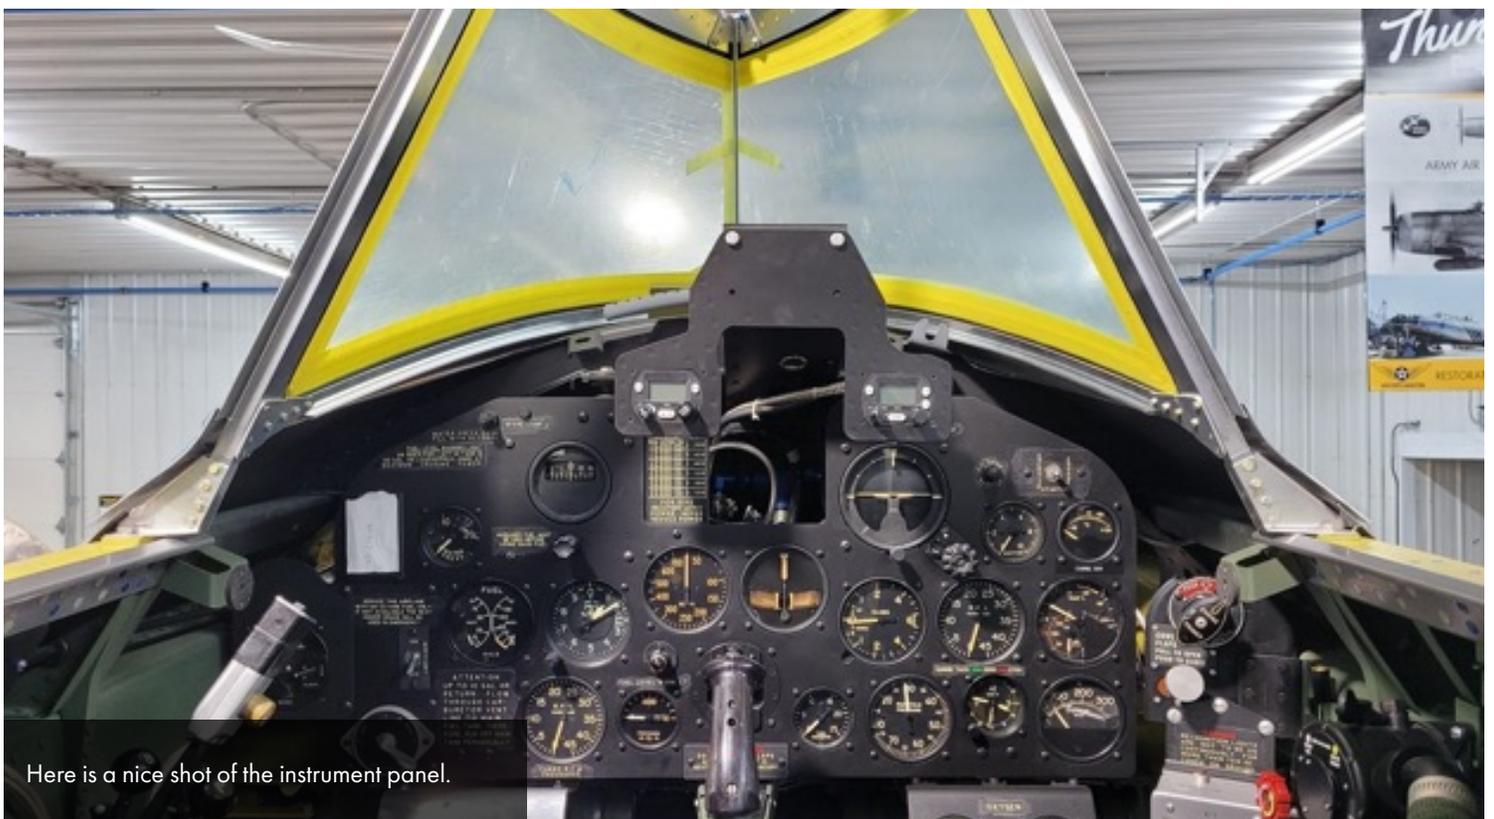
Here is a nice shot of the instrument panel.

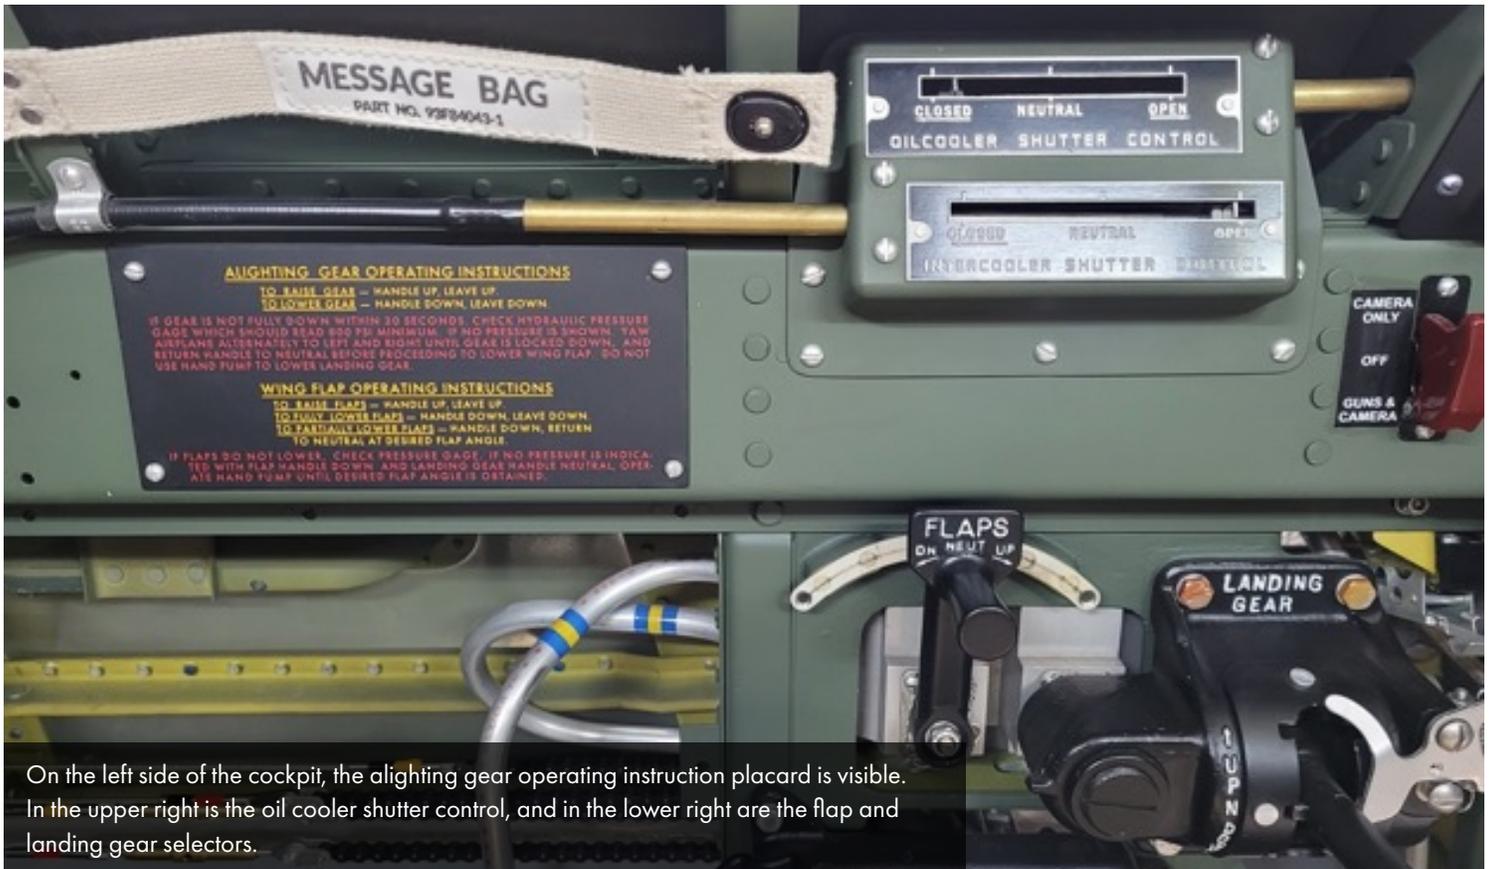
On the left side of the cockpit, the alighting gear operating instruction placard is visible. In the upper right is the oil cooler shutter control, and in the lower right are the flap and landing gear selectors.

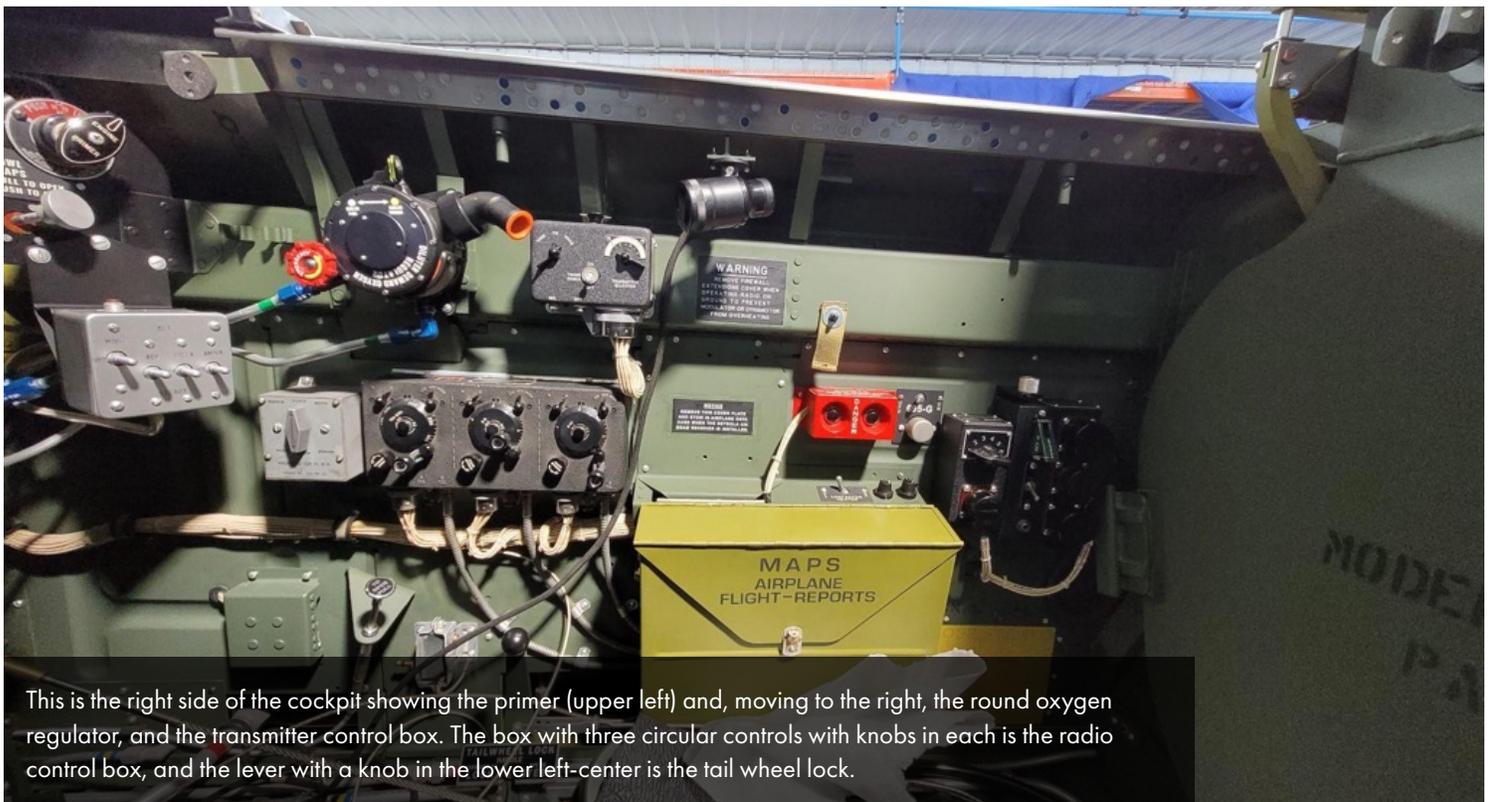
This is the right side of the cockpit showing the primer (upper left) and, moving to the right, the round oxygen regulator, and the transmitter control box. The box with three circular controls with knobs in each is the radio control box, and the lever with a knob in the lower left-center is the tail wheel lock.

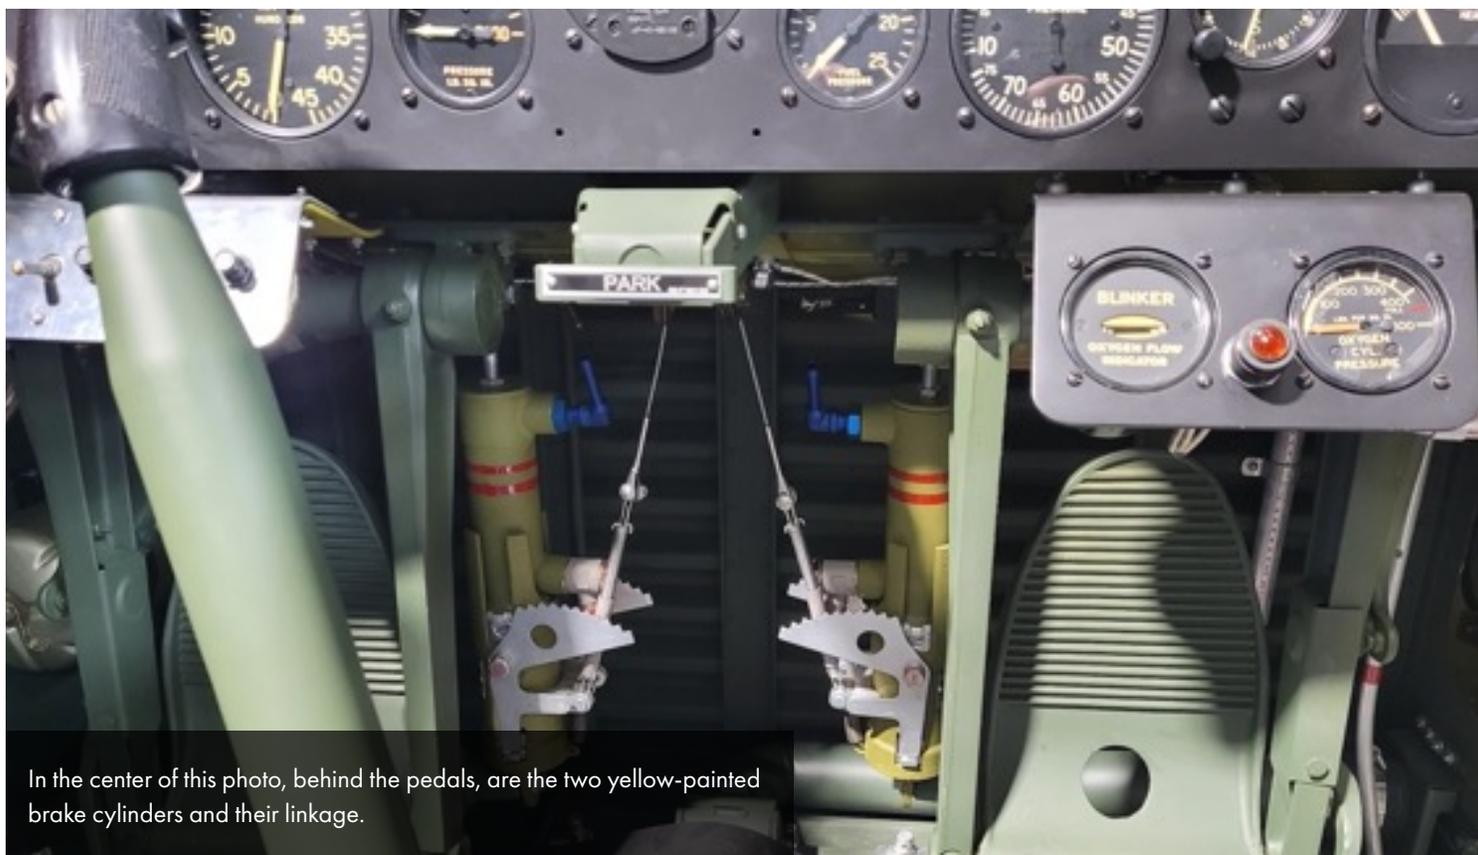
In the center of this photo, behind the pedals, are the two yellow-painted brake cylinders and their linkage.

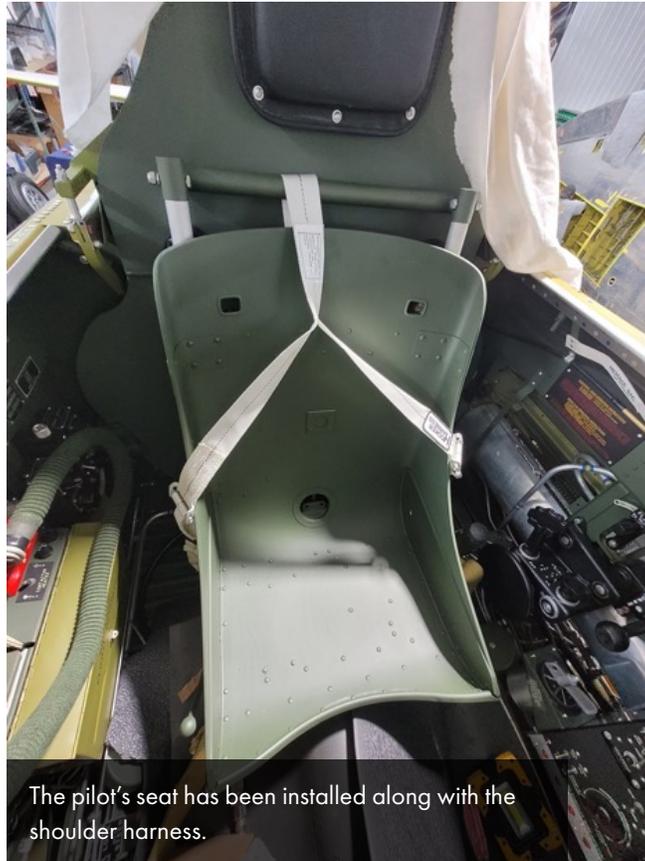
The pilot's seat has been installed along with the shoulder harness.

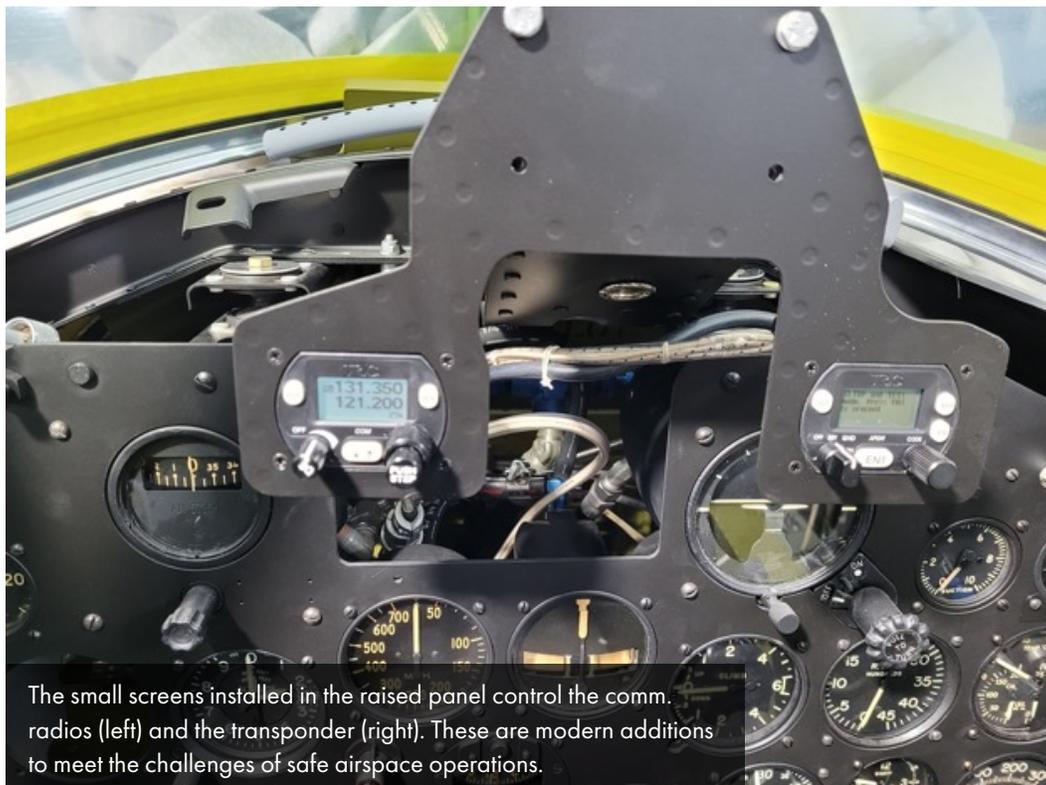
The small screens installed in the raised panel control the comm. radios (left) and the transponder (right). These are modern additions to meet the challenges of safe airspace operations.

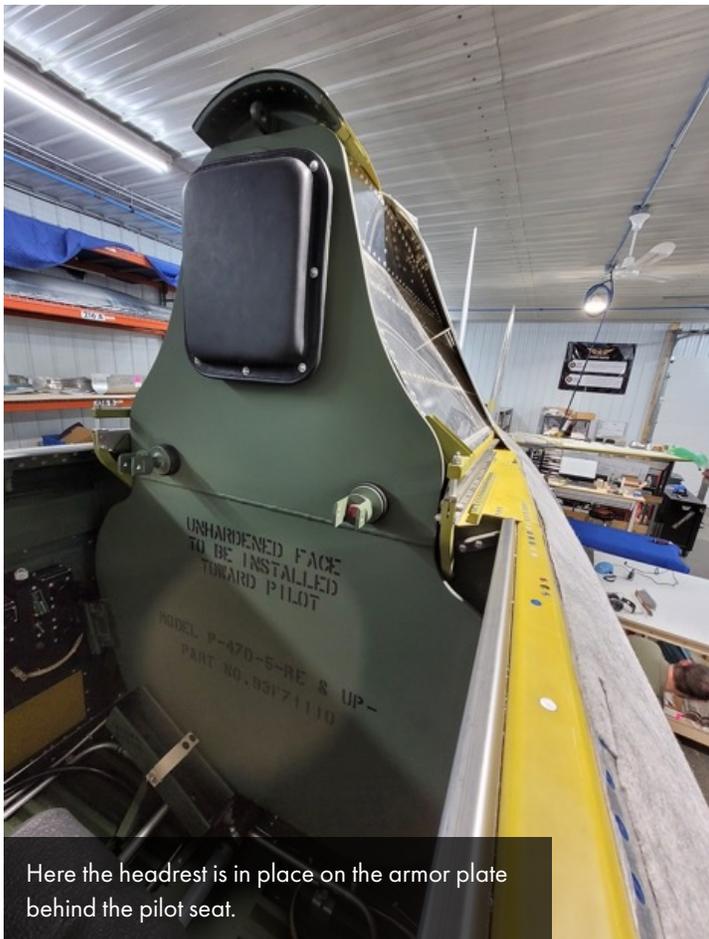
Here the headrest is in place on the armor plate behind the pilot seat.

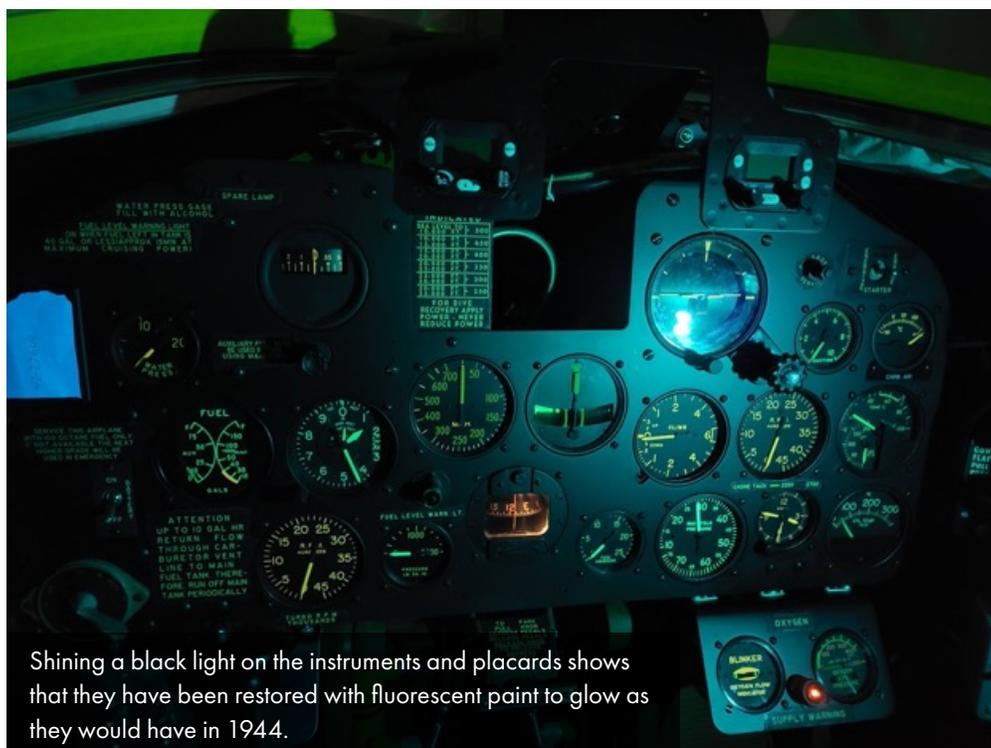
Shining a black light on the instruments and placards shows that they have been restored with fluorescent paint to glow as they would have in 1944.

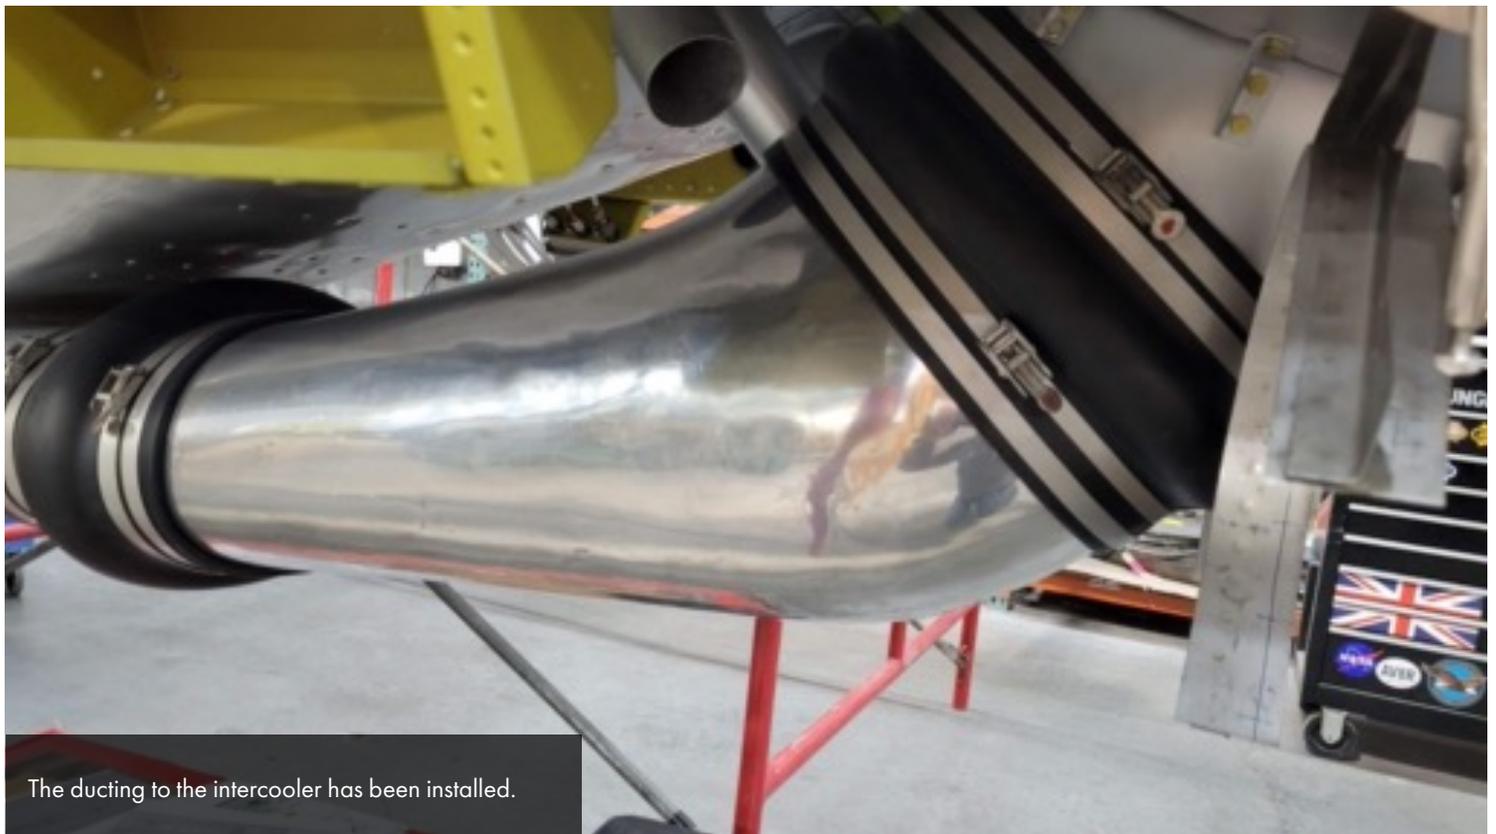
The ducting to the intercooler has been installed.
