Dakota Territory Air Museum's P-47 Update

AIRCORPS AVIATION

by Chuck Cravens

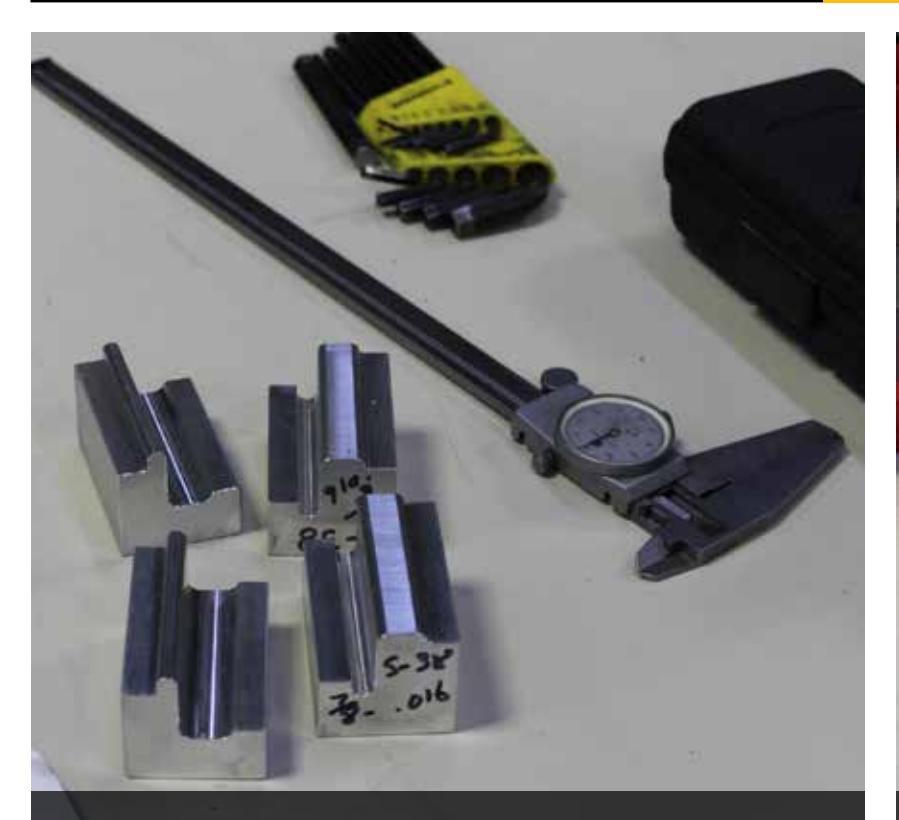
The P-47 has many extrusions and quite a few need joggles formed in them. These are dies made to form joggles in wing extrusions.

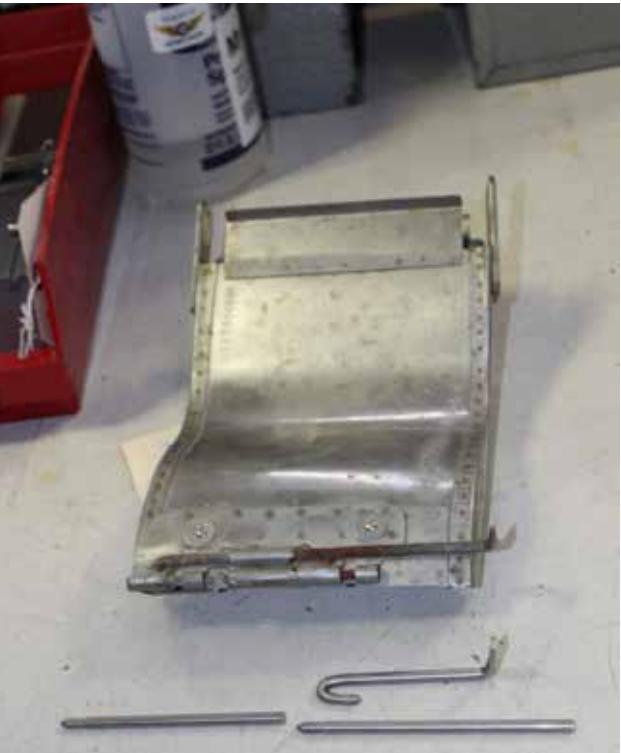
Steve made the double hook spring latch arm and pin assembly to replace the original rusted one on this ammunition feed chute.

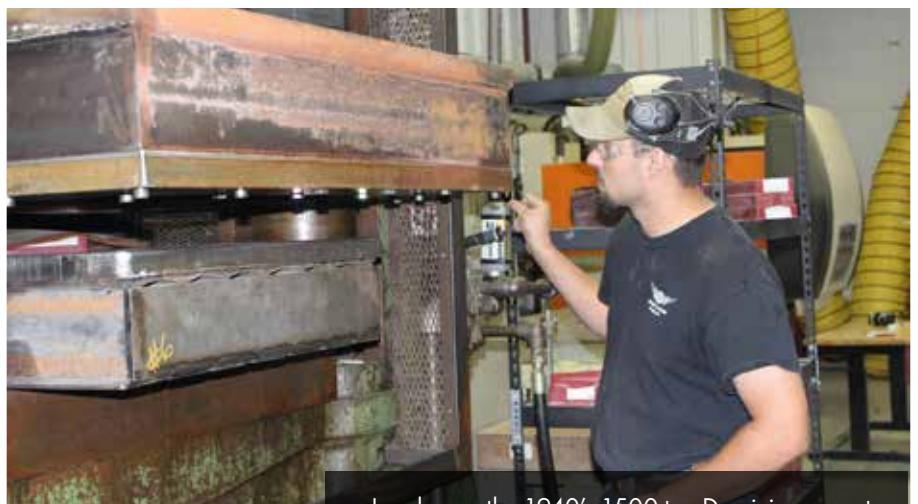
Jacob uses the 1940's 1500 ton Dominion press to form a shroud for the turbo supercharger ducting.

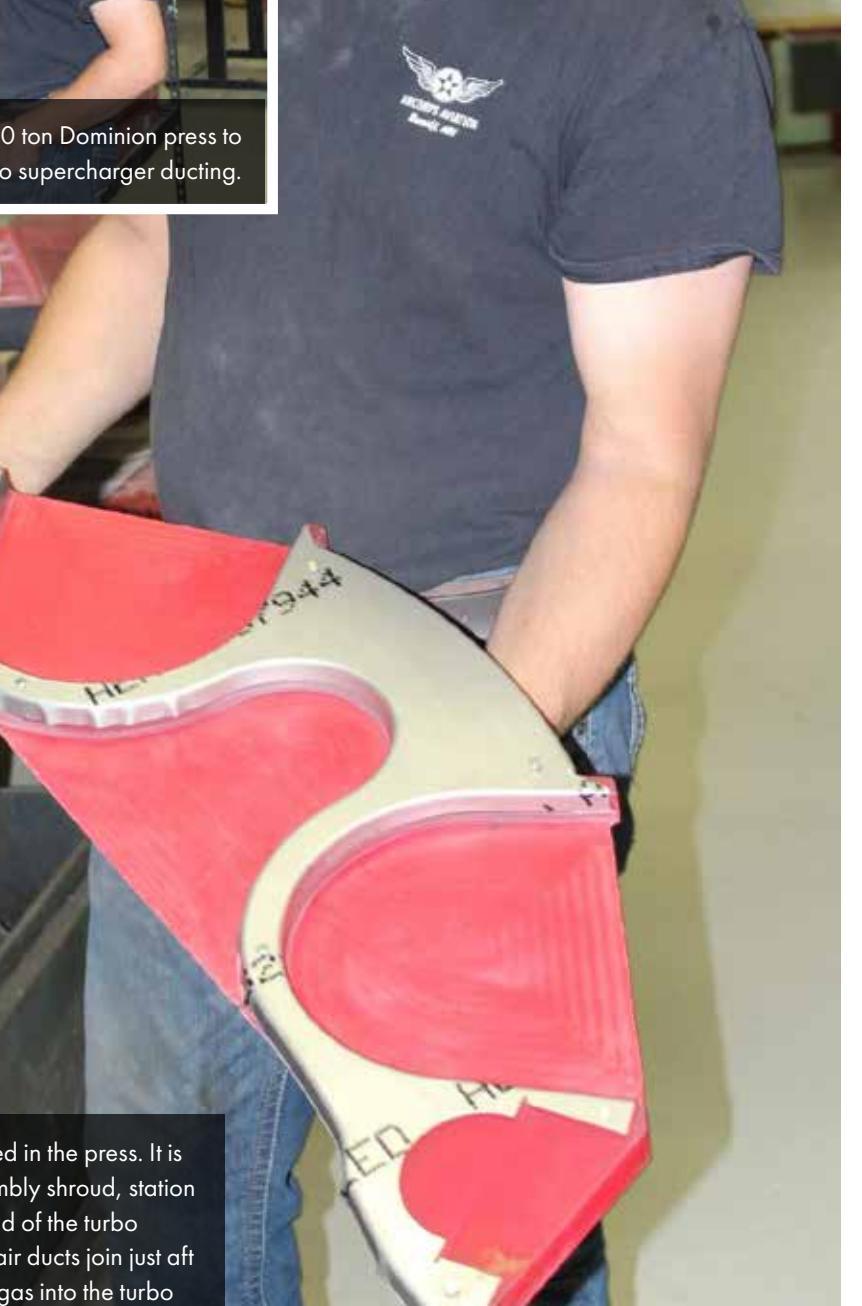
Here is the part after being formed in the press. It is part no. 89F11924, former assembly shroud, station 232 1/2. That station is just ahead of the turbo supercharger and the two turbo air ducts join just aft of this shroud; then feed exhaust gas into the turbo supercharger to drive the turbine wheel.
