Dakota Territory Air Museum's P-47 Update by Chuck Cravens

Update

Fuselage skin riveting was nearly finished this month and the tail cone has been permanently attached to the forward fuselage. A great deal of progress was also made on the cockpit enclosure.

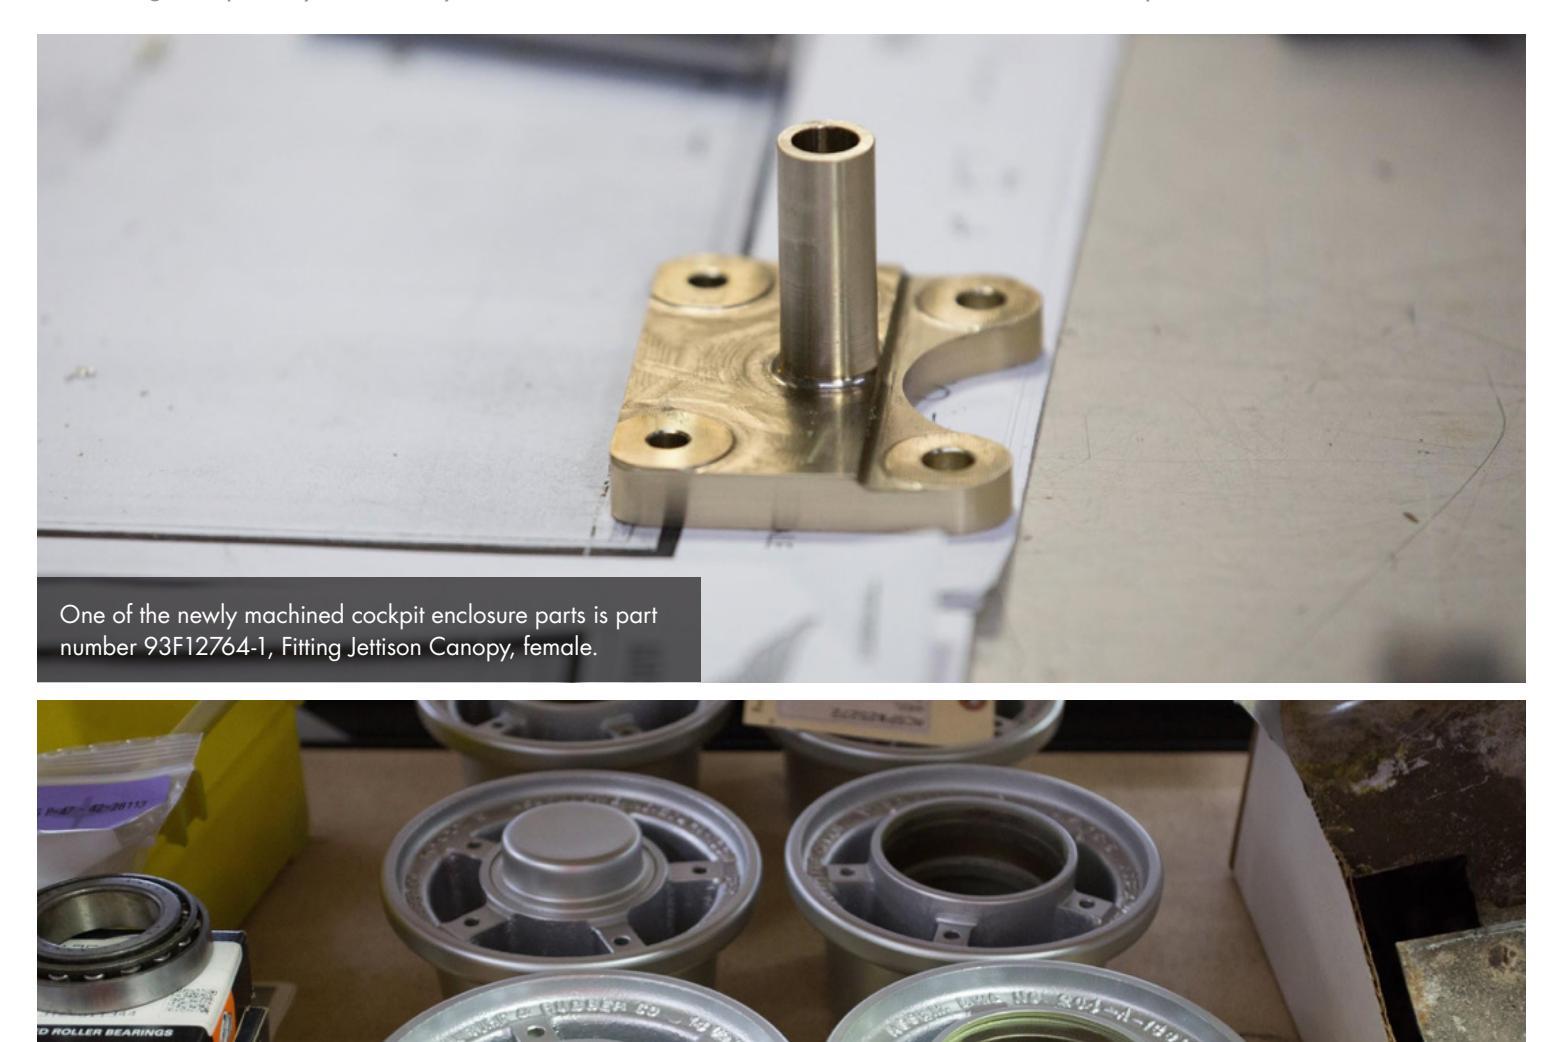
These are tail wheel castings. The lettering indicates they were produced by General Tire and Rubber Company.

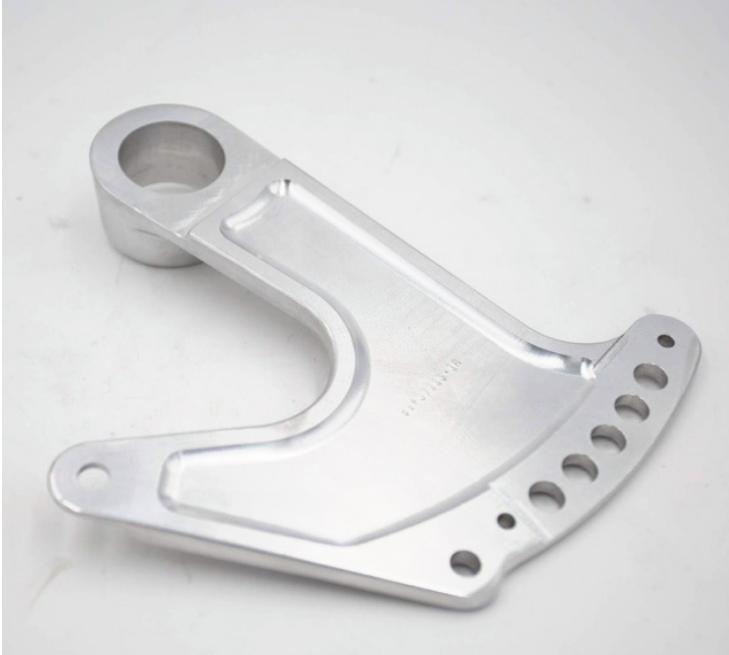
This odd shaped part is the Quadrant Assembly, Rudder Pedal Adjustment, part number 89F37711. It attaches to the side of the rudder pedal assembly frame.

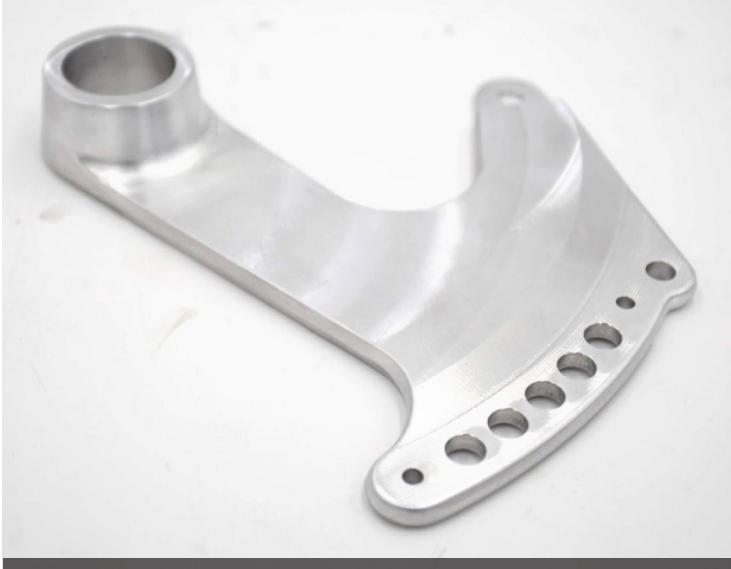
This view shows the other side of the rudder pedal quadrant pedal adjustment.

The line of 5 identical sized holes allows adjustment of the cable tension by moving the pivot pin. The rudder pedal cable attaches to the single small hole that is furthest left.

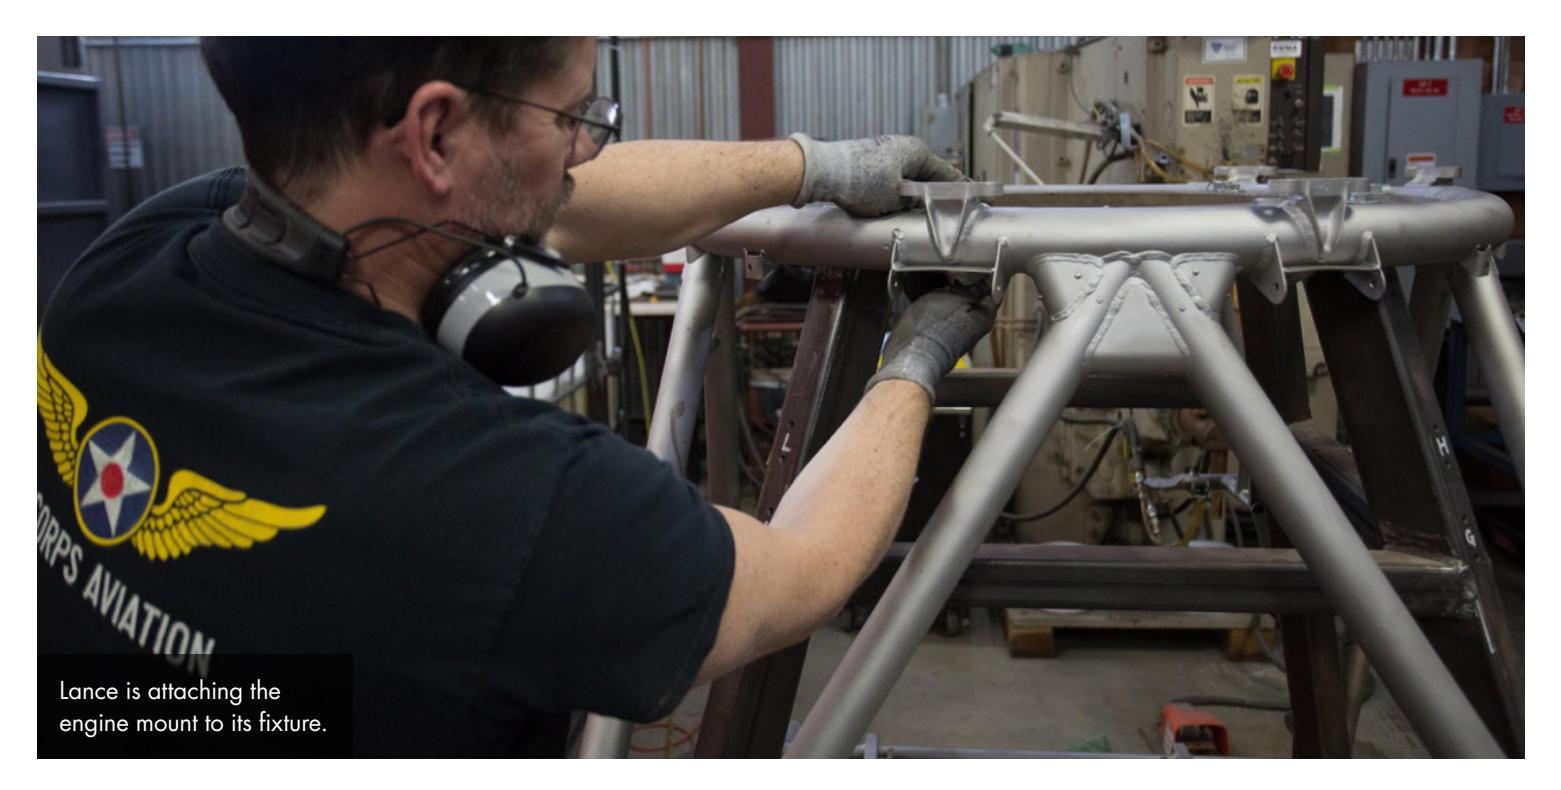
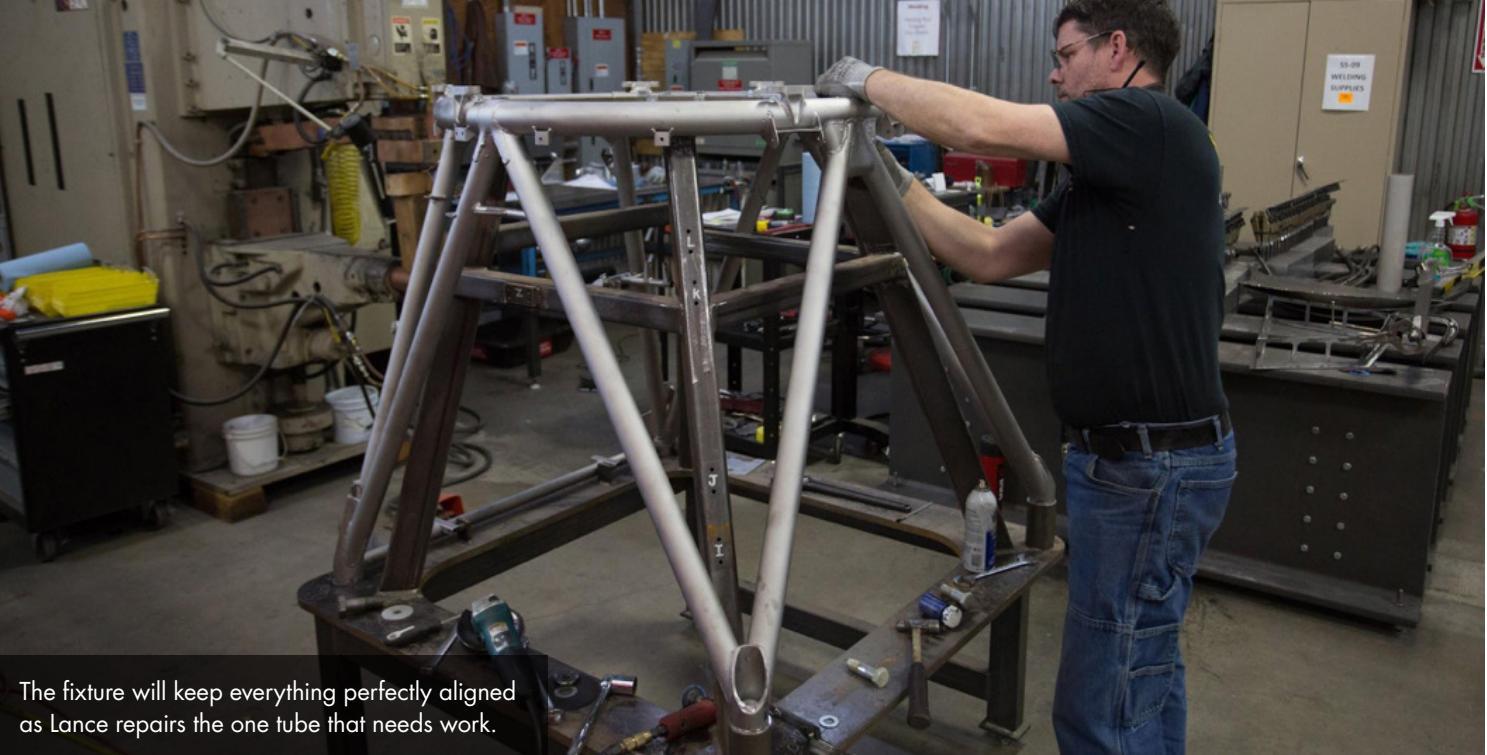
It takes a strong engine mount to hold the well over 2000 lb. R-2800, and handle the vibrations and torque as it runs. Lance has been inspecting and restoring an engine mount. It is in pretty good shape, but needs repair on one of its steel tubes.

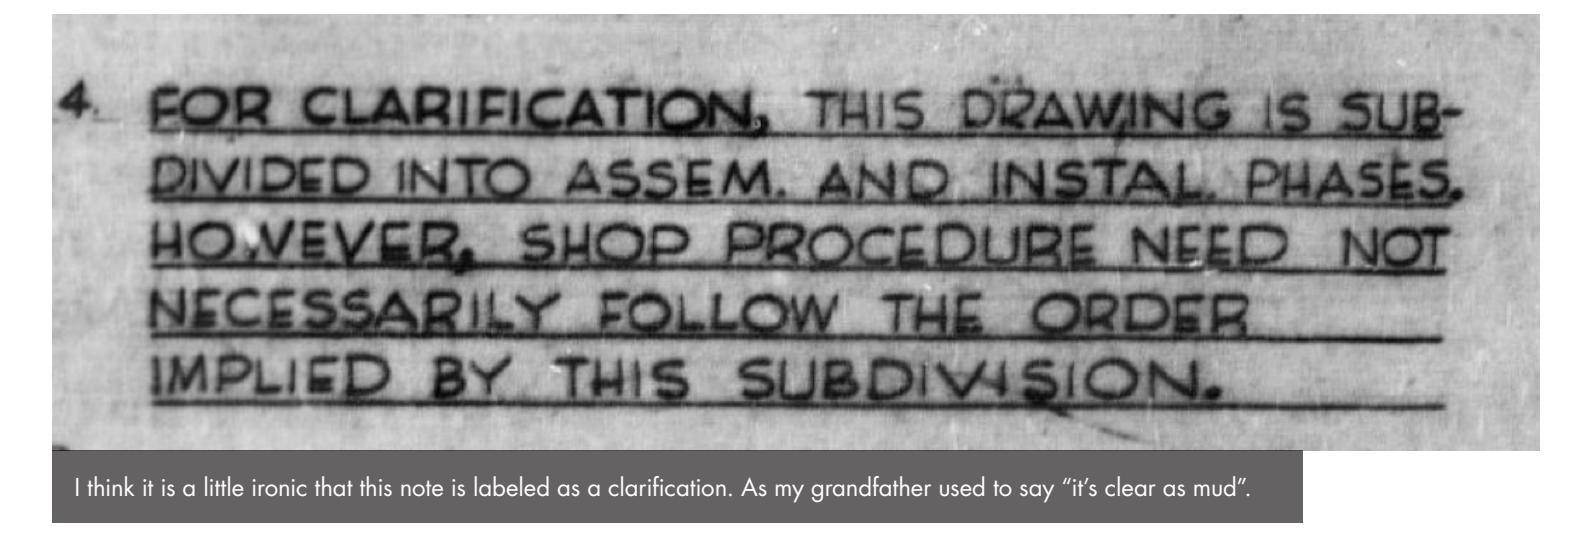
Sometimes the drawings are simply ambiguous and a little confusing as in the note below:

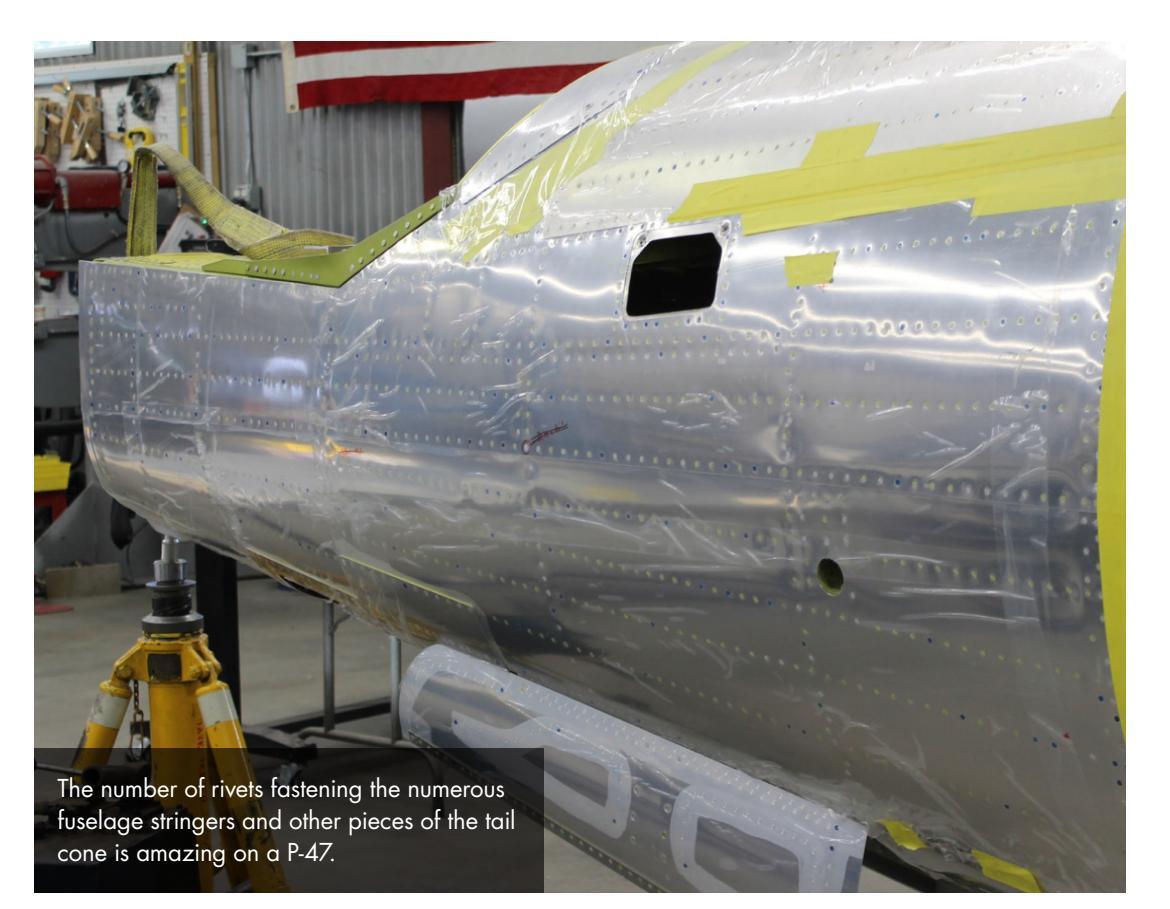
The Thunderbolt's interior structure also adds complications to the job. With so many passages for ducting and reinforcement plates, there are numerous very tight spaces for bucking rivets. These are created by inner and outer walled off areas, even though overall, the inside of the fuselage is cavernous.
