AT-10 WICHITA

Cadet Air Museum AT-10 Project
by Chuck Cravens

AIRCORPS AVIATION

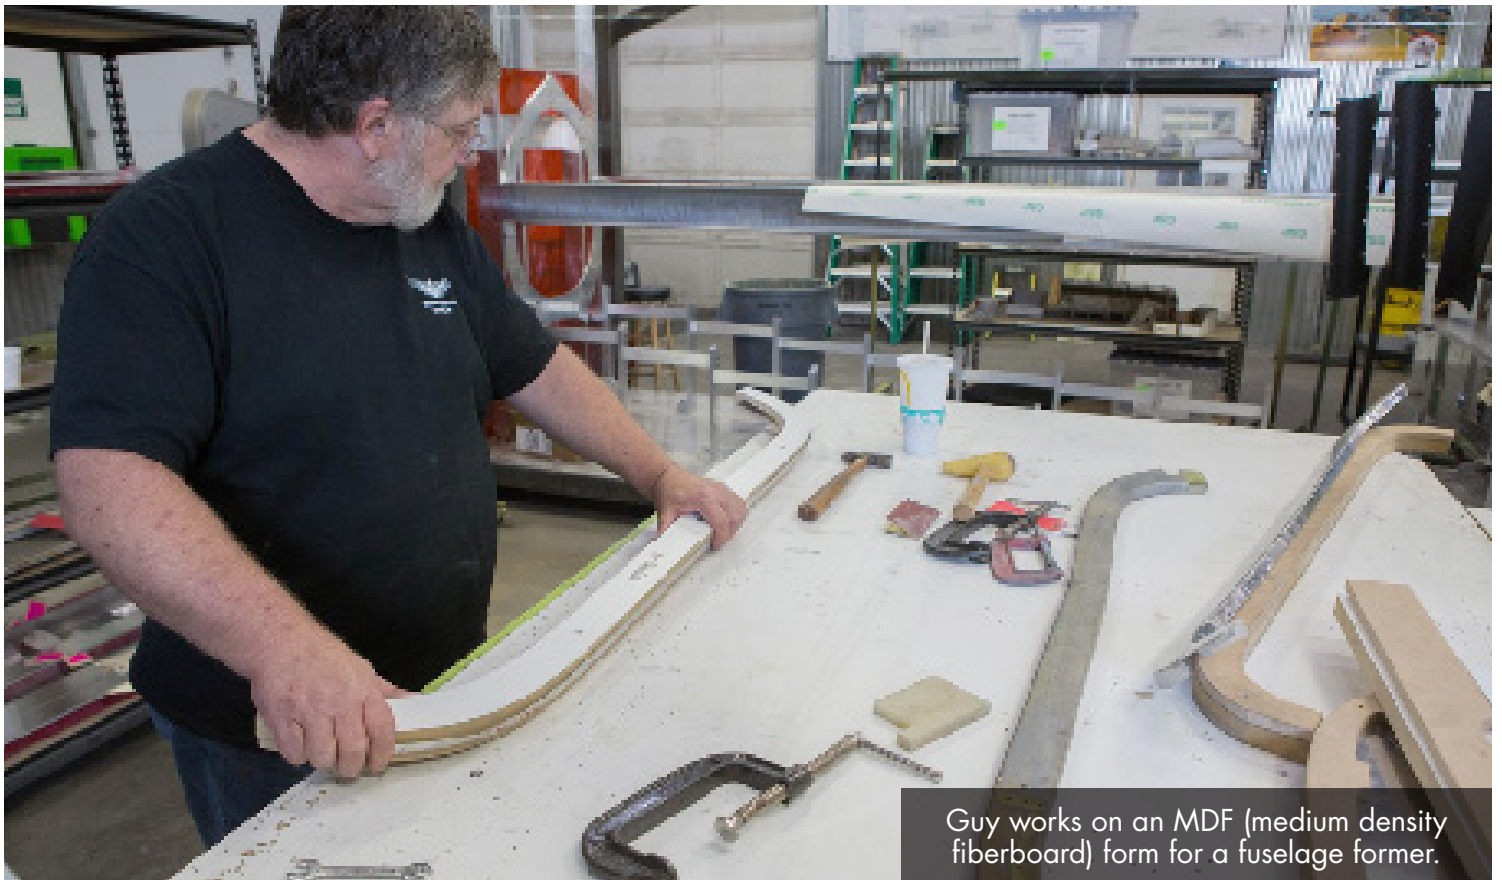
Guy works on an MDF (medium density fiberboard) form for a fuselage former.

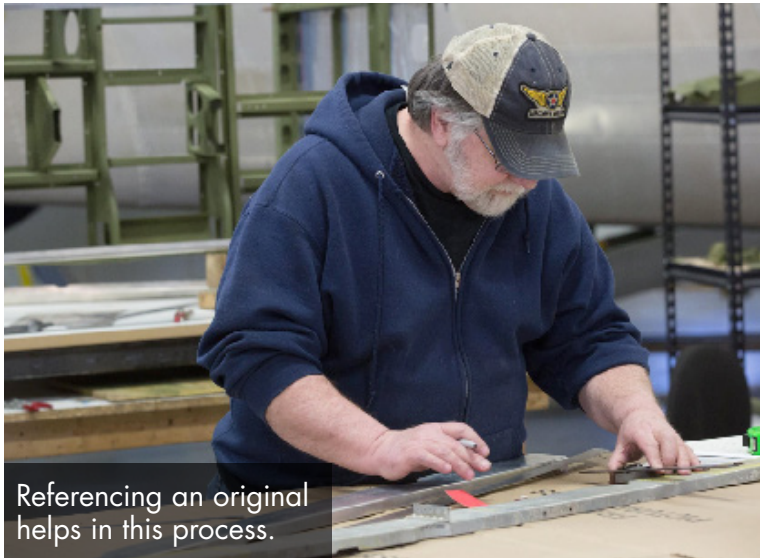
Referencing an original helps in this process.

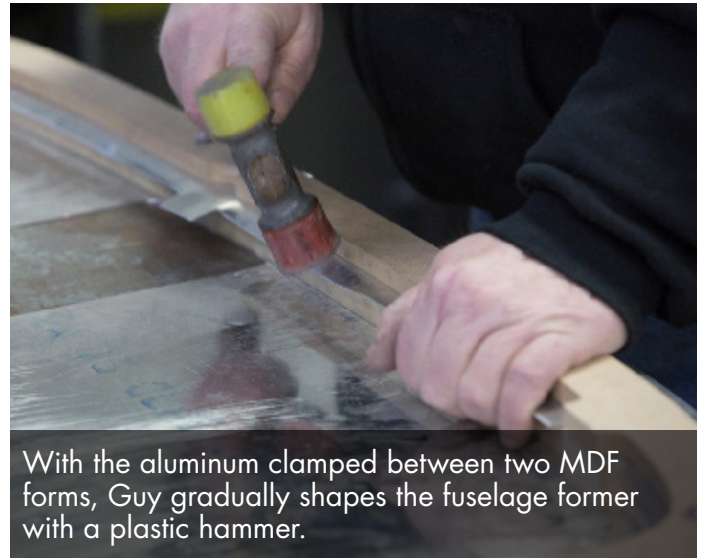
With the aluminum clamped between two MDF forms, Guy gradually shapes the fuselage former with a plastic hammer.

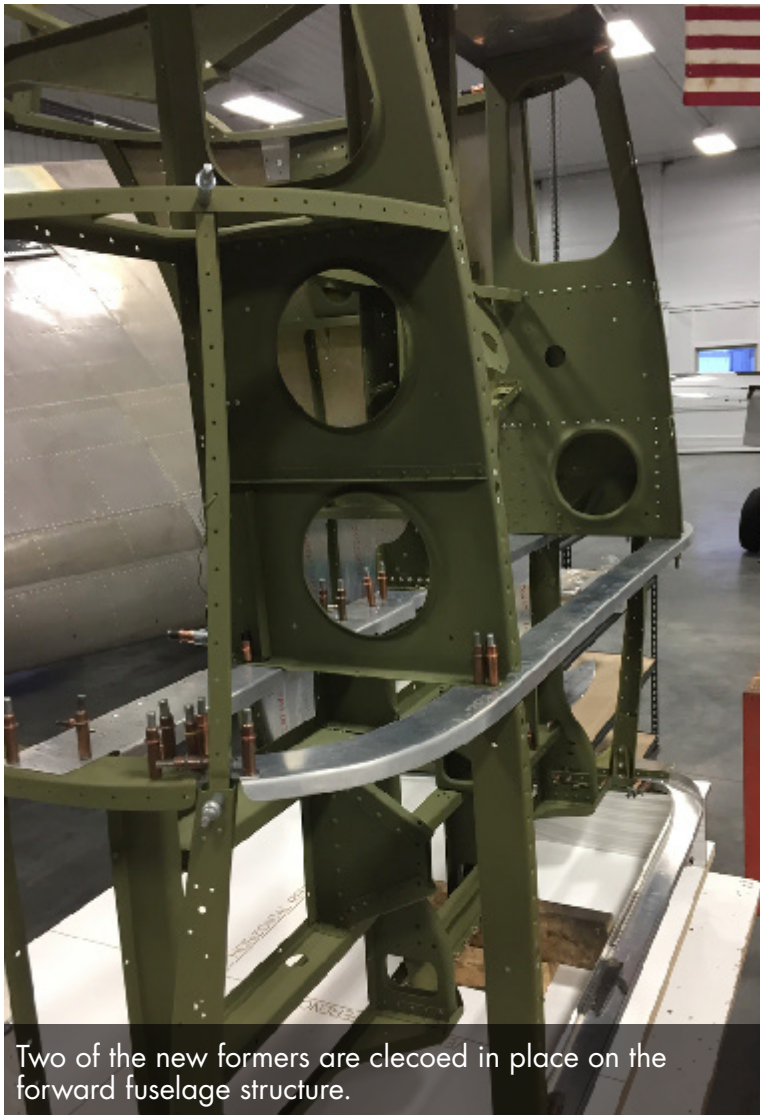
Two of the new formers are clecoed in place on the forward fuselage structure.

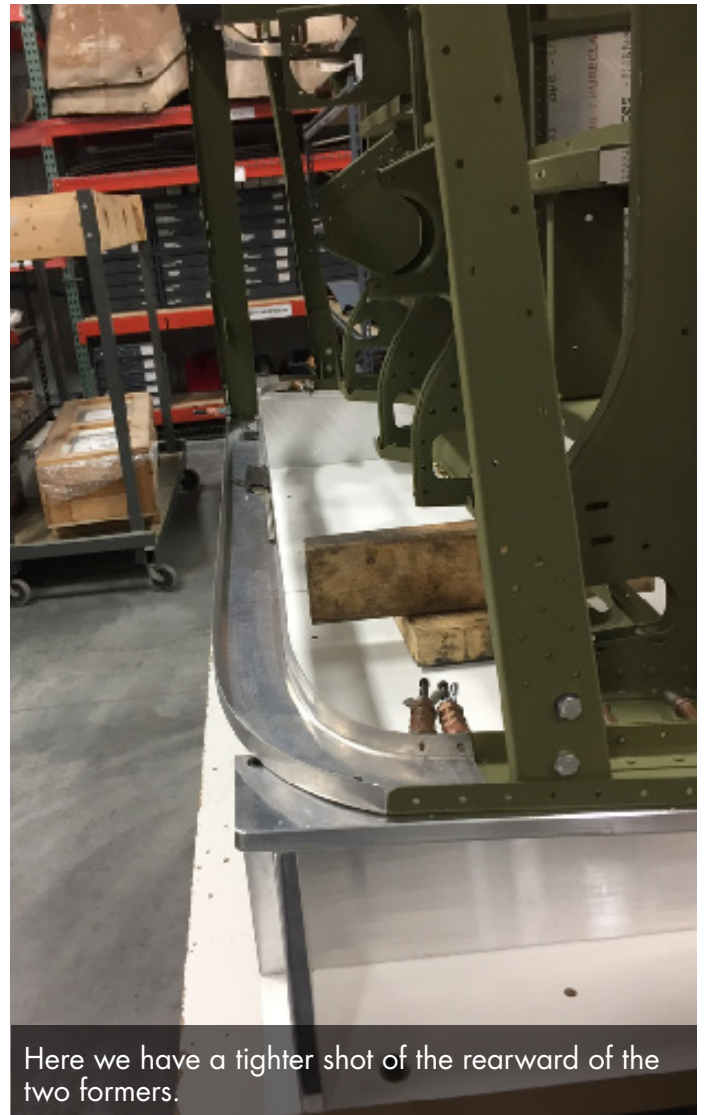
Here we have a tighter shot of the rearward of the two formers.

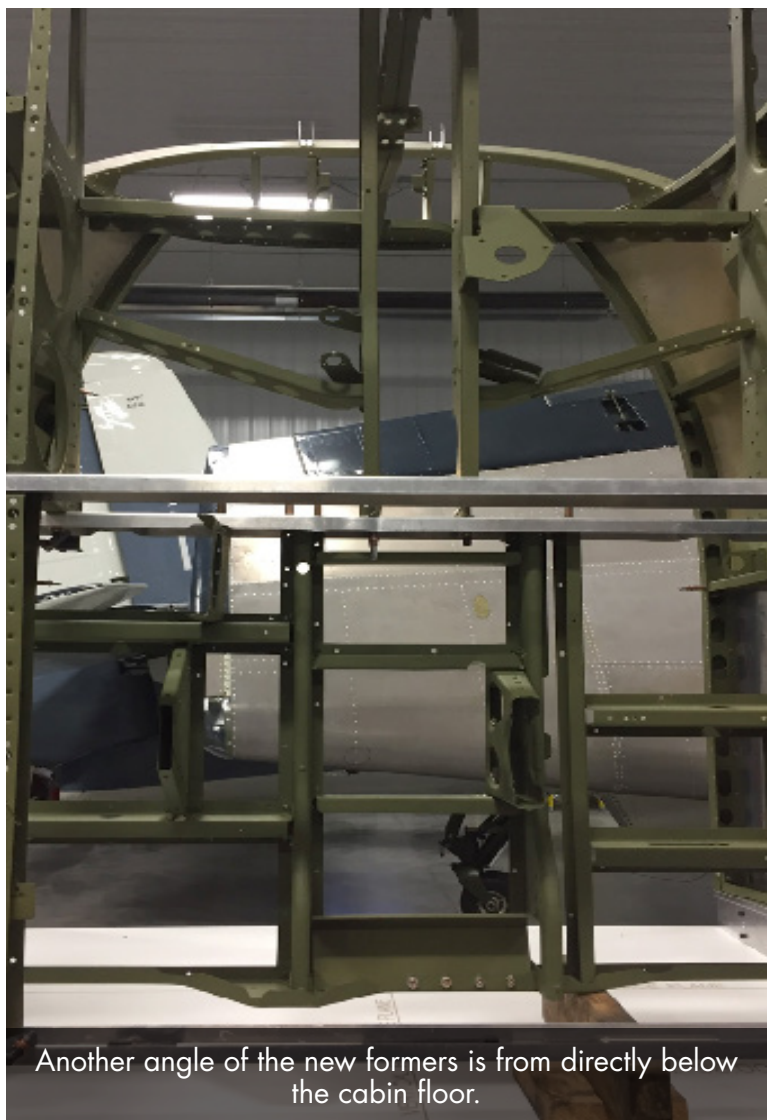
Another angle of the new formers is from directly below the cabin floor.

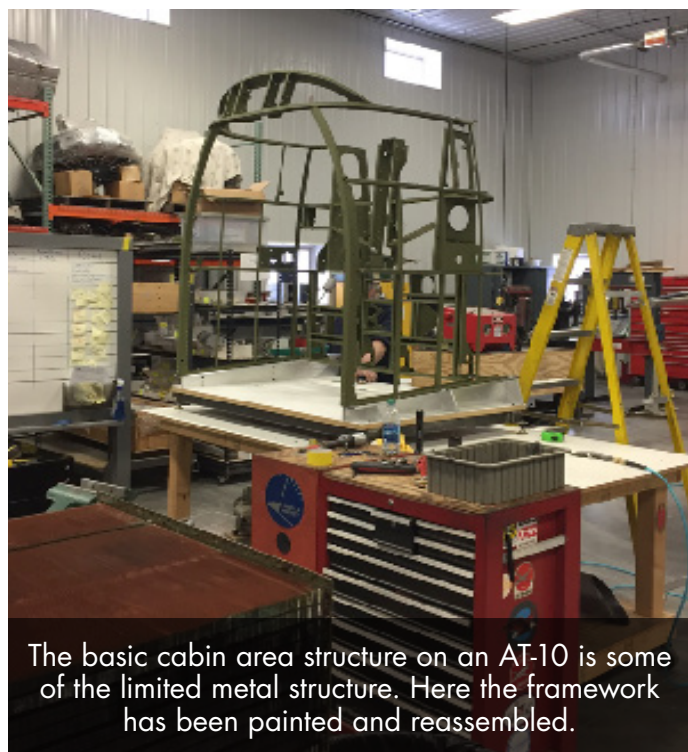
The basic cabin area structure on an AT-10 is some of the limited metal structure. Here the framework has been painted and reassembled.

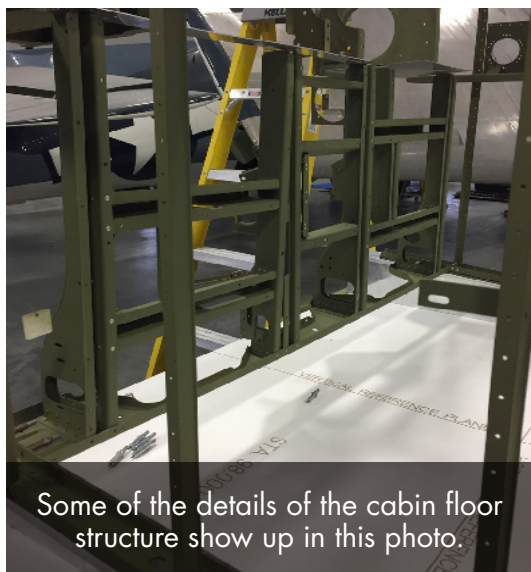
Some of the details of the cabin floor structure show up in this photo.

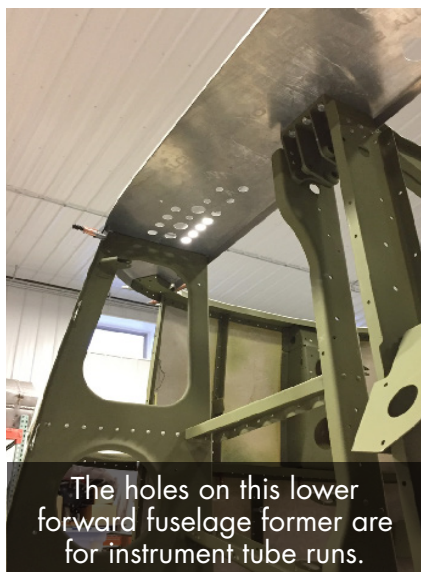
The holes on this lower forward fuselage former are for instrument tube runs.

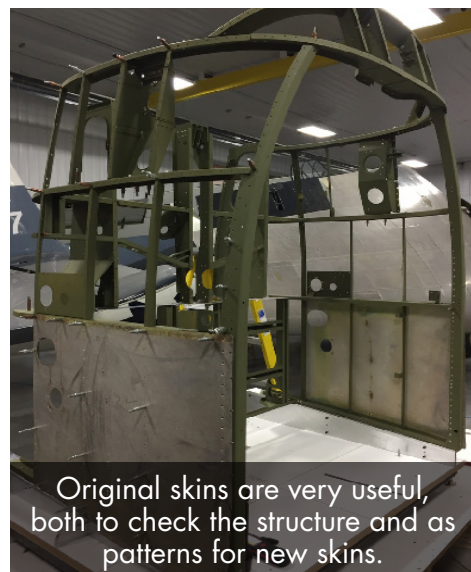
Original skins are very useful, both to check the structure and as patterns for new skins.

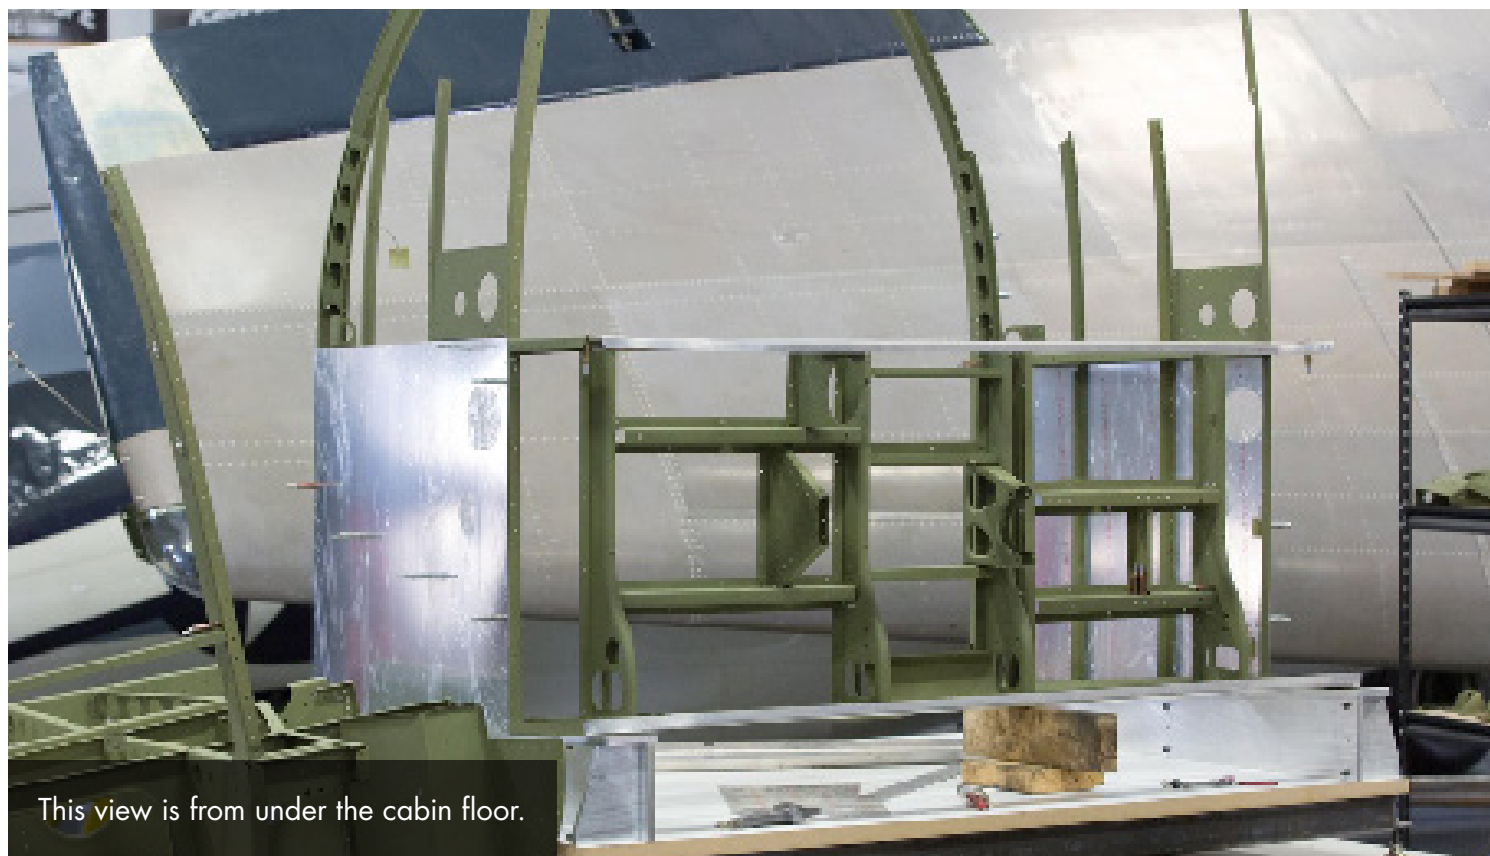
This view is from under the cabin floor.

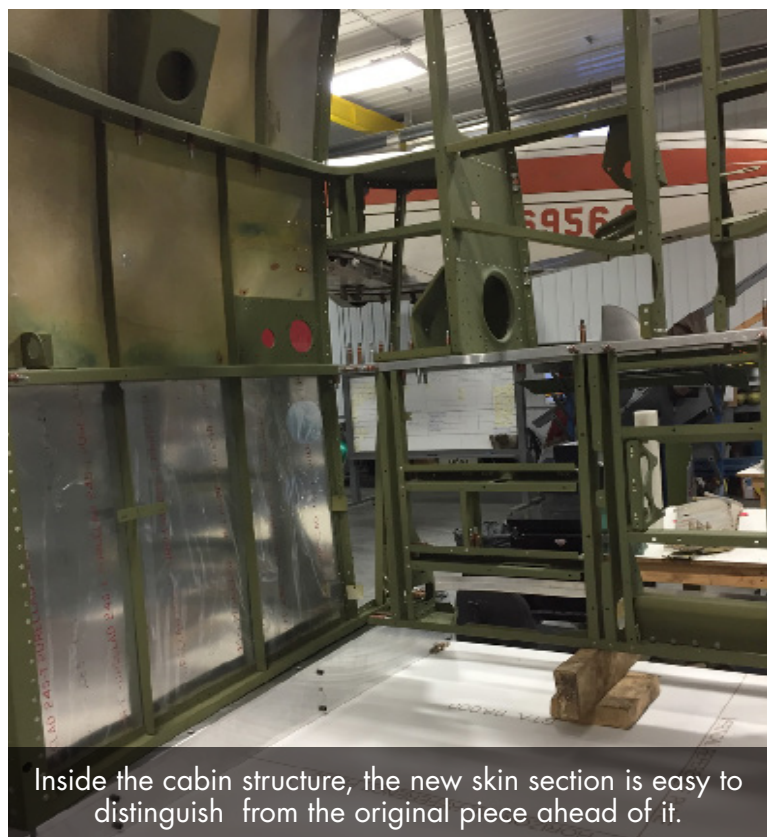
Inside the cabin structure, the new skin section is easy to distinguish from the original piece ahead of it.

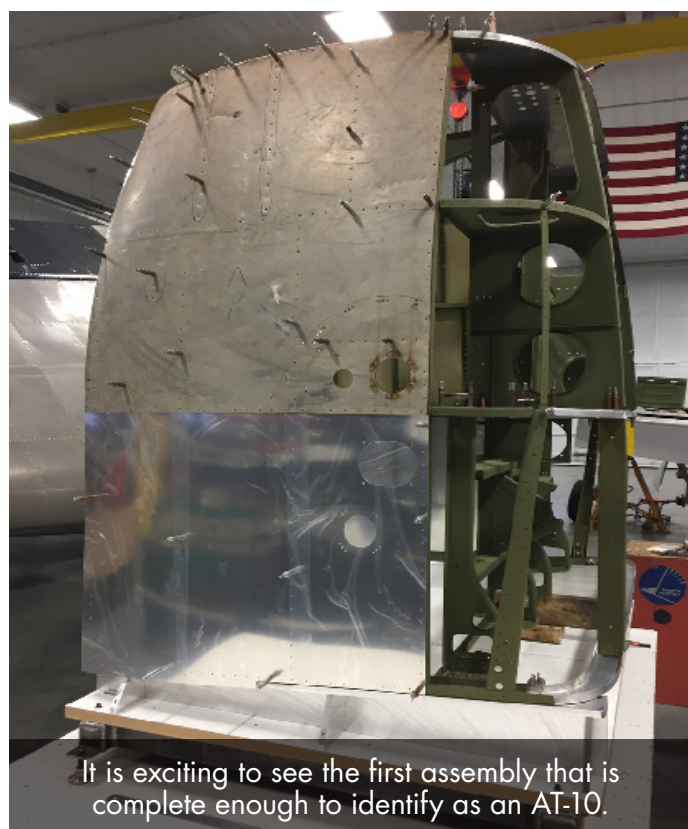
It is exciting to see the first assembly that is complete enough to identify as an AT-10.
